HAP 17-001-L

TO:	<div>CHAIR AND MEMBERS</div> <div>LONDON ADVISORY COMMITTEE ON HERITAGE</div> <div>MEETING ON WEDNESDAY MARCH 8, 2017</div>
FROM:	<div>JOHN M. FLEMING</div> <div>MANAGING DIRECTOR, PLANNING AND CITY PLANNER</div>
SUBJECT:	<div>HERITAGE ALTERATION PERMIT APPLICATION</div> <div>AT 30 OXFORD STREET WEST,</div> <div>BLACKFRIARS/PETERSVILLE HCD</div> <div>BY: FEROZE ZUBAIR</div>

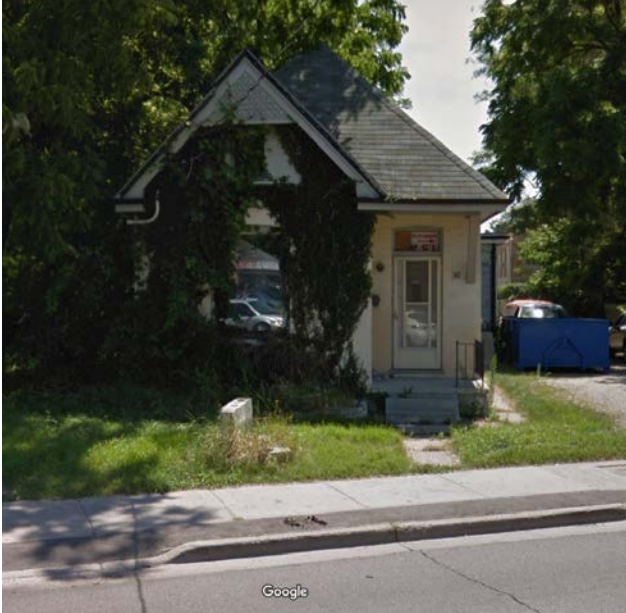
Image 1: Main (north) façade of the building located at 30 Oxford Street West (Google, July 2016).

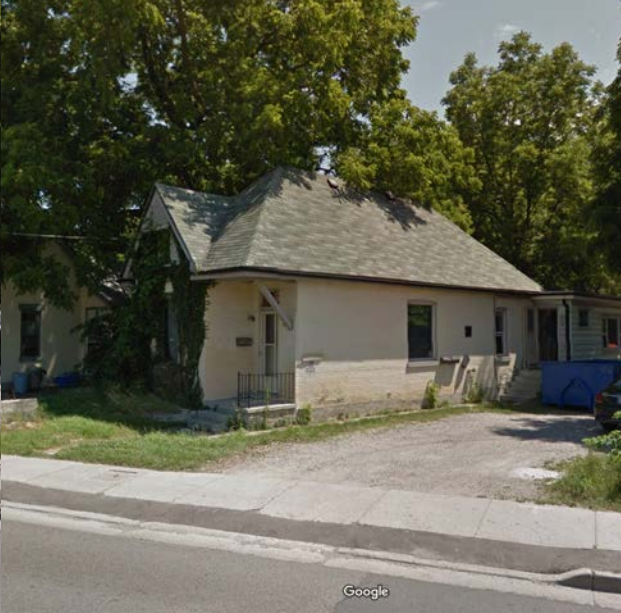
Alterations were undertaken at 30 Oxford Street West in summer 2016 without obtaining Heritage Alteration Permit approval. An existing window on the west façade was removed and replaced by a much smaller window with the remainder of the void in the brick structure filled in by horizontal vinyl siding. The transom above the front door, which was previously covered, was subject to alterations when the front door was replaced. Instead of restoring the lost transom, the cladding was altered.

Image 2: West façade of the building located at 30 Oxford Street West (Google, July 2016).

- The window on the west façade which was previously filled in with a smaller window and siding must be replaced by a window which fills the entire opening of the brick, in a style, orientation, and proportion that is compatible with the building

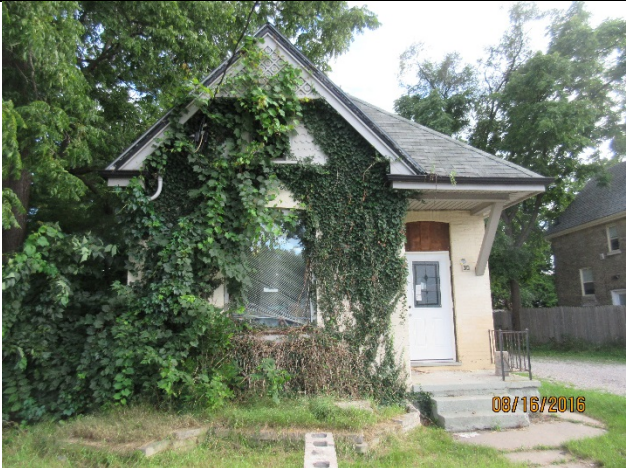
Image 1: Main (north) façade of the building located at 30 Oxford Street West.

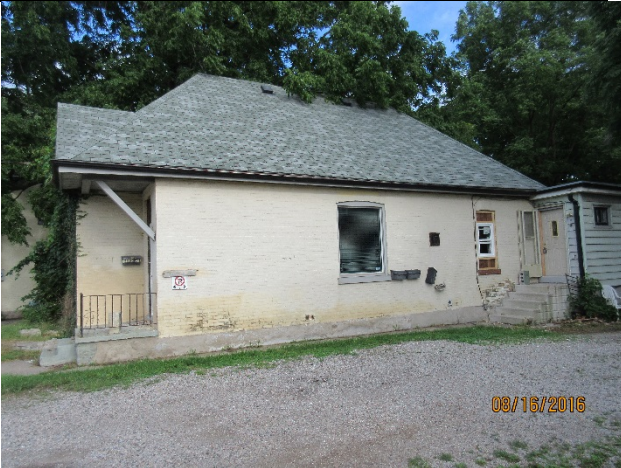
Image 2: West façade of the building located at 30 Oxford Street West.

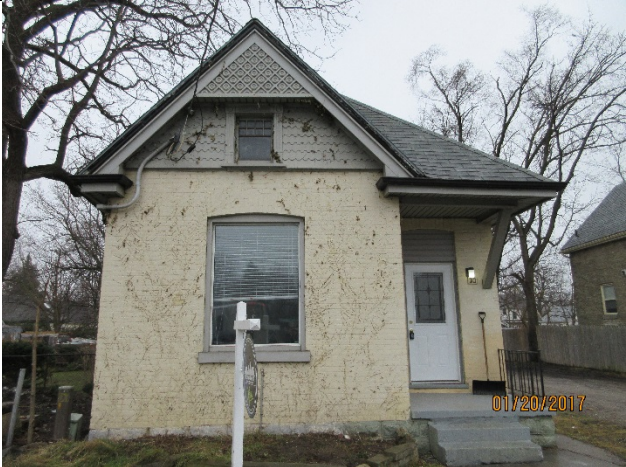
Image 3: Main (north) façade of the building located at 30 Oxford Street West.

- (e.g. hung window);
- The transom of the front door must be reinstated; and,
 - Paint the replacement door and window to blend in with the existing building per section 11.2.10 of the *Blackfriars/Petersville HCD Plan*.

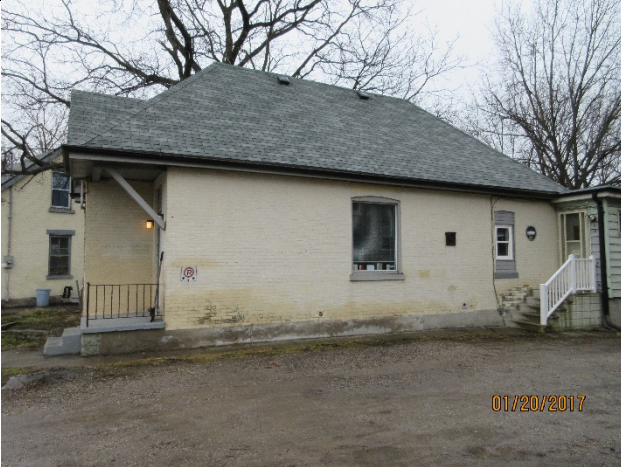
Image 4: West façade of the building located at 30 Oxford Street West.

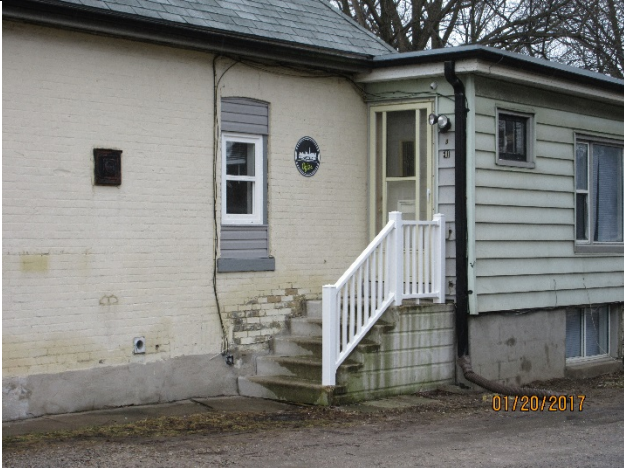
The previously undertaken alterations to the building at 30 Oxford Street West have resulted in an adverse impact to the property’s cultural heritage value as a Contributing Resource in the Blackfriars/Petersville HCD. The alterations have not been sympathetic to the architectural style or existing patterns of solids and voids of the brick structure, and are distinguishable in a negative manner.

Image 5: Detail of window replacement on west façade of the building located at 30 Oxford Street West.

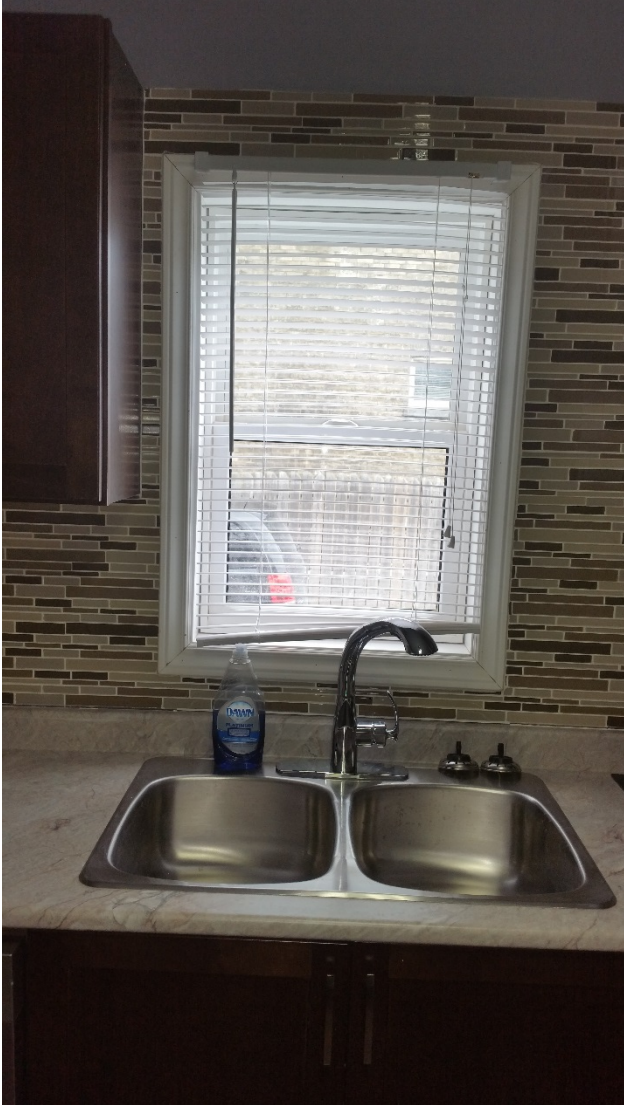
Image 7: Interior image provided by the property owner showing the space inside of the altered window on the west façade.
