TO:	CHAIR AND MEMBERS PLANNING & ENVIRONMENT COMMITTEE MEETING ON MONDAY JUNE 19, 2017
FROM:	JOHN M. FLEMING MANAGING DIRECTOR, PLANNING AND CITY PLANNER
SUBJECT:	REQUEST FOR DEMOLITION OF HERITAGE LISTED PROPERTY AT 220 GREENWOOD AVENUE BY: JULCON DEVELOPMENTS INC.

RECOMMENDATION

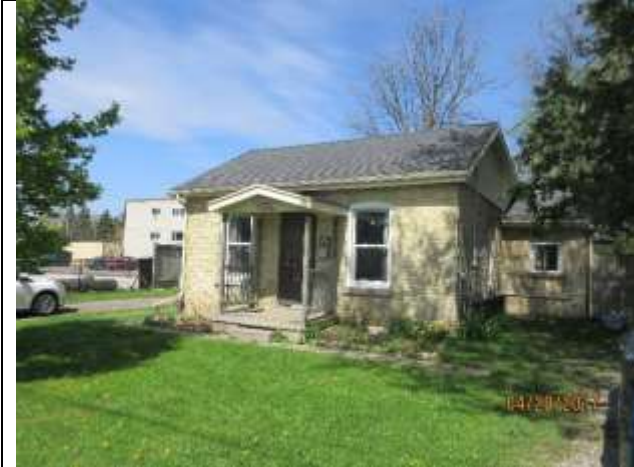
Image 1: Main (west) façade of the building located at 220 Greenwood Avenue.

The building located at 220 Greenwood Avenue is a single storey, buff brick, vernacular cottage (Appendix B). What appears to be the original building has a rectangular shape with a gable roof clad in asphalt. The foundation is constructed of three courses of buff brick with a crawl space beneath the original building. The main (west) façade of the building is symmetrical with a central entrance door, accessed via a newer gable roofed porch, flanked by two sash windows. None of the windows or doors are original, but appear to be within the original voids of the structure. The segmented arch window voids are emphasized by a radiating brick soldier course with header bricks above. Some members of the Stewardship Sub-Committee thought that the building may have been constructed using a stacked plank technique, however selective demolition undertaken by the property owner on the interior of the original building did not identify stacked plank construction but conventional framing.

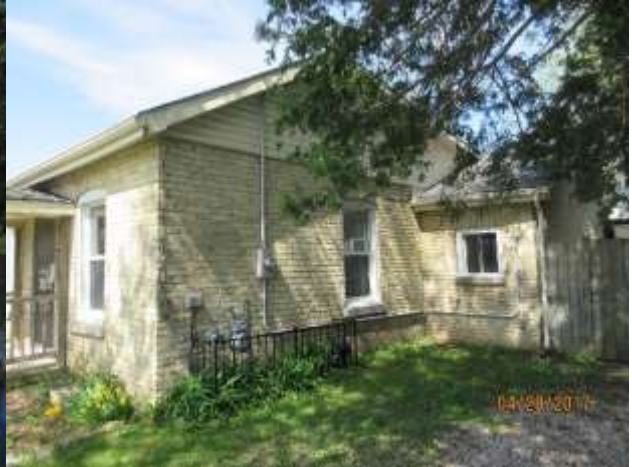
Image 2: South façade of the building at 220 Greenwood Avenue.

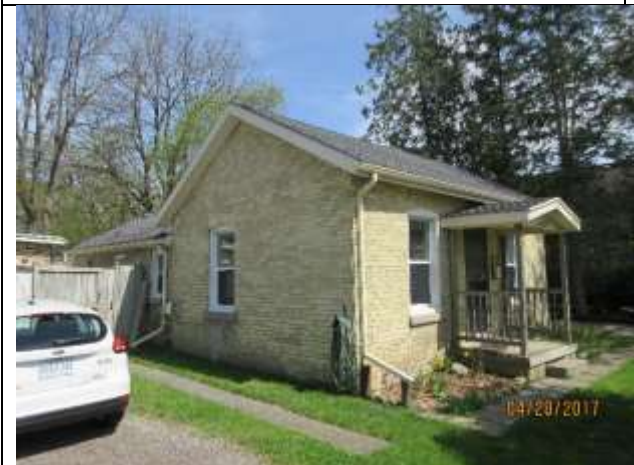
Image 3: North façade of the building located at 220 Greenwood Avenue.

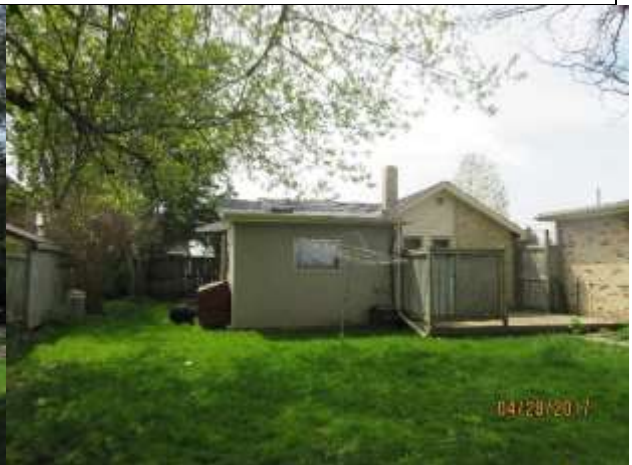
Image 4: Rear (east) façade of the building located at 220 Greenwood Avenue, with garage at right.

Several additions have been built onto the original structure. These changes are demonstrated by different materials, different orientation of forms, changes in the roof line, and changes in floor level seen on the interior. Some of the additions are clad in buff brick, but others are constructed of exposed concrete block or a combination of brick and siding.

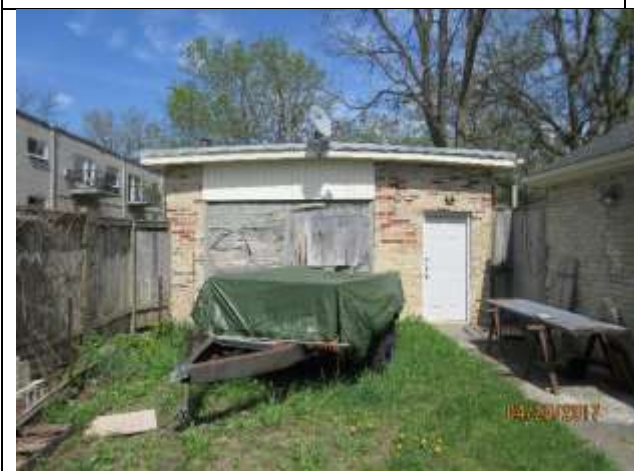
Image 5: Detached garage located at 220 Greenwood Avenue.

The building is centred on the property's frontage with a consistent setback to abutting residential properties on Greenwood Avenue. The property also has two driveways, one of which leads to a detached garage. The detached garage (built c.1977) is located to the northeast of the house and is partially clad in buff brick that may have been salvaged.

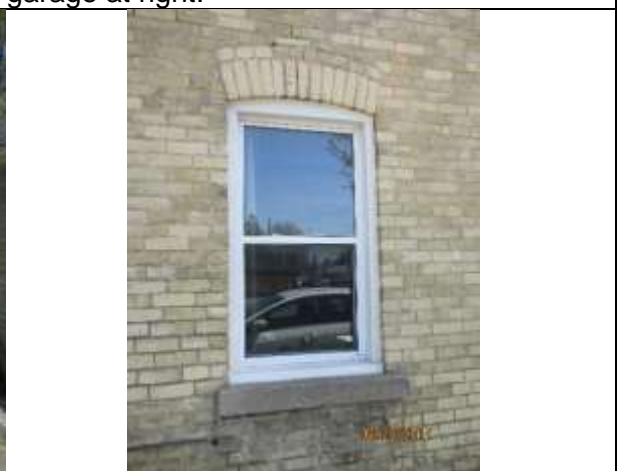
Image 6: Detail of window on the north façade of the building at 220 Greenwood Avenue.
