<b>TO:</b>	<b>CHAIR AND MEMBERS PLANNING &amp; ENVIRONMENT COMMITTEE MEETING ON MONDAY JULY 17, 2017</b>
<b>FROM:</b>	<b>JOHN M. FLEMING MANAGING DIRECTOR, PLANNING AND CITY PLANNER</b>
<b>SUBJECT:</b>	<b>REQUEST FOR DEMOLITION OF HERITAGE LISTED PROPERTY AT 660 SUNNINGDALE ROAD EAST BY: PETER SERGAUTIS</b>

APPENDIX A — Maps

APPENDIX B — Images

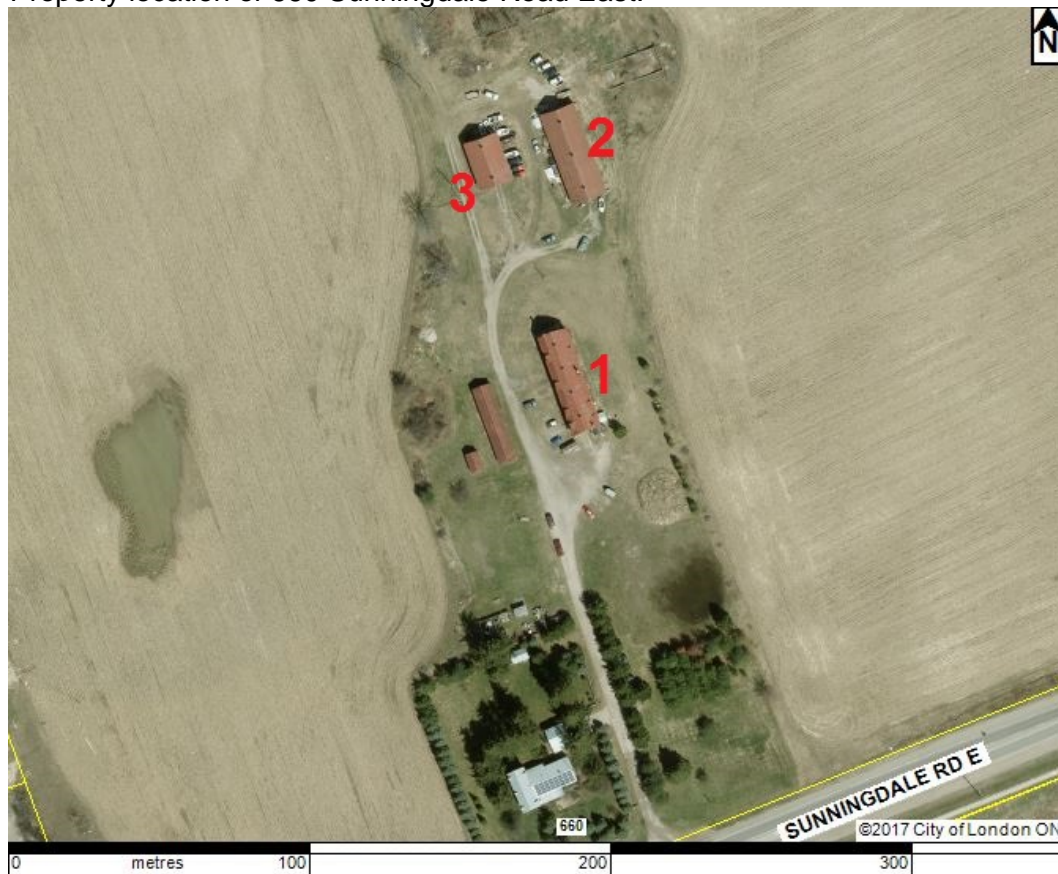
Map 2: Detail of the property located at 660 Sunningdale Road East identifying Barn 1, Barn 2, and Barn 3.

The recommended action would begin designation of the property pursuant to Section 29 of the Ontario Heritage Act, with the intent of retaining Barn 2 and Barn 3 [see Map 2 Appendix A]. No demolition would be permitted until the municipality passes a heritage designation by-law registered on property title. Thereafter, pursuant to Section 34, Council would have 90 days to consider any received demolition request.

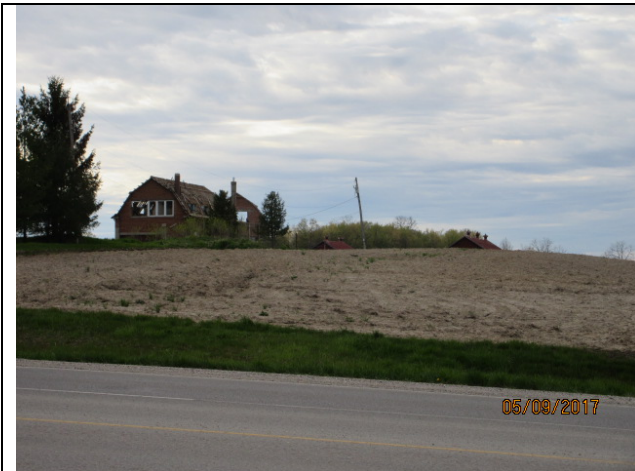
Image 1: The three barns at 660 Sunningdale Road East.

Along with a detached frame dwelling, there are three barns<sup>a</sup> located on the property at 660 Sunningdale Road East (Appendix A, Image 2; Appendix B). These buildings are located on a high point of the property, which slopes down towards the Sunningdale Road East/Adelaide Street North intersection. The dwelling is located near the southwest corner of the property, with a laneway off of Sunningdale Road East to the east of the dwelling. This laneway connects the three barns to the dwelling and road.

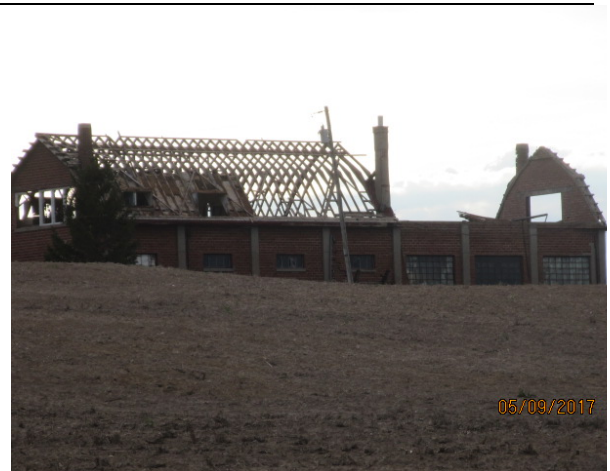
Image 2: Detail the east façade of Barn 1.

**Barn 1** – The largest of the three barns has a gambrel roof (see Appendix A, Image 2; Appendix B). It is two storeys in height. The building’s structure is composed of concrete-faced piers; the corner piers appear to be constructed of pressed brick. Barn 1 is seven bays in length, with a single bay across the north and south walls. Multi-pane windows were located high on the side walls, above the height of a single leaf entrance door. A large overhead door is located on the south wall, with an entrance vestibule with a gambrel roof to one side. Five windows separated by mullions are set above the overhead door and centred under the open end of the gambrel. No opening is located on the north wall on the ground storey, but a window void is located in the open end of the gambrel which is believed to match that of the south gambrel end. All of the windows appear to have brickwork or smaller clay tile detailing around the windows. The barn used to have a metal roof with four ventilators evenly spaced across the ridge of the roof. The gambrel roof had four shed dormers. A chimney is located at each end of the structure (see images in Appendix C).

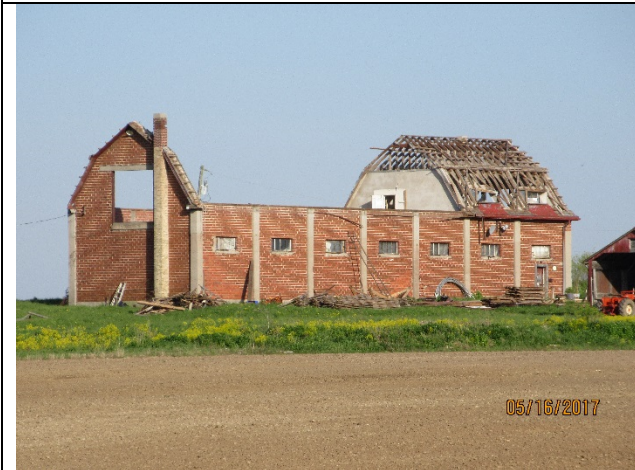
Image 3: Detail of the west façade of Barn 1.

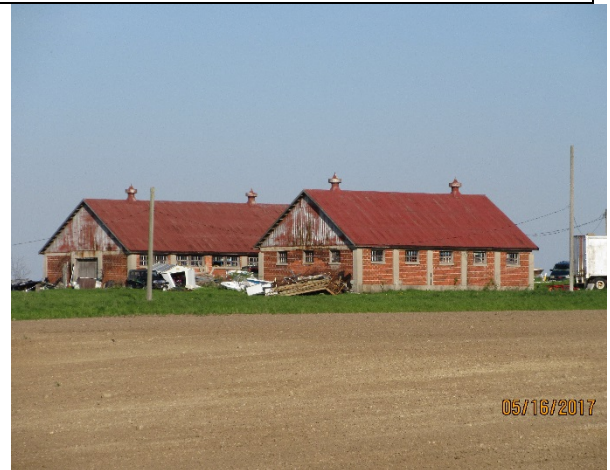
Image 4: Partial view of Barn 2 (background).

**Barn 2** – The medium sized barn located to the north of Barn 1 has a gable roof with projecting purlins and three ventilators at its ridge (see Appendix A, Image 2; Appendix B). The end gable is clad in corrugated steel; the same material clads the roof. The building is single storey in height and nine bays in length with each bay defined by a protruding concrete pier and filled by the red clay tile. Paired multi-pane windows, with a five-over-five fenestration pattern, separated by a mullion are located in the upper part of each bay as well as flanking the end doorways. Large doorways are located on the north and south façades, with a sliding barn-style door on the south facade.

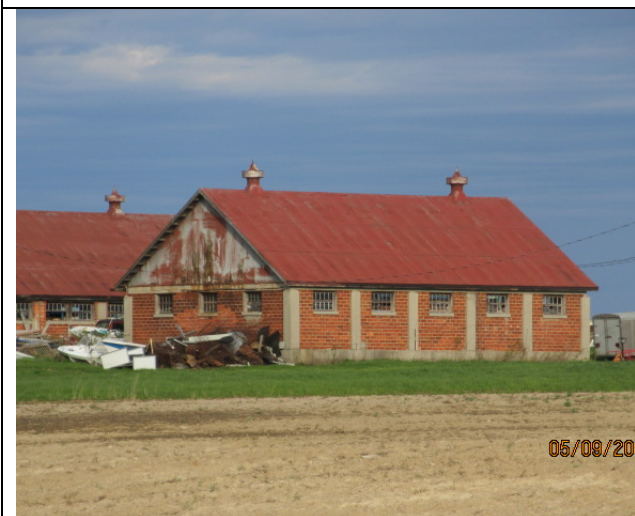
Image 5: The west façade of Barn 3.

**Barn 3** – The smallest of the red clay tile barns is located north of Barn 1 and to the west of Barn 2 (see Appendix A, Image 2; Appendix B). Like Barn 2 it has a gable roof with projecting purlins, but only two ventilators at its ridge. The end gables of Barn 3 are also clad in corrugated steel, as is its roof. The building is single storey in height and five bays in length with each bay defined by a protruding concrete pier and filled by the red clay tile. Individual multi-pane windows, with a five-over-five fenestration pattern, are located in each bay: five on the west façade, four windows and one door on the east façade. Three windows evenly spaced across the north façade, and a large doorway on the south façade with a smaller doorway and window to one side and a pair of windows to the other.

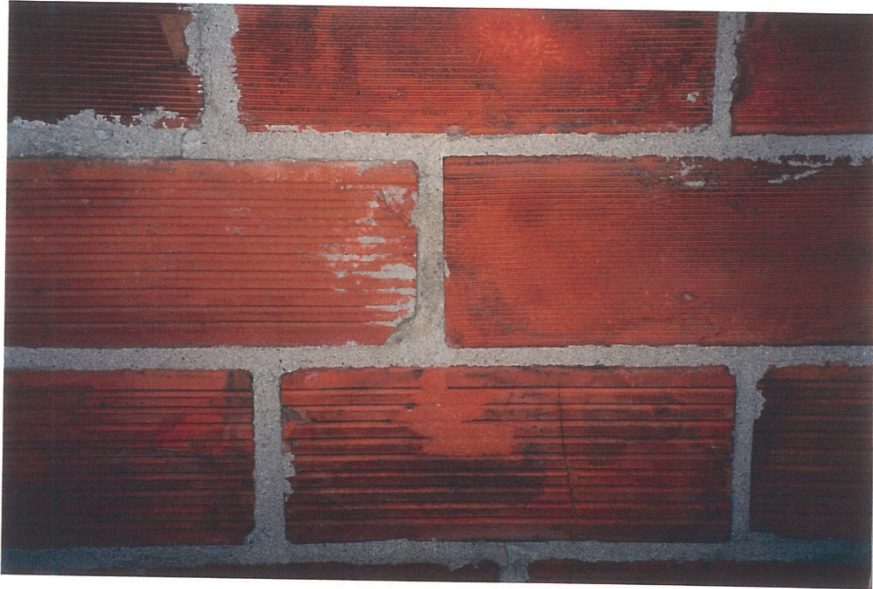
**Figure 16: Detail of Tiles on West side of the Two-Storey Building at 660 Sunningdale East**

What makes the barns distinctive is the use of hollow clay tiles for the wall structure between the piers as the exposed wall surface. The tiles are laid in double thickness, with an airspace between. The clay tiles measure about 5” in height, about 3½” in depth, and between 12” and 12½” in length. In the *Stage 1 Archaeological & Built Heritage Assessment, Uplands North Area Plan* (Archaeologix 2002; extract included as Appendix C) Nancy Tausky reports, “the uniformity of these measurements suggests that the tiles were manufactured using an extrusion process in which the clay was forced through a long mould and cut at appropriate intervals after it emerged” (Archaeologix 2002, 31). The tiles have scored or grooved surfaces. Multi-pane windows are located in most bays between the piers.

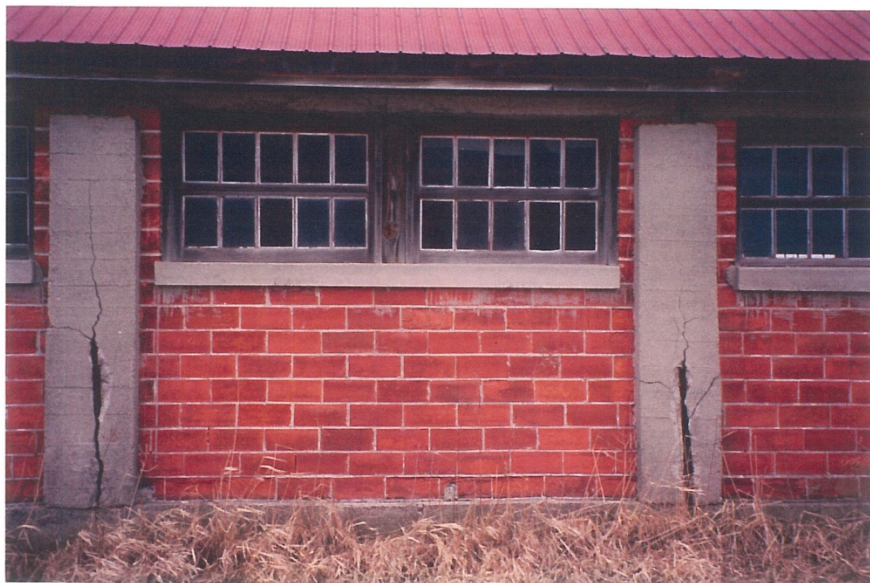
**Figure 17: Deterioration on West Side of Northeast Building, 660 Sunningdale Road East**

Condition of Buildings: Moderate. The inner supports are still firm, but the iron and cement piers and the tile blocks have deteriorated badly at many crucial points (Fig. 17).

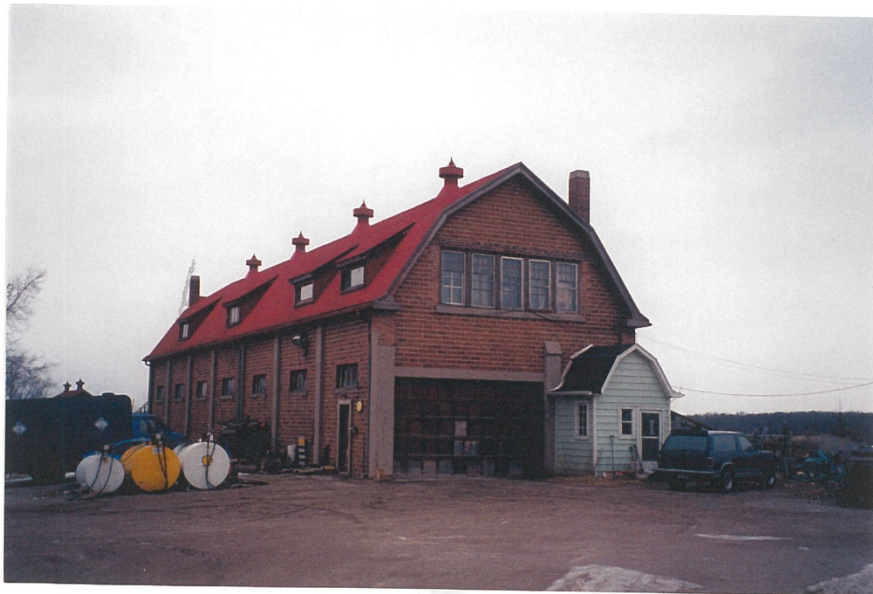
**Figure 7: Southernmost Building, 660 Sunningdale Road East**

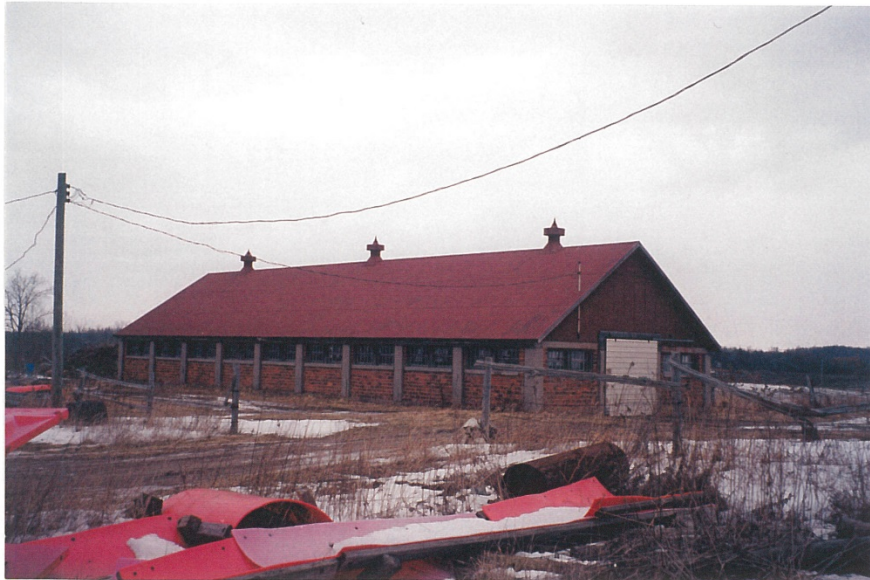
**Figure 8: Northeast Building, 660 Sunningdale Road East**

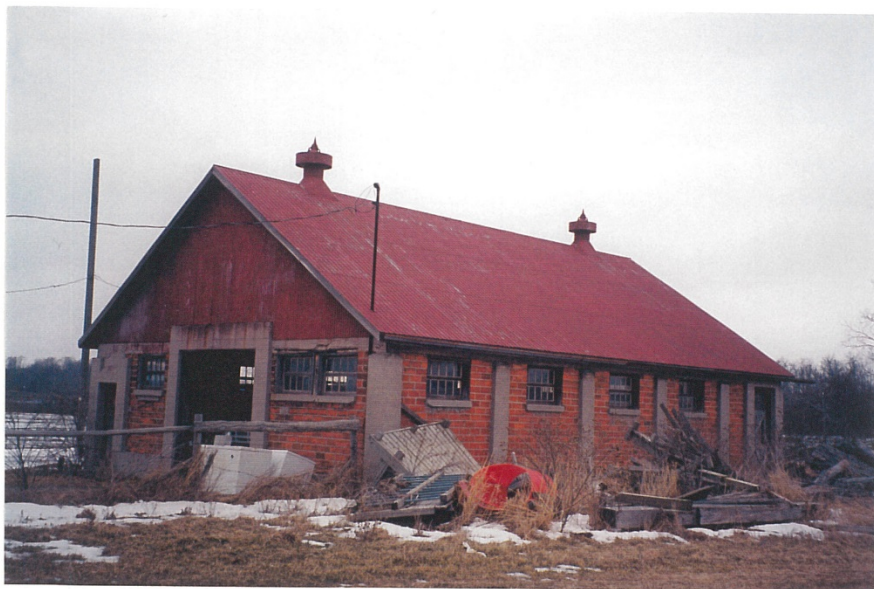
**Figure 9: Northwest Building, 660 Sunningdale Road East**
