TO:	CHAIR AND MEMBERS LONDON ADVISORY COMMITTEE ON HERITAGE MEETING ON WEDNESDAY JULY 12, 2017
FROM:	JOHN M. FLEMING MANAGING DIRECTOR, PLANNING AND CITY PLANNER
SUBJECT:	REQUEST FOR DEMOLITION OF HERITAGE LISTED PROPERTY AT 660 SUNNINGDALE ROAD EAST BY: PETER SERGAUTIS

APPENDIX A — Maps

APPENDIX B — Images

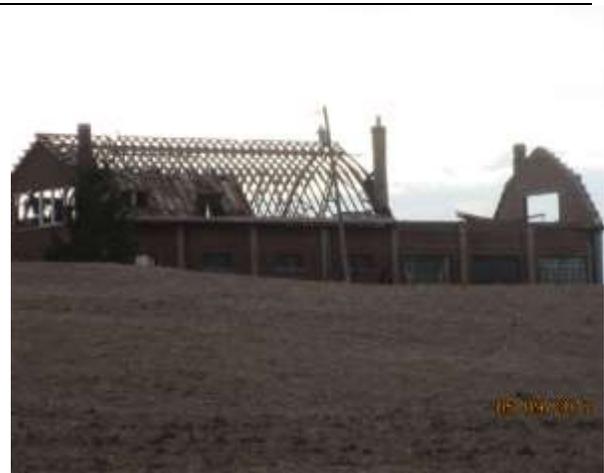
Image 2: Detail the east façade of Barn 1.

Barn 1 – The largest of the three barns has a gambrel roof (see Appendix A, Image 2; Appendix B). It is two storeys in height. The building’s structure is composed of concrete-faced piers; the corner piers appear to be constructed of pressed brick. Barn 1 is seven bays in length, with a single bay across the north and south walls. Multi-pane windows were located high on the side walls, above the height of a single leaf entrance door. A large overhead door is located on the south wall, with an entrance vestibule with a gambrel roof to one side. Five windows separated by mullions are set above the overhead door and centred under the open end of the gambrel. No opening is located on the north wall on the ground storey, but a window void is located in the open end of the gambrel which is believed to match that of the south gambrel end. All of the windows appear to have brickwork or smaller clay tile detailing around the windows. The barn used to have a metal roof with four ventilators evenly spaced across the ridge of the roof. The gambrel roof had four shed dormers. A chimney is located at each end of the structure (see images in Appendix C).

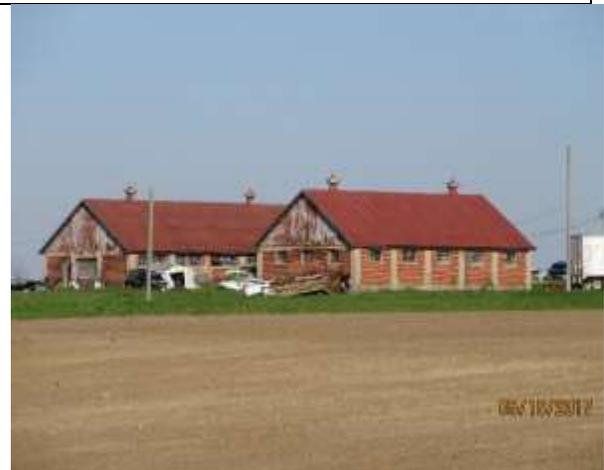
Image 4: Partial view of Barn 2 (background).

Barn 2 – The medium sized barn located to the north of Barn 1 has a gable roof with projecting purlins and three ventilators at its ridge (see Appendix A, Image 2; Appendix B). The end gable is clad in corrugated steel; the same material clads the roof. The building is single storey in height and nine bays in length with each bay defined by a protruding concrete pier and filled by the red clay tile. Paired multi-pane windows, with a five-over-five fenestration pattern, separated by a mullion are located in the upper part of each bay as well as flanking the end doorways. Large doorways are located on the north and south façades, with a sliding barn-style door on the south facade.

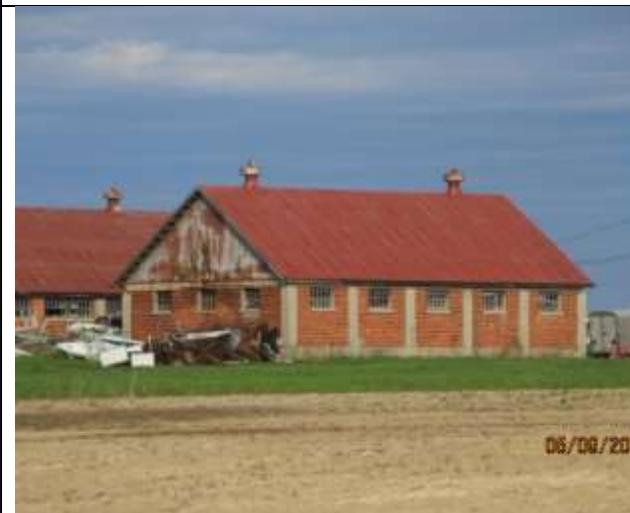
Image 5: The west façade of Barn 3.

Barn 3 – The smallest of the red clay tile barns is located north of Barn 1 and to the west of Barn 2 (see Appendix A, Image 2; Appendix B). Like Barn 2 it has a gable roof with projecting purlins, but only two ventilators at its ridge. The end gables of Barn 3 are also clad in corrugated steel, as is its roof. The building is single storey in height and five bays in length with each bay defined by a protruding concrete pier and filled by the red clay tile. Individual multi-pane windows, with a five-over-five fenestration pattern, are located in each bay: five on the west façade, four windows and one door on the east façade. Three windows evenly spaced across the north façade, and a large doorway on the south façade with a smaller doorway and window to one side and a pair of windows to the other.

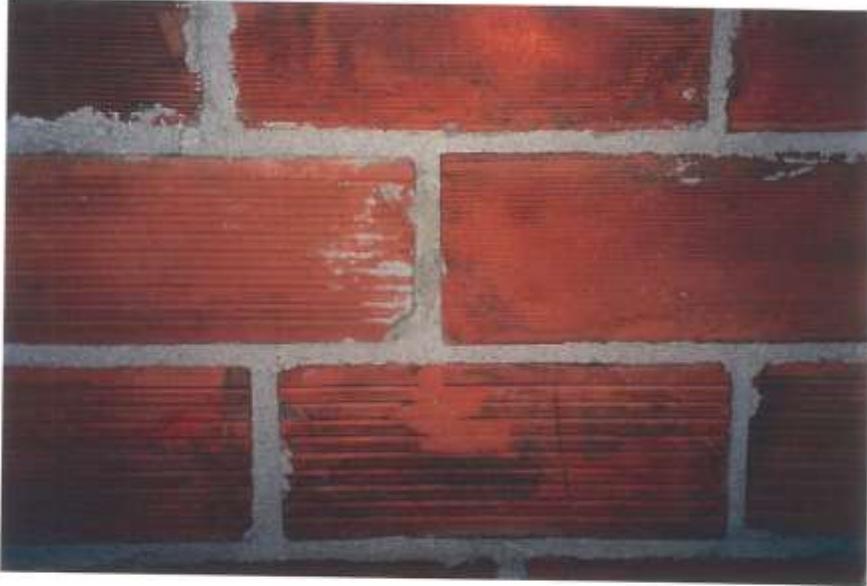
Figure 16: Detail of Tiles on West side of the Two-Storey Building at 660 Sunningdale East

One of the features giving the buildings a distinctive quality is the use of hollow clay tiles both for the wall structure between the piers and for the exposed wall surface. Many varieties of hollow clay tiles were marketed in the middle decades of the twentieth century, and their recommended use was for "side construction." Here, the barn walls are comprised of tiles laid in a double thickness with an air space between; the combination of air spaces within and between the tiles would have provided effective insulation. Each of the tiles measures about 5 inches in height and about 3 and 1/2 inches in depth. The uniformity of these measurements suggests that the tiles were manufactured using an extrusion process in which the clay was forced through a long mould and cut at appropriate intervals after it emerged. The cutting was done somewhat imprecisely with these tiles, in that the length of the tiles varies from about 12 to 12 and 1/2 inches, and not all of the cuts intersect the outer edge of the tile at exactly a ninety-degree angle. What is particularly striking about the wall materials here is that the tiles are used as an exterior facing material: as Whitney Clark Huntington explains in his practical guide *Building Construction* (1929, 1941), "the exposed faces of regular structural clay tile must be covered with some facing material except in warehouses and garages and in other locations where appearance is not a factor. Surfaces which are to be plastered re *scored*, with parallel scratches, to improve the bond" (277). The tiles on these barns have grooved surfaces, and some of them have vertical scratches and/or scalloped edges as well. The considerable variety in the grooving, cutting, and colour of the tiles indicates curiously little regard for the appearance of the buildings on the part of the builder; it even suggests that he may have been using seconds (Figure 16).

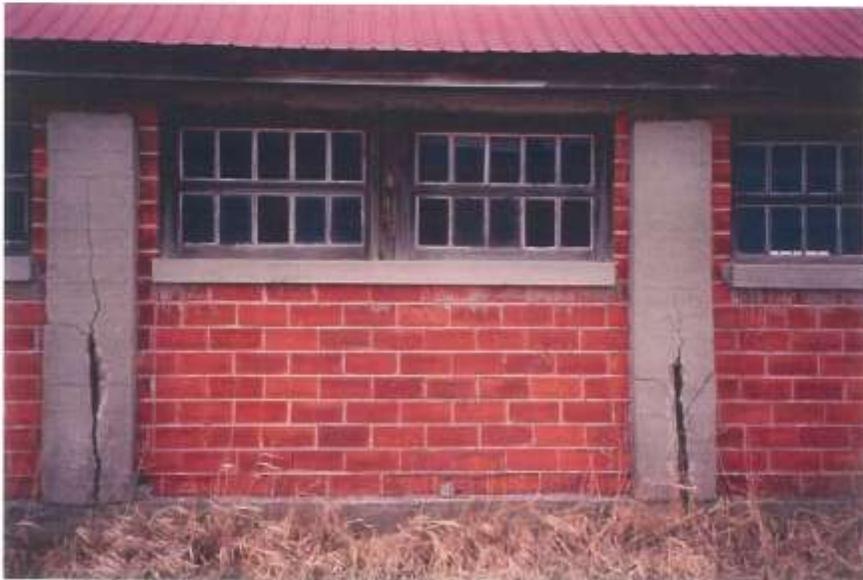
Figure 17: Deterioration on West Side of Northeast Building, 660 Sunningdale Road East

Condition of Buildings: Moderate. The inner supports are still firm, but the iron and cement piers and the tile blocks have deteriorated badly at many crucial points (Fig. 17).
