The Corporation of the City of London

Cultural Heritage Evaluation Report
3544 Dingman Drive
London, Ontario
South London Wastewater Servicing
Municipal Class EA Master Plan

AECOM

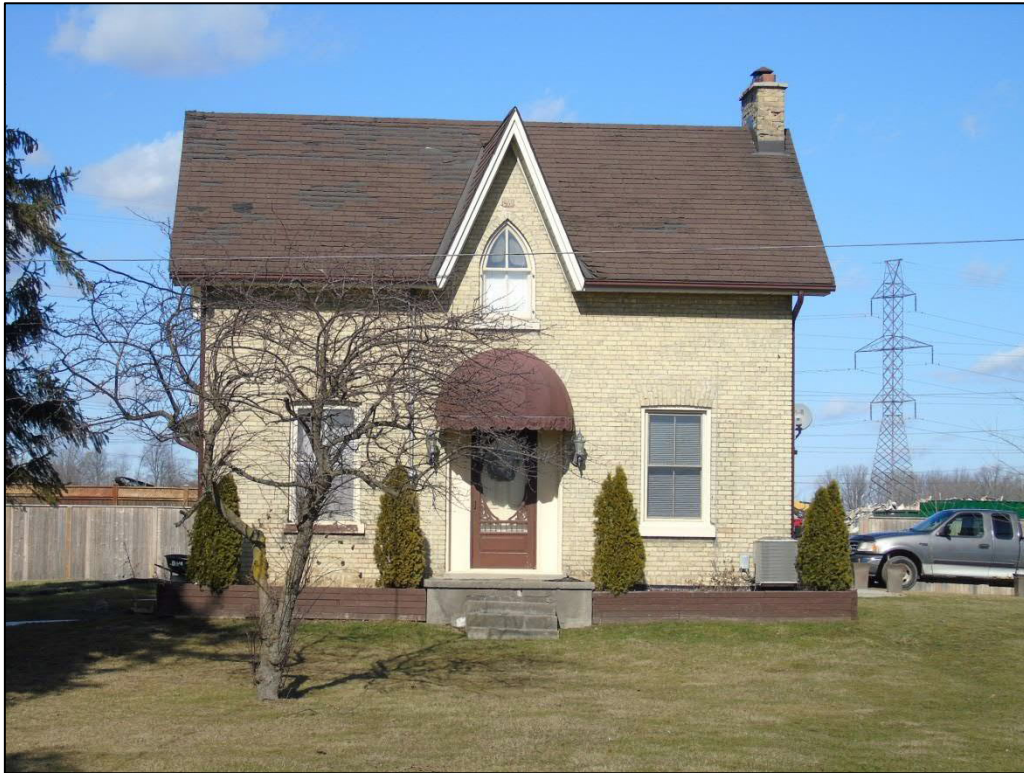
Image 2: Front facade of the farmhouse at 3544 Dingman Drive (2018)

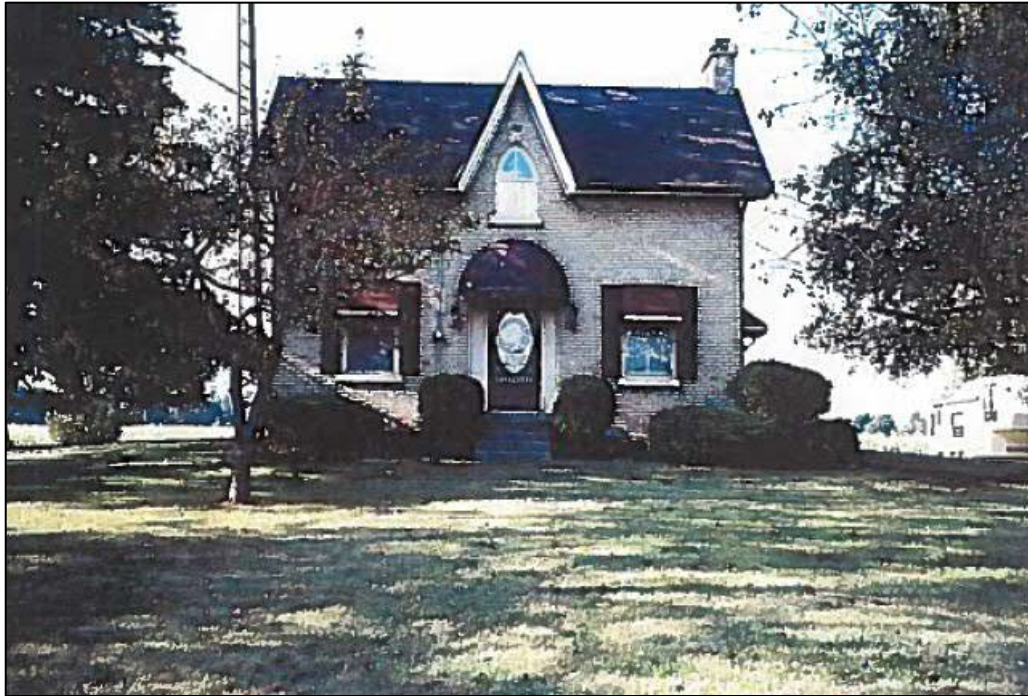
Image 3: Front facade of the farmhouse at 3544 Dingman Drive, as shown in 2003 report (2003)

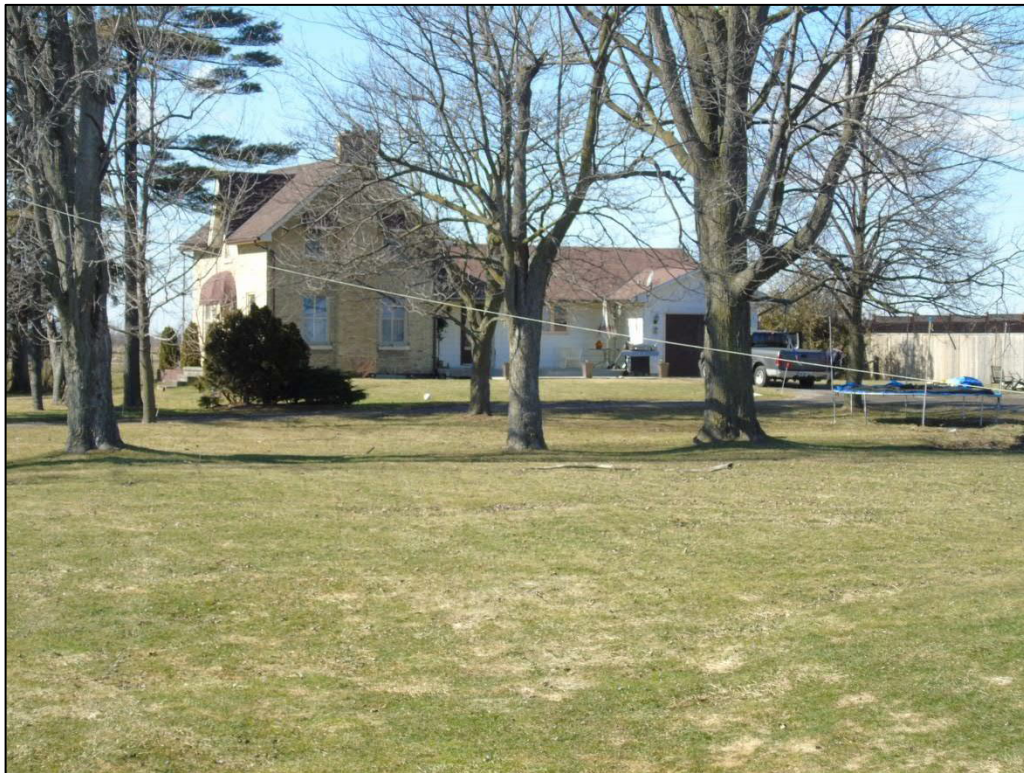
Image 5: View showing east side of the farmhouse. The historic portion of the dwelling is located on the left and the rear wing is a much newer addition (2018)

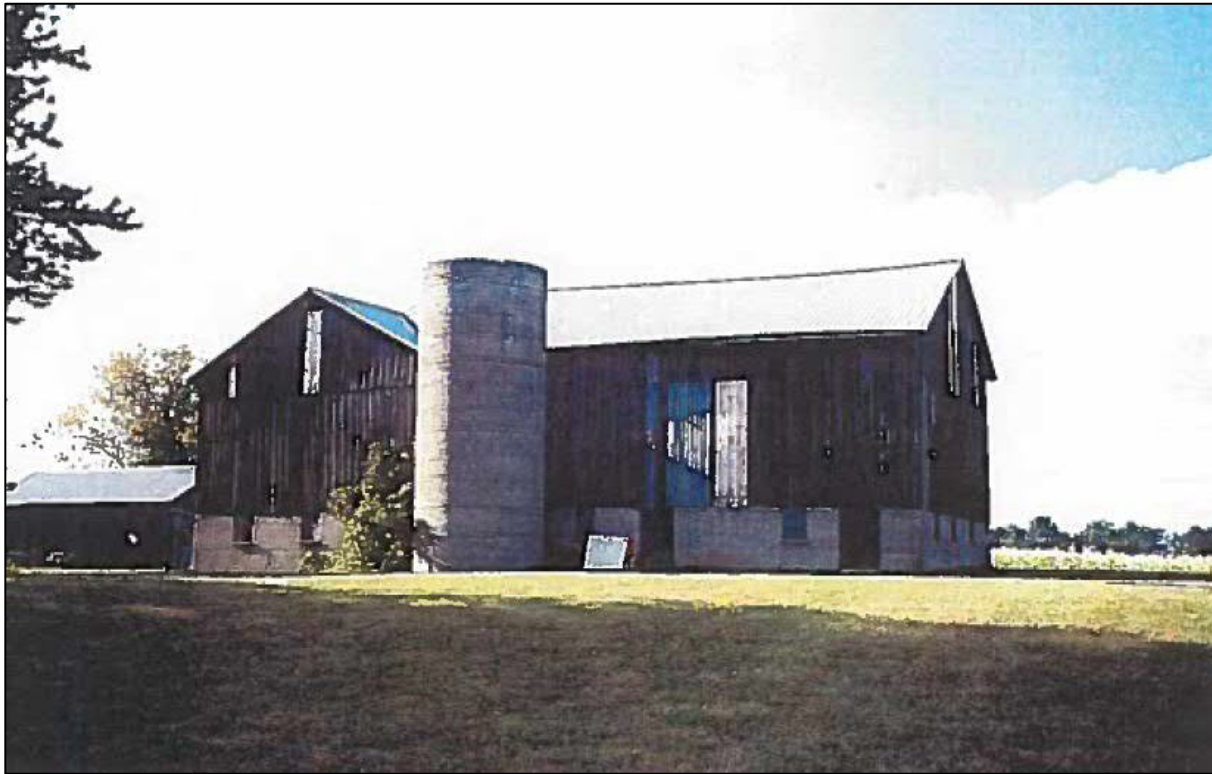
The 2018 site investigation determined that the barn has been demolished since the 2003 assessment and all of the timber frame and foundation details removed. The footprint of the barn is now level with the grade of the property and is beginning to naturalize. The only visible built component related to the barn that remains is the bottom few metres of the concrete silo. A review of aerial photography indicates that the barn was likely demolished in 2015. Although the property is no longer used for agricultural purposes, the farmhouse combined with the barn and the arrangement of the buildings on the property would have formed a farm structure complex that is common among historic agricultural properties. The removal of the barn from the property has altered the landscape context of the former agricultural property (Images 7 – 9).

Image 7: View showing former barn on the property as shown in 2003 report. The barn was evidently demolished in 2015 (2003)

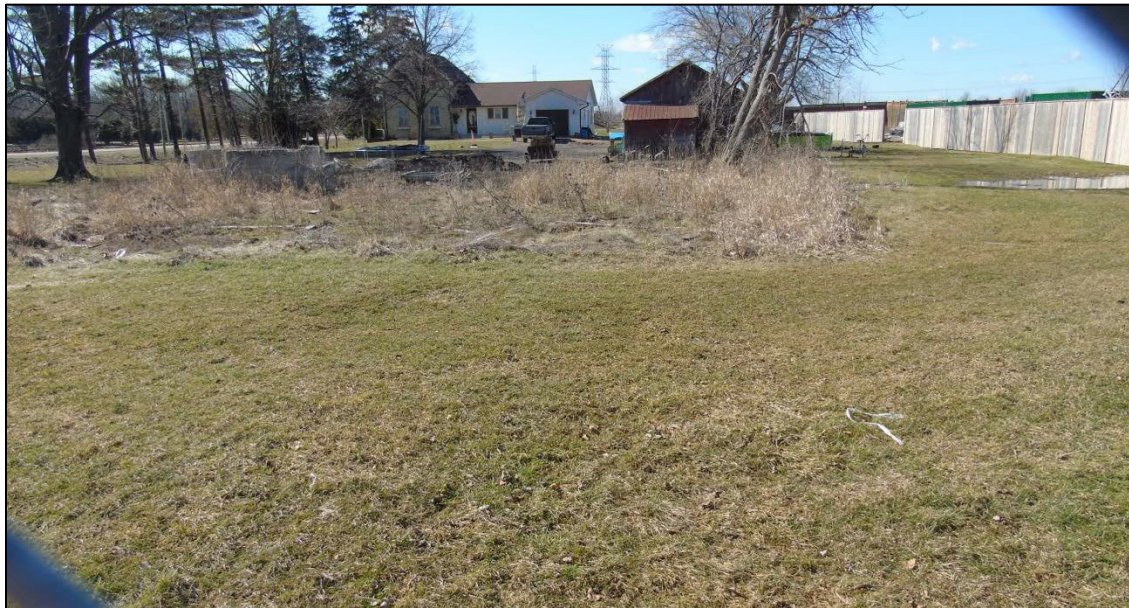
Image 8: View looking from the chain-link fence of the Dingman Creek Pumping Station to the site of the former barn. Very little remains of the structure (2018)

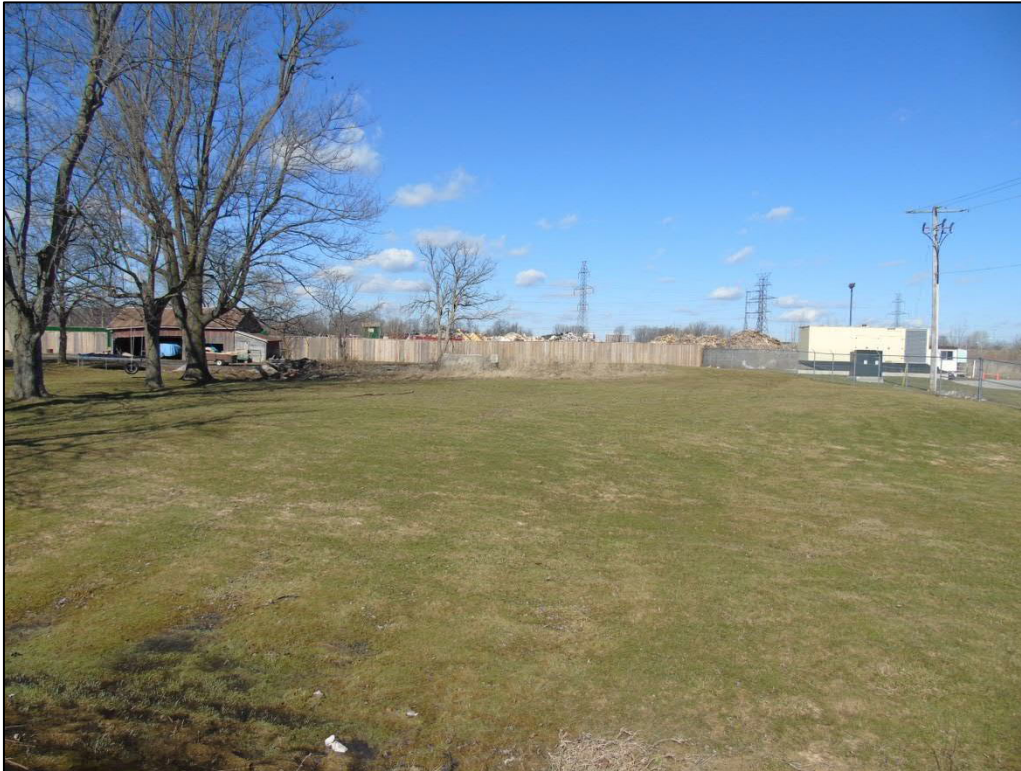
Image 9: View looking south from Dingman Drive showing the site of the former barn. The farmhouse is located to the left outside of the photograph, and the Dingman Creek Pumping Station property is at right (2018)

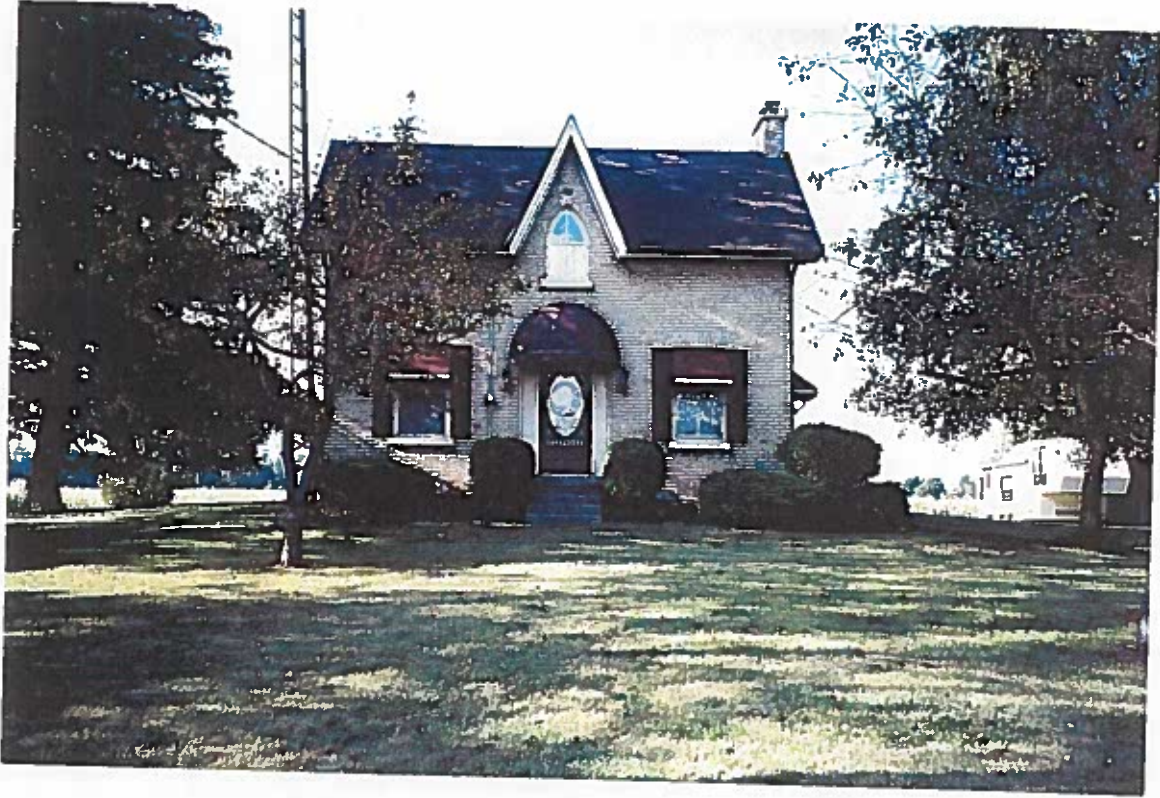
The farmhouse at 3544 Dingman Drive (fig. 4) is currently included in the City of London *Inventory of Heritage Resources*, with a rating of priority 2, which we recommend be retained. There is also a barn on this property (fig. 5) that should be listed in the *Inventory*, with a priority rating of 1, merited because of its largely intact mid-nineteenth-century framing. We recommend (1) that efforts be made to encourage the retention of both buildings and (2) that structural components of the barn be thoroughly documented. Such documentation would be especially crucial should the barn face demolition. Detailed assessments of the farmhouse and barn are included below.

4. Front view, House at 3544 Dingman Drive

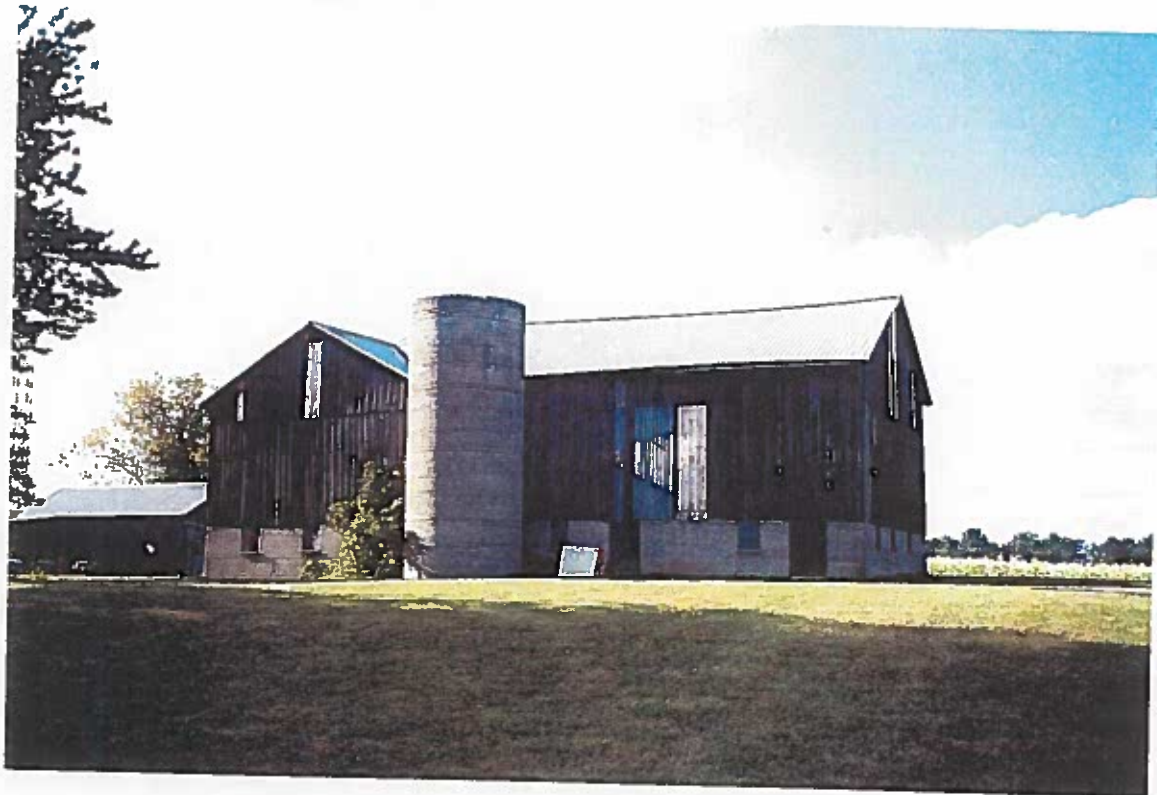
BARN -- There are some weak boards in the lofts and occasional cracks in the cement foundation, but the structure is generally solid.

5. Barn at 3544 Dingman Drive

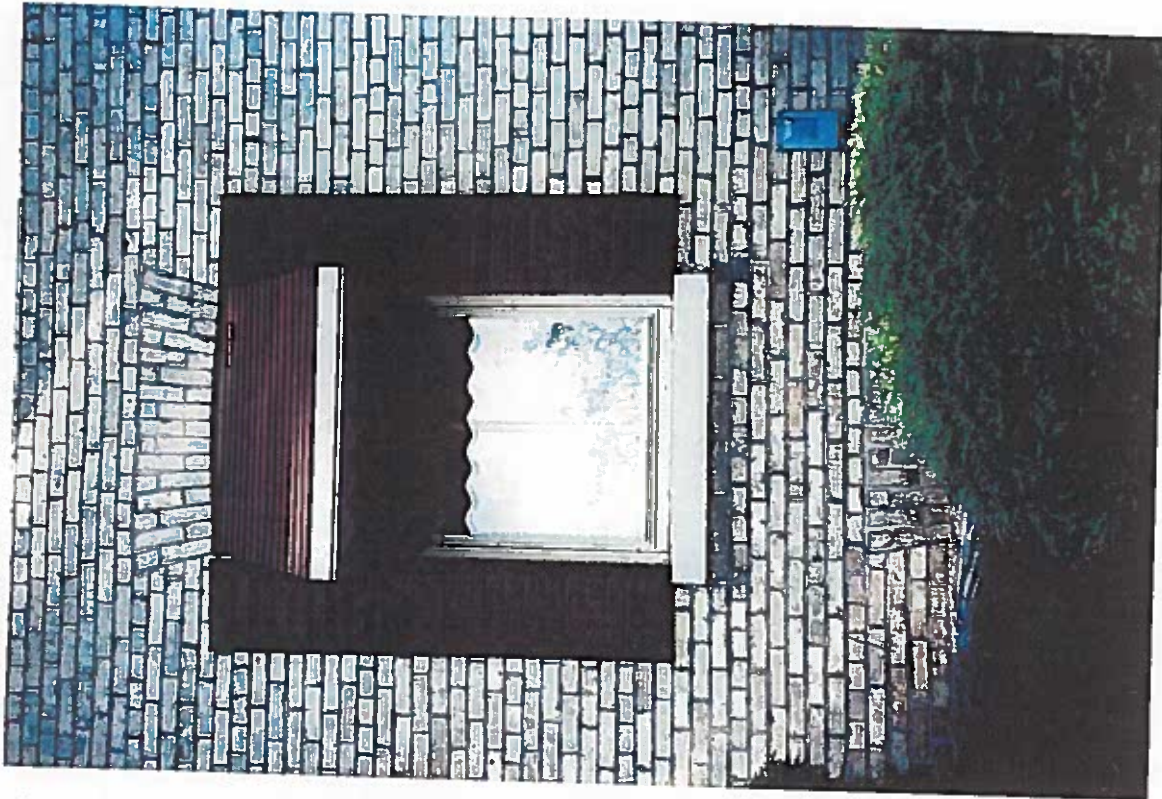
HOUSE -- The historic front section of the house is of brick construction, with inner and outer layers of brick tied through a consistent pattern of English common bond, in which every sixth course is laid in headers (fig. 6). This part of the house sits on a stone foundation (fig. 7), surmounted by a wooden sill on which rest the joists and the brick walls of the house (fig. 8). A back wing containing a kitchen, garage, and family room is a relatively recent addition (fig. 9), replacing a wooden wing that likely predated the brick house (Millson).

6. Eastern window on front facade, 3544 Dingman Drive

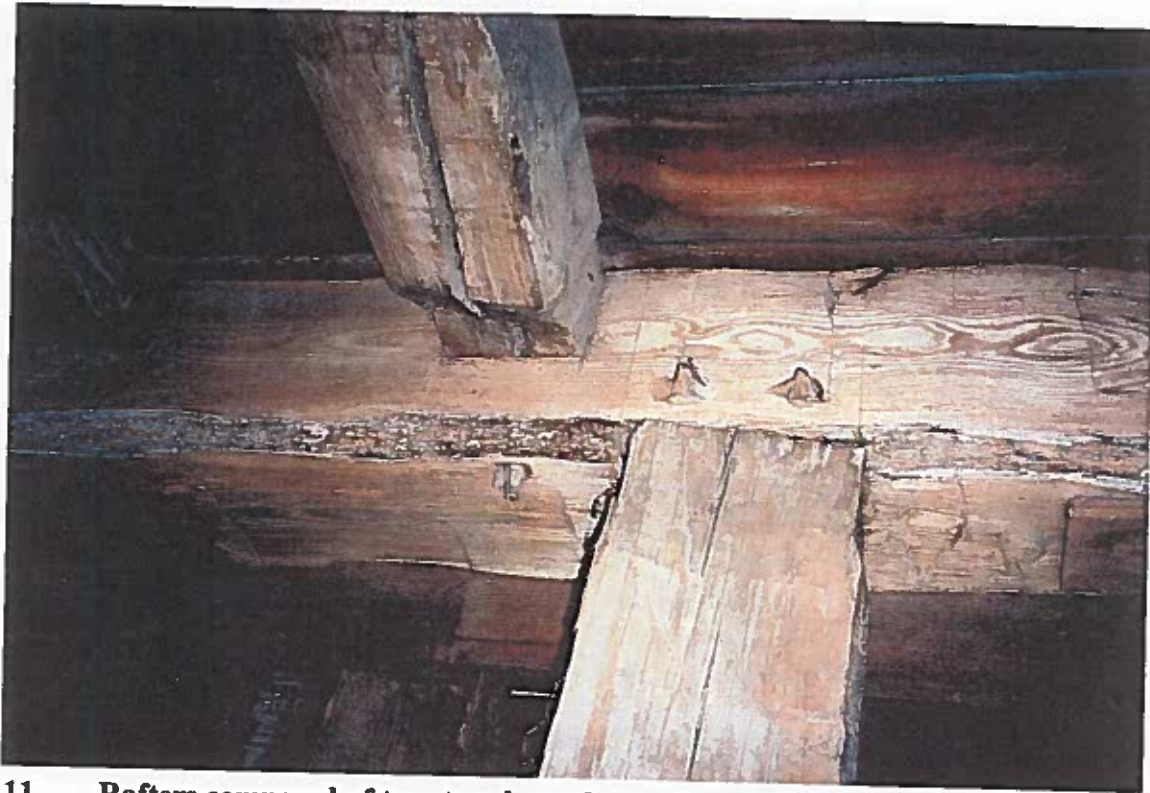
10. Post and girts in eastern barn at 3544 Dingman Drive, showing mortise and tenon joints and broad axe marks

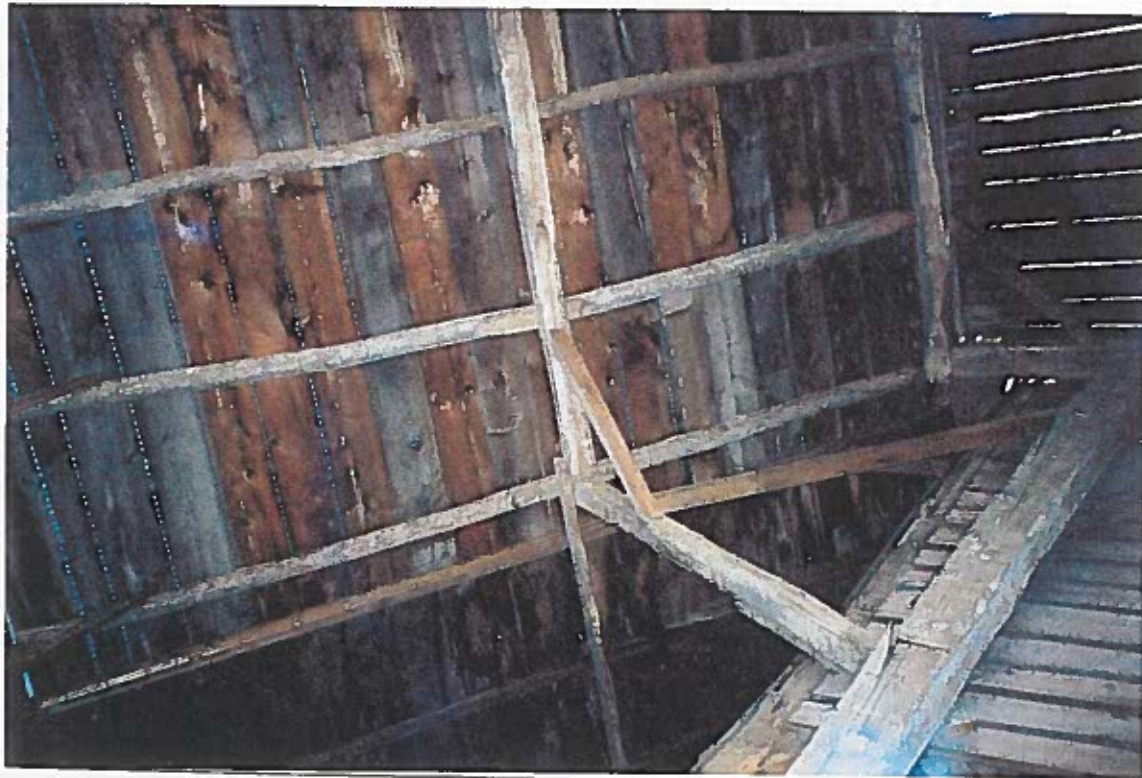
11. Rafters composed of tree trunks and sawn boards in eastern barn at 3544 Dingman Drive

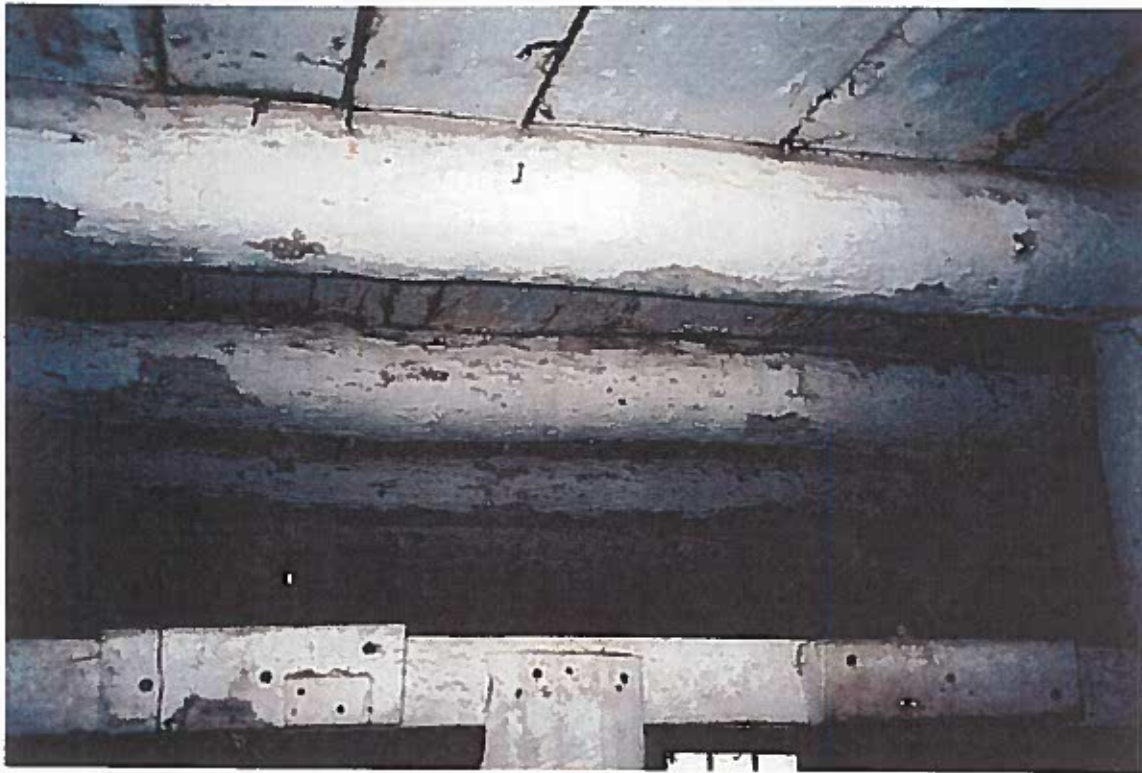
12. Joists beneath eastern barn, 3544 Dingman Drive

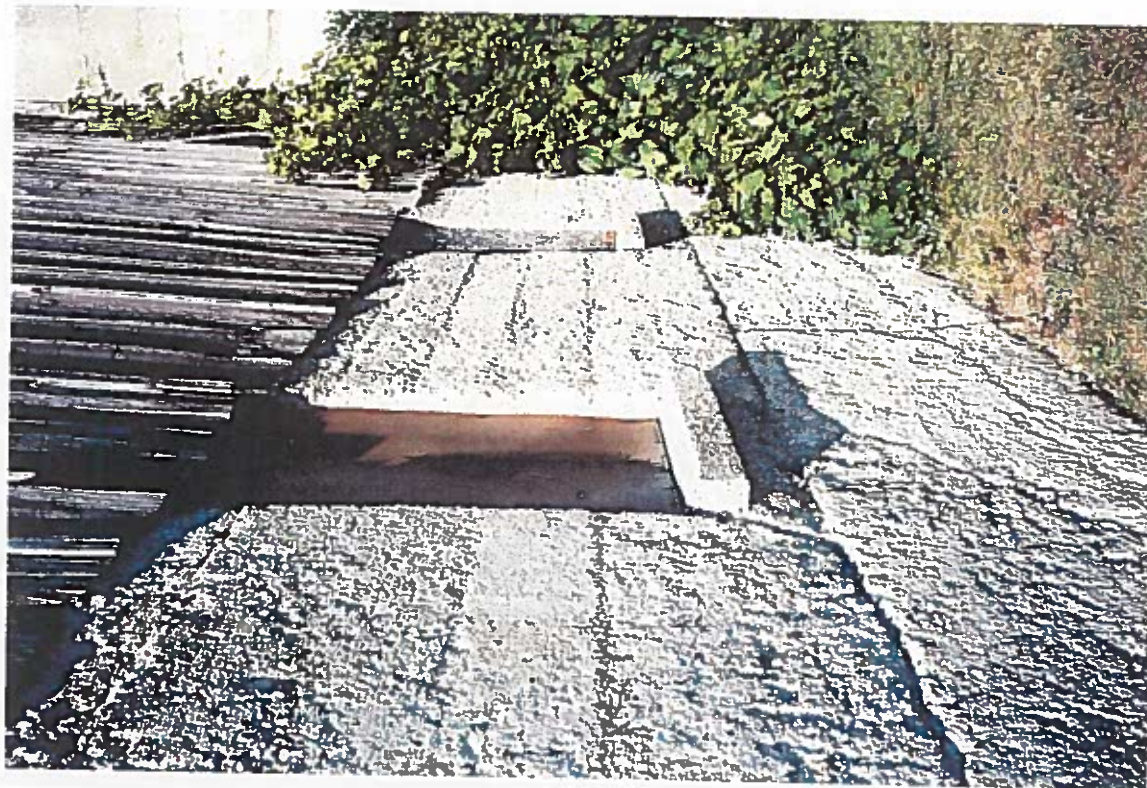
13. Cement foundation, south side, western barn, 3544 Dingman Drive

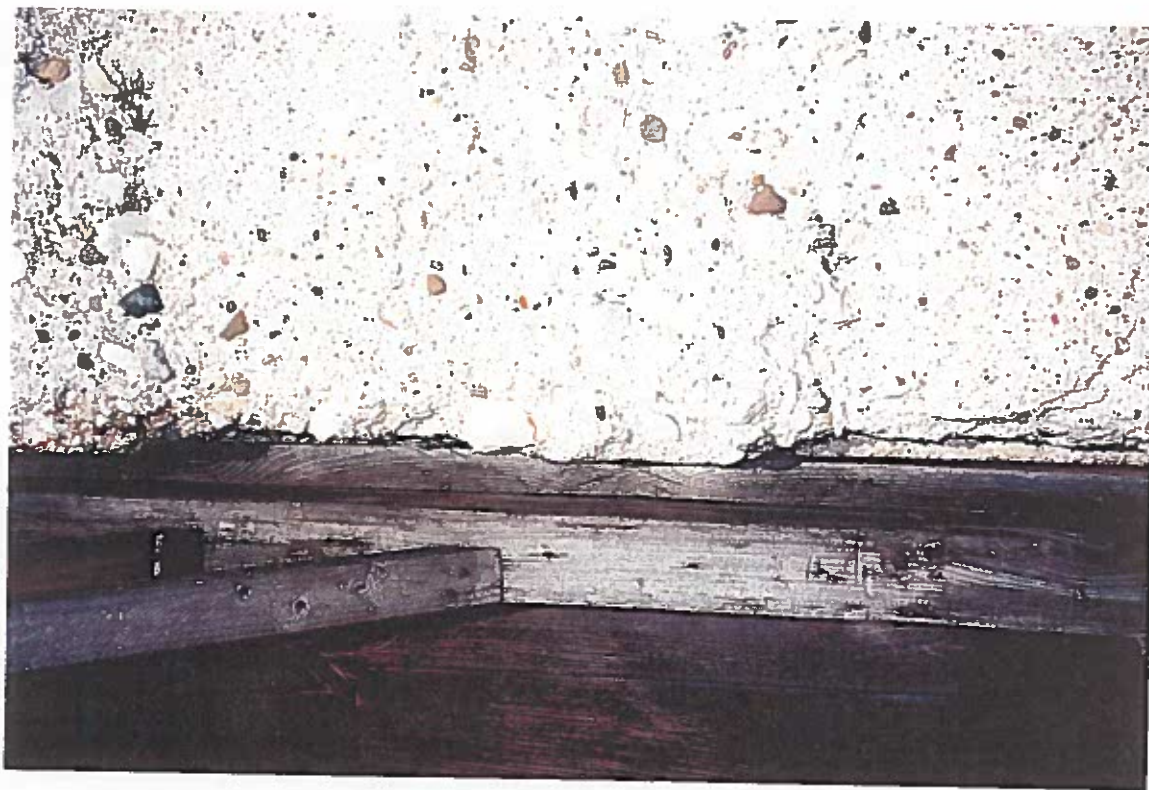
14. Cement foundation, west side, western barn, 3544 Dingman Drive

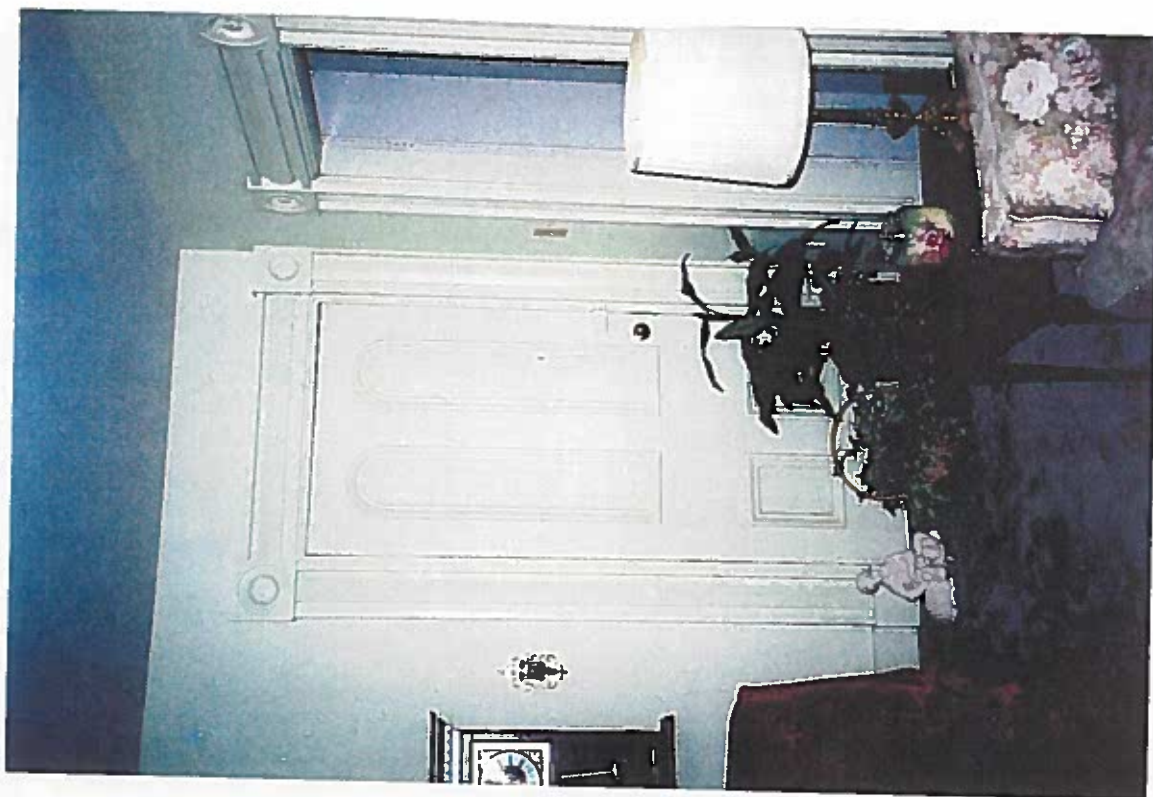
kitchen wing rises behind it. Because the southern end of the wall between the rooms directly intersects the sidelight immediately west of the front door, one must assume that this wall is a later addition (compare fig. 24 with figs. 18, 19). While it is difficult to envision the house with walls in a different configuration (the centre hall plan usually found in houses of this style would require awkwardly small rooms to each side of the hall), it is virtually certain that the current arrangement of downstairs rooms, and likely the striking outer moldings around the living room windows and doors, are the result later renovations -- probably, to judge by the style of the moldings, around the second or third decade of the twentieth century.

24. Juncture of main floor dividing wall with front entranceway, 3544 Dingman Drive.
