3544 Dingman Drive Cultural Heritage Evaluation Report South London Wastewater Servicing Study

Michael Greguol, Cultural Heritage Specialist

March 14, 2018

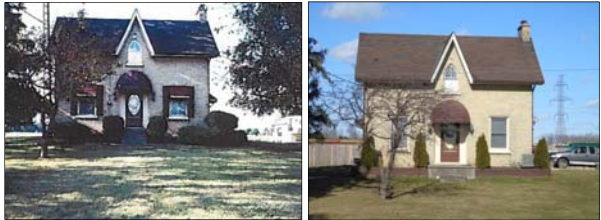
Site Description – Farmhouse

- Property Access
 - 2003 – *Stage 1 Archaeological and Built Heritage Assessment for Dingman Drive Area Plan*
- Farmhouse
 - Gothic Revival Ontario Farmhouse
 - Three bays, 1 ½ storeys
 - Centre door, gable roof, cross gable for pointed arch window
 - Terra cotta panel above pointed arch window
 - Front door – fielded panels and mouldings, sidelights and transoms
 - Minor exterior alterations since 2003

2003 2018

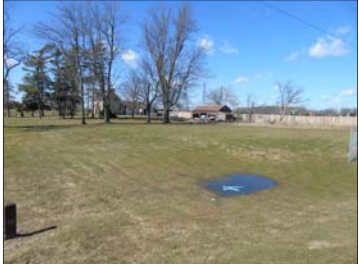
Site Description – Barn, outbuildings, and landscape

- Barn
 - 2003 – *Stage 1 Archaeological and Built Heritage Assessment* for Dingman Drive Area Plan
 - Timber frame barn
 - Mortise and tenon joints
 - Vertical plank exterior
 - Demolished in 2015
- Outbuilding/Garage
- Landscape
 - Agricultural history
 - 1.75 acres
 - Driveway
 - Rows of trees
