## Report to the London Advisory Committee on Heritage

**Subject:** Heritage Alteration Permit Application By: M. Telford  
200 Wharncliffe Road North, Blackfriars/Petersville Heritage  
Conservation District

**Meeting on:** Wednesday March 14, 2018

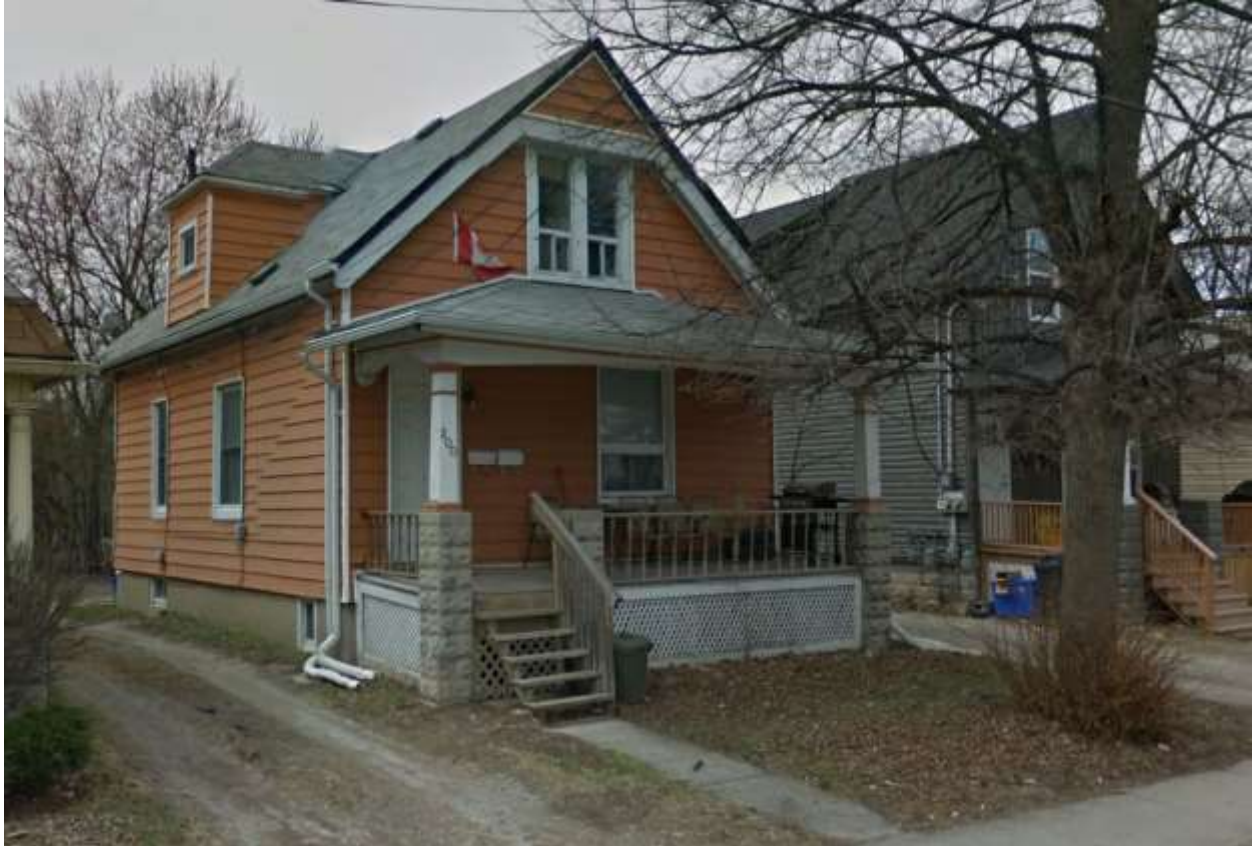
The porch located at 200 Wharncliffe Road North is composed of square piers set on rusticated cast concrete block plinths at each end of the porch, connected by a shallow-pointed wood arch beam. Two shorter shallow-pointed beams connect the porch to the structure of the building. A rusticated cast concrete block plinth is located adjacent to the wood entrance steps to the porch. The steps are located directly in front of the entry door to the building. The porch has a tongue and groove wood floor, which had a painted finish. The railings are affixed at the capstone of the concrete block plinth. The railings were once comprised of turned spindles set widely between a top and bottom rail; these were replaced with chamfered-end square pickets affixed outside of a top and bottom rail (see Appendix B). A painted wood lattice porch skirt set in a wood frame finishes the porch.

*Image 1: View of the property located at 200 Wharncliffe Road North (April 2015).*

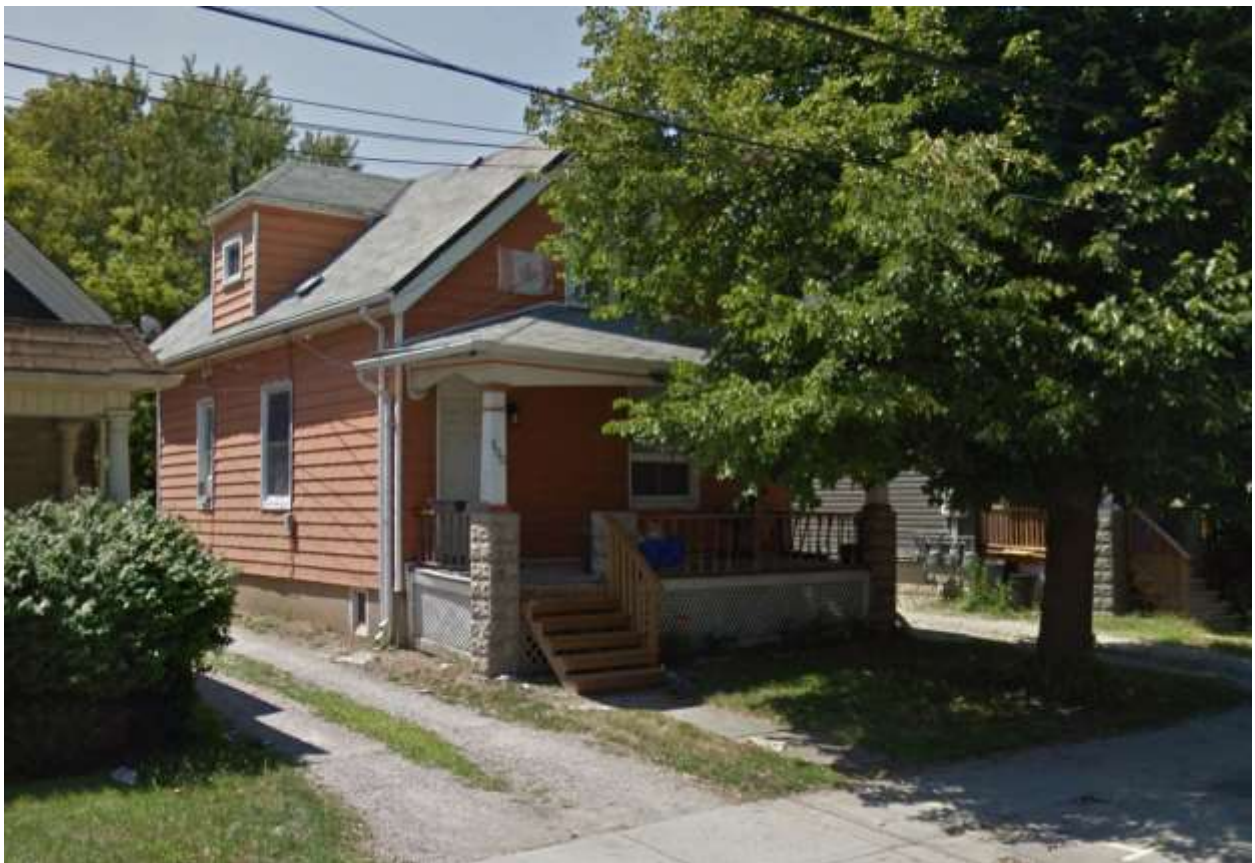
*Image 2: View of the property located at 200 Wharncliffe Road North (July 2016).*

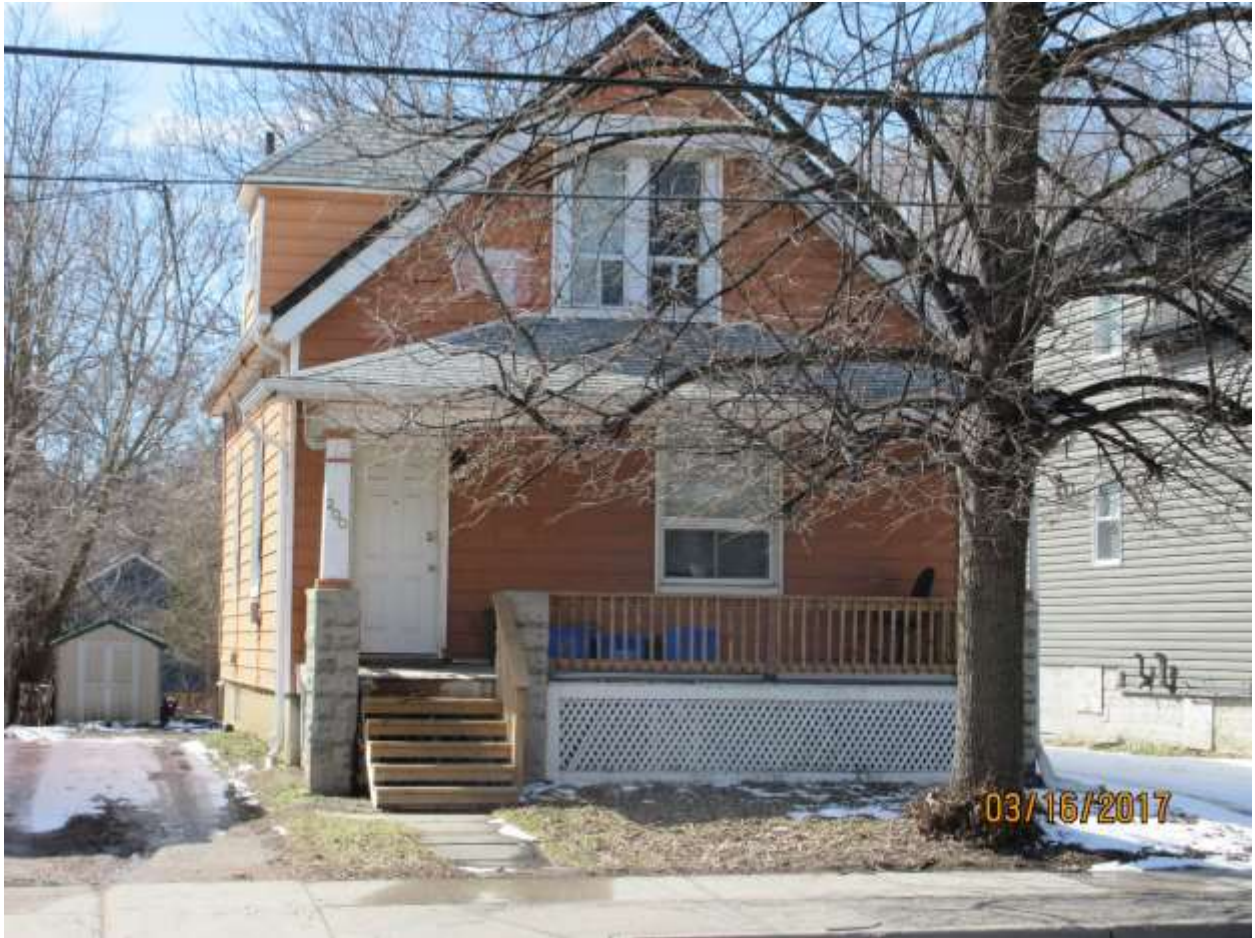
The porch railing that was installed before March 16, 2017 is not compatible with the heritage character of the Blackfriars/Petersville Heritage Conservation District. It was altered without Heritage Alteration Permit approval. While retention and restoration of heritage attributes is preferred, this approach is not possible for the porch of the building at 200 Wharncliffe Road North. The former baluster of the porch was comprised of turned spindles set widely between a top and bottom rail. This was replaced by the present baluster which is comprised of chamfered-end square spindles affixed outside

*Image 3: View of the property located at 200 Wharncliffe Road North (March 16, 2017).*

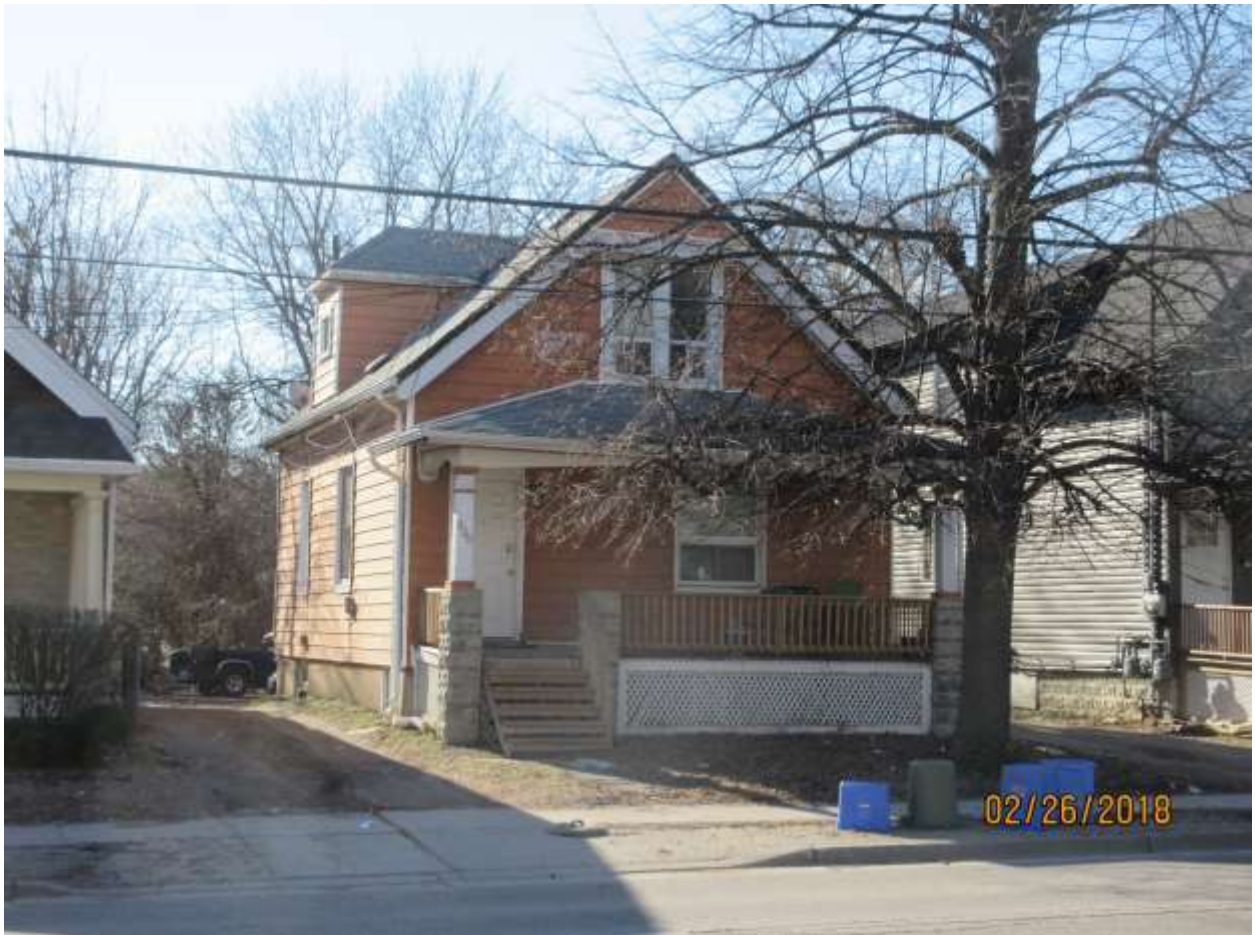
of a top and bottom rail which does not fit in with the heritage character of the Blackfriars/Petersville Heritage Conservation District (see Appendix B). It is not clear when the turned spindles were installed; however, they do not appear to be historic in origin due to their wide spacing and unpainted finish. There is no historic documentation (e.g. historic photographs) to accurately identify historic precedence or the “authentic limits” of a restoration approach, so a design approach seeking compatibility with the heritage character of the Blackfriars/Petersville Heritage Conservation District was sought. Examples of porch balustrades that fit within the heritage character of the Blackfriars/Petersville Heritage Conservation District can be found locally, at 197 Wharncliffe Road North and 149 Wharncliffe Road North (see Appendix B, Images 8-9). These examples should guide the replacement of the existing porch balustrade at 200 Wharncliffe Road North. The unapproved alterations to the porch at 200 Wharncliffe Road North did not change the proportions or dimensions of the porch. The unapproved alterations retained the historic height of the railing at approximately 24”, which aligns with the capstone of the cast concrete plinths (see Appendix B).

*Image 4: View of the property located at 200 Wharncliffe Road North (February 26, 2018).*

Compatibility can be achieved through replacement of the existing balustrade with a traditional balustrade for a porch comprised of square spindles set between a top and bottom rail. This style should also be used on the railings for the steps. The top rail of the balustrade must align with the capstone of the cast concrete plinths, as existing and former. The spindles should be spaced no more than 4” on centre.

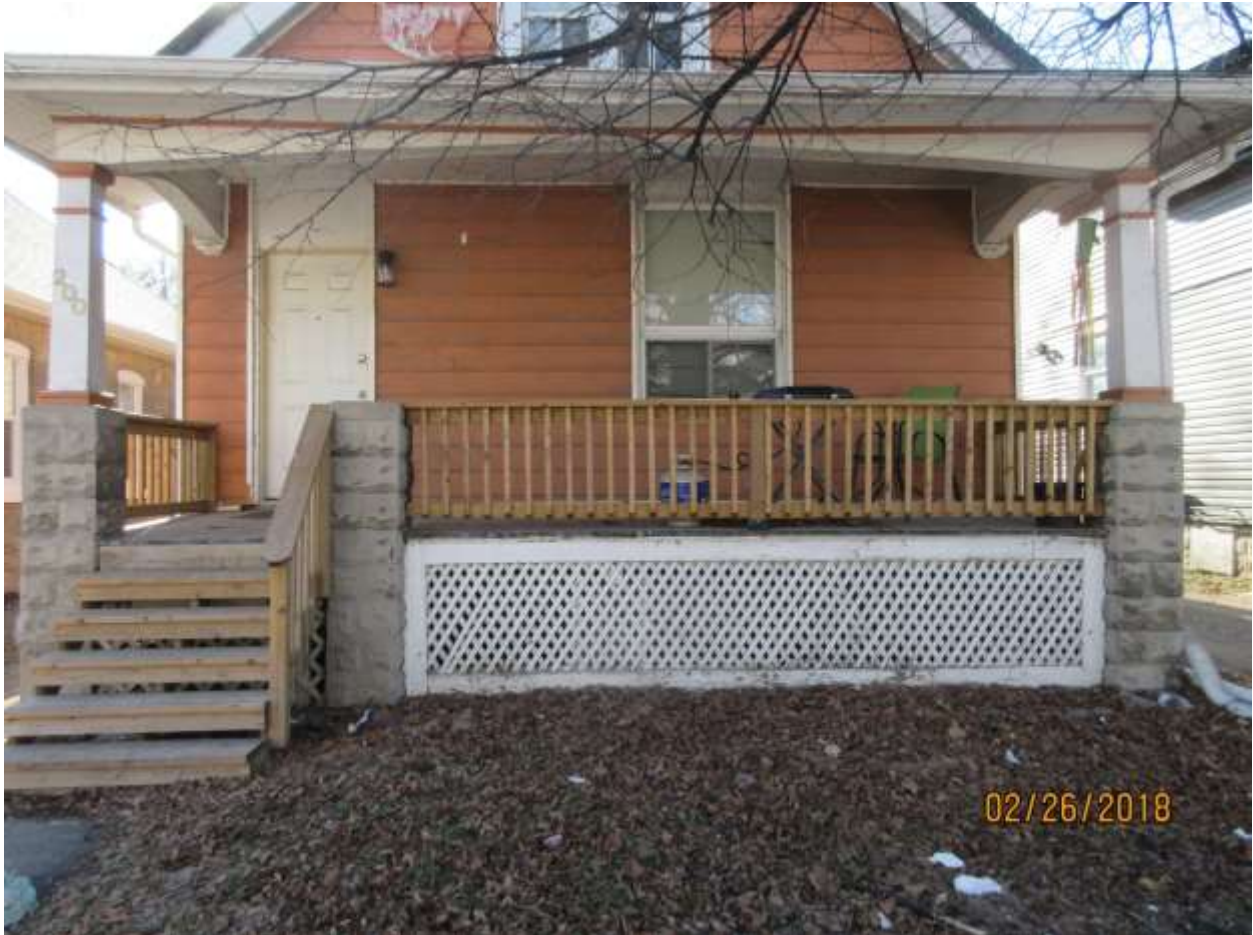
*Image 5: Detail of the existing front (east) balustrade of the porch of the building at 200 Wharncliffe Road North.*

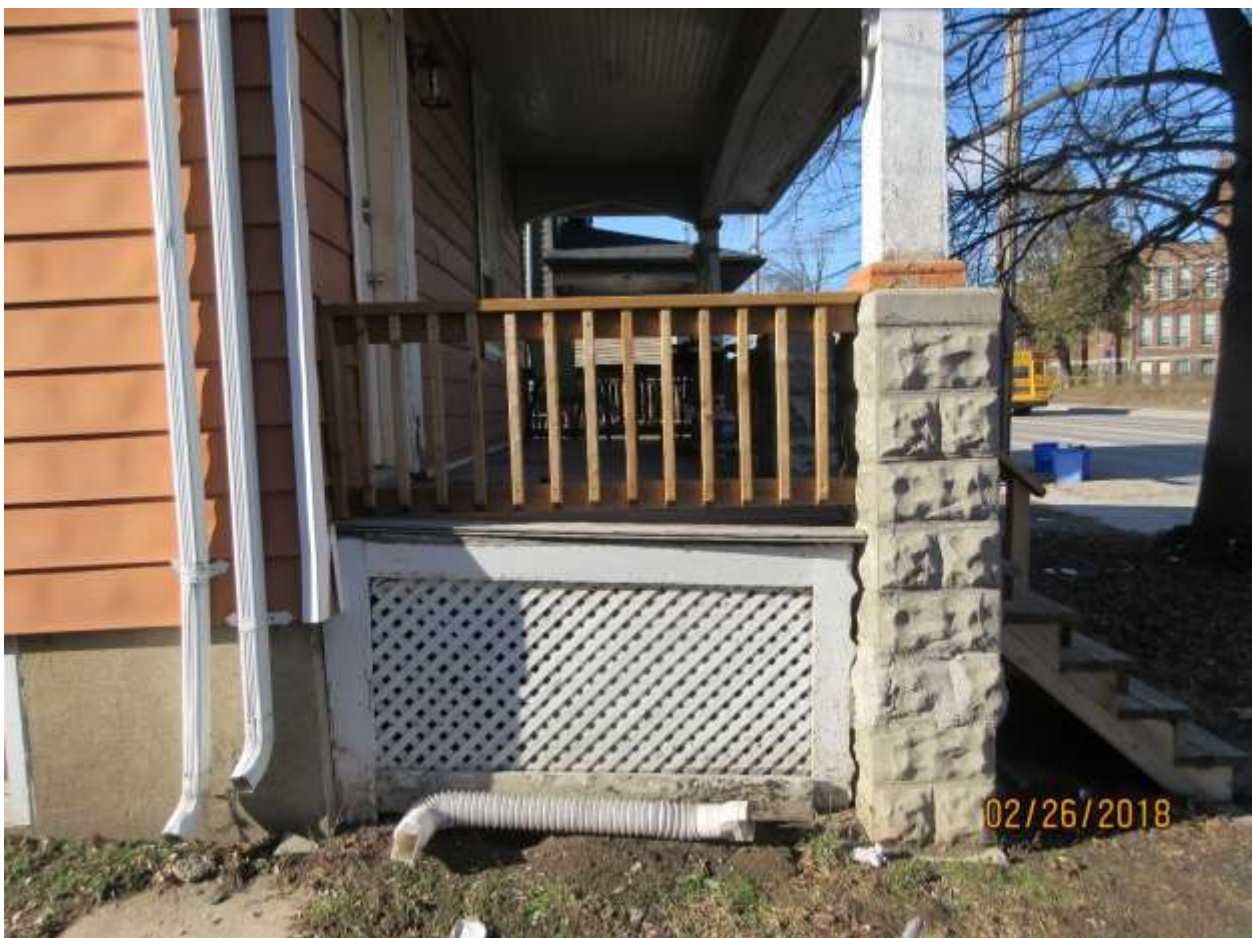
*Image 6: Detail of existing south balustrade of the porch of the building at 200 Wharncliffe Road North.*

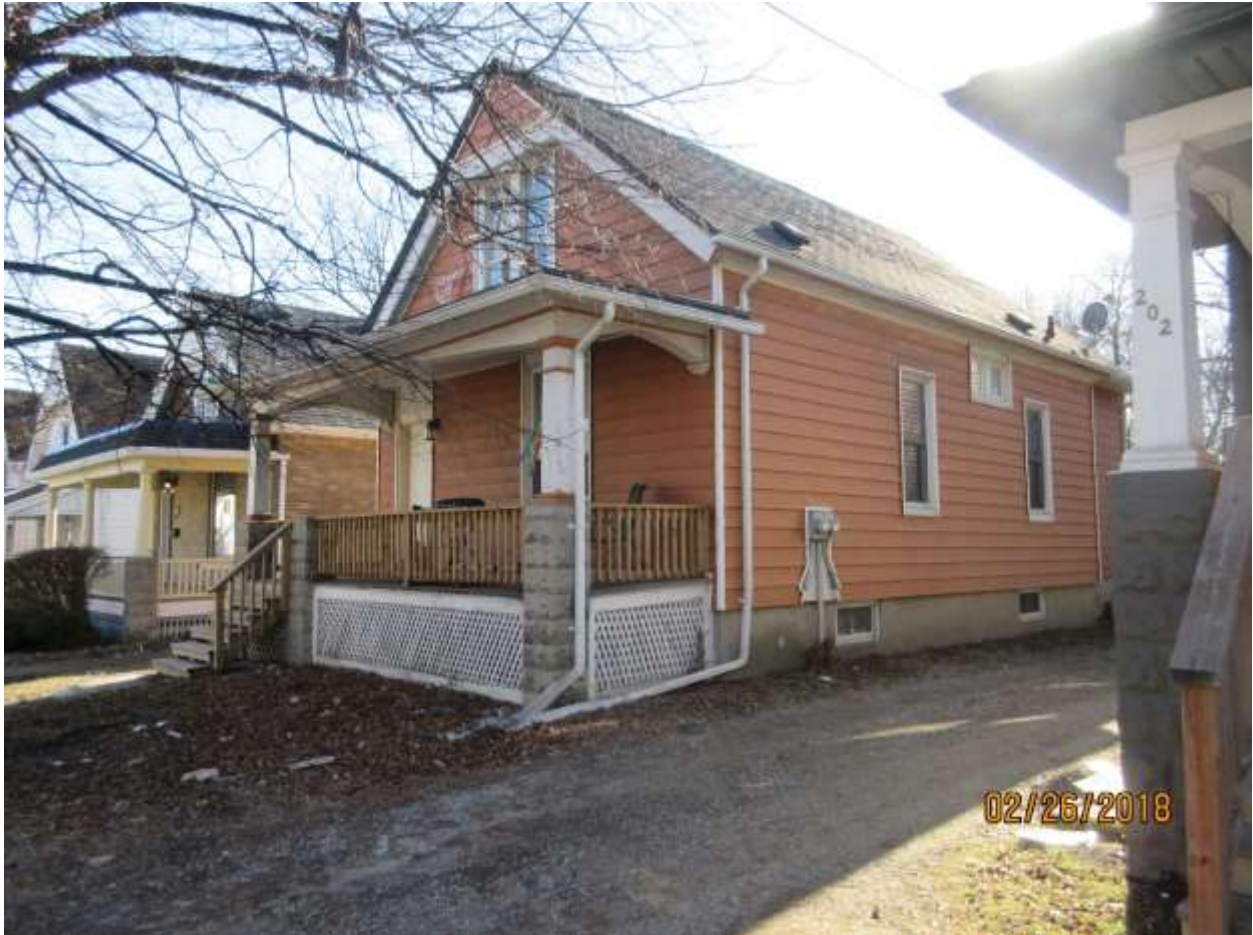
*Image 7: Detail of existing north and east balustrades of the porch of the building at 200 Wharnccliffe Road North.*

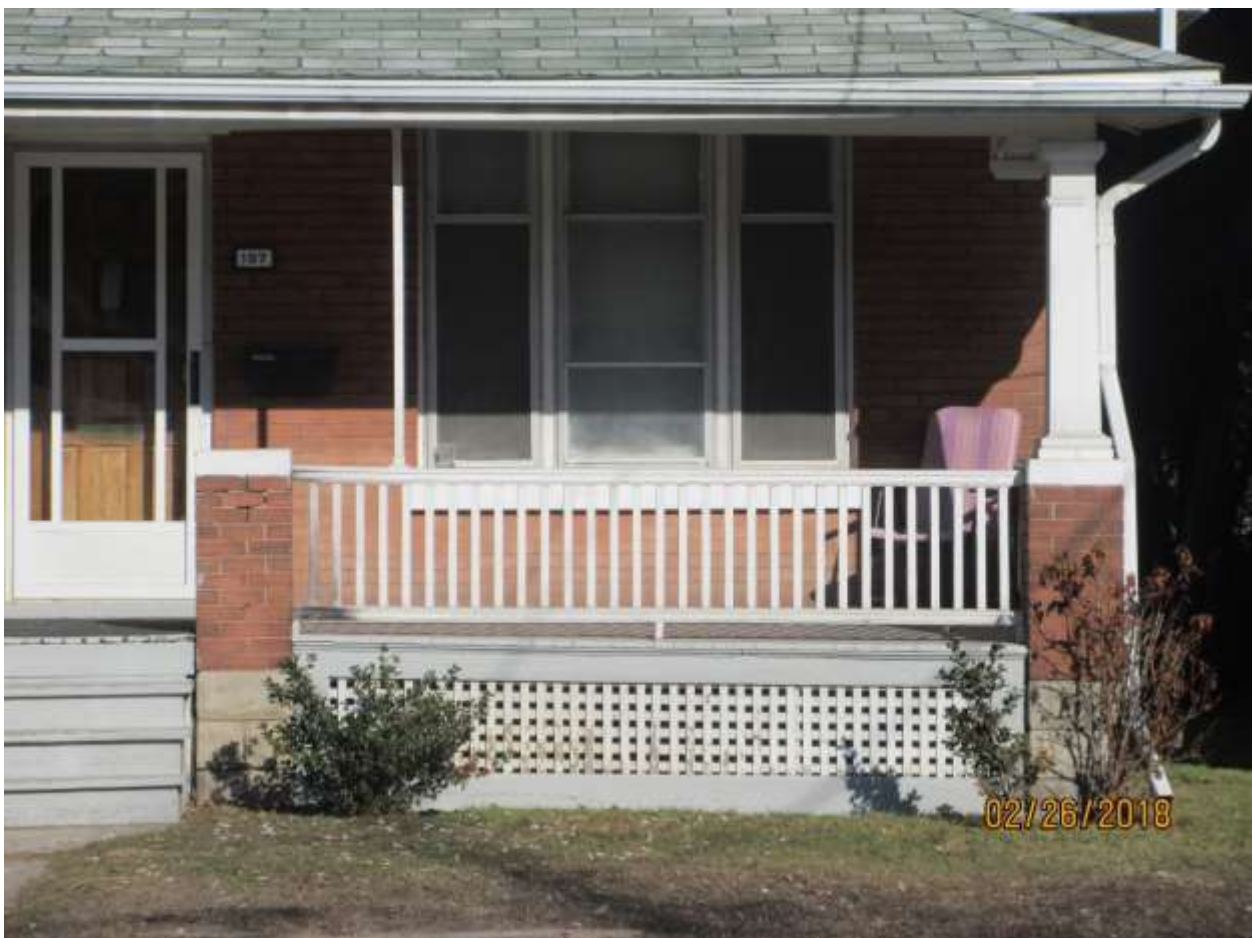
*Image 8: Detail of porch balustrade at appropriate height with appropriate details and finish located at the building at 197 Wharnccliffe Road North. Note the height of the balustrade is at the appropriate height to match the capstone of the brick plinths.*

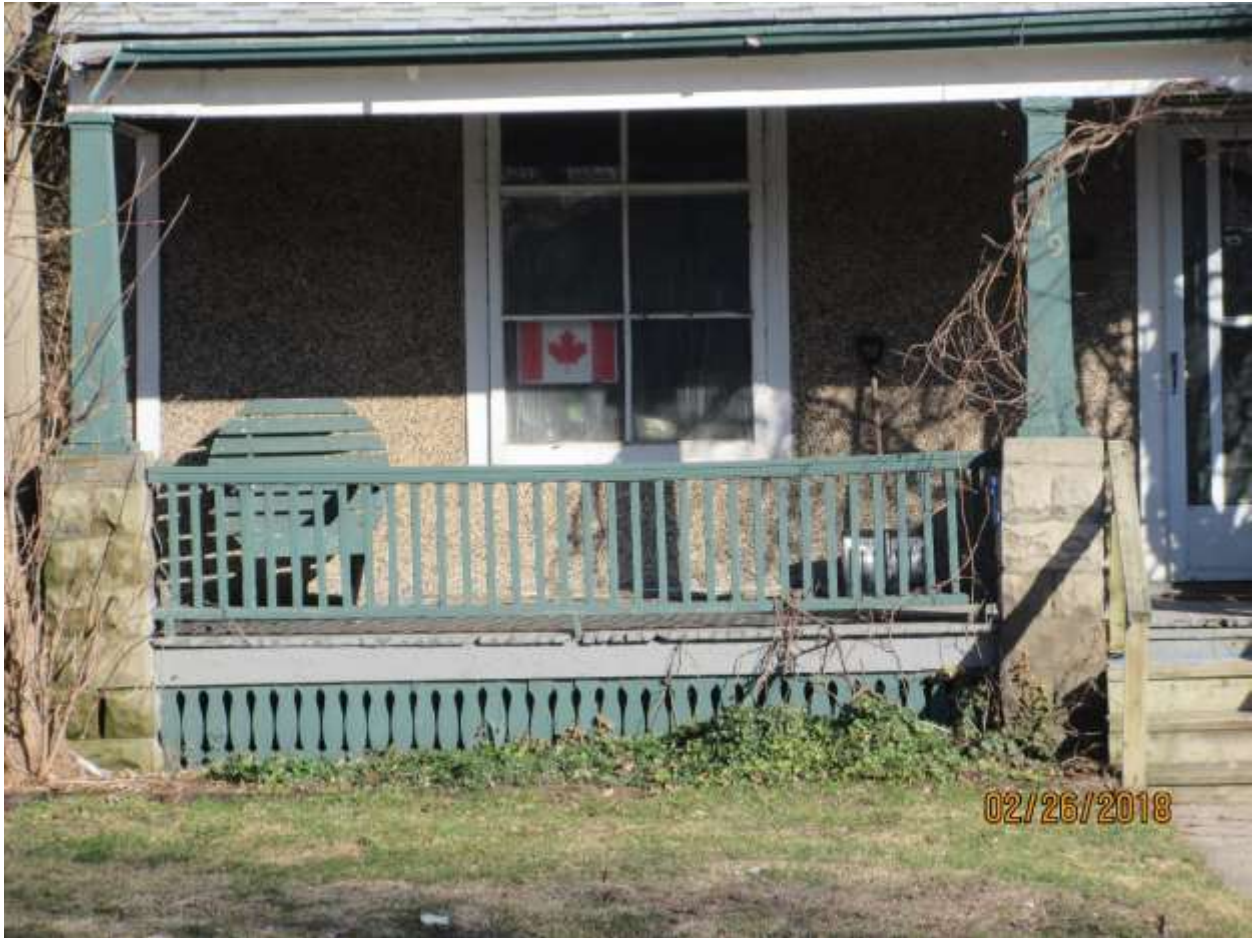
*Image 9: Detail of porch balustrade at appropriate height with appropriate details and finish located at the building at 149 Wharncliffe Road North. Note the height of the balustrade is at the appropriate height to match the capstone of the cast concrete plinths.*
