**Heritage Impact Statement  
2096 Wonderland Road North  
City of London, Ontario**

Part Lot 20, Concession 5, Former Township  
of London

April 10, 2018

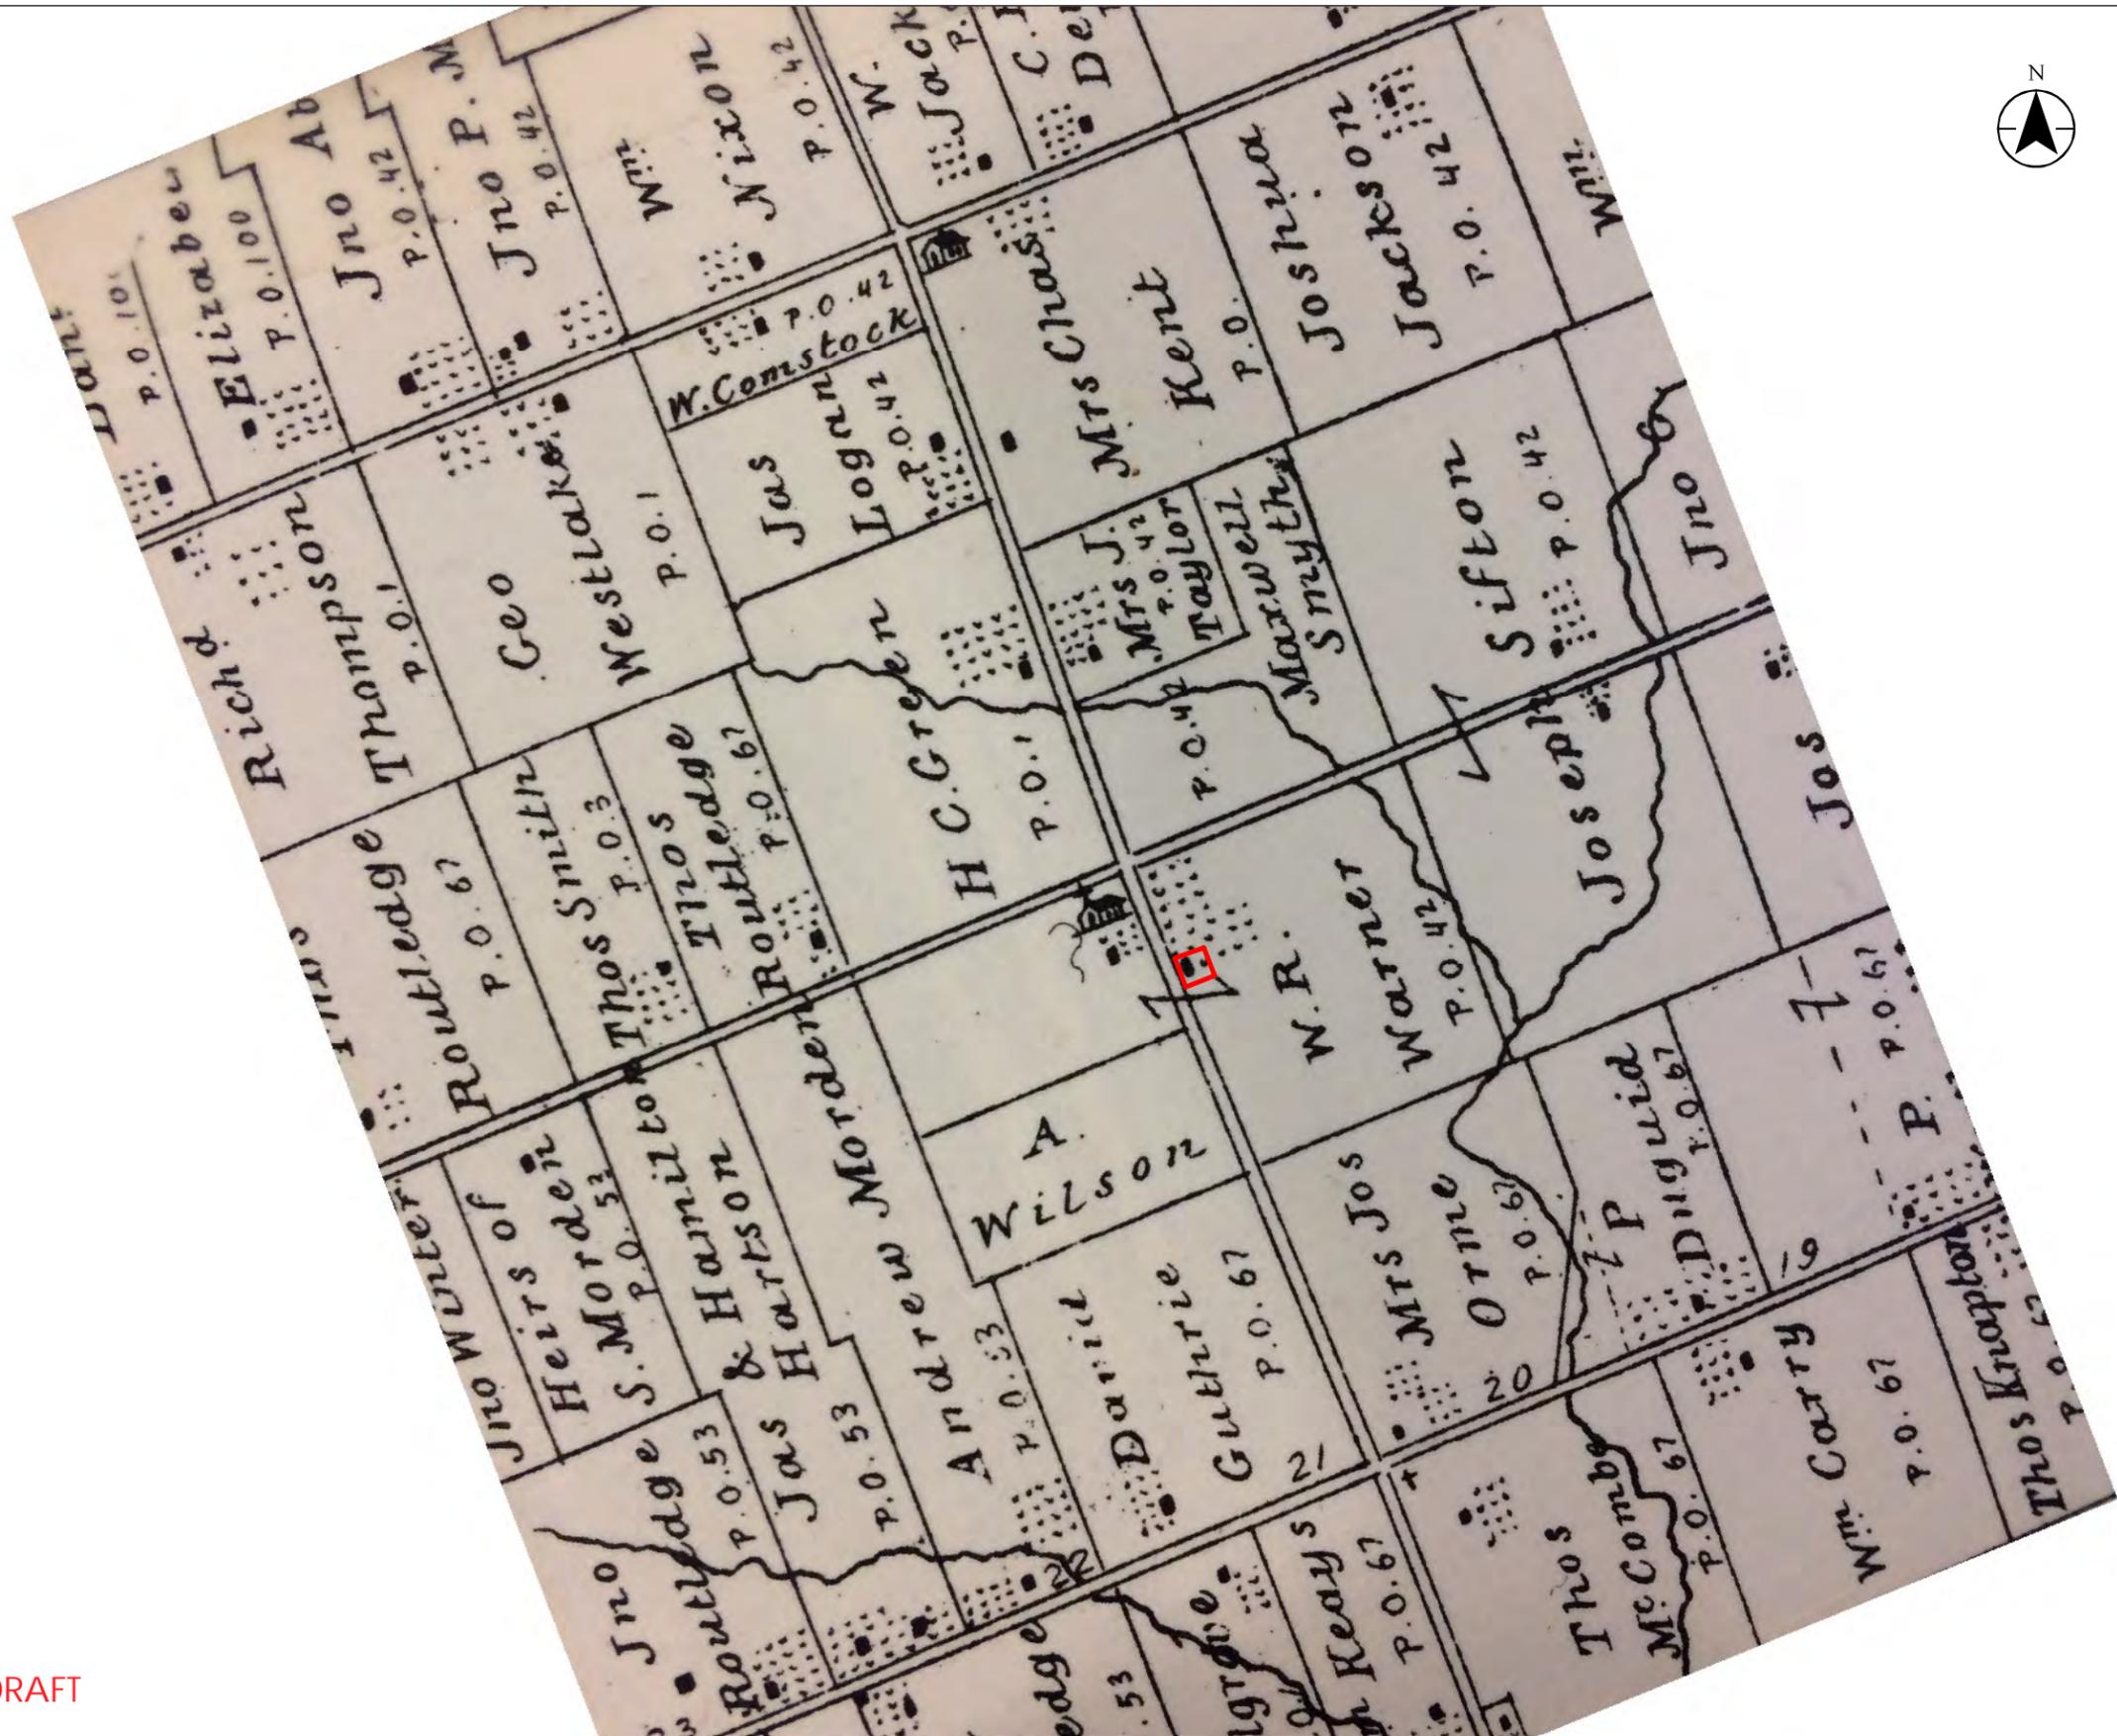
Title  
Map of Study Area, 1877

Page's 1877 map of London Township shows a building present at approximately the same location as the current structure on the property (Figure 3). The map also depicts orchards and that the Warner family owned part of the adjacent lot. The existing residence at the property is a Georgian style building, a style popular in Upper Canada from 1780 to 1860, and which usually replaced a settler's first log-cabin structure (Kyles 2016). The Georgian style residence fell out of favour by 1860 as more ornate Victorian styles, such as Italianate, Queen Anne, and Vernacular residences, became increasingly popular. Therefore, the City of London's Inventory of Heritage Resources date of construction for this residence as circa 1850 is supported, and matches the period of construction of other Georgian residences in the City of London. The Warner family had a farm of an above average value, so they were able to afford a statelier two storey Georgian residence. The prevailing building style at the time in Ontario was the one and a half storey Ontario Gothic Cottage (University of Waterloo 2009).

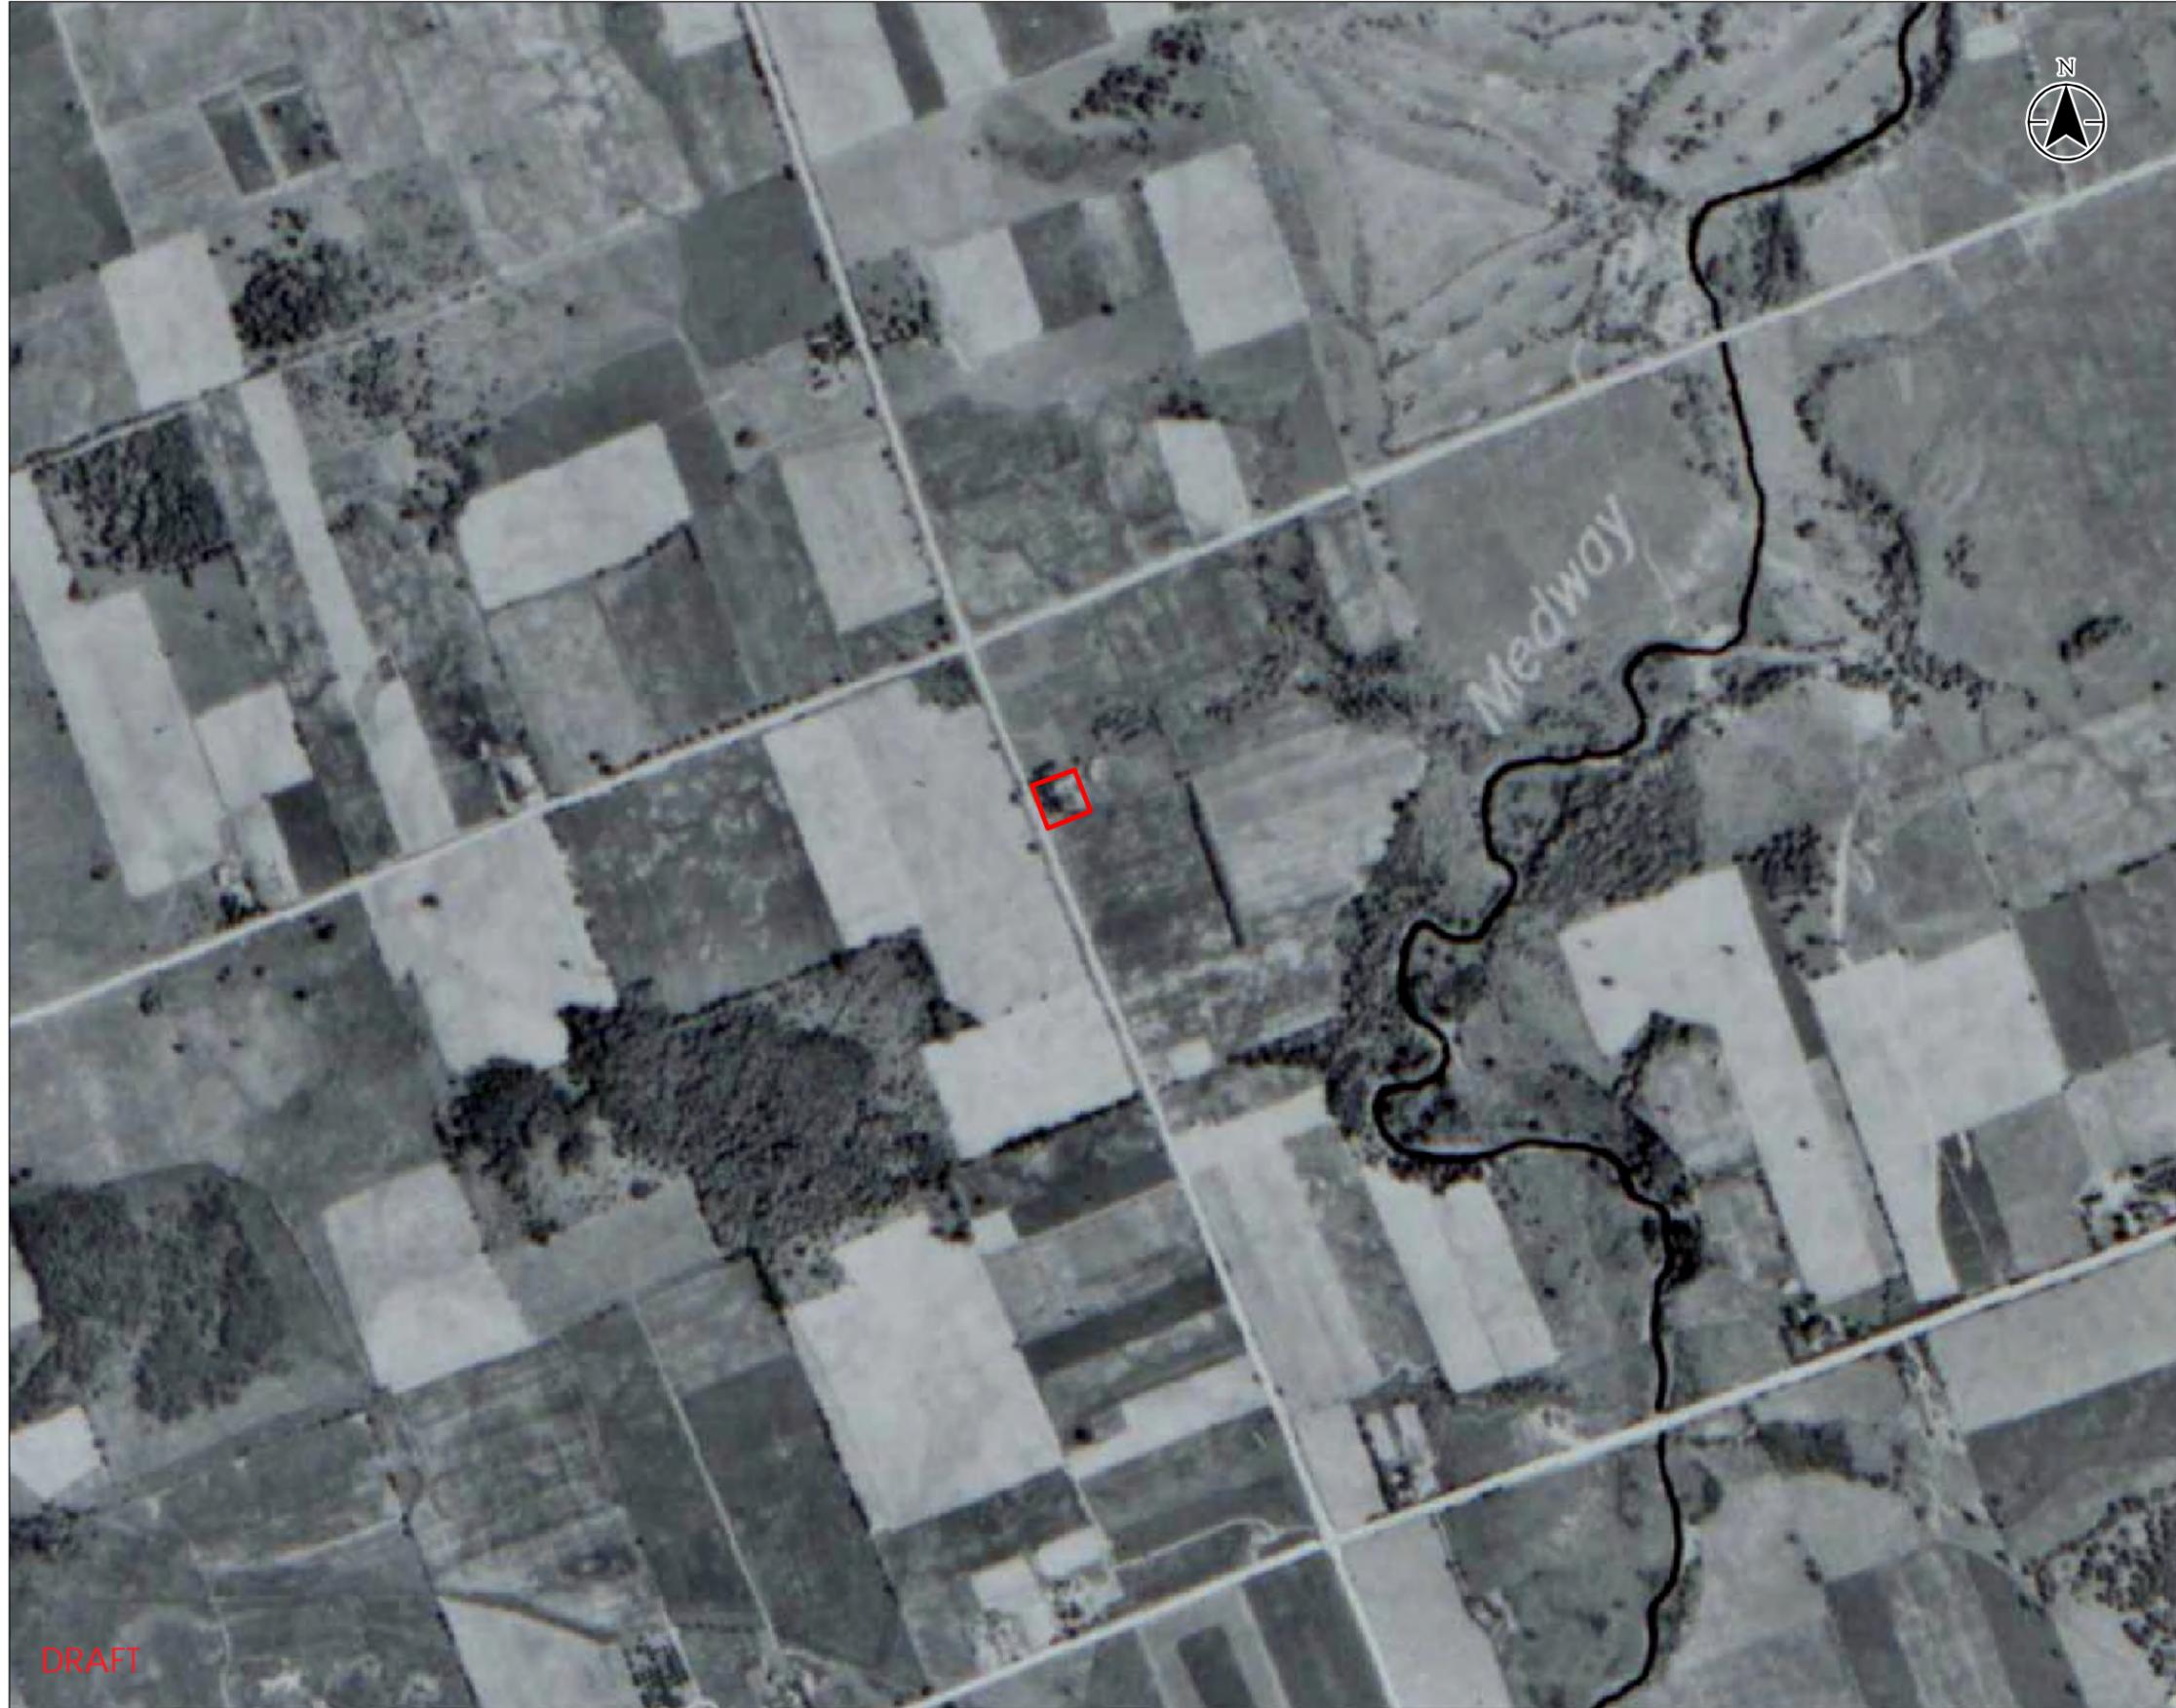
Title  
 Aerial View of Study Area, 1954

In the post-war period, the property and surrounding area remained largely agricultural. A 1954 aerial photograph (Figure 4) of the study area shows an entirely agricultural landscape with the exception of a golf course (now part of Sunningdale Golf & Country Club) along Medway Creek, north of Sunningdale Road. By 1967, the Sunningdale Golf Course had been extended to the southern side of Sunningdale Road (Figure 5). Also during the mid-20<sup>th</sup> century, the Medway Valley Heritage Forest was created by the Upper Thames River Conservation Authority (Upper Thames River Conservation Authority n.d.). Included in the Medway Valley Heritage Forest-North is part of Lot 20, Concession 5. The study area remained mostly agricultural in the 1970s. Topographic mapping from 1973 shows the residence to be one of only four structures north of the intersection of Fanshawe Park Road and Wonderland and south of Sunningdale Road and Wonderland. Additionally, it shows that the Sunningdale Golf & Country Club owned land adjacent to the study area on the north side (Figure 6). By 1989, development was starting to take place north of Fanshawe Park Road along Wonderland, with the first subdivisions visible in aerial photos (Figure 7).

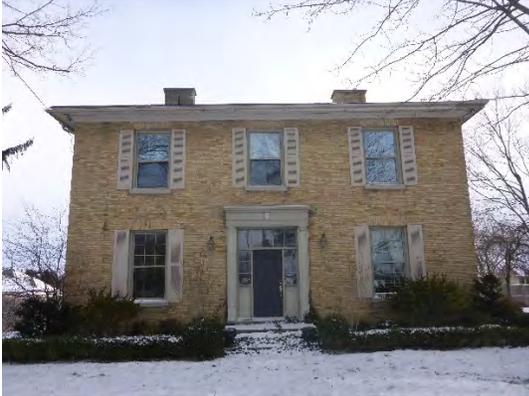
**Plate 5: Front façade (western elevation)**

The residence at 2096 Wonderland Road North is a two-storey Georgian style farmhouse with a buff brick exterior and stone foundation. The house has a square shape plan, with an addition connecting to a modern garage on the east elevation. The addition likely dates to the 1970s or 1980s. According to the City of London Heritage Register, the original portion of the residence dates to about 1850. The original portion of the residence has a hip roof clad in asphalt shingles and bookend chimneys. The chimney on the south elevation is brick and the chimney on the northern elevation is clad in concrete, the original brick partially visible. The addition is a shed roof garage with loft that is connected to the residence by a buff brick flat roof addition to the original residence.

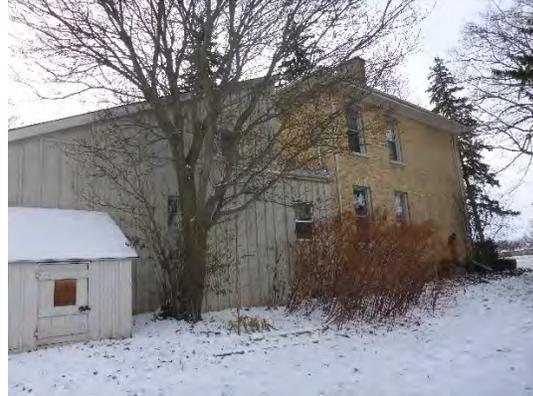
**Plate 6: Northern elevation**

The north elevation (side) on the second storey has two modern windows with brick voussoirs. The first storey also has two modern windows with brick voussoirs. The stone foundation of the residence is visible and this elevation has three modern basement windows with brick voussoirs just above the foundation where the buff brick exterior meets the stone foundation (Plate 6).

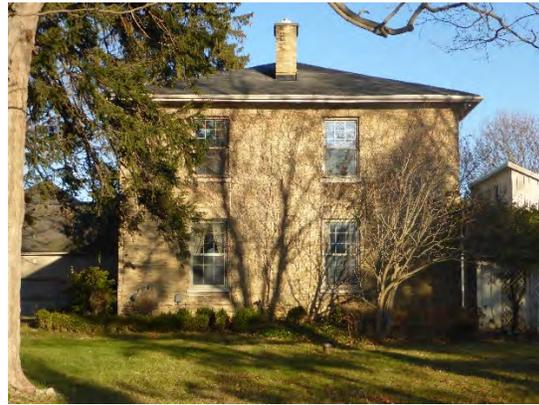
**Plate 8: Southern elevation**

The south elevation (side) has two modern windows on the second storey with brick voussoirs. The first storey has two modern windows with brick voussoirs. The foundation on this elevation is not as visible compared to the north elevation. Two basement windows are located below the first storey windows and these windows have brick voussoirs where the foundation meets the buff brick exterior (Plate 8).

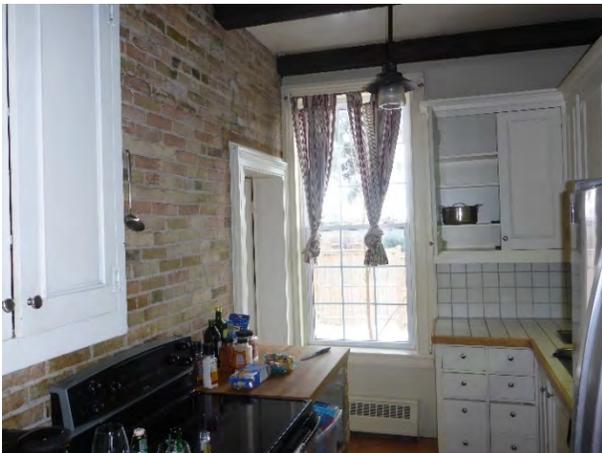
**Plate 9: Kitchen**

The interior arrangement of the residence at 2096 Wonderland Road North is a typical layout for a 19<sup>th</sup> century Ontario farmhouse. The first storey contains a kitchen (Plate 9), a laundry room (part of the addition) (Plate 10), dining room (Plate 11, Plate 12), living room (Plate 13, Plate 14), bathroom (Plate 15), den (Plate 16), and foyer (Plate 17, Plate 18). The central portion of the first storey has a hallway with the front entrance door and a staircase which leads to the second storey (Plate 19, Plate 20, Plate 21, Plate 22). The dining room, central hallway, and living room, part of the foyer, and bathroom have wainscoting that is either painted white or naturally finished. The flooring in the foyer, bathroom, and kitchen is modern ceramic tile. The den is carpeted. The living room, dining room and central hallway feature wide plank wooden flooring that appears to be the original hardwood flooring.

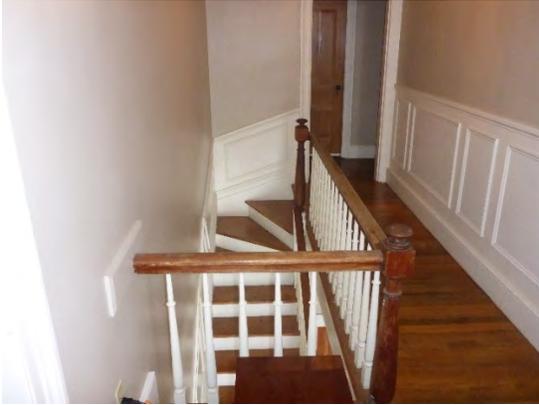
**Plate 23: Staircase from 2<sup>nd</sup> floor**

The second storey is accessed through the staircase in the central hallway (Plate 23, Plate 24) of the residence and contains two bathrooms and four bedrooms. One bedroom was locked and inaccessible. One bedroom was carpeted, had a fireplace mantle, and an ensuite bathroom (Plate 25, Plate 26). The remainder of the accessible bedrooms had wooden flooring (Plate 27, Plate 28, Plate 29) and the bathroom accessible from the hallway had modern ceramic

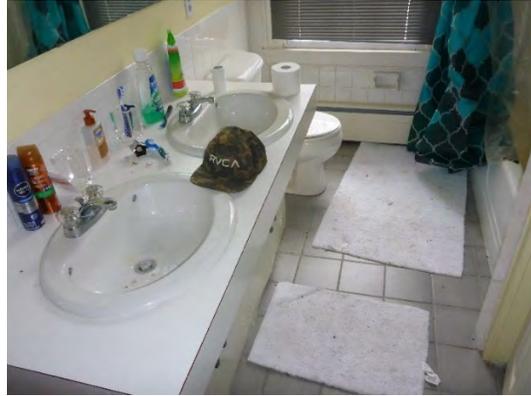
**Plate 30: Upstairs bathroom accessed from hallway.**

flooring (Plate 30). All of the rooms, except the ensuite bathroom, are connected by a hallway with a hardwood floor (Plate 31).

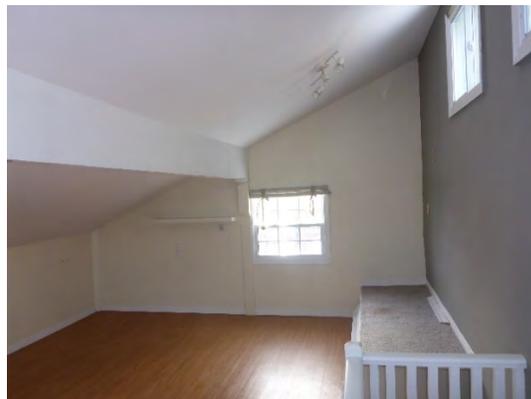
**Plate 34: Loft above garage**

The doors in the residence are wooden and many of them feature skeleton key locks and ornate door knobs (Plate 33). The modern attached garage has a loft above it and is connected to the main residence via the laundry room (Plate 34).

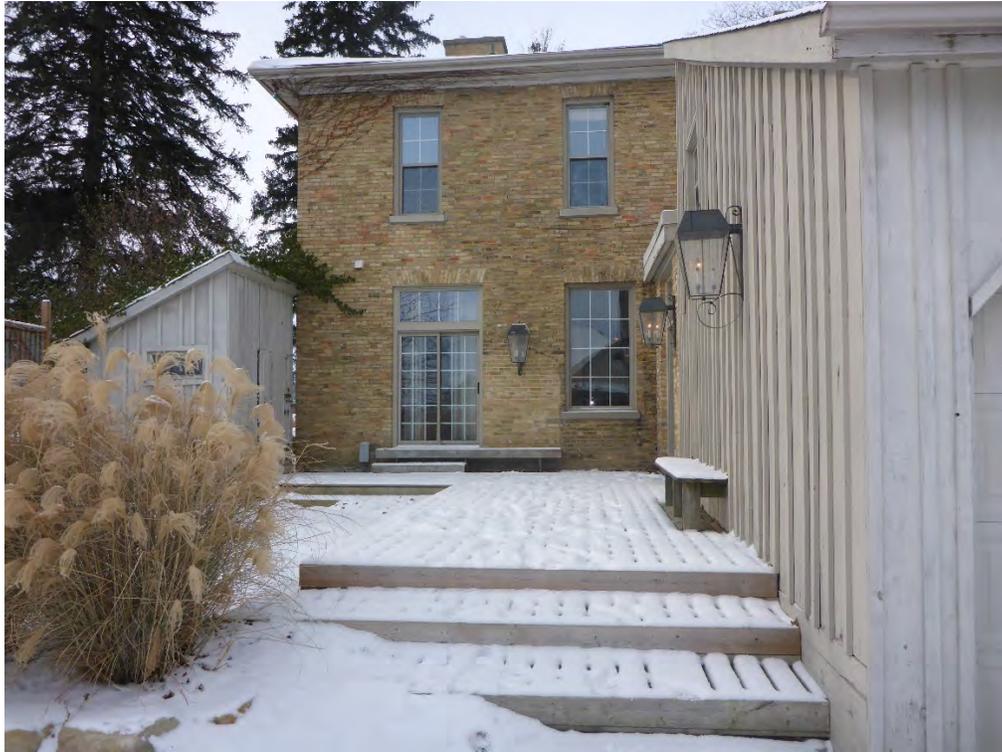
**Plate 35: Sauna and Deck**

The subject property contains one outbuilding, which is a sauna located on the southeast corner of the residence (Plate 35). The sauna is adjacent to a deck. In aerial photography until at least 1967, outbuildings which may have been barns are present at the east elevation of the property. These barns do not appear in the 1973 Topographic Map or 1989 aerial photo of the area.

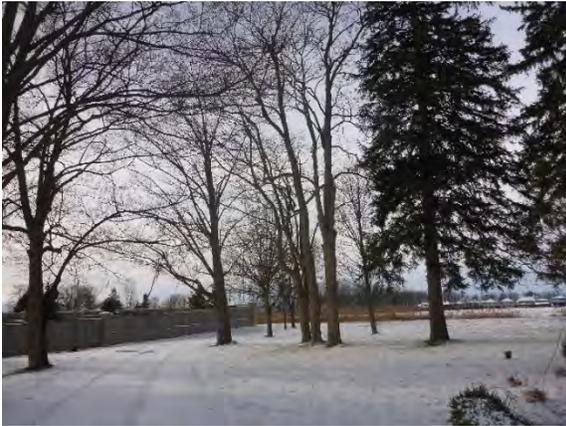
**Plate 36: Gravel driveway and mature trees on property, looking southwest**

The subject property contains several landscape features. The property contains a gravel driveway which leads to an asphalt driveway and parking area (Plate 36). There are a number of mature evergreen and deciduous trees on the property (Plate 37). The southeast corner of the property has an ornamental garden (Plate 38). The residence is surrounded with bushes and shrubs including boxwood and yew (Plate 39). The east (rear) elevation has a wooden deck.

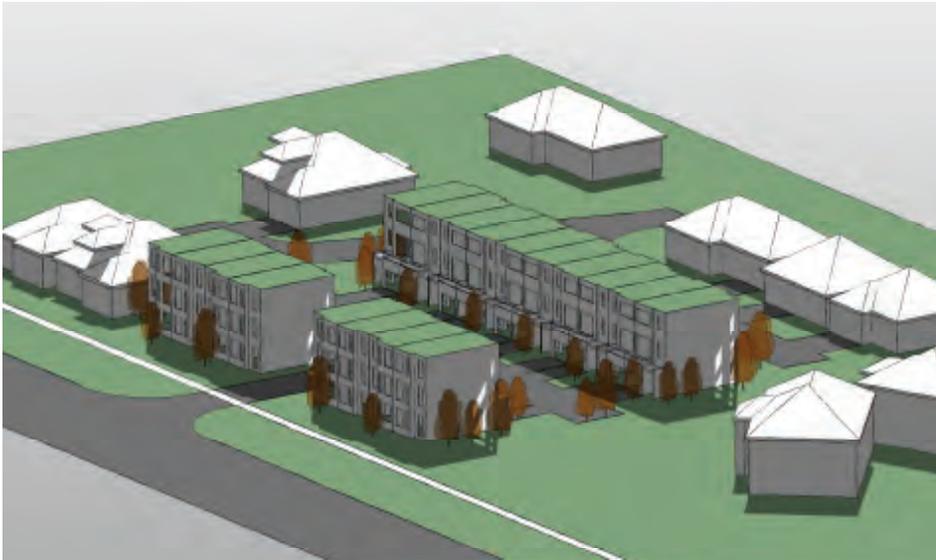
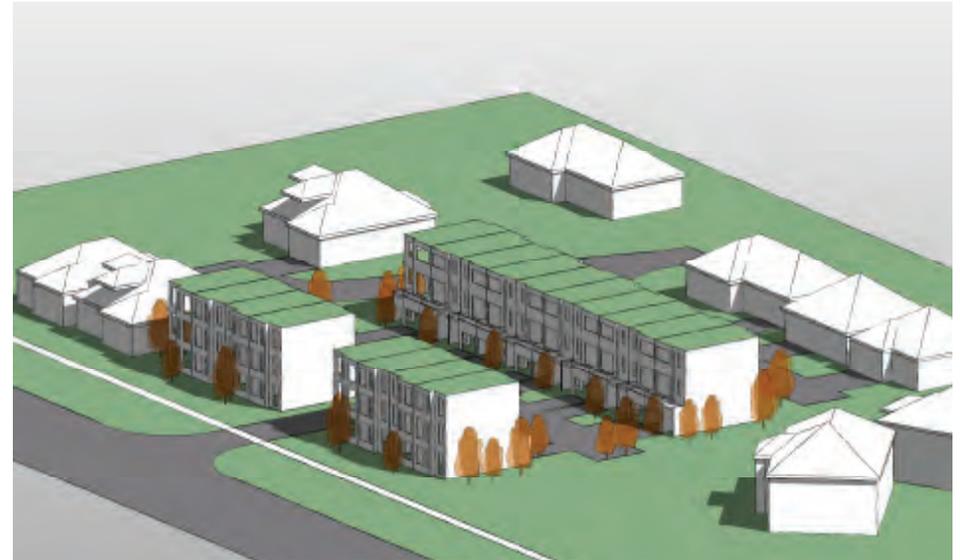
*Shadow Study : June 15 @ 9.00am*

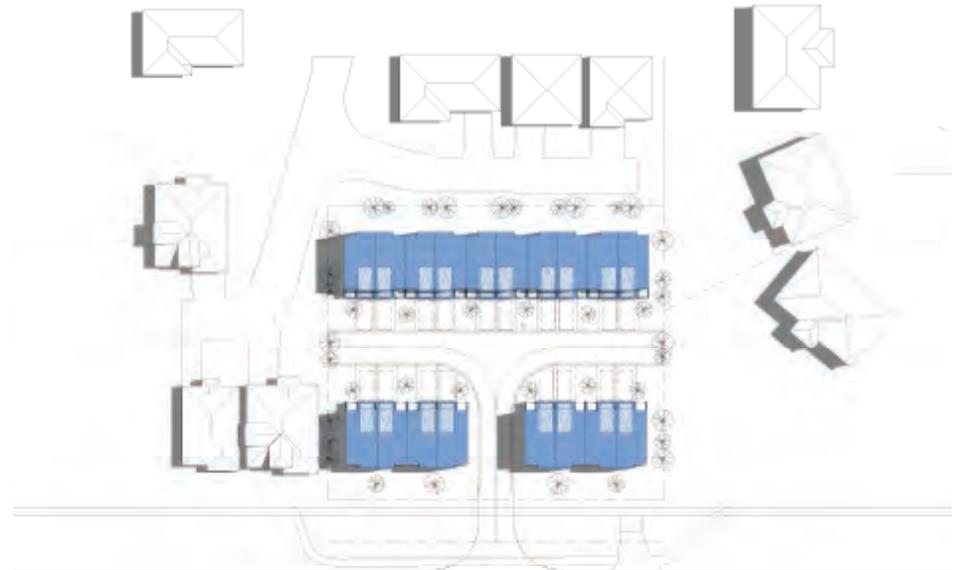
*Shadow Study : June 15 @ 2.00Pm*

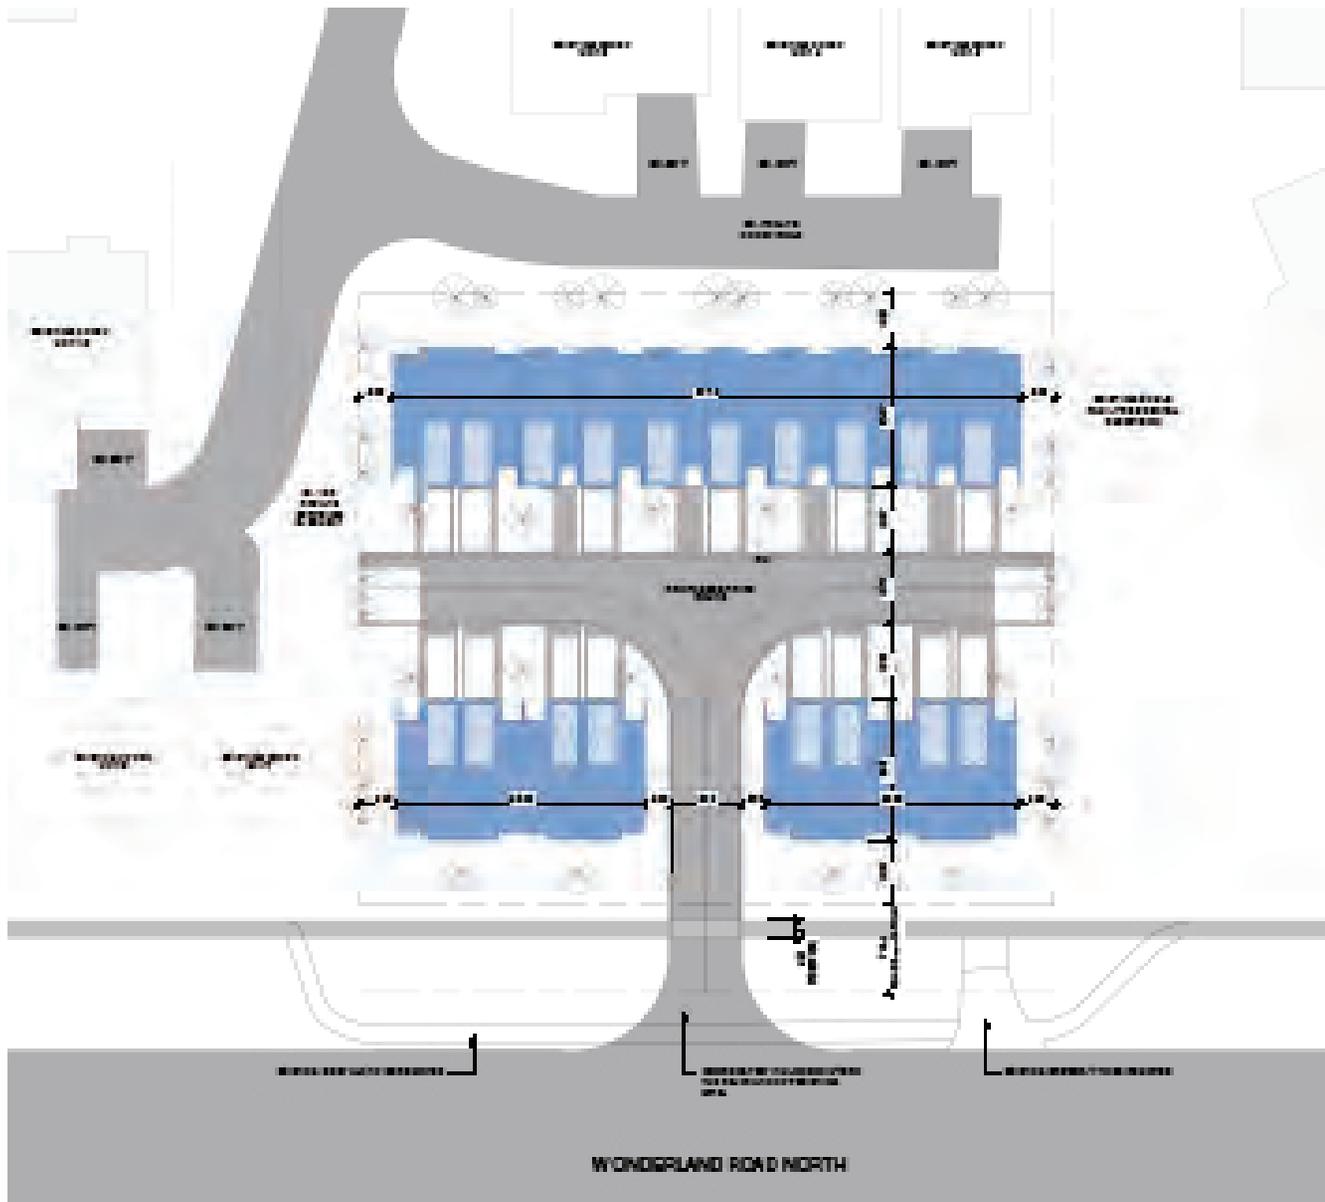
### 3.0 SITE PLAN AND STATISTICS

Site Statistics		
Address: 2096 Wonderland Road North Zoning: RB-5		
LEGAL DESCRIPTION:	xxx	
ZONING	REQUIRED/ALLOWED	PROPOSED
SITE (LOT) AREA:(min.)	800m <sup>2</sup>	4046m <sup>2</sup> GROSS 3,641m <sup>2</sup> NET
LOT FRONTAGE (min.)	16 m	68.6 m
FRONT YARD (min.)	6 m	6 m
EXTERIOR YARD (min.)	8 m	6 m
INTERIOR AND REAR YARD (min.)	3m TO 6m DEPENDING ON BUILDING HEIGHT AND WINDOWS	3m TO 6m
LOT COVERAGE (max.)	40%	81.80%
LANDSCAPE, OPEN SPACE (min.)	30%	81.52%
BUILDING HEIGHT (max.)	12m	12m
UNITS		18
DENSITY (max.)	25 UNIT/ Ha	34.6 UNIT/ Ha GROSS 38.8 UNIT/ Ha NET
PARKING:	1.8 SPACE/ UNIT (min. 27)	36
