Victoria Bridge Municipal Class EA Civic Works Committee

John Puccio, P. Eng., Project Manager

June 19 2018

AECOM

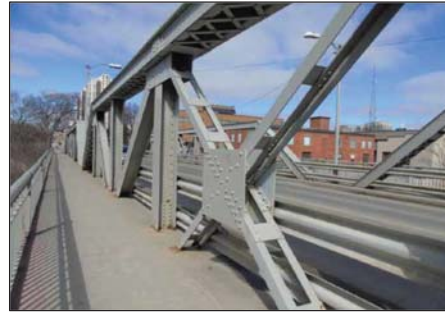
Victoria Bridge

- The bridge is a seven panel modified Warren steel-pony truss bridge with an exposed concrete deck.
- The two-span structure was built in 1926 as the fourth crossing of the Thames River.
- Portions of the north abutment and pier date back to 1875.
- The bridge supports Bell cables, a sanitary sewer and watermain.

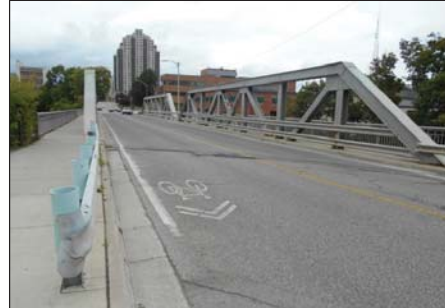
Active Transportation

- Currently there are shared bike facilities (sharrows) along the bridge as part of the bike lanes running north-south along Ridout Street. Important connection for commuter trips between residential areas and downtown.
- The bridge is a connection between on-road network and the Thames Valley Parkway system.
- The transition from pathway to bridge is narrow.
- The vertical clearance between the bridge and the pathway does not meet acceptable standards.

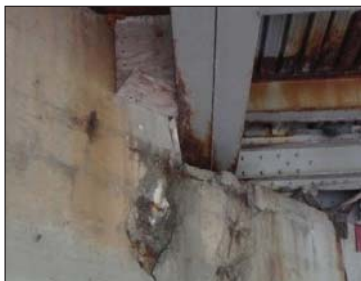
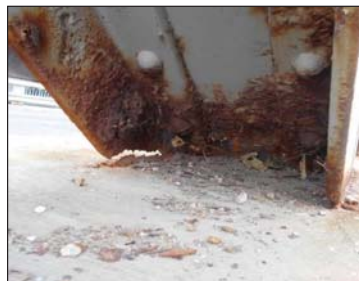
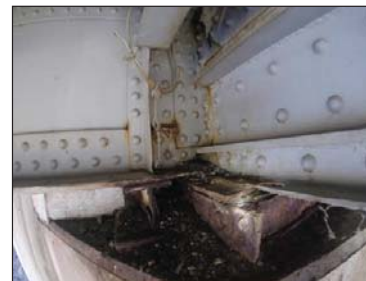
Structural Assessment – Rehabilitation (2016)

- A structural analysis was undertaken to determine the feasibility of accommodating a wider sidewalk on the bridge for cyclists.
- The structural analysis determined there is sufficient load capacity to accommodate a wider sidewalk and rehabilitation of the bridge was feasible.
- Removal of the existing sidewalk and railing system would be required to accommodate a maximum 3m wide cantilevered sidewalk.
- Structural deficiencies include the deck, barrier systems, steel components, bottom chords, steel roller bearings, piers and abutments, etc.
- Utilizing the existing north abutment and pier (1875) will not extent the service life of the overall structure.

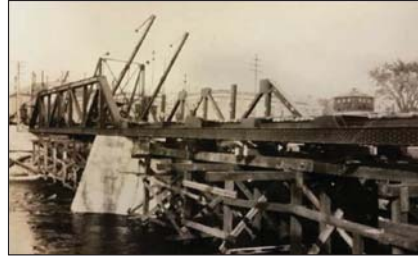
Cultural Heritage (2016)

- A Cultural Heritage Evaluation Report (CHER) identified the Victoria Bridge as having significant cultural heritage value or interest under Ontario Regulation 9/06.
- The bridge is not currently designated or listed on the City's Inventory of Heritage Resources or other provincial/federal registries or inventories.
- The CHER recommended conserving the cultural heritage of the bridge either by bridge rehabilitation with sympathetic modifications or other forms of heritage conservation.

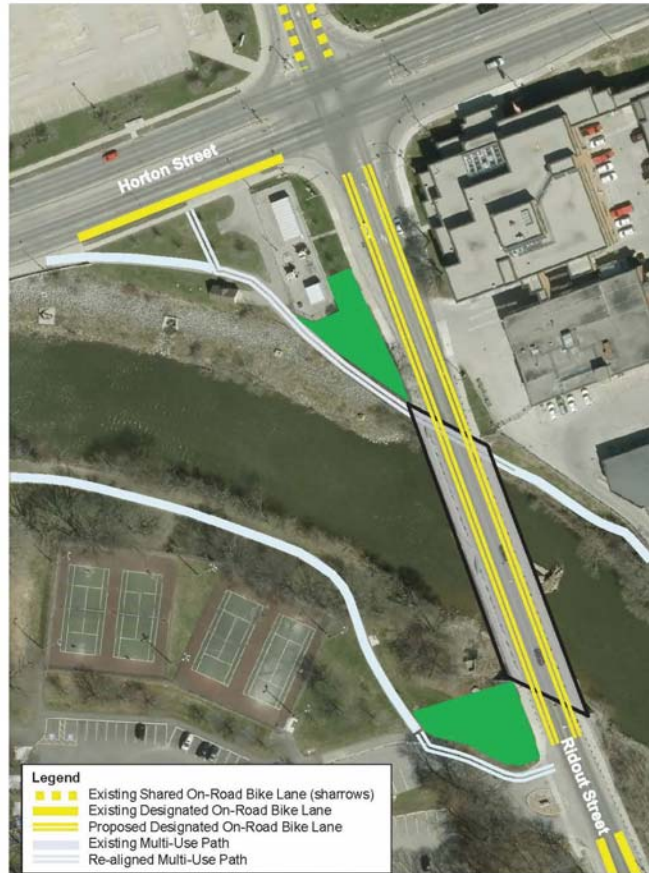
- Existing multi-use path splits east of Horton Street bridge:
 - multi-use path continues along Thames River
 - designated bike lane on Horton Street west of Ridout Street.
- Existing shared bike lane on Ridout Street upgraded to a designated bike lane south of Horton Street to south of Victoria Bridge to join existing designated bike lane.
- Multi-use path improvements to provide acceptable clearance under bridge.
- Improvements to increase vertical profile of Horton Street, London Hydro entrance and Thames Park entrance.

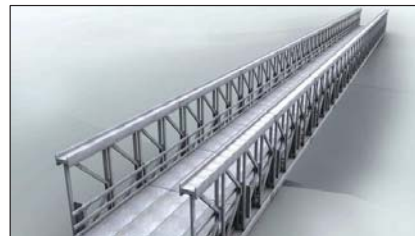
Temporary bridge example

- Install temporary Bridge (for pedestrian use and support of existing utilities) and approaches to bridge.
- Disconnect and relocate existing services (sanitary and Bell only).
- Remove existing bridge structure.
- Construct concrete abutment including piles and piers.
- Install structural steel.
- Construct concrete deck.
- Construct concrete parapet walls and railing system.
- Reconstruct Thames Valley Parkway path below north side of bridge.
- Complete approach work including regrading and entrances.
- Waterproof and asphalt pavement.

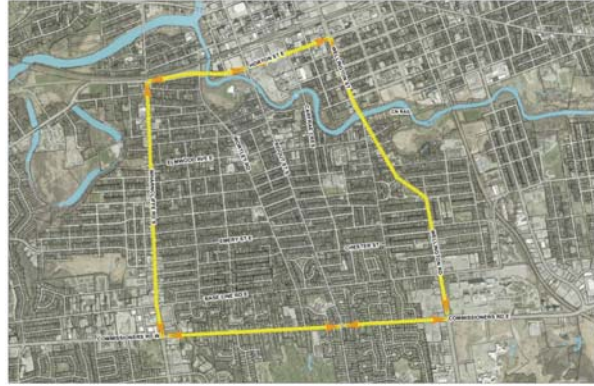
Active Transportation Detour

- Temporary closure of Thames Valley Pathway below the bridge is anticipated for the full duration of construction.
- A temporary bridge will provide access for pedestrians and cyclists across the river during construction.
