CSMO 2018: CONSERVATION TREATMENT PROPOSAL #3085/2018/05/24

CONSERVATION of SCULPTURES, MONUMENTS & OBJECTS

PROJECT: Simcoe School War Memorial Treatment Proposal

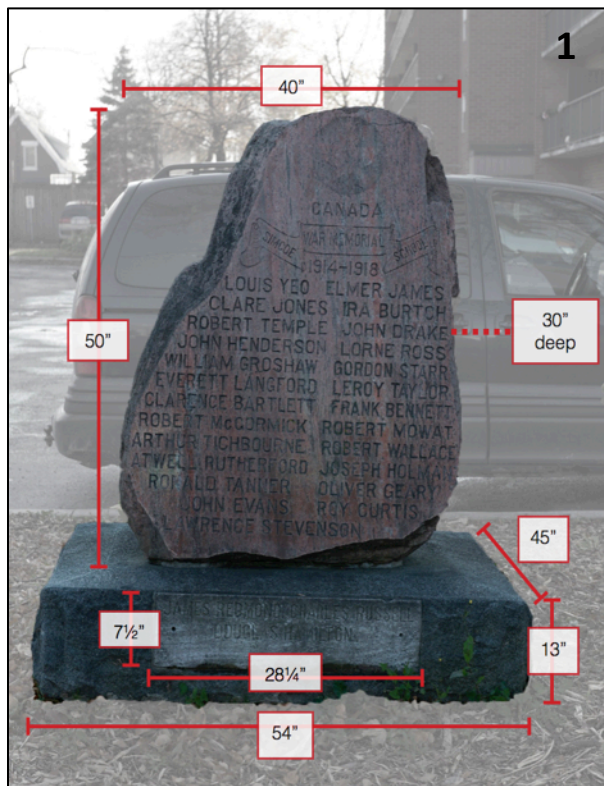
The Simcoe School War Memorial is composed of three main components: rectangular granite base, pink granite slab, and small limestone plaque.

- 1: Overall dimensions of the Simcoe School War Memorial
- 2: Detail of the limestone plaque. All inscriptions on the monument are a serif font
- 3: The monument, photographed front the North East corner
- 3: The monument, photographed from the West side

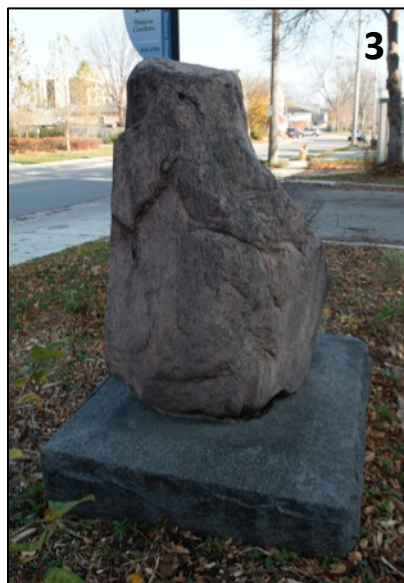
The base is made of a salt and pepper dark grey coloured granite. The surface of the stone is unfinished and the tooling marks from manufacture are clearly visible along the stone's edge. Part of the front face of the base has been cut away to accommodate additional commemorative names on a limestone plaque.

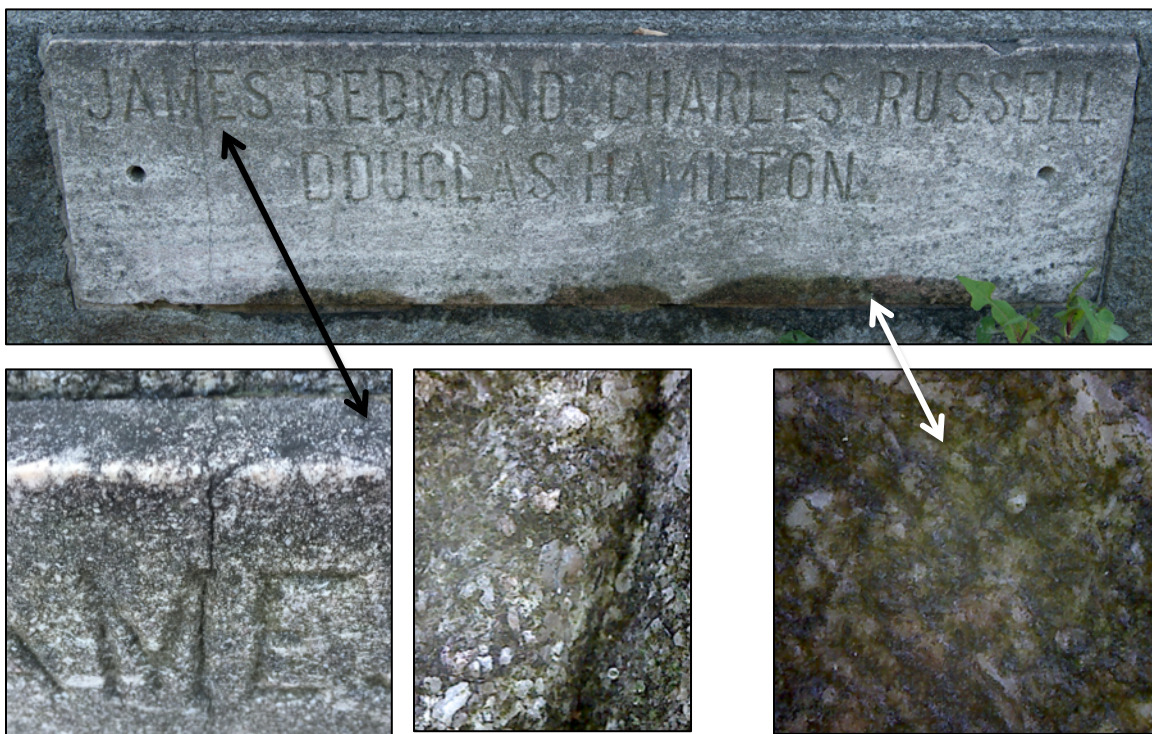
Overall the granite of the base is very stable; there is minimal cracking visible on the surface of the stone. There is concern, however, with the condition of the limestone plaque that has been added to the base. A collection of moisture at the base of the plaque suggests that water is collecting in behind the stone plaque, thus between the plaque and the base. Though some water is draining out of the base of the plaque, any collection of moisture between two stones for an extended period of time is concerning, as it may lead to the degradation of both stone surfaces.

This is especially concerning with outdoor monuments in this environment, as the freezing and thawing of any water built-up in the stone will cause cracking and even delamination or loss over time. This issue is already beginning to occur as there is a cracking running down the front of the limestone plaque. This crack has yet to fracture through the entire thickness of the stone, but will continue to grow if not stabilized.

This collection of water is also accommodating bio-growth such as moss and mould. If left untreated, these will enable the growth of higher plant life that could further compromise the stability of the stone matrix. Thin build-up of this type of bio-growth is also marring the names on the surface of plaque, decreasing their legibility.

Condition Concerns with limestone plaque include:

- cracking (Black arrow; seen here in detail and at 40x magnification)
- moisture access and bio-grown (White arrow; seen here in detail and at 40x magnification)

The moisture access to the front limestone plaques needs to be addressed as soon as possible to prevent worsening of the existing signs of instability, such as cracking. The seam surrounding the plaque needs to be sealed, while still allowing for moisture drainage to prevent trapping.

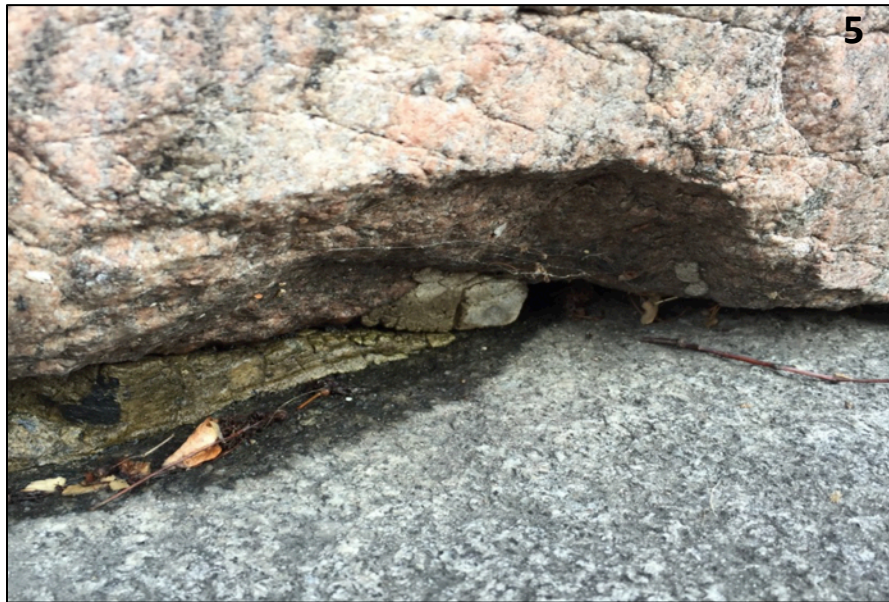
As with the rest of the monument, the granite boulder is stable overall. The main concern for future stability is the degradation and loss of the mortar that fills the seam between the boulder and its granite base. There is a large section along the back seam of the monument that is missing, allowing access underneath the boulder itself. Though this access is relatively small, moisture is clearly building up and being trapped in this area.

- 1: Stable, clean pink granite (40x magnification)
- 2: Dirtied granite surface (40x magnification)
- 3: Stable bio-growth in sandblasted letter (40x magnification)
- 4: Unstable higher plant life in sandblasted letter (40x magnification)
- 5: Loss of joining material

In addition to the seam along the plaque, the loss in joining material along the base of the granite boulder also needs to be replaced.
