Report to the London Advisory Committee on Heritage

To: Chair and Members
London Advisory Committee on Heritage
From: John M. Fleming
Managing Director, Planning and City Planner
Subject: Heritage Alteration Permit Application By: E. Seminara
187 Dundas Street
Downtown Heritage Conservation District
Meeting on: Wednesday September 12, 2018

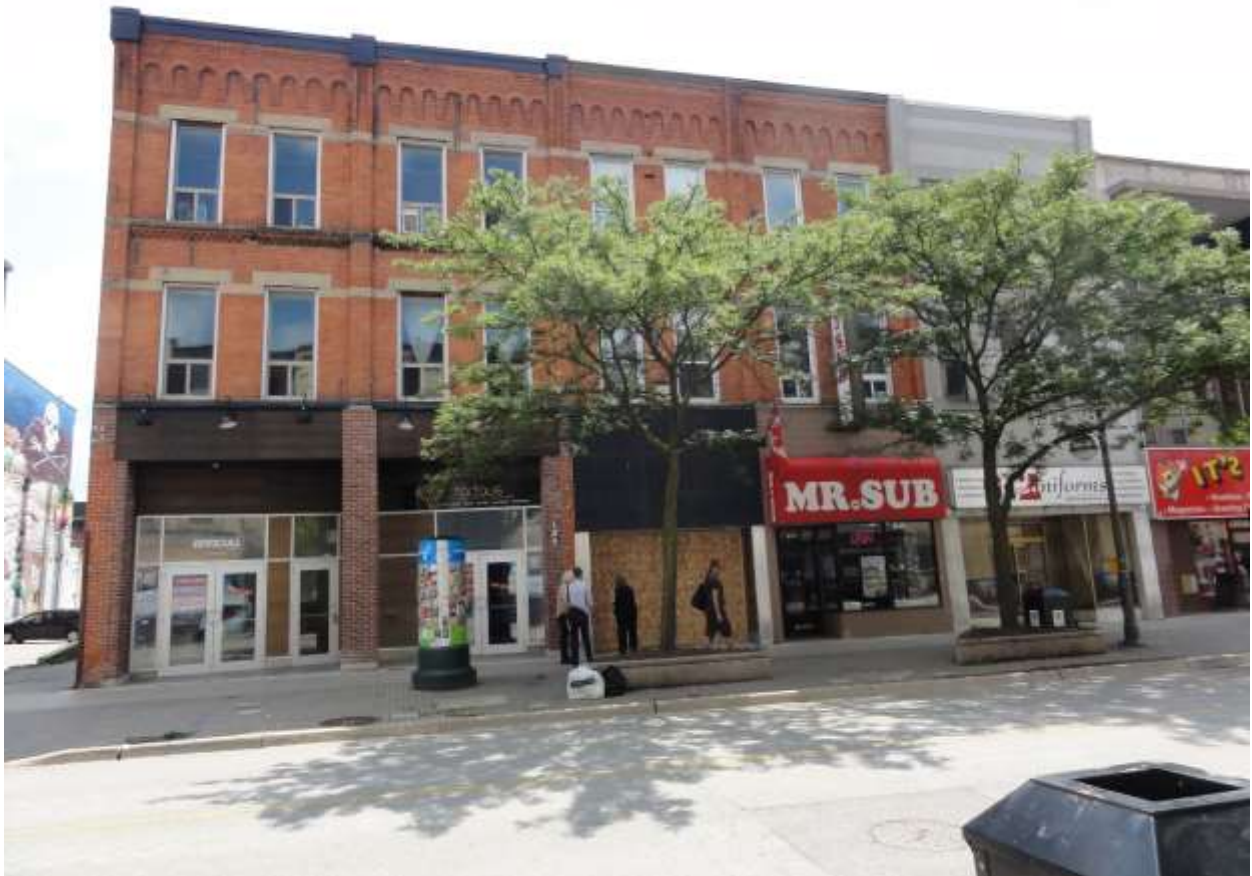
Image 1: View Union Block at 183, 185, 187 and 189 Dundas Street (August 9, 2018)

The cultural heritage resource located at 187 Dundas Street is a three-storey di-chromatic brick, commercial building constructed circa 1887 (Appendix B). 187 Dundas Street is part of the Union Block which also includes 183, 185 and 189 Dundas Street. This block is representative of several other late 19th century commercial blocks in the City of London which are identifiable by the use of red brick with stone trim at the lintels and decorative courses (Baker, p85). An ornamental brick corbel table adorns the cornice of the building – unifying the block, while storefronts and signage exhibit variety in the use of materials and detailing. The upper limits of the commercial signage band is uniform – its datum line defined by the sills of the second-floor windows.

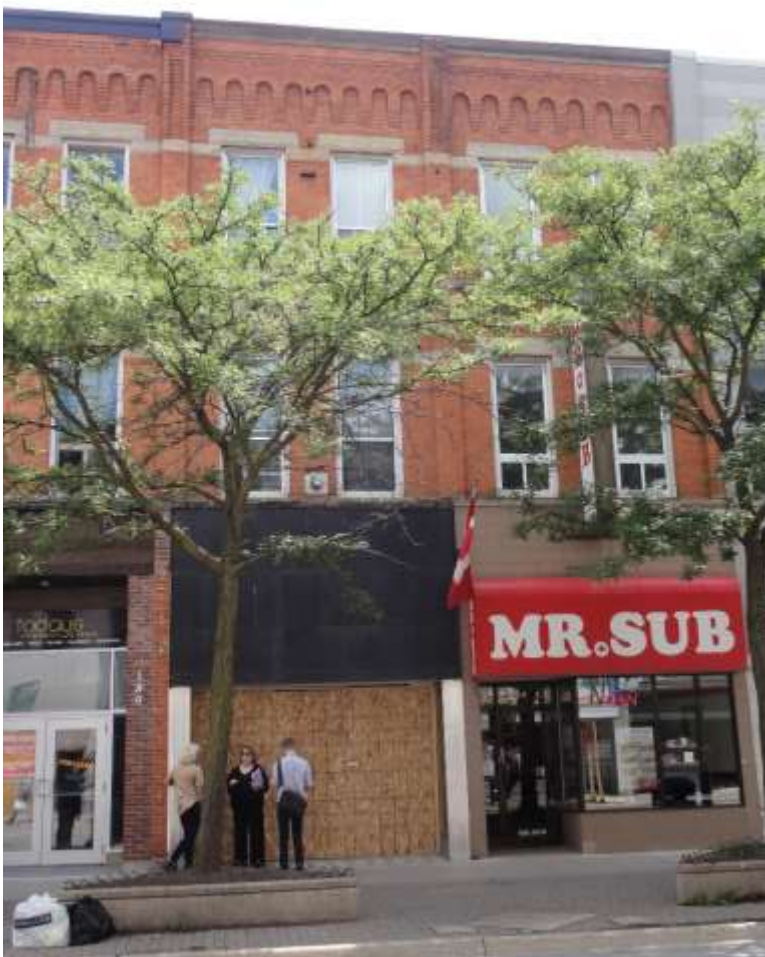
Image 2: View of 187 Dundas Street (August 9, 2018)

As per Section 42(1) of the Ontario Heritage Act, a Heritage Alteration Permit is required to make alterations to a property within a Heritage Conservation District. Heritage staff noted unapproved alterations underway at 187 Dundas Street (specifically the removal of portions of the existing storefront), and a letter was sent to the property owner on July 10, 2018; work was immediately halted.
