CULTURAL HERITAGE EVALUATION REPORT

TRANSIT PROJECT ASSESSMENT PROCESS
LONDON BUS RAPID TRANSIT

736, 740, 742, 744, 746 RICHMOND STREET
CITY OF LONDON
PROVINCE OF ONTARIO

PROJECT NO.: 141-21085-00
DATE: NOVEMBER 2018

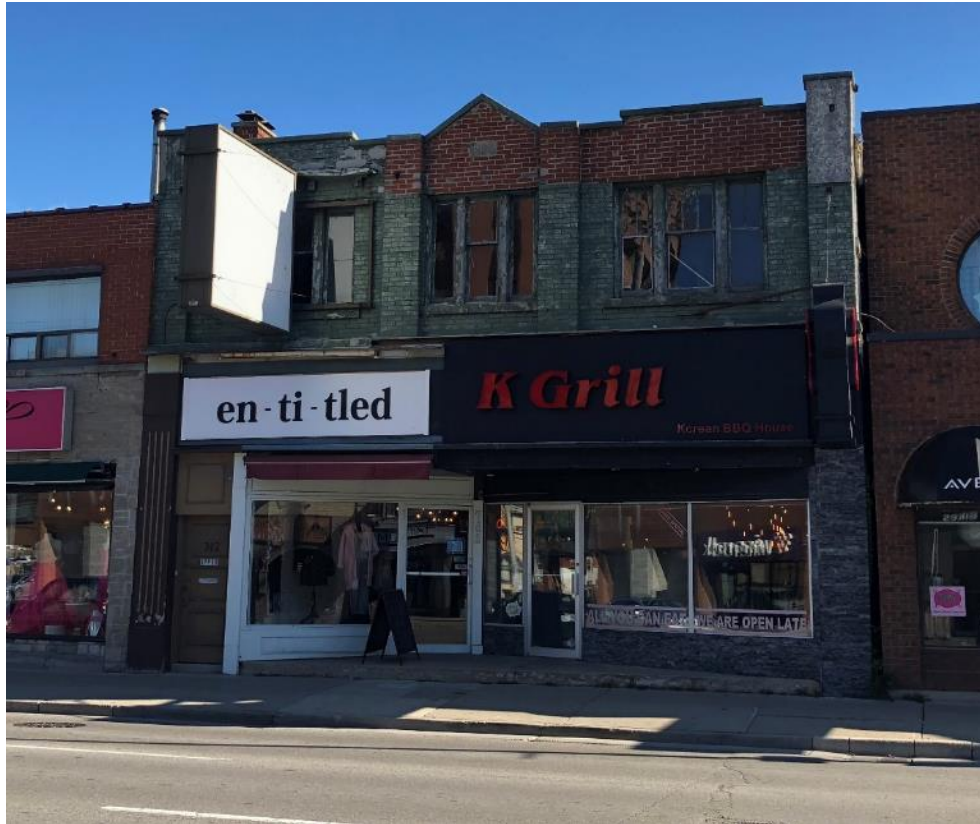
Image 3: 742 Richmond Street

The subject property consists of a two-storey red brick commercial building constructed in 1925, which was designed by W.H. Hawkins and built by general contractor Hubert Thornton. It was originally a red and white brick building, was designed to be fireproof, and cost \$20,000 to build. It included a basement, and was heated with hot water. The upstairs apartments were accessed via a central front door with a high arched transom and sidelights. Carriage-style garage doors that allowed cars and trucks to enter an automotive storage area have been replaced by storefront windows at street level (Figure 15).

- Original architectural features of W.H. Hawkins design including:
 - scale
 - massing
 - red brick façade
 - flat roof
 - four battlements or stepped parapets
 - central peaked frontispiece
 - brick squared pilasters
 - 1925 datestone
 - divided wood window grouping
- Fire protection and prevention features, including:
 - all steel joists
 - 24-foot beams
 - brick construction
 - six inches of concrete between the first and second floors

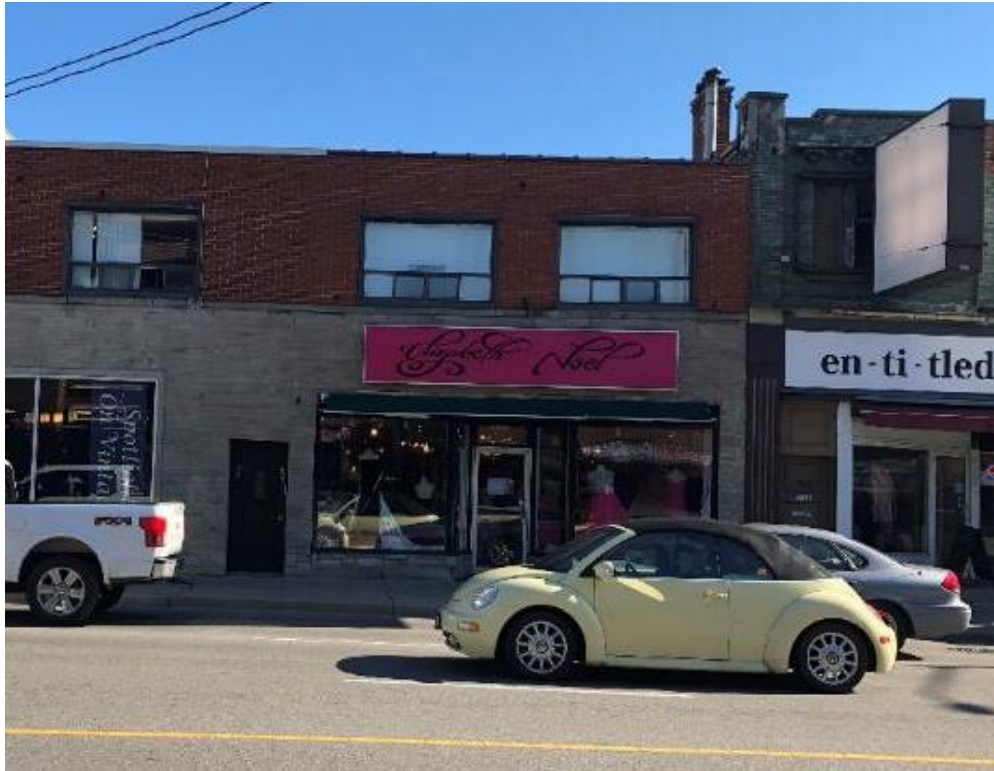
Image 4: 744 Richmond Street

The 1957 Geodetic Survey of Canada (Figure 14) confirms that the residential dwelling at 744 Richmond Street had been replaced, as its new footprint is shown as larger and more rectangular than in the Fire Insurance Plans. As well, the structure is now located close to the front property line along Richmond Street which matches the current footprint of the building.

Based on the evaluation of background historical research, site investigation and application of criteria from *Ontario Regulation 9/06*, the subject property at 744 Richmond Street was determined to not have significant cultural heritage value or interest. Accordingly, no Statement of Cultural Heritage Value or Interest and list of Attributes has been prepared.

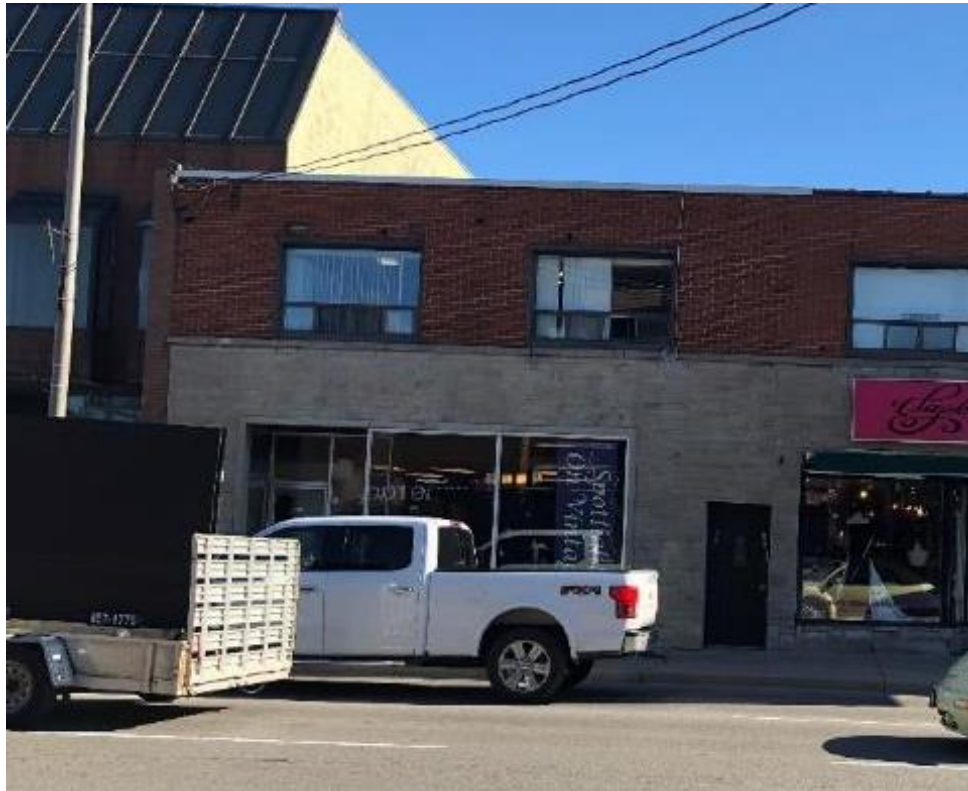
Image 5: 746 Richmond Street

Correspondence with Mark Tovey via the Scotiabank Archives (Mark Tovey, via email [Nov. 9, 2018]) confirmed that the bank opened a branch at 746 Richmond Street on May 8, 1950 and remained at this location until it relocated to 750 Richmond Street in 1974. An historical image of the streetscape from November 1955 shows The Bank of Nova Scotia located in a two-storey brick structure at 746 Richmond Street which is the same building that currently exists at the address. (Figure 17) The 1957 Geodetic Survey of Canada (Figure 14) confirms that the original building at 746 Richmond Street had been replaced, with the footprint shown as larger and more rectangular than the building footprint shown in the 1892 revised 1907 and 1912 revised 1922 Fire Insurance Plans. In addition, the structure is located close to the property line along Richmond Street which matches the current footprint of the building.

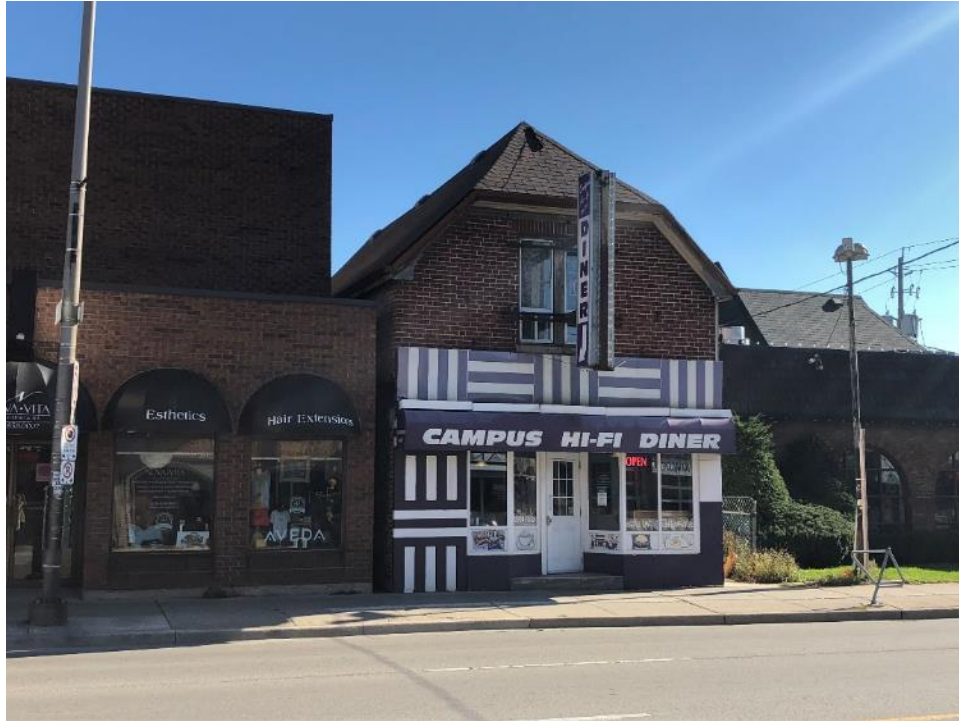
Image 6: View of front elevation of the building located at 736 Richmond Street. (WSP, 2018)

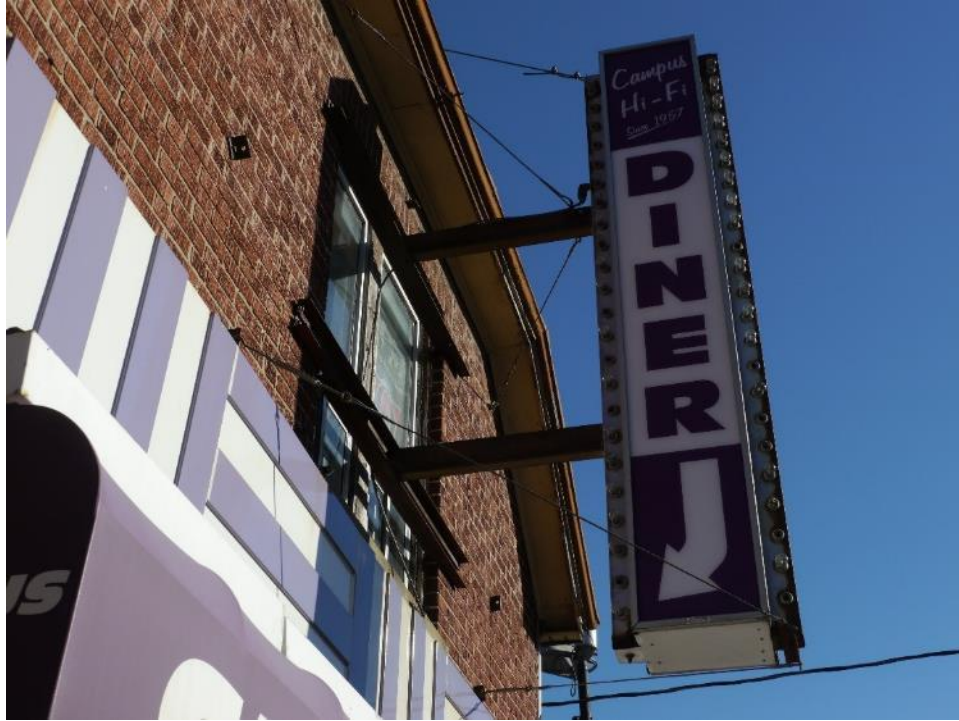
The second floor features a centrally located pair of windows in the gable end, with a brick lintel and concrete sill. The wood window frame is still visible; however, the window inserts have been replaced with what appears to be an undivided vinyl window. Spanning in front of these windows is the bracket for the projecting illuminated sign which is reinforced with several metal cables. The projecting illuminated sign is back lit with individual bulb lights running vertically on either side of the letters. The sign is oriented perpendicular to Richmond Street, with the sign face visible to pedestrians and vehicular traffic travelling along Richmond Street. The sign identifies the Diner’s establishment date as 1957.

Image 7: Detail of second storey on the front elevation and projecting from the building located at 736 Richmond Street. (WSP, 2018)

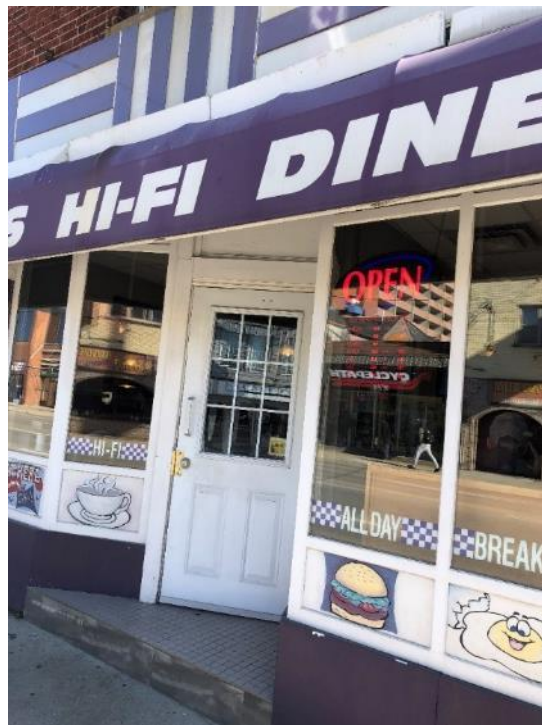
Commercial adaptations including the large storefront windows, central angled entranceway, purple and white cladding, and projecting illuminated sign.

Image 8: Detail of storefront on front elevation, with angled door, of the building located at 736 Richmond Street. (WSP, 2018)

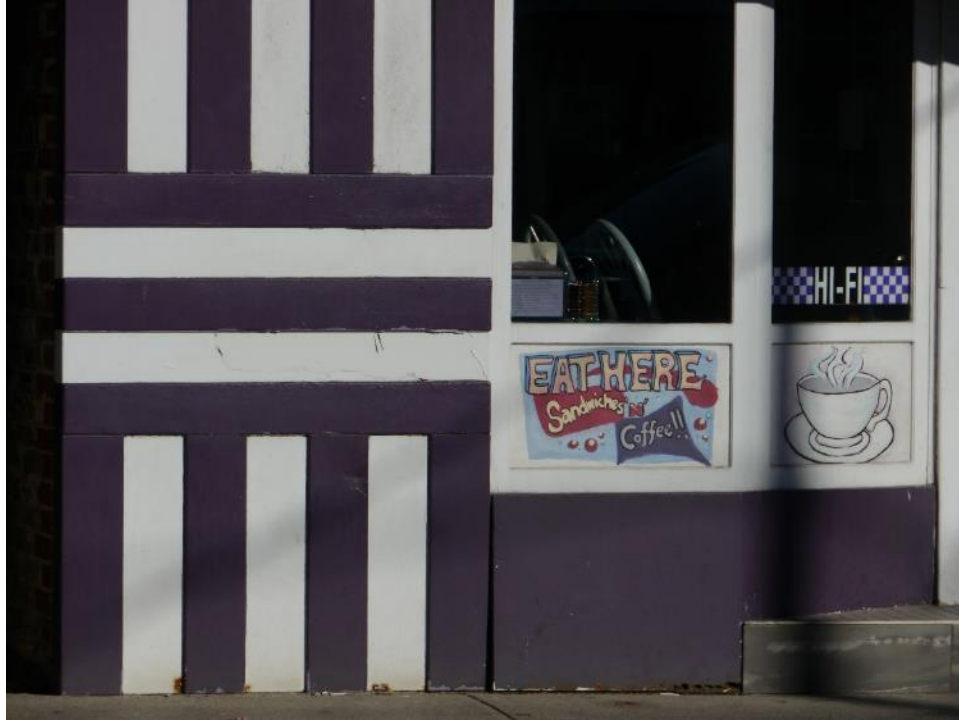
Image 9: Detail of painted metal panels on front elevation of the building located at 736 Richmond Street. (WSP, 2018)

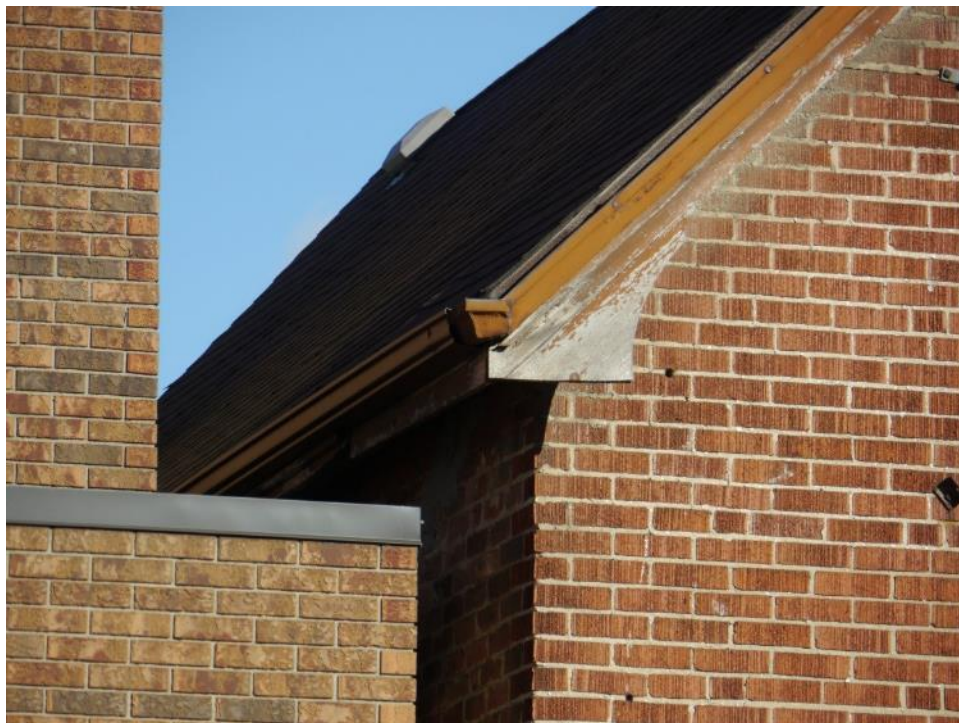
Image 10: Detail of roofline on front elevation of the building located at 736 Richmond Street. (WSP, 2018)

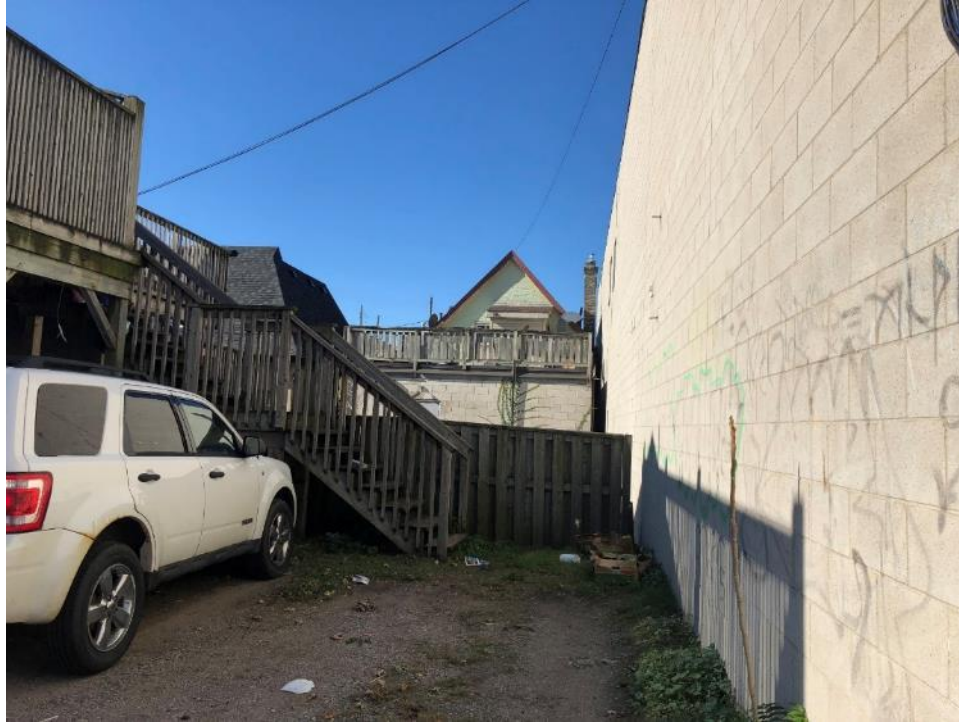
Image 11: Rear elevation of the building located at 736 Richmond Street. (WSP, 2018)

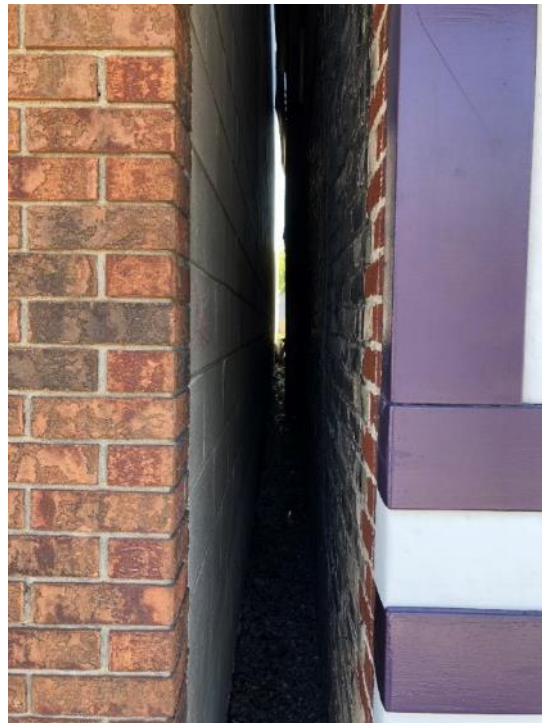
Image 12: View of north side elevation of the building located at 736 Richmond Street (right) adjacent to the building located at 740 Richmond Street (left) (WSP, 2018)

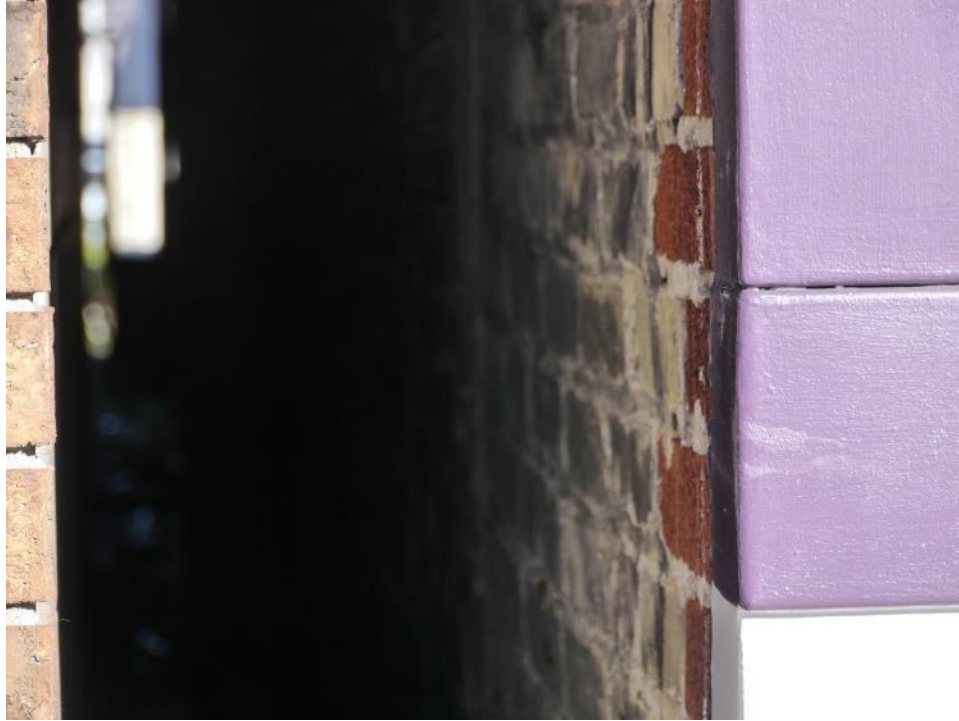
Image 13: Detail of buff brick on north side elevation of the building located at 736 Richmond Street. (WSP, 2018)

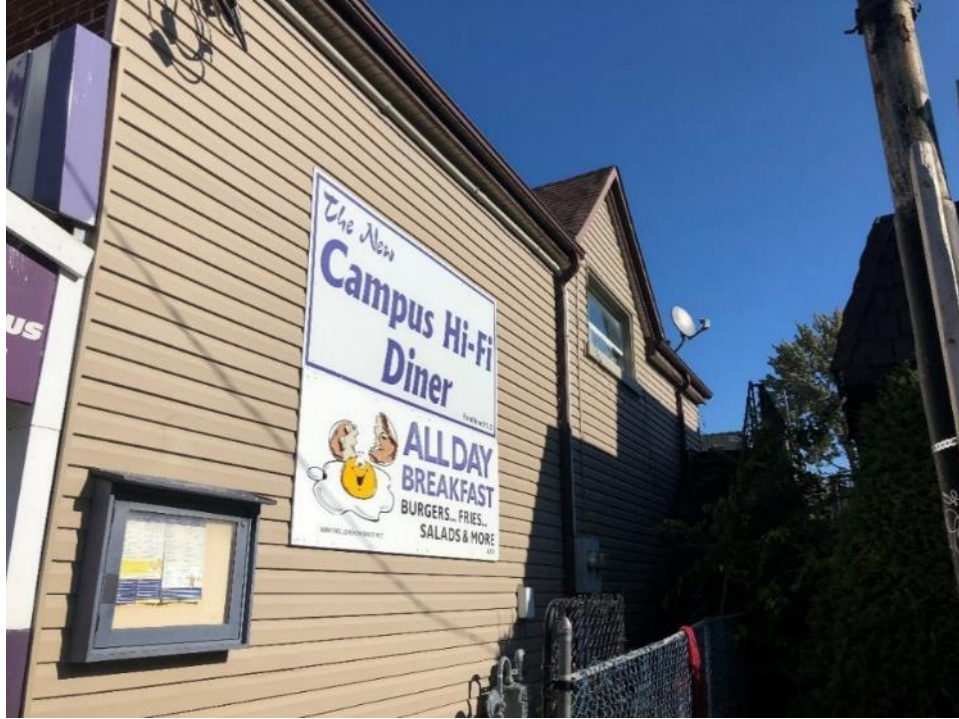
Image 15: View of south side elevation of the building at 736 Richmond Street. (WSP, 2018)

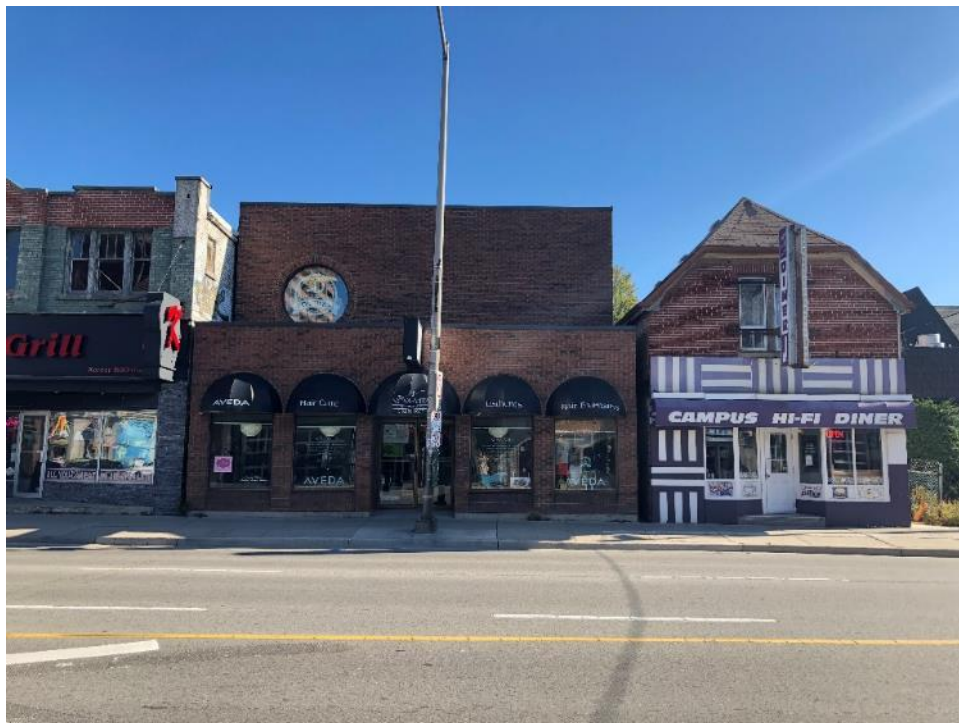
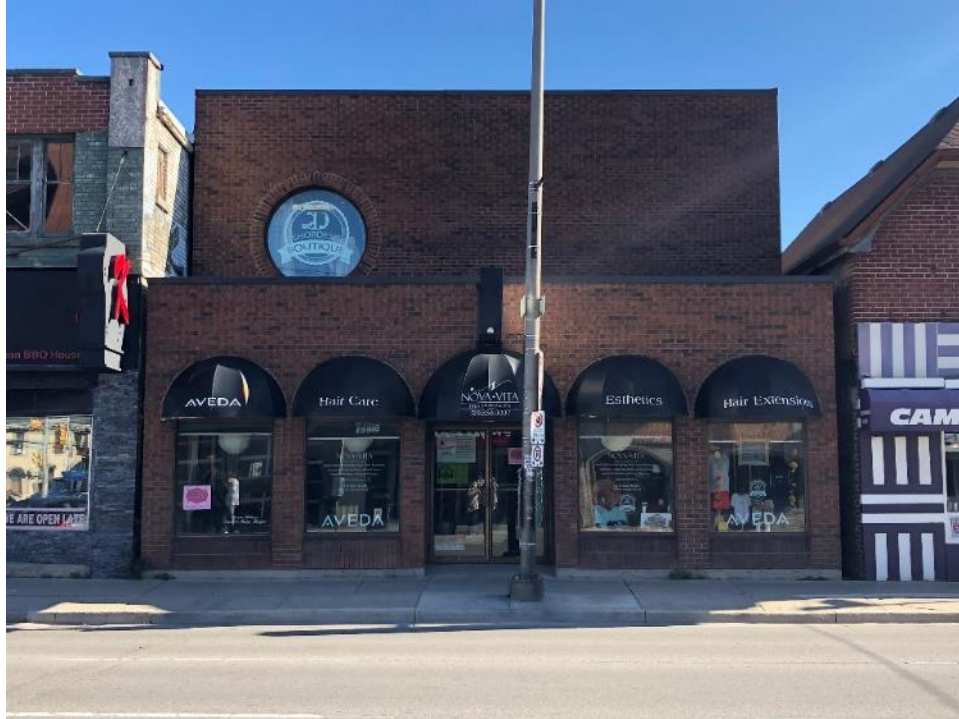
The front (west) elevation (Images 16-19) consists of a two-storey, red brick façade with a flat roof and concrete foundation. The footprint of the first storey extends to the western boundary of the property line along Richmond Street, with the second storey setback from the property line. The first-storey has a recessed central entrance with two glass aluminum-framed commercial storefront doors. The front elevation of the first-storey is symmetrical, with two arched windows, reminiscent of an arcade, located on either side of the central entrance. Black dome awnings are located above the entrance and windows with “Aveda”, “Hair Care”, “Nova Vita”, “Esthetics”, and “Hair Extensions” painted on them from left to right. A sign for “Nova Vita” overhangs the sidewalk and is located above the central entrance and awning. The awnings obscure the view to the vertical brick arches above the windows. The arches above the windows feature rectangular bricks with tapered mortar joints. Two rows of bricks laid in a vertical stack bond and are slanted inward are present underneath each window.

Image 16: Looking east at front elevation of the building located at 740 Richmond Street. (WSP, 2018)

Image 17: Looking east at front elevation of the building located at 740 Richmond Street. (WSP, 2018)

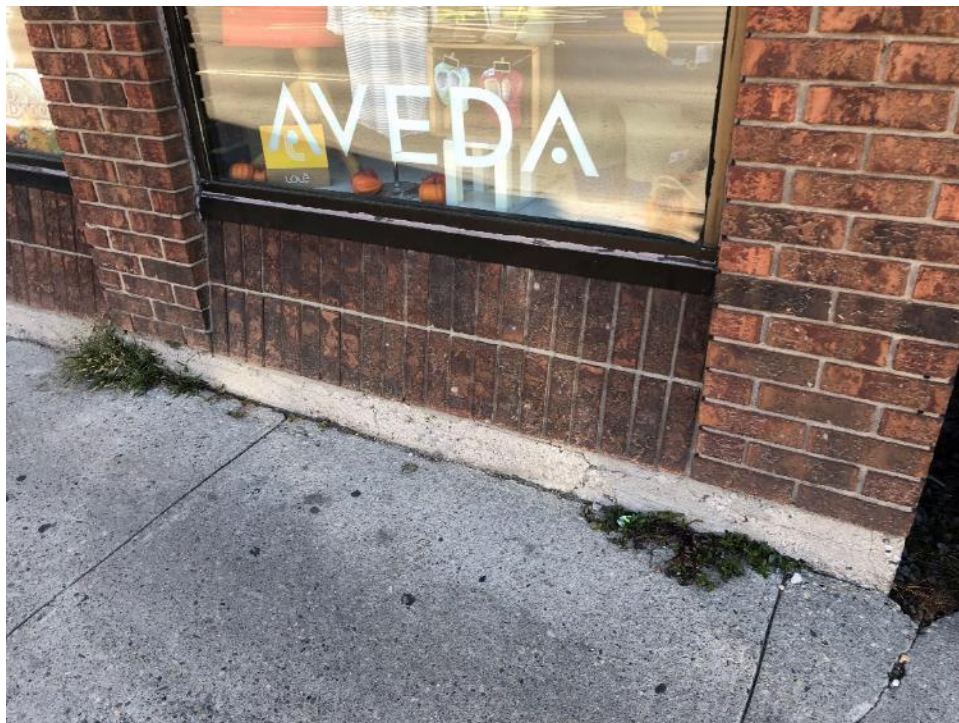
Image 18: Looking east at detail on front on front elevation of the building located at 740 Richmond Street, note the sloping brick. (WSP, 2018)

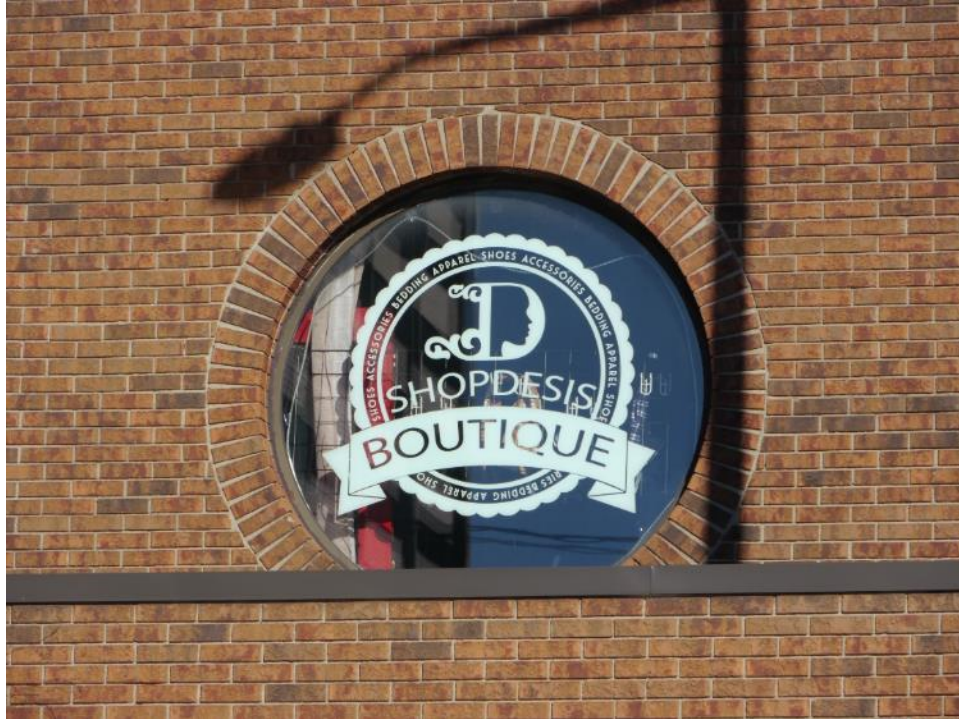
Image 19: Looking east at oculus window on front elevation of the building located at 740 Richmond Street (Photo provided by Mark Tovey).

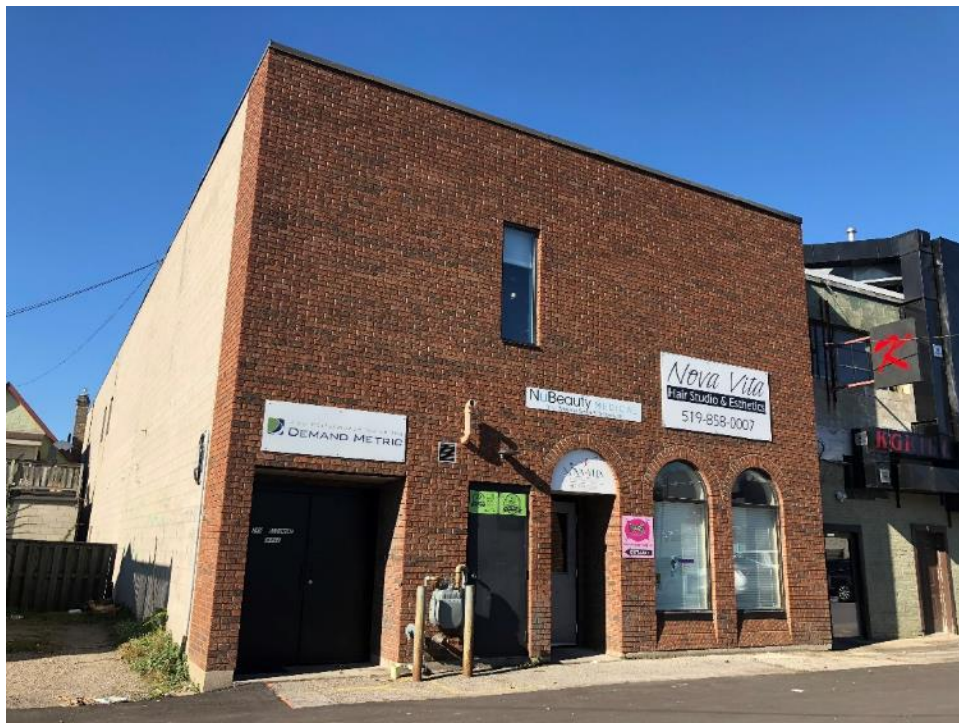
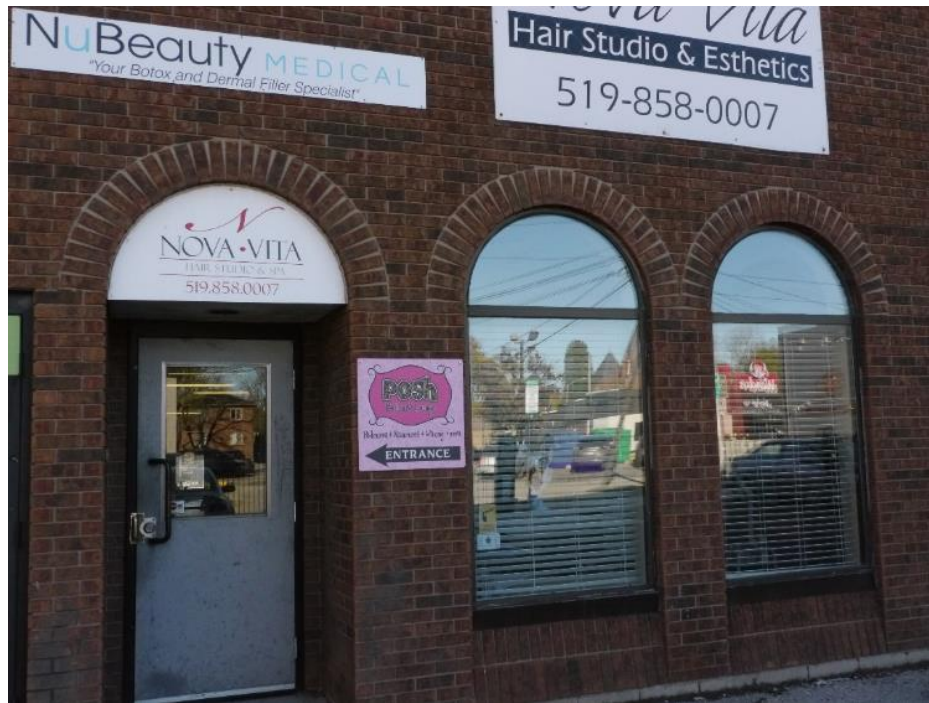
Image 20: Looking west at rear elevation of the building located at 740 Richmond Street. (WSP, 2018)

Image 21: Looking west at rear elevation of the building located at 740 Richmond Street (Photo provided by Mark Tovey).

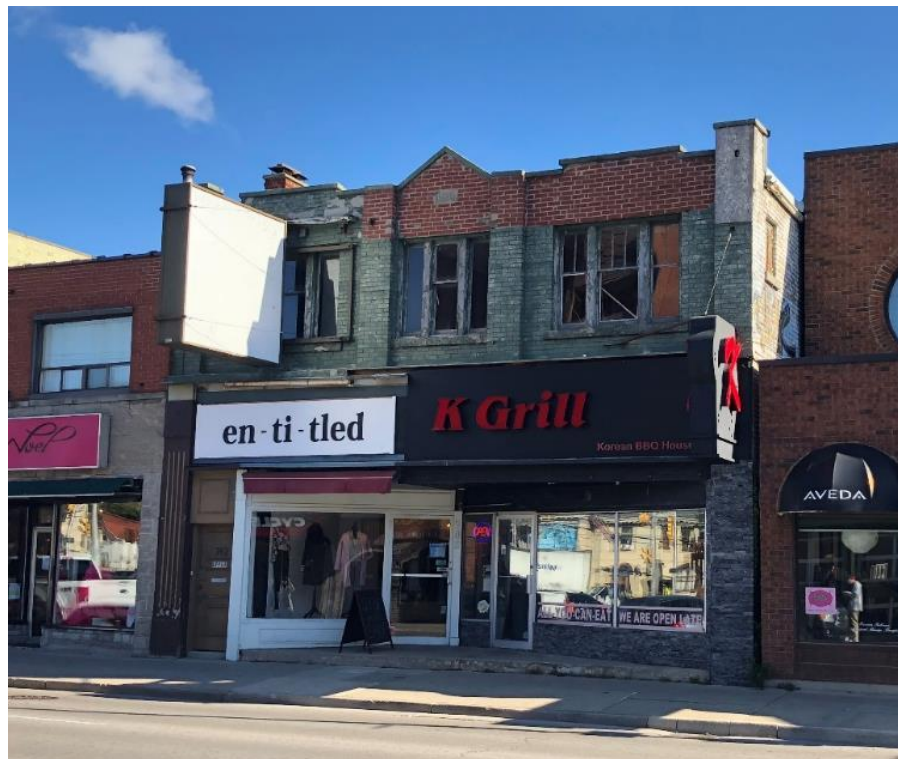
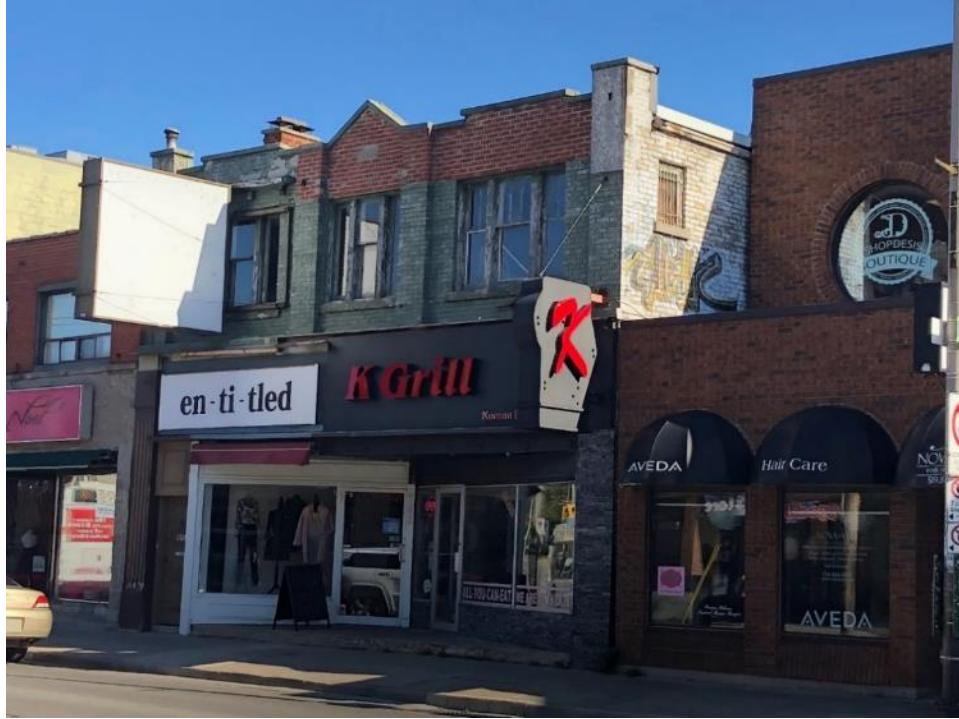
The subject property retains its two-storey commercial materials, scale and massing. The building has been extensively altered and adapted for use from a taxi building and storage space, to a two-unit commercial space. The carriage-style garage doors have been removed and replaced with main floor storefront windows. The upstairs apartments were formerly accessed by a central front door with a high arched transom and sidelights, which has been removed. Only one of the three wood window groupings on the second storey front elevation remain. The brick has been painted over in green.

Image 22: Front (West) Elevation, the building located at 742 Richmond Street, looking east. (WSP, 2018)

Image 23: Front (West) and Side (South) Elevations, the building located at 742 Richmond Street, looking northeast. (WSP, 2018)

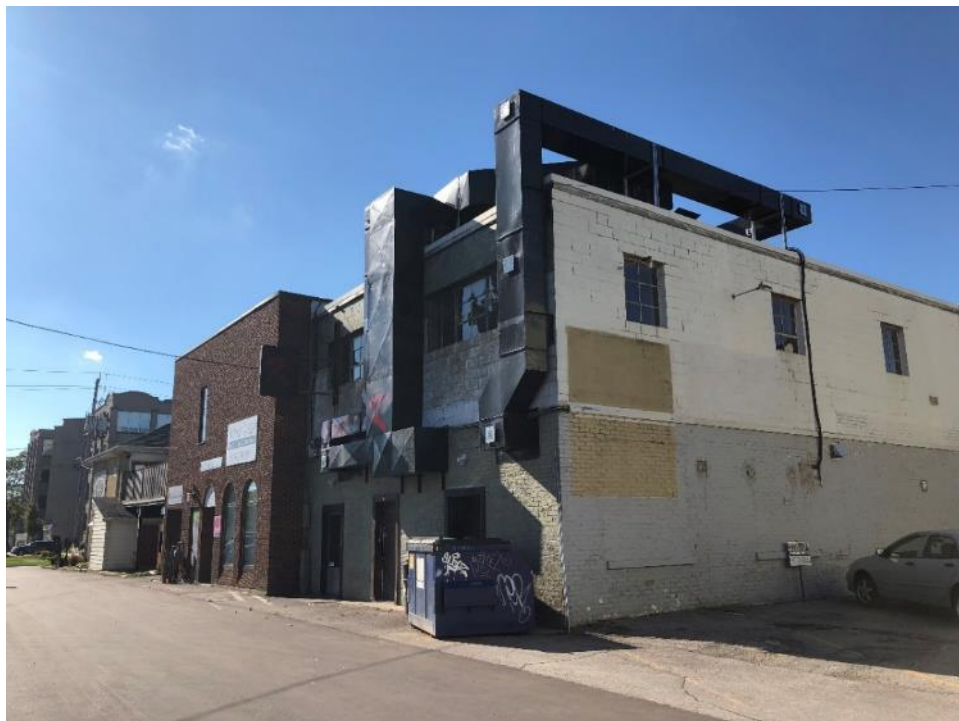
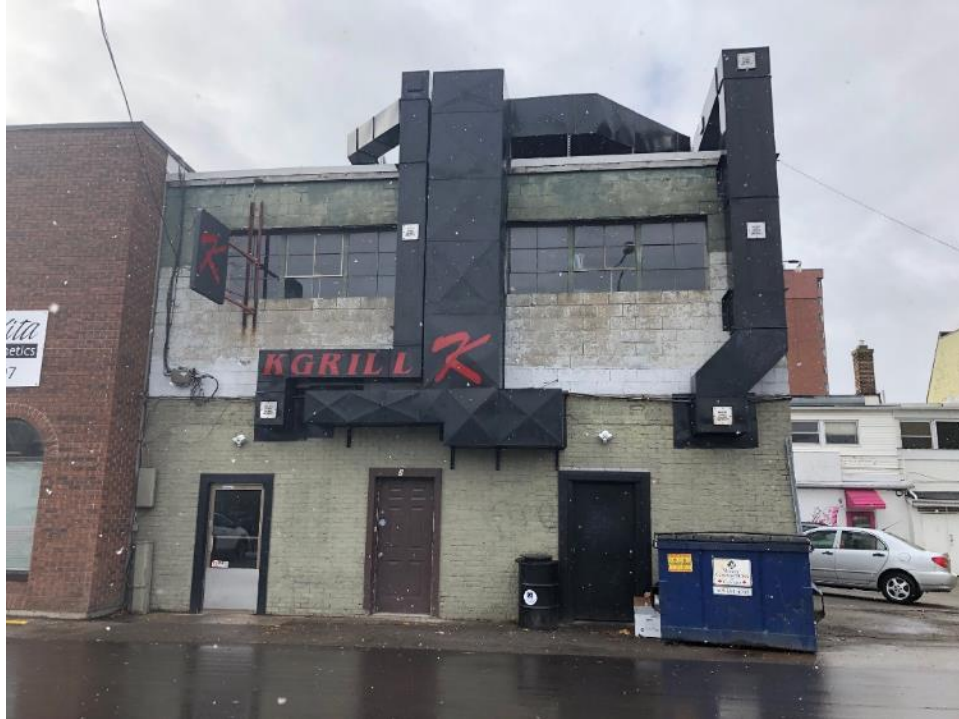
Image 24: Rear (East) and Side (North) Elevations, 742 Richmond Street, looking southwest. (WSP, 2018)

Image 25: Rear (East) Elevation, the building located at 742 Richmond Street, looking west. (WSP, 2018)

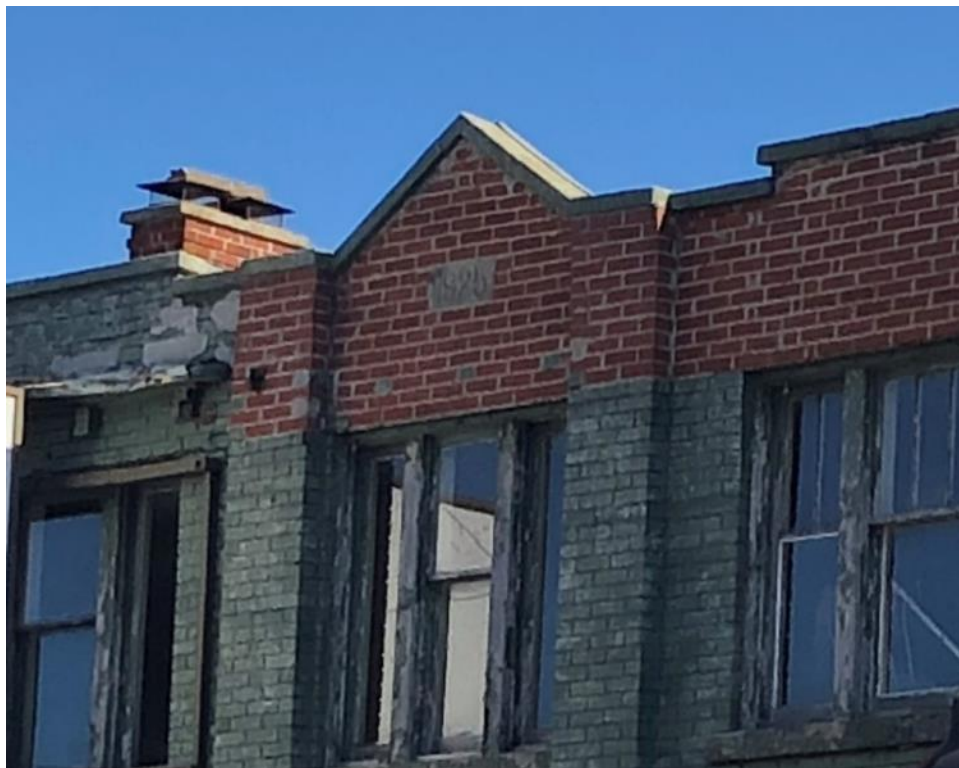
Image 26: Detail view of 1925 datestone, the building at 742 Richmond Street. (WSP, 2018)

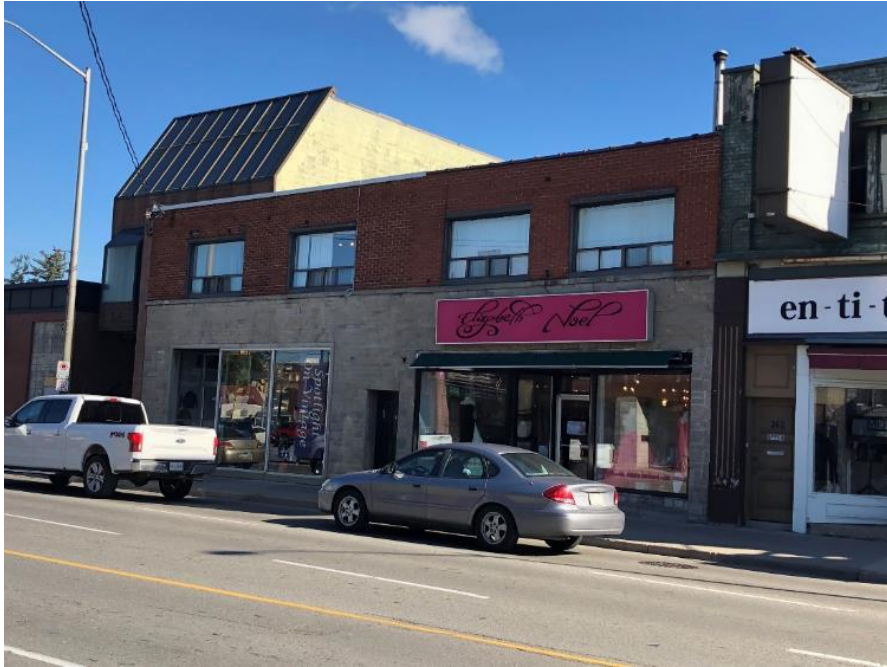
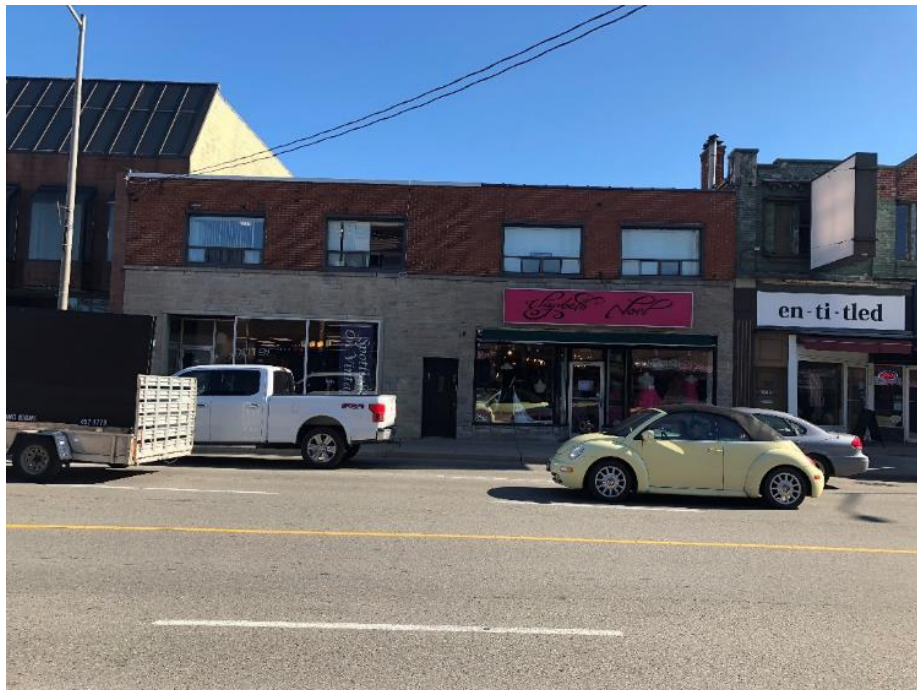
The front elevation (west) (Images 27-28) consists of a two-storey façade with a flat roof and concrete foundation. The first storey is clad with angel stone, a common type of applied stone, which extends partially onto the second storey, ending just under the second storey window ends at the sill. This cladding along the bottom of the façade and along the south side of the elevation appears to be slightly different than that located on both the north side and the lower portion of the second storey, which indicates that they

The front elevation (west) (Images 27-28) consists of a two-storey façade with a flat roof and concrete foundation. The first storey is clad with angel stone, which extends partially onto the second storey. The top row of this brick contains thin rectangular concrete bricks with a smooth surface. The façade of the second storey consists of red-brick laid in running bond. The second storey also has two black aluminium picture windows with small slider windows at the base.

The subject property retains a two-storey commercial building with the original brick and angel stone clad façade from its construction in 1950. However, the storefront windows and both windows on the second storey were replaced at an unknown date as they differ from the original windows shown in a 1955 historical photo of the Bank of Nova Scotia (Figure 17). At the rear of the building, it is apparent from the property inspection that the concrete block wall has been cut into and refitted with a vinyl-sided wall. Given alterations to the front and rear elevations, the building generally retains little of the integrity of its built character.

Image 27: Looking east at front elevation of the buildings located at 744 and 746 Richmond Street. (WSP, 2018)

Image 28: Looking east at front elevation of the buildings located at 744 and 746 Richmond Street. (WSP, 2018)

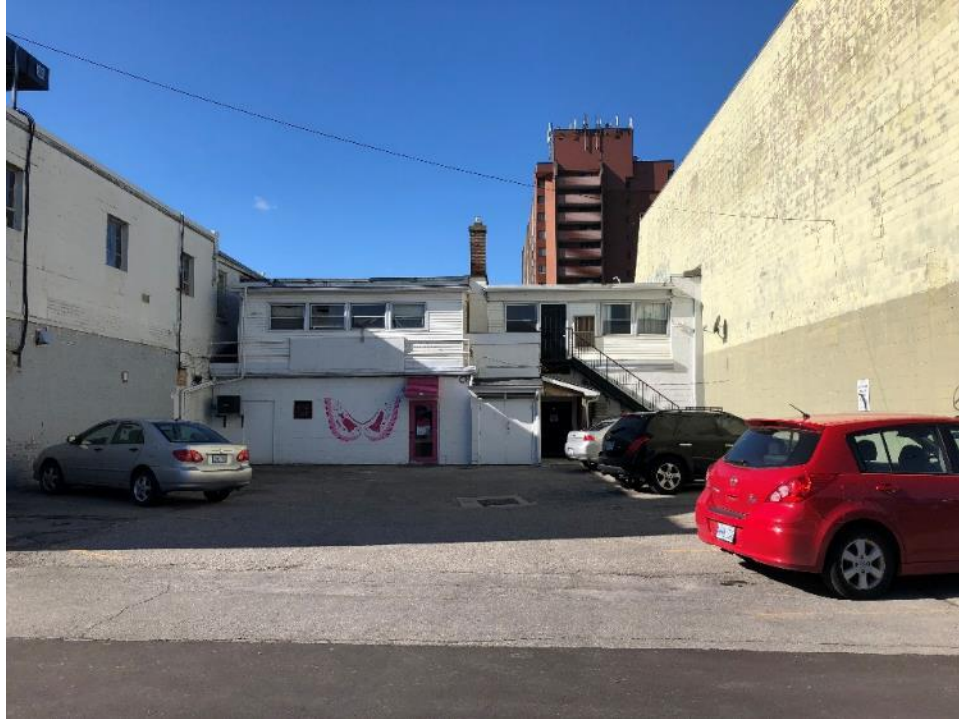
door which is accessed via the staircase. An air conditioning unit is present in the center of the second storey, with two 1/1 windows located on the north side.

Image 29: Looking west at rear elevation of the buildings located at 744 and 746 Richmond Street. (WSP, 2018)

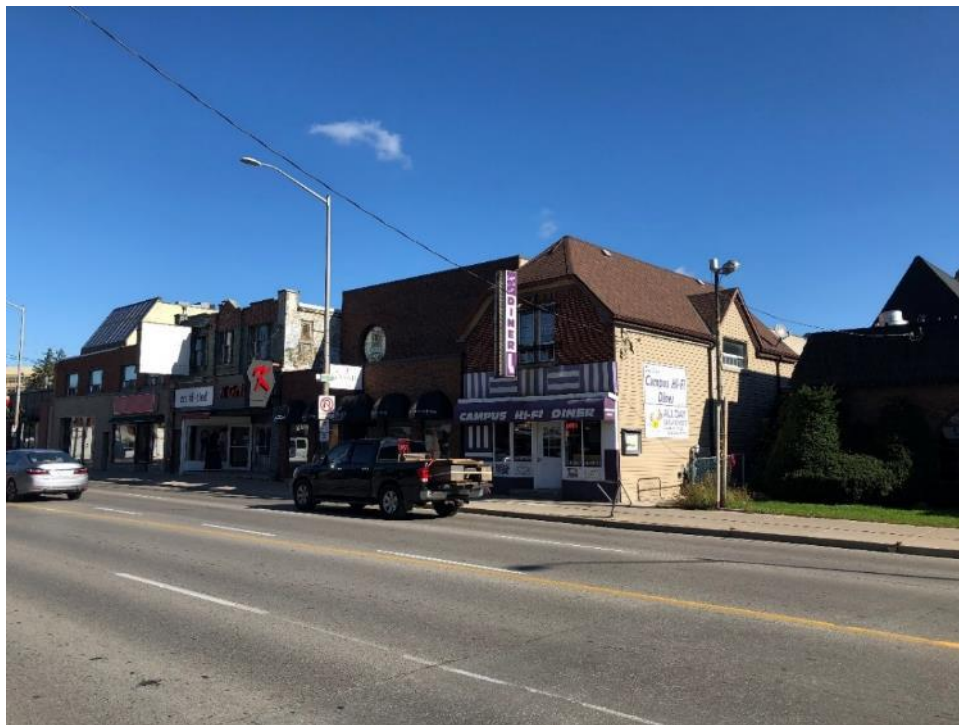
Image 30: View of the buildings located at 736 to 746 Richmond Street, looking northeast. (WSP, 2018)

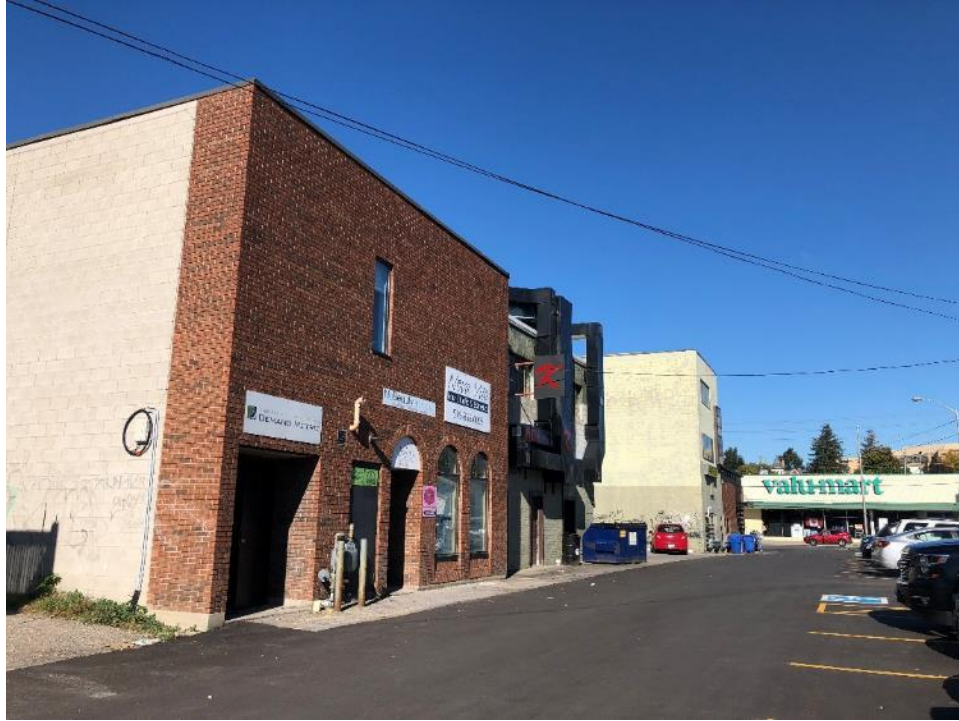
Image 33: View of rear elevations, 736 to 746 Richmond Street, looking northwest towards Oxford Street East, from Piccadilly Street. (WSP, 2018)

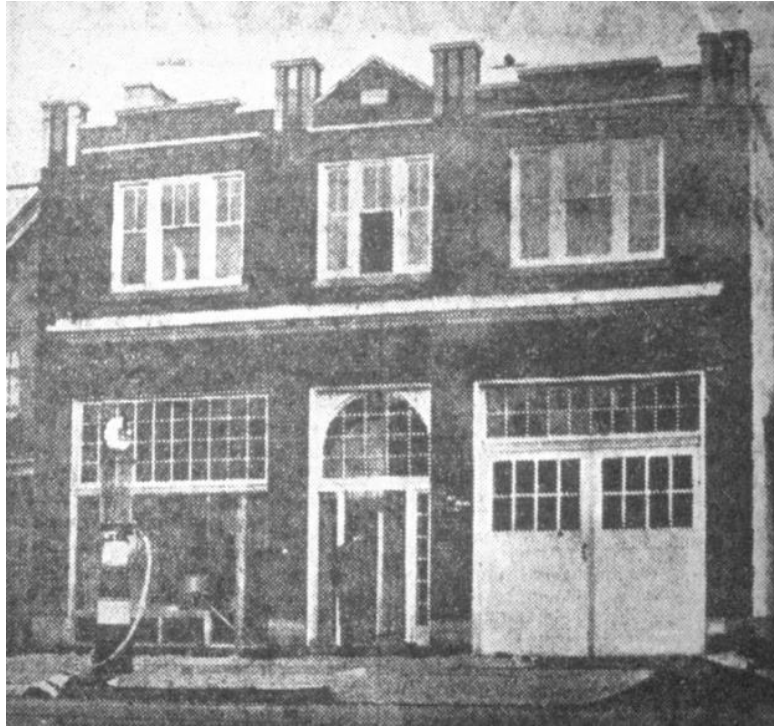
Figure 18 – 742 Richmond Street, the Davis Taxi Building. Courtesy: Western Archives, Western University, London Free Press Image Archives – November 23rd, 1925

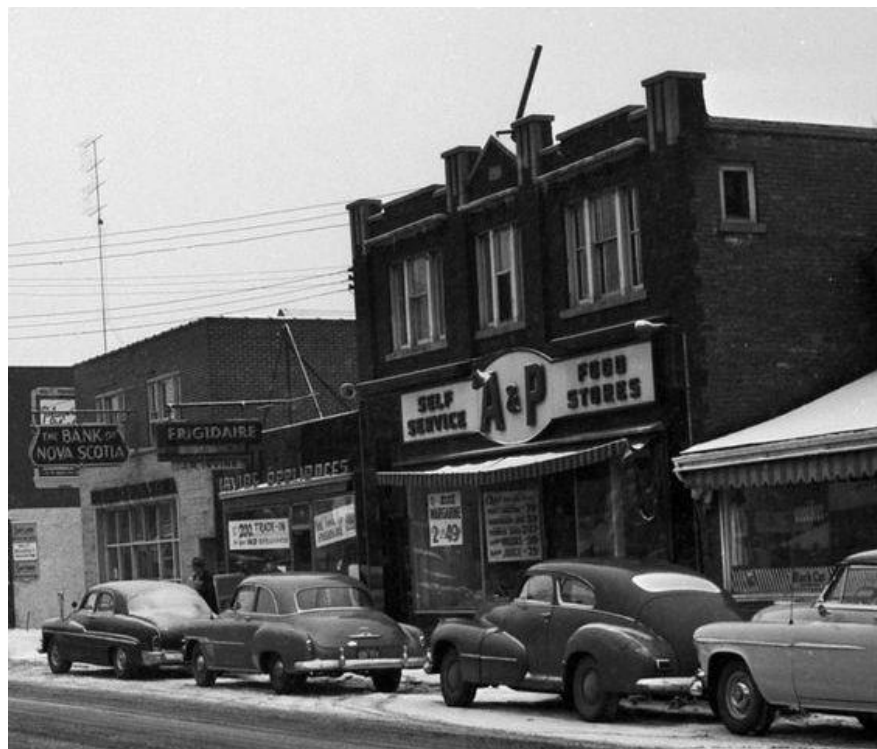
Figure 19 – 742, 744 and 746 Richmond Street in 1955, Courtesy: Western Archives Western University London Free Press Image Archives – November 11, 1955.
