CULTURAL HERITAGE EVALUATION REPORT

TRANSIT PROJECT ASSESSMENT PROCESS
LONDON BUS RAPID TRANSIT

736, 740, 742, 744, 746 RICHMOND STREET
CITY OF LONDON
PROVINCE OF ONTARIO

PROJECT NO.: 141-21085-00
DATE: NOVEMBER 2018

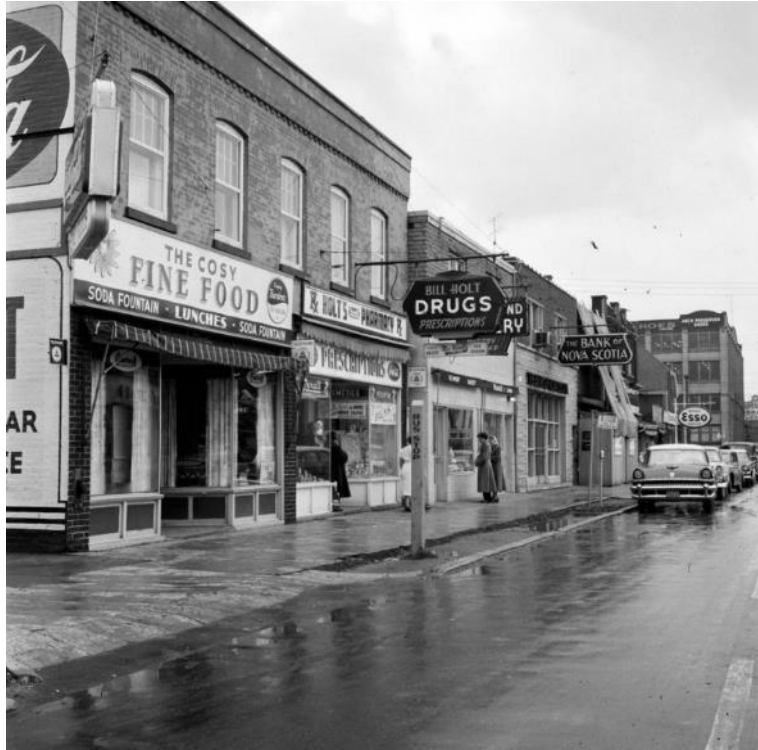
Figure 20 – View looking south along east side of Richmond Street from Oxford Street Courtesy: Western Archives Western University London Free Press Image Archives – September 24, 1957.
