| SUBJECT: | REQUEST FOR DEMOLITION 591 MAITLAND STREET PUBLIC PARTICIPATION MEETING ON: MONDAY, NOVEMBER 5, 2012: NOT BEFORE 5:30 P.M. |

The residence at 591 Maitland Street is a one and one half storey wood frame building clad with vinyl siding built c. 1884. It is located on the west side of Maitland Street mid-block between Central Avenue and Princess Avenue. (Appendix 1)

FIELD REPORT

Re: Structural Review
591 Maitland Street
London, Ontario
Our File: 12-594

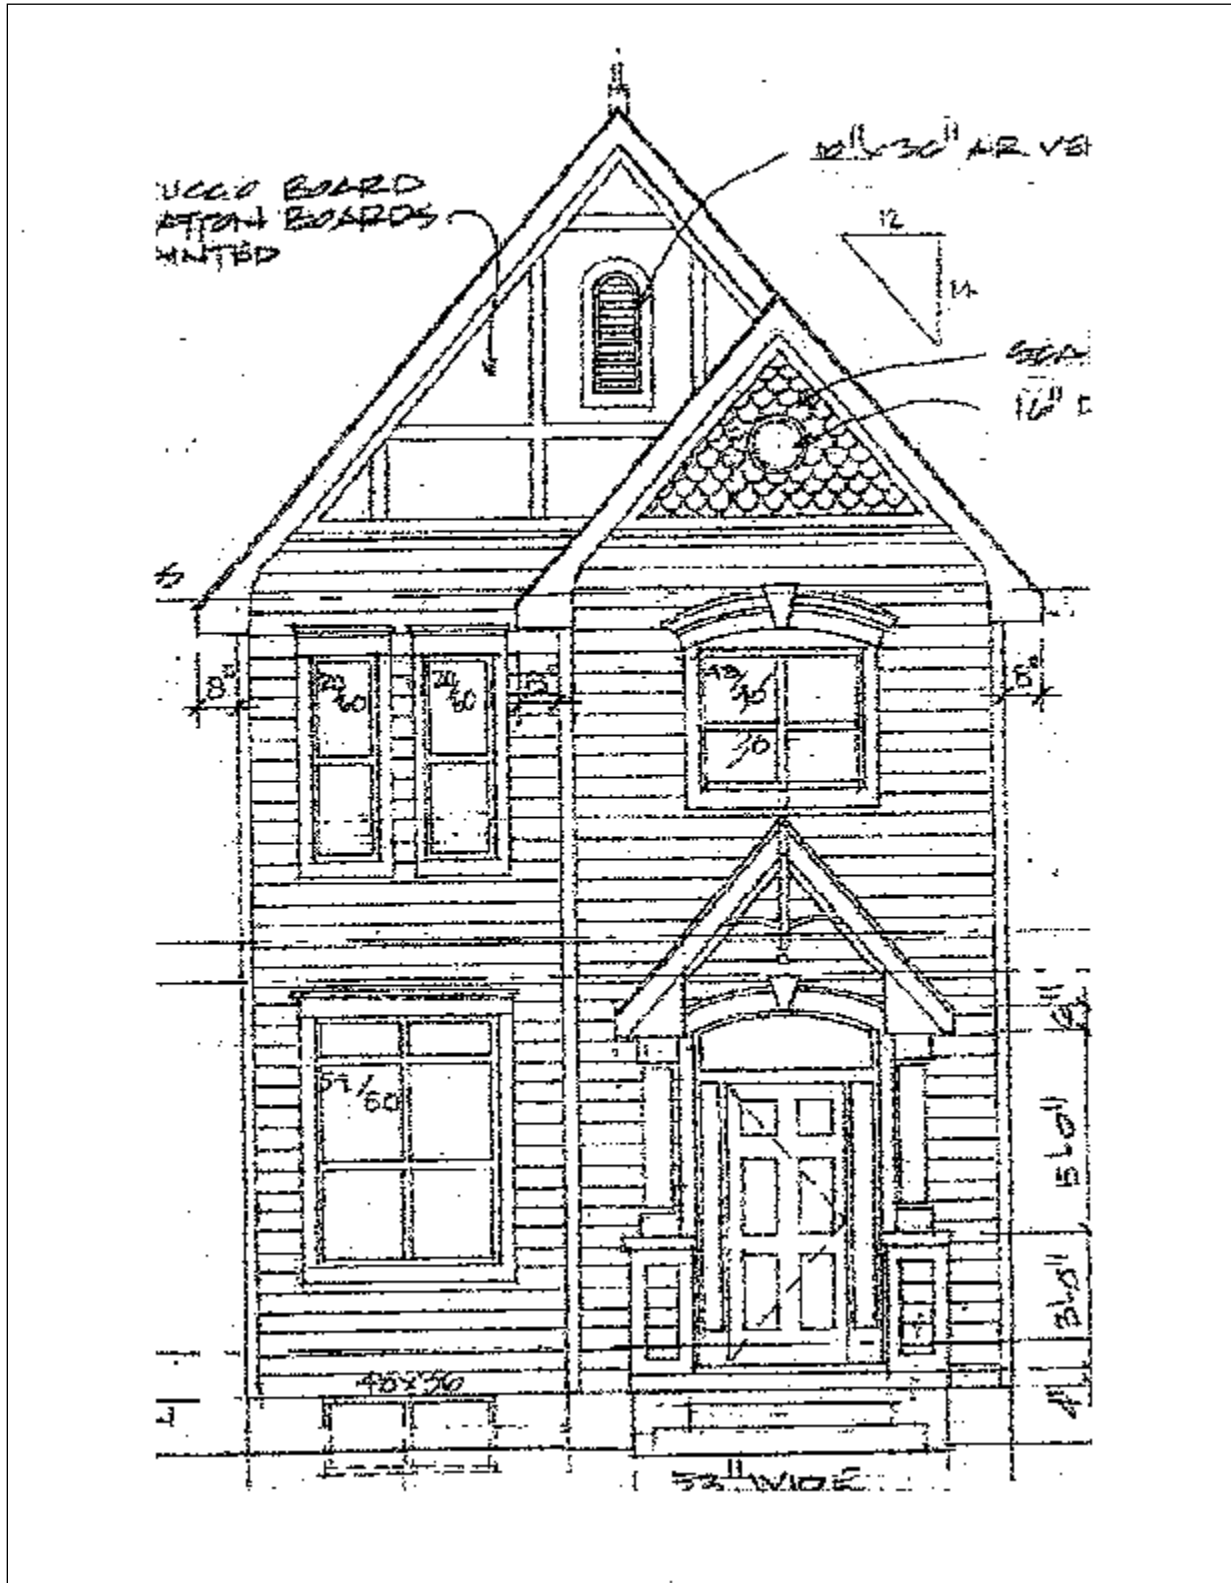
Appendix 4: Concept Drawing for Proposed New Building

If Council approves the request for demolition, a new building may be built in conformity with the guidelines for new construction within the District. The concept plan (Appendix 4) has elements which appear to be in keeping with the Guidelines. Notwithstanding this, it would be a new building, not part of the streetscape present at the time of the creation of the District. Such a building would still require heritage alteration application and approval.
