CULTURAL HERITAGE EVALUATION REPORT

HIGHBURY AVENUE NORTH OVERPASS
CITY OF LONDON
PROVINCE OF ONTARIO

PROJECT NO.: 141-21085-00
DATE: JANUARY 2019

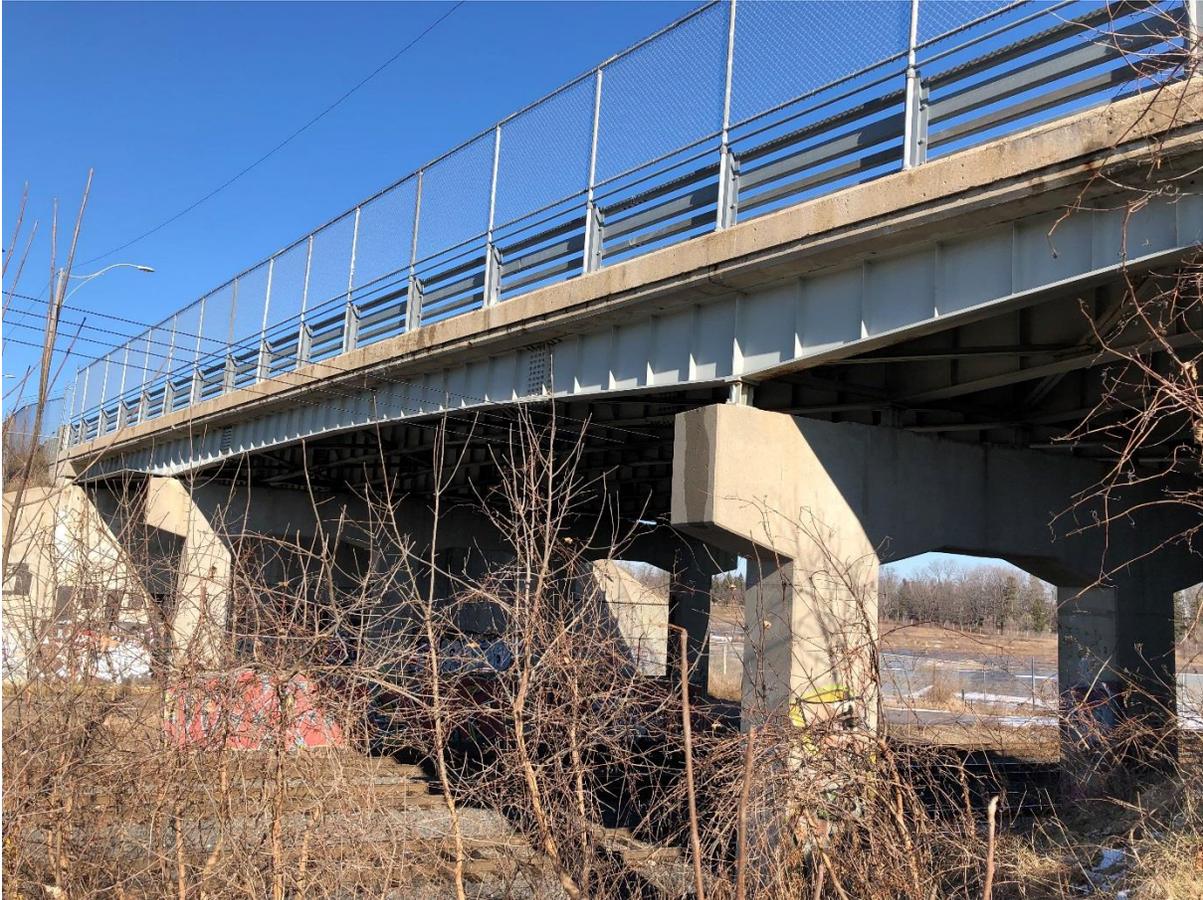
Image 1: View of the Highbury Avenue North Overpass, looking northeast (WSP, 2018).

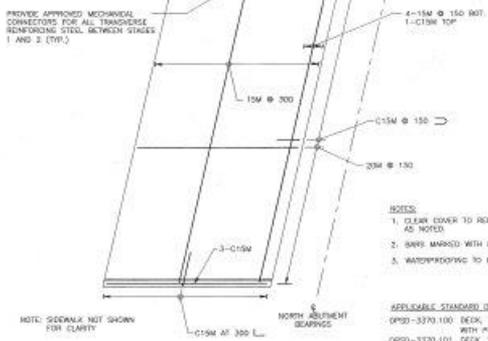
APPROACH SLAB REINFORCEMENT DETAILS
SCALE 1:50

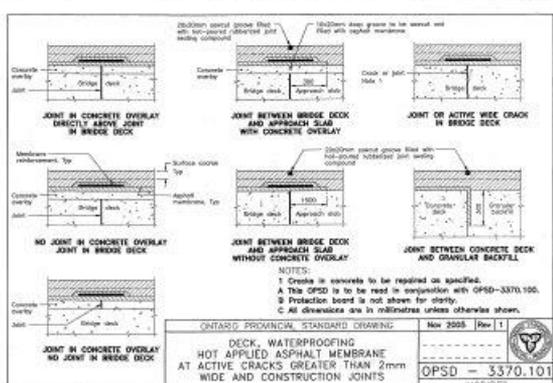
OPSD - 2300.010

DECK, WATERPROOFING HOT APPLIED ASPHALT MEMBRANE AT ACTIVE CRACKS GREATER THAN 2mm WIDE AND CONSTRUCTION JOINTS

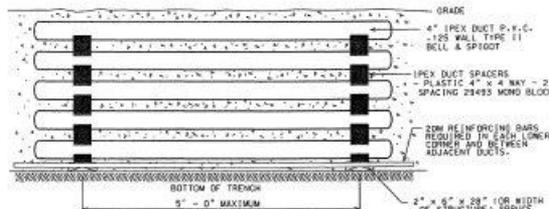
CROSS SECTION SHOWING 20-4" P.V.C. DUCT STRUCTURE

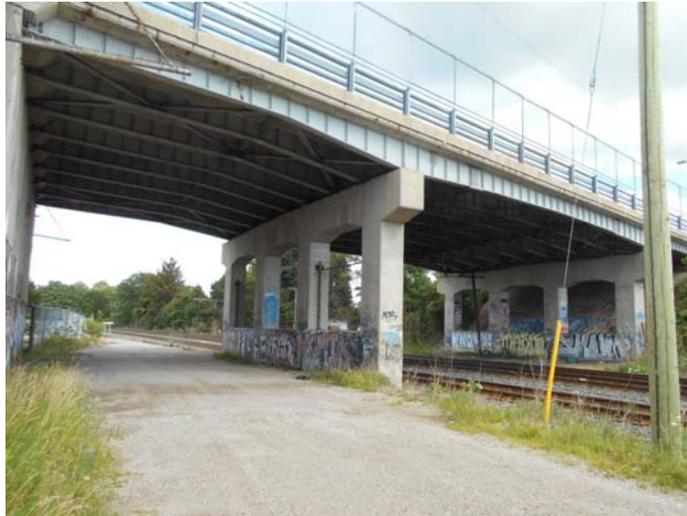
WEST ELEVATION-AUG'15 (2)

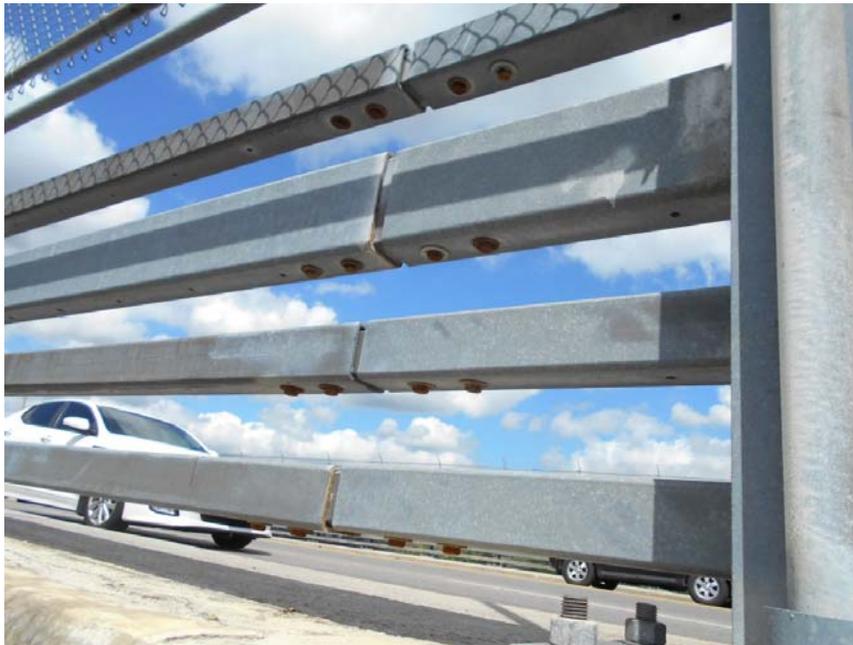
CORROSION ON THE RAILING-AUG'15

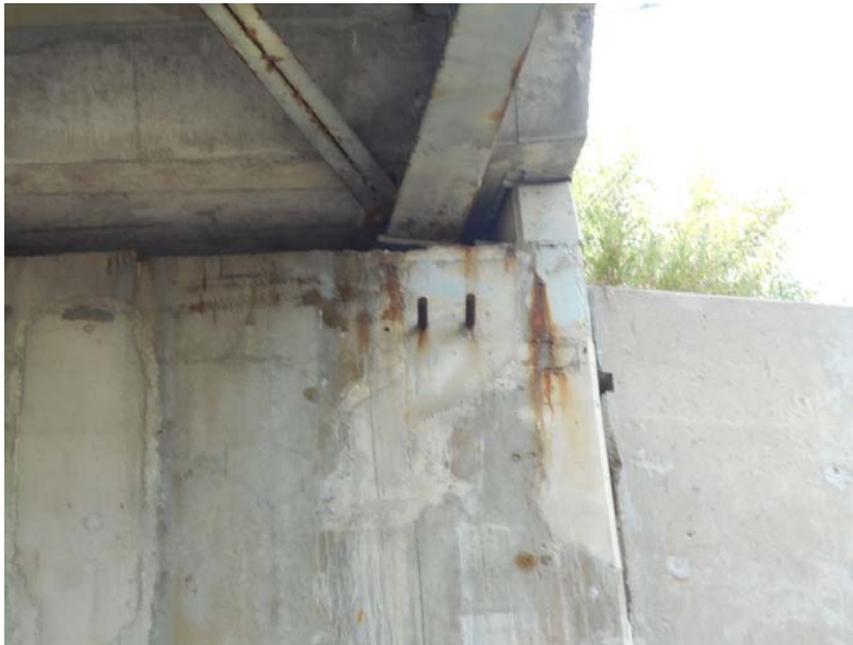
NE BEARING-AUG'15

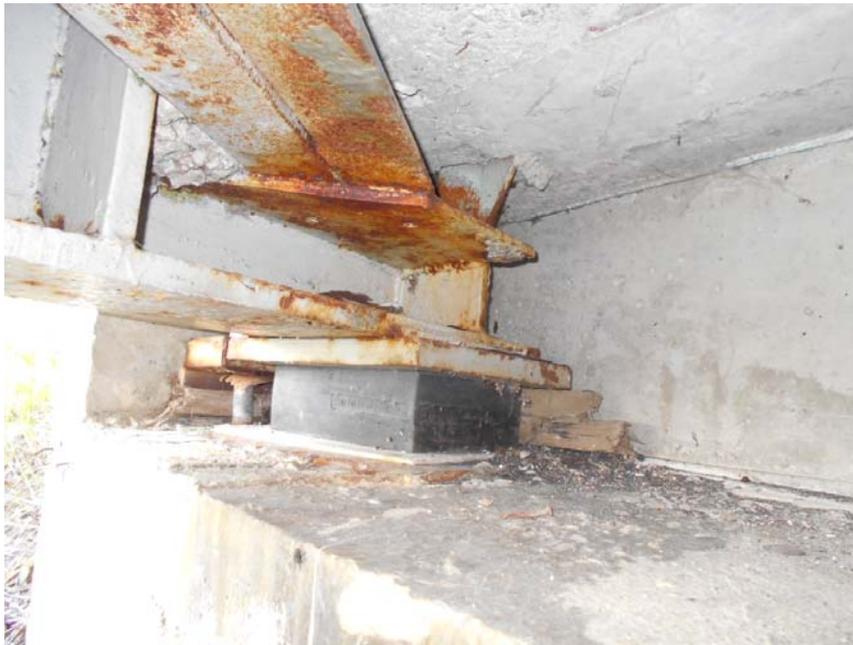
SOUTH ABUTMENT BEARINGS-AUG'15 (1)

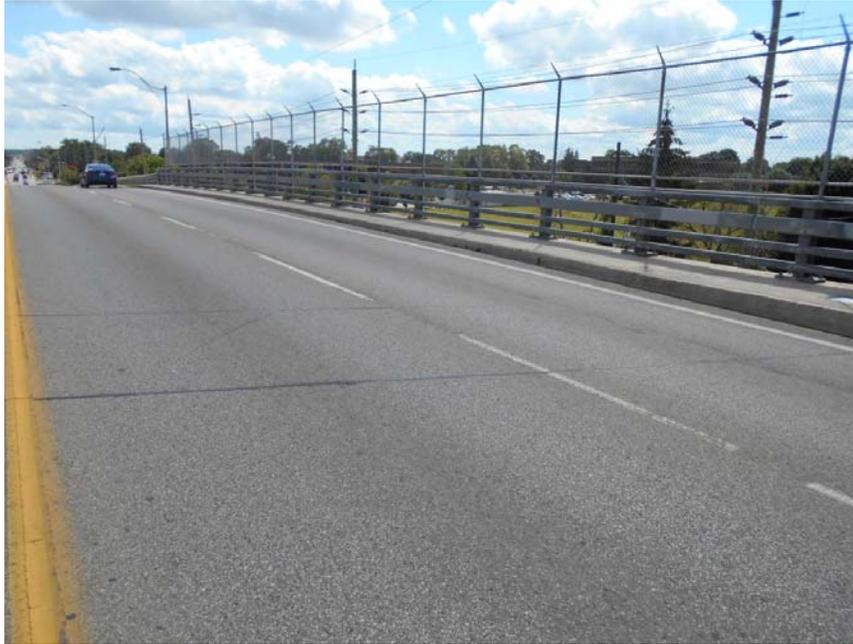
WEARING SURFACE ON DECK-AUG'15 (1)

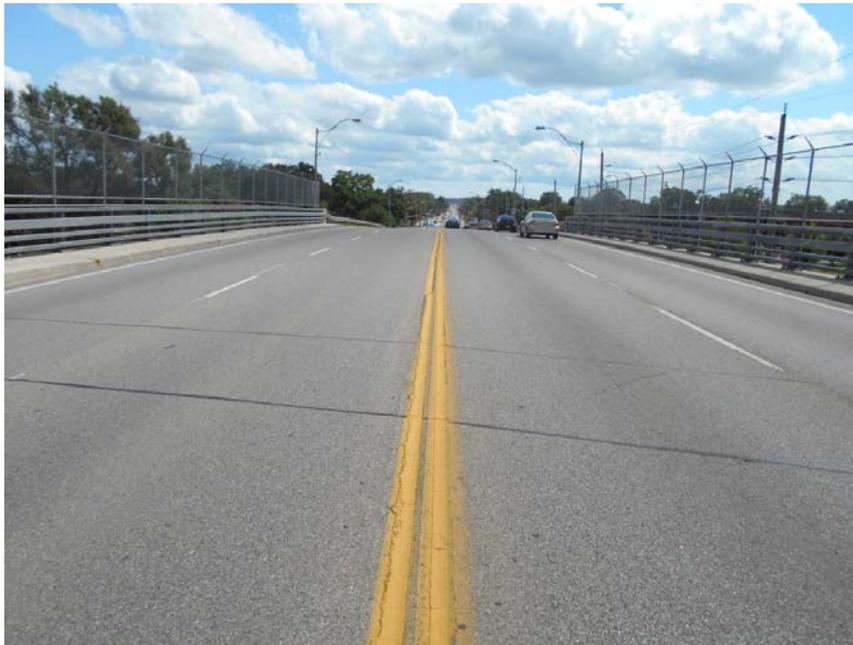
WEARING SURFACE ON DECK-AUG'15 (2)
