London Advisory Committee on Heritage Report

The 6th Meeting of the London Advisory Committee on Heritage
May 8, 2019
Committee Rooms #1 and #2

Demolition Request – 123 Queens Avenue

VanBoxmeer & Stranges Ltd.

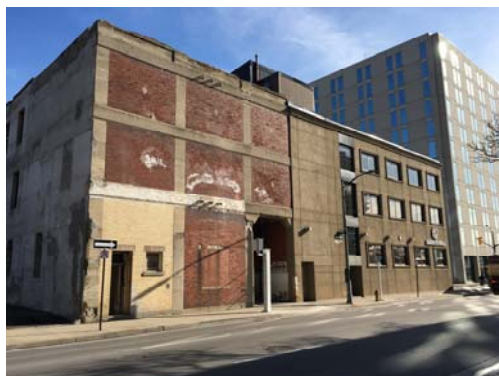
123 Queens Avenue

- Built between 1916-1922
- Three storey industrial structure
- Constructed of reinforced concrete
- Ornamental concrete diamonds
- Concrete parapet
- Recessed entrance with concrete lintel
- Connected to 450 Talbot

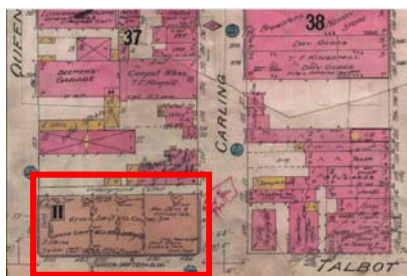
*Fire Insurance Plan 1912 Rev. 1915
(Courtesy of Western Archives)*

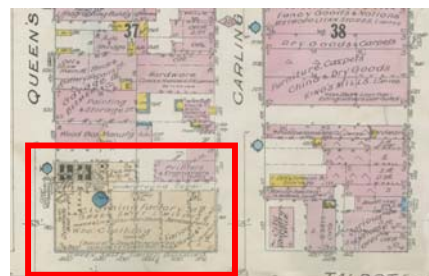
*Fire Insurance Plan 1912 Rev. 1922
(Courtesy of Western Archives)*

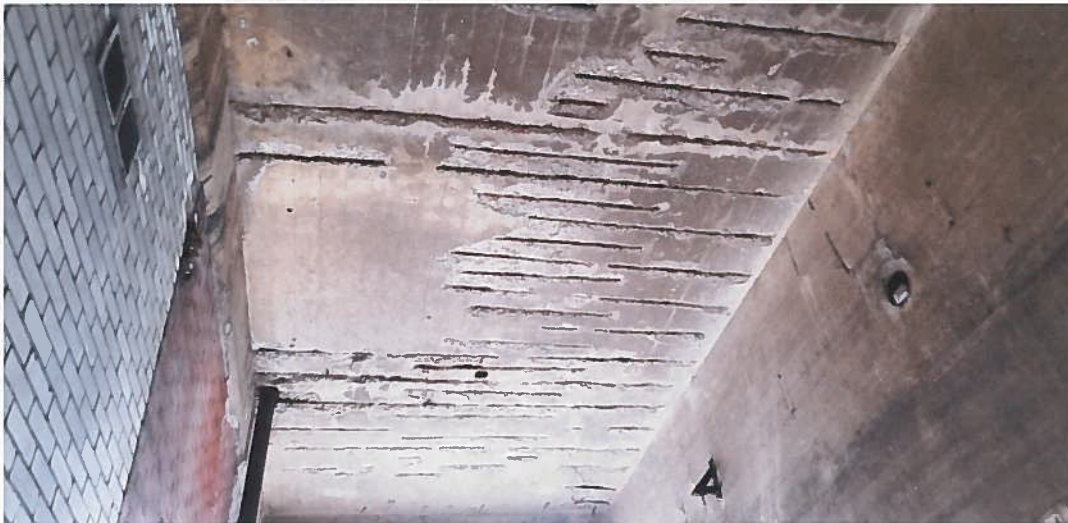
Photo No 06: Suspended Link Slab (Exterior)

The suspended slab in the link connecting 123 Queens Avenue is exposed to view. **See Photo No 06.** The underside of the concrete slab is severely delaminated exposing the reinforcing bars. Approximately 70% of the reinforcing bar is exposed and corroded. Given the large amount of concrete delamination, bar corrosion and bar exposure, we believe that this slab has lost a majority of original design capacity.

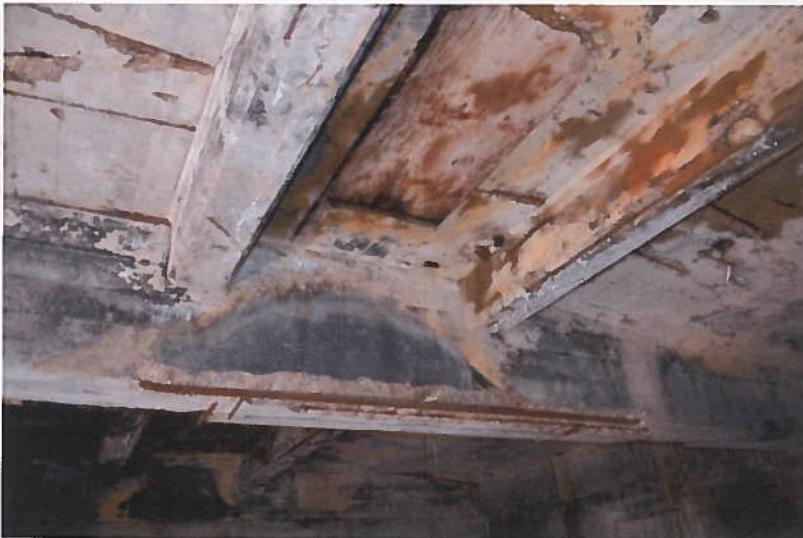
Photo No 08: Typical Interior Upper Beam

The interior upper beams are all delaminated in varying degrees. Similar to the exterior beam, the concrete at the bottom of the beam has delaminated and has completely spalled and will continue to spall over time. **See Photo No 08.** There are no signs of any stirrups in any of the concrete beams.

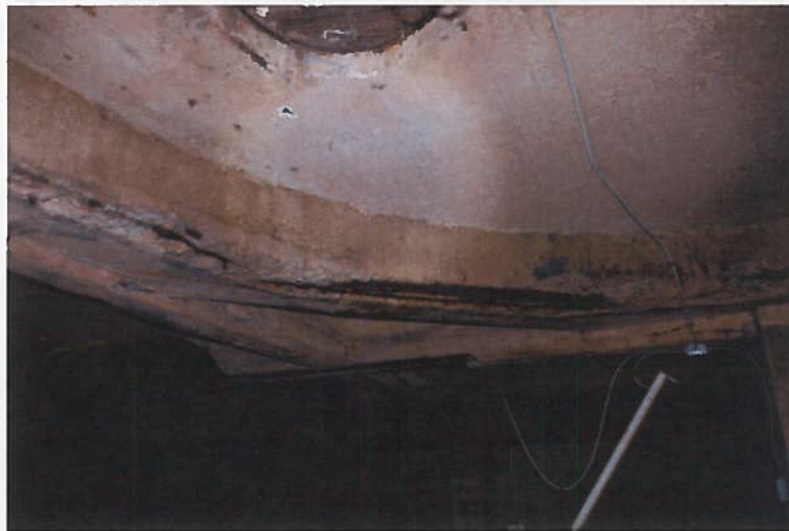
Photo No 09: Interior Basement Beams (south end)

This portion of the floor is constructed of a series of concrete beams and slabs. **See Photo No 09.** It appears that this portion of the floor supported the old boiler. Of all of the beams in the building, it is the beams in this area appear to be the most compromised. The bottom of the beams in the southern half have delaminated and the reinforcing bars being corroded the most. It is presumed that continual humidity and moisture has contributed to the condition of these beams.

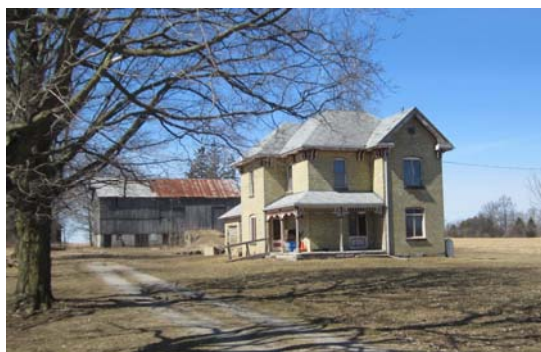
3303 Westdel Bourne - Farmhouse

- Built in 1877 in the Italianate Style
- Two storey, buff brick asymmetrical farmhouse with a one storey wing in the rear
- Projecting bay with a front gable and an oculus window in the gable's centre
- Paired brackets
- Paired, tall, narrow windows
- Field stone foundation

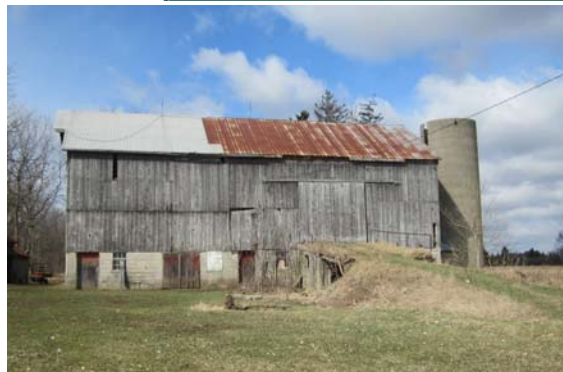
Barn 1 located at 3303 Westdel Bourne

- Form, scale, and massing of the two level, timber frame barn;
- Relationship to the farmhouse;
- Parged concrete foundation with a number of openings for multi-pane windows;
- Gable roof covered in corrugated metal;
- Vertical barn board siding;
- Mix of hand hewed and machine cut beams connected to the post with mortise-and-tenon joints;
- A reinforced concrete silo is connected to the north façade of the barn;
- A barn hill is connected to the east façade;
 - The form, scale, and massing;
 - Suspected root cellar that has been parged on the exterior; and
 - An open space in the middle of the barn hill – known as a “walk way”.

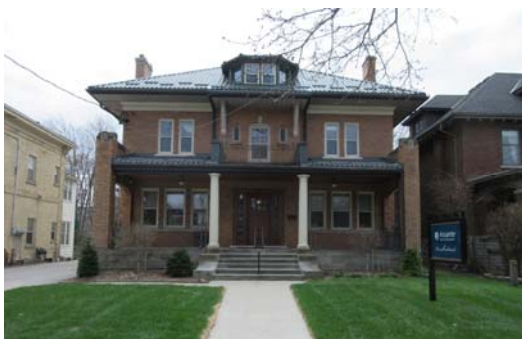
371 Dufferin Avenue

- Constructed 1914
- Two and half storeys
- Symmetrical residential-type building
- Central entryway, flanked by a triplet of windows
- Broad verandah with metal balustrades
- Building set back from Dufferin Avenue

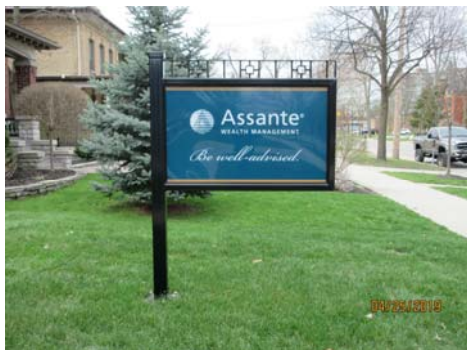
- Freestanding on a 33cm/4" metal pole (1.88m/74" high, 1.37m/54" wide) set on a base plate;
- Coloured plexiglass sign (72cm/28.5" high, 1.19m/47" wide) set in a metal frame;
- No electrical (therefore, not illuminated).

That, on the recommendation of the Managing Director, City Planning and City Planner, with the advice of the Heritage Planner, the application under Section 42 of the Ontario Heritage Act to permit the existing signage at 371 Dufferin Avenue, West Woodfield Heritage Conservation District, **BE PERMITTED** with the terms and conditions that internal illuminations be prohibited
