Report to Planning and Environment Committee

Subject: Demolition Request for Heritage Listed Property at 3303 Westdel Bourne by Carvest Properties Ltd.

Public Participation Meeting on: Monday May 13, 2019

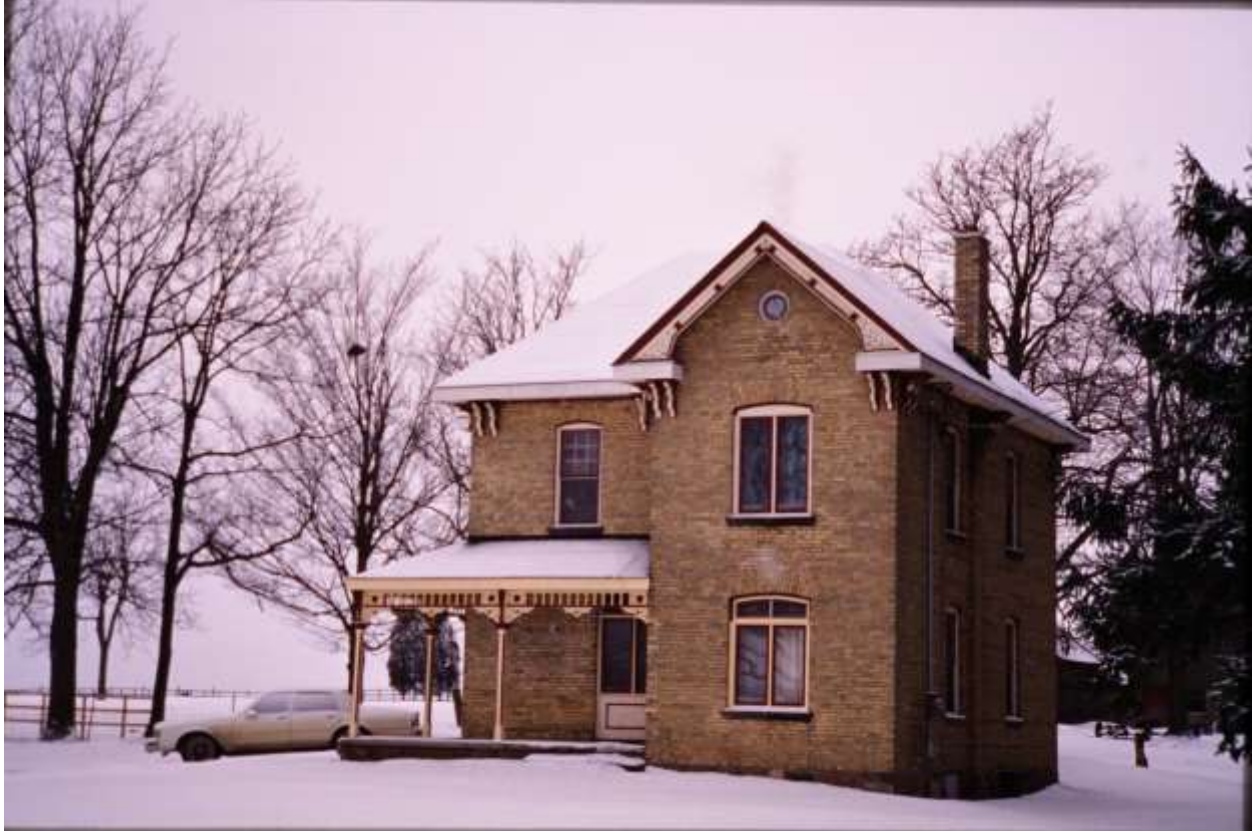
Image 1. Front façade of the farmhouse located 3303 Westdel Bourne. The largest barn and the barn hill seen in the rear, looking west. Date unknown.

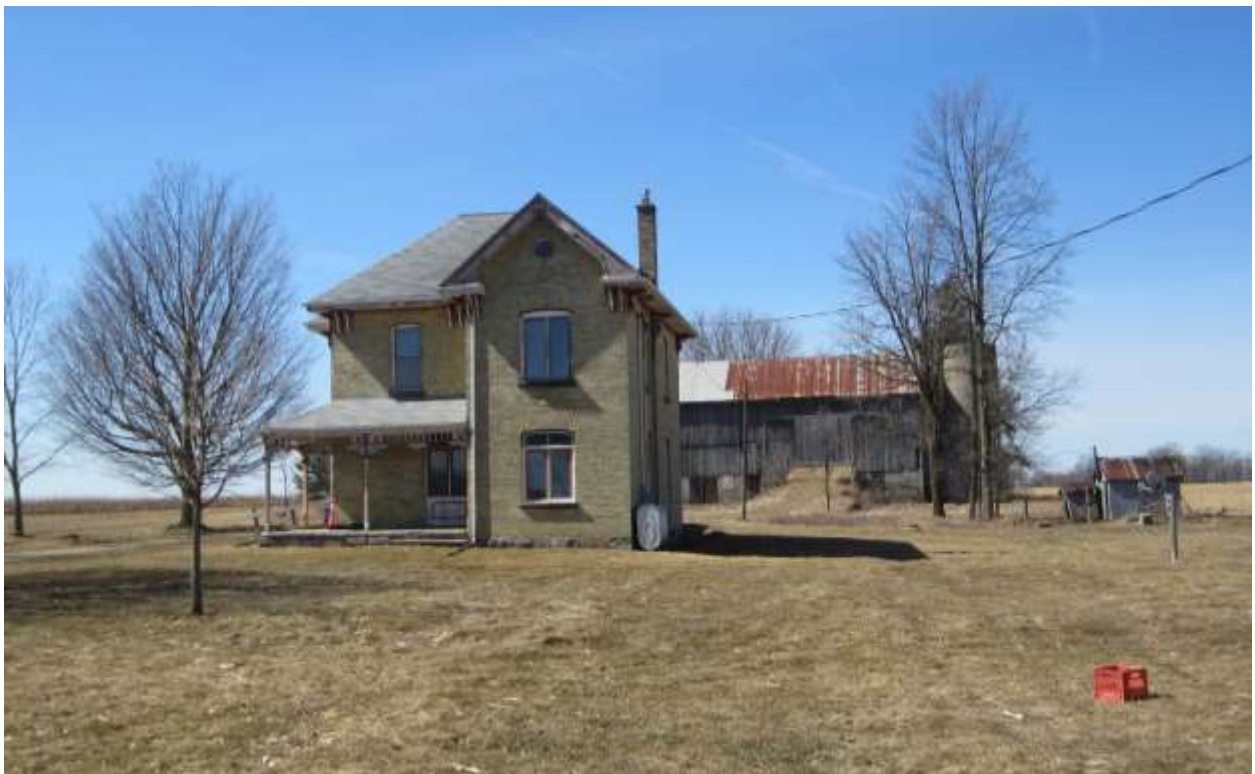
Image 2. Front façade of the farmhouse located 3303 Westdel Bourne. The largest barn and the barn hill seen in the rear, looking west. April 2019.

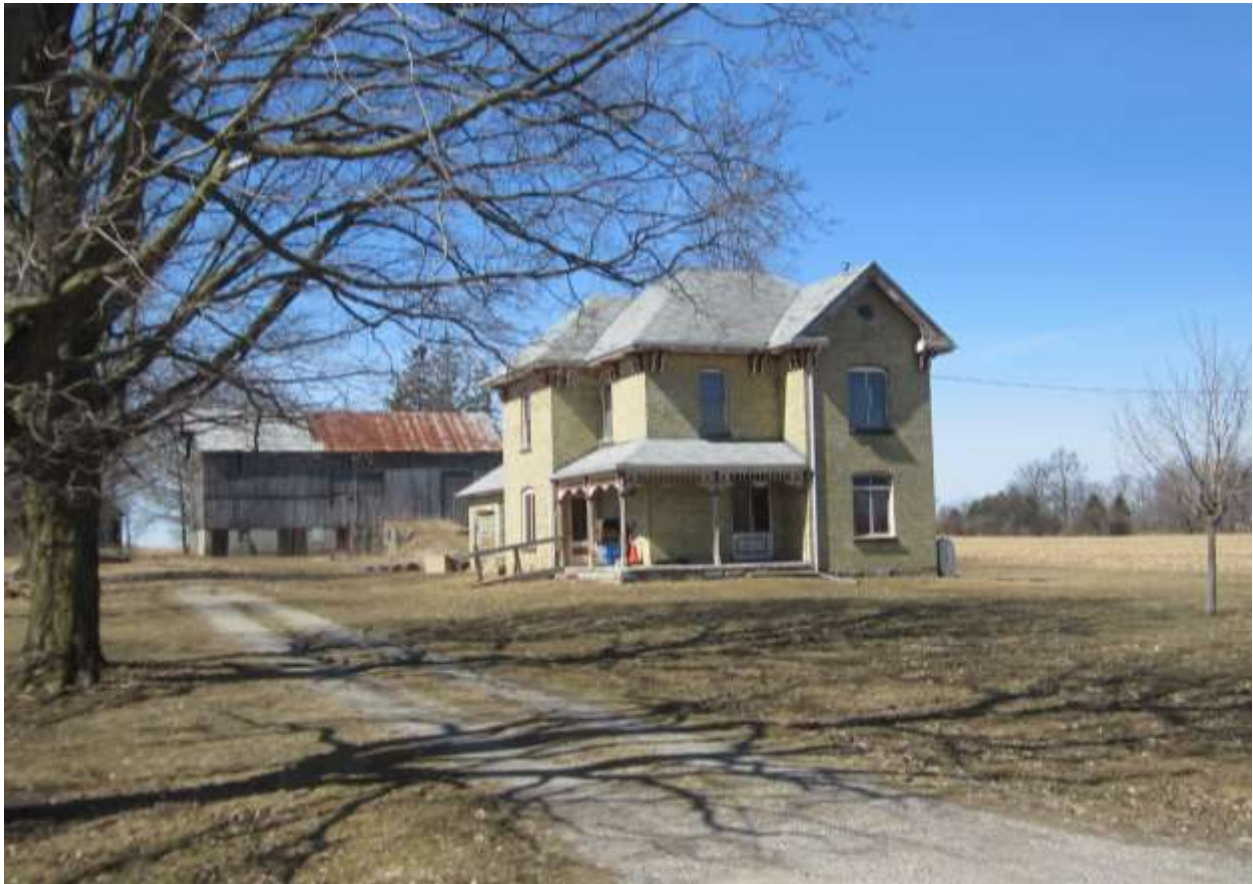
Image 3. Front façade of the farmhouse located 3303 Westdel Bourne. The largest barn and the barn hill seen in the rear, looking northwest. April 2019.

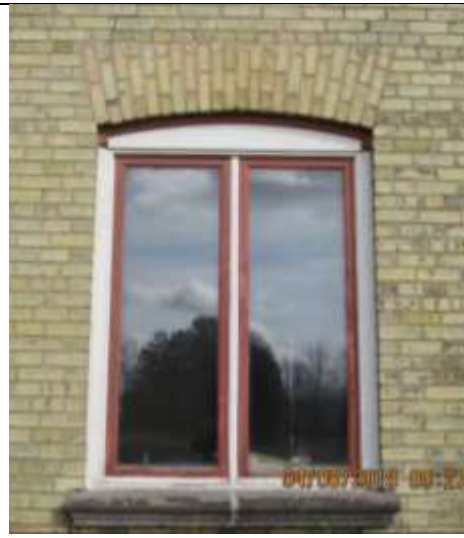
Brick voussoirs with contrasting mortar appear above every original window and door opening. Many of the windows are tall, narrow and in pairs with segmented arch openings. Although all the windows appear to have been replaced; the replacement windows are wood and maintain their openings. The original cast stone sills can still be found below each window.

Image 11 Window example, front façade of the farmhouse located at 3303 Westdel Bourne. April 2019.

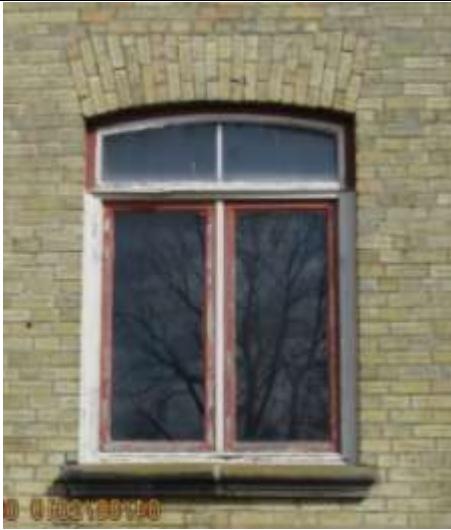
Image 12. Window example, front façade of the farmhouse located at 3303 Westdel Bourne. April 2019.

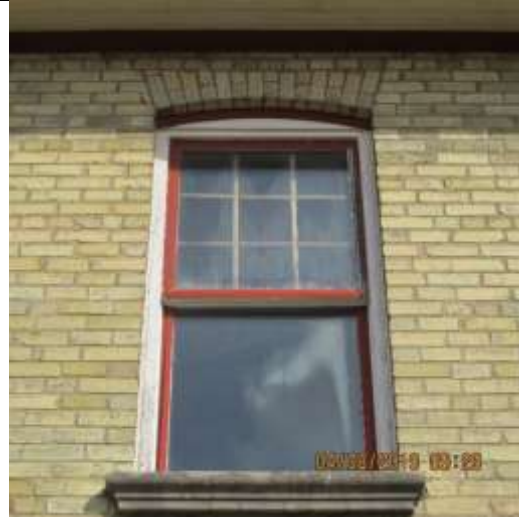
Image 13. Window example, south façade of the farmhouse located at 3303 Westdel Bourne, looking west. April 2019.

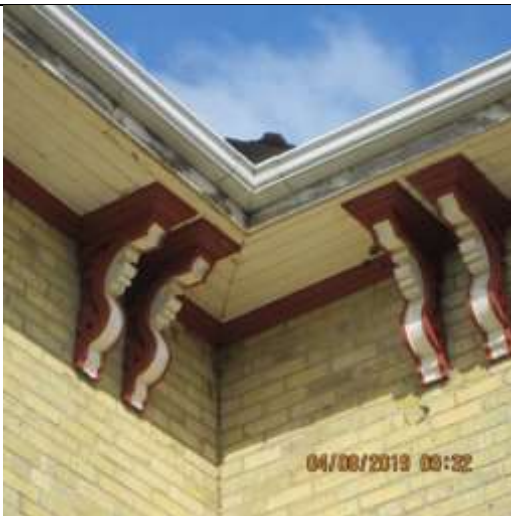
The farmhouse located on the property at 3303 Westdel Bourne displays many of the elements commonly found on building in the Italianate style, including the most defining element of the style, paired brackets. The farmhouse also has narrow segmented arched windows, paired windows, hipped roof, wide overhanging eaves, and a projecting bay with gable and oculus window. These elements include the most defining element of the style, paired brackets, as well as narrow segmented arched windows, paired windows, and wide overhanging eaves. Although the form of the farmhouse is not a common Italianate form as there is a recessed and projecting bay, there is a wing extending at the back.

Image 14. Example of the paired brackets at the farmhouse located at 3303 Westdel Bourne. April 2019.

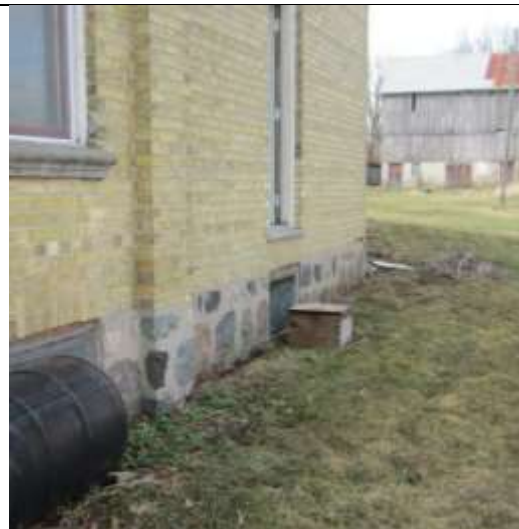
The buff brick is laid in a common bond pattern and the foundation is field stone with coursing detail. Although it has not been confirmed, the field stone in the foundation appear to be similar to the "glacial erratics" fieldstone used to build the Kilworth United Church (2442 Oxford Street West), which is approximately 6km away.

Image 15. Field Stone foundation, north façade of the farmhouse located at 3303 Westdel Bourne. April 2019.

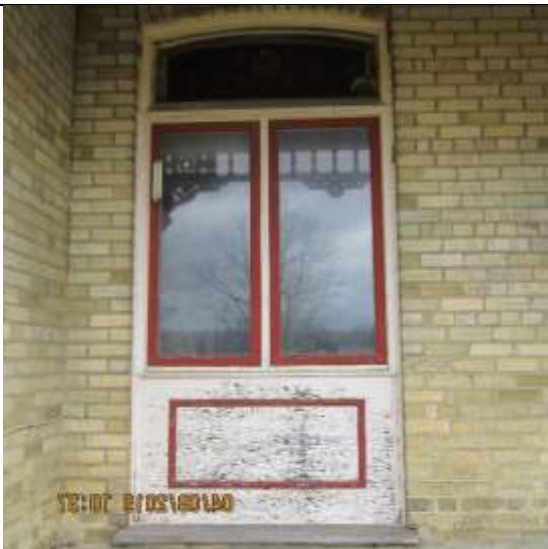
The building has an asymmetrical façade that is comprised of one recessed bay and one projecting bay. The projecting bay is highlighted by the decorative bargeboard on the front gable and an oculus window in the gable's centre. On the main floor, an entry door is located in the recessed bay. The door itself has been replaced, but the original opening has been retained. Two fixed windows in the central bay are now in the place of the original door, and the segmented arch transom with decorative etched glass. The etched glass shows a floral motif surrounding a bird.

Image 16. Original front door opening, front façade of the farmhouse located at 3303 Westdel Bourne. April 2019.

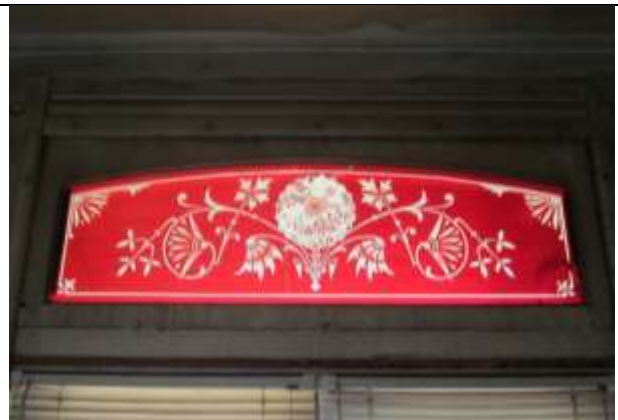
Image 17. Etched glass above original front door opening. Interior photo of the farmhouse located at 3303 Westdel Bourne. April 2019.

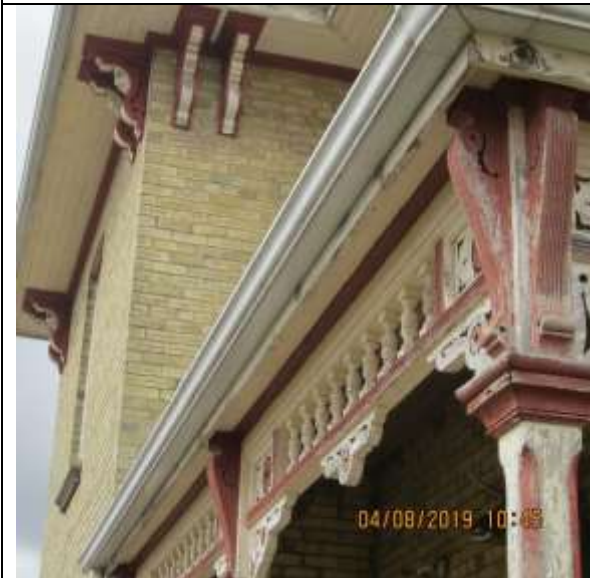
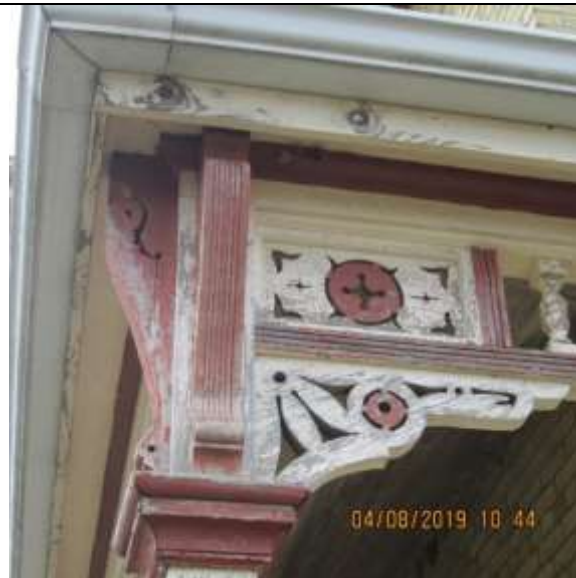
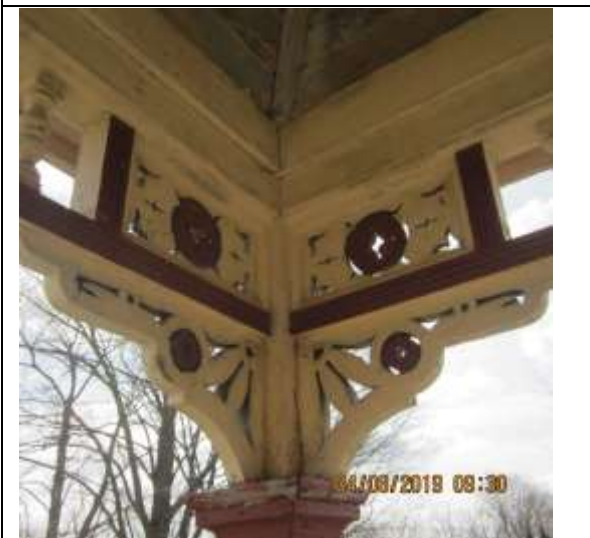
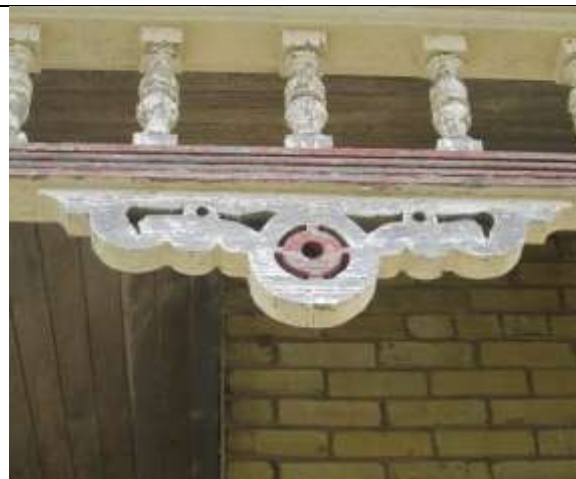
The ell shaped wrap-around verandah is covered by a hipped roof and supported by decorative chamfered posts. The chamfered posts are connected to a concrete base with pressed design and are topped with capitals connected to fluted brackets. Each fluted bracket connects to a pierced panels supported by a decorative bracket. Spandrels extend around the verandah with a centre decorative bracket attached below.

Image 20. Close up of verandah detail. Front façade of the farmhouse located at 3303 Westdel Bourne. April 2019.

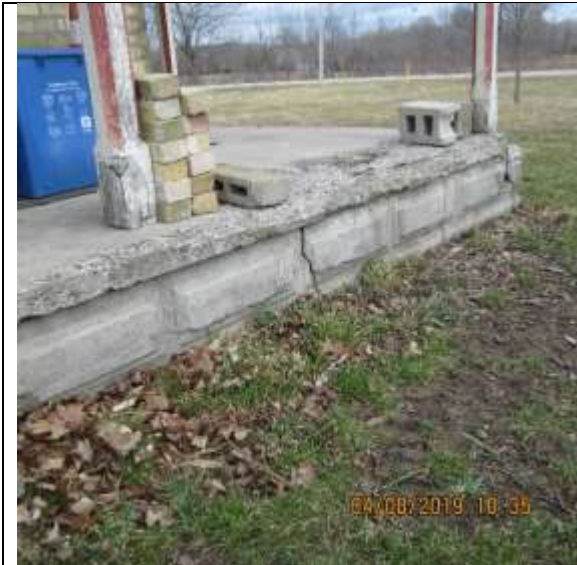
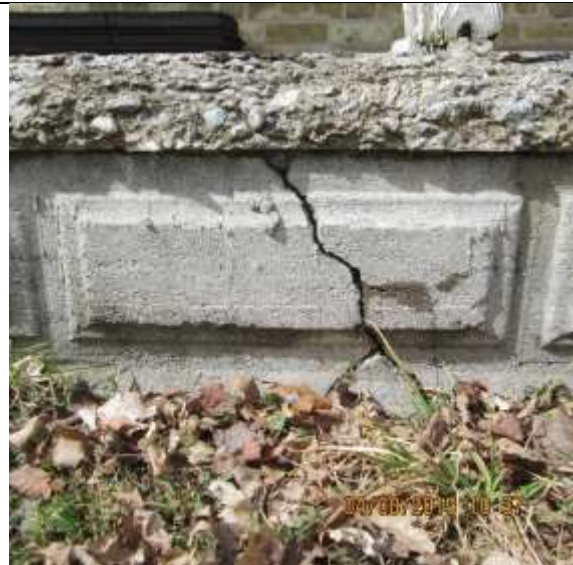
Image 24. Verandah concrete base. Front façade of the farmhouse located at 3303 Westdel Bourne. April 2019.

Image 25. Close of up of the concrete base of the verandah. Front façade of the farmhouse located at 3303 Westdel Bourne. April 2019.

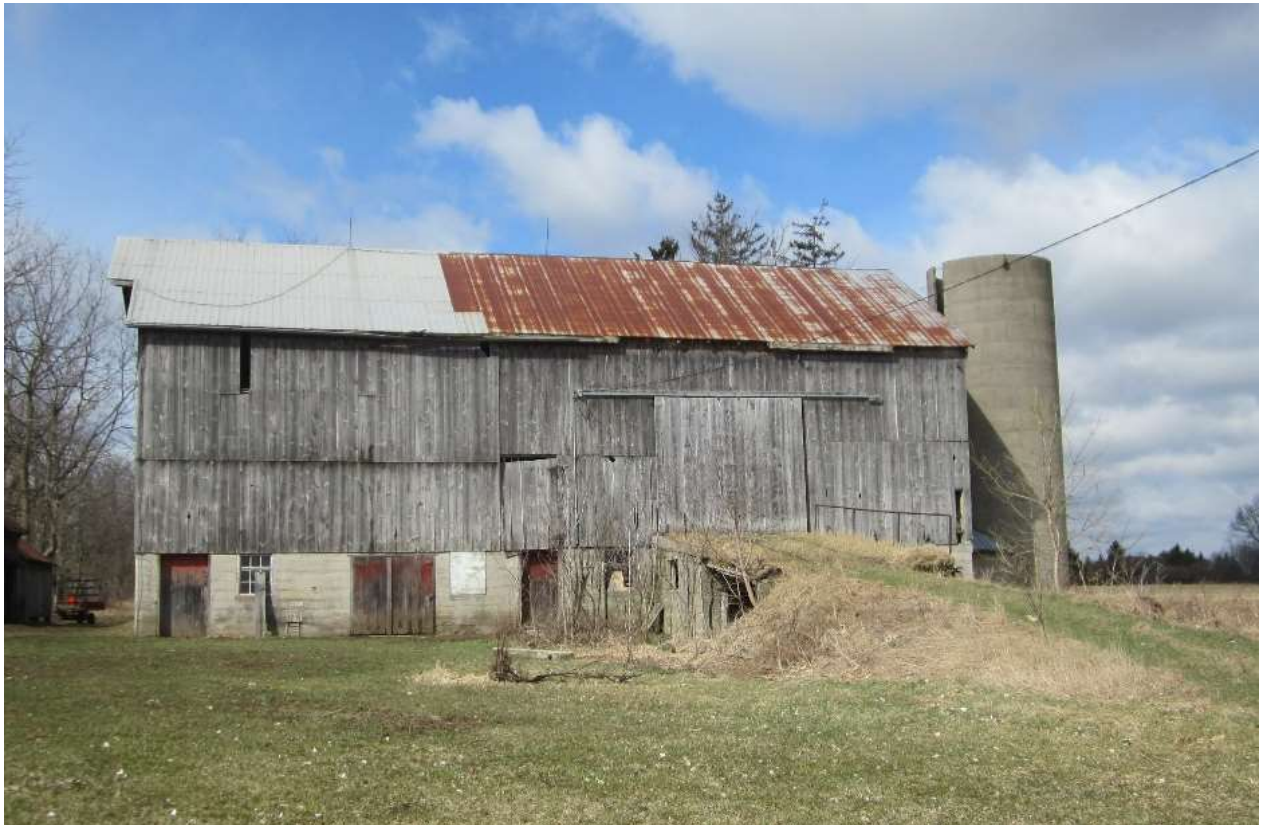
A barn hill is connected to the east façade of Barn 1. The barn hill appears to have a root cellar that has been parged and altered. An open space in the middle – known as a "walk way", and field stones make up the rest of the barn hill.

Image 26. View of Barn Hill, east façade of Barn 1 located at 3303 Westdel Bourne, looking west. April 2019.

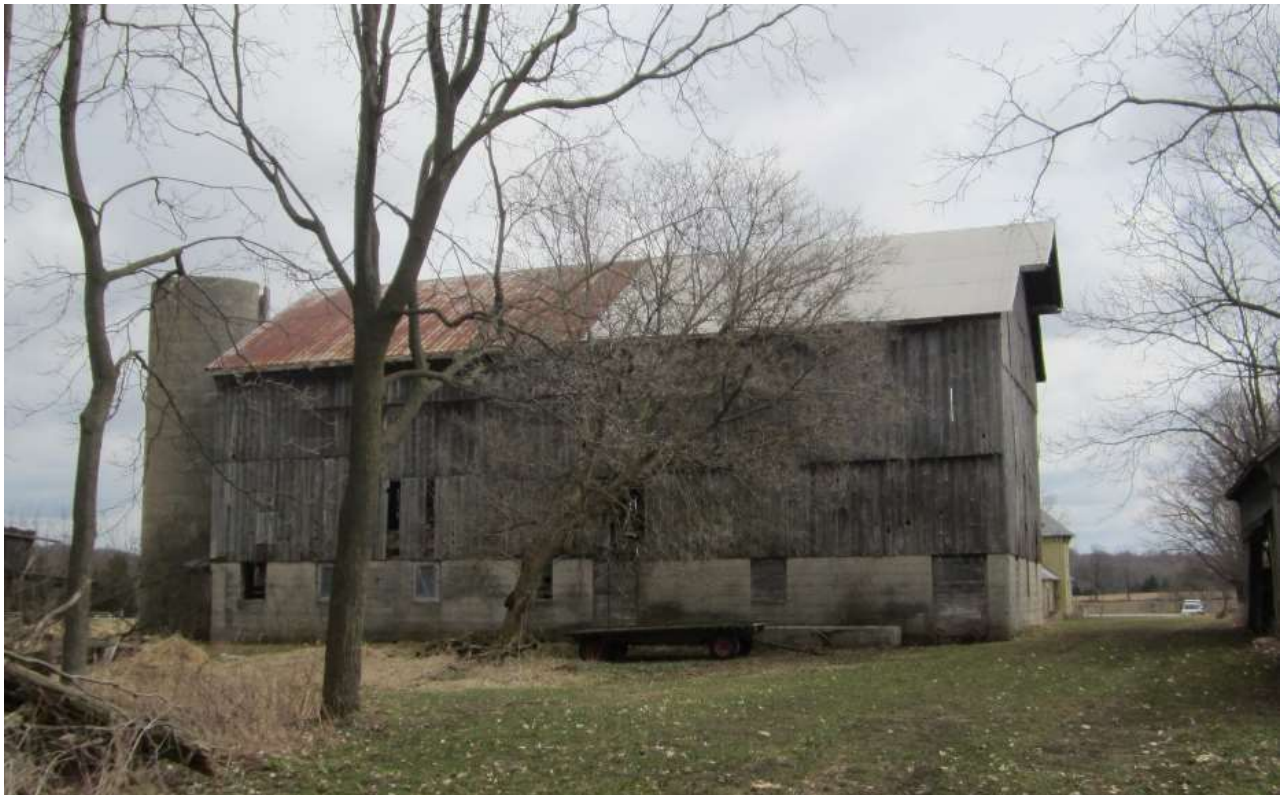
Barn 1 is the largest of the barns located on the property at 3303 Westdel Bourne. Barn 1 is in the Bank Barn style as the lower level housed animals and the upper level served as storage. The foundation of the barn has been parged in concrete and has a number of openings for multi-pane windows. The barn is a timber frame with a gable roof covered in corrugated metal and vertical barn board siding. The beams in the barn are a mix of hand hewed and machine cut with a typical diagonal post and beam brace connection. The beams are connected to the post with mortise-and-tenon joints. The beams on the first level are notched into the top of the foundation wall. A reinforced concrete silo is connected to the north façade of the barn.

Image 27. West façade of Barn 1 located at 3303 Westdel Bourne, looking east. April 2019.

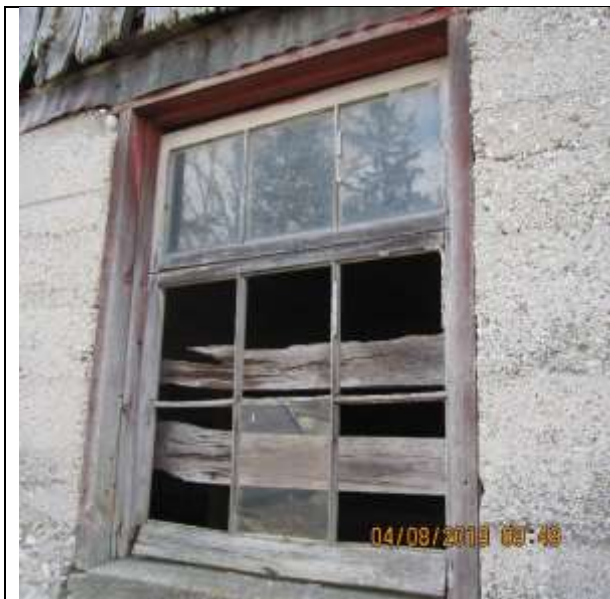
Image 28. Window example. Barn 1 located at 3303 Westdel Bourne. April 2019.

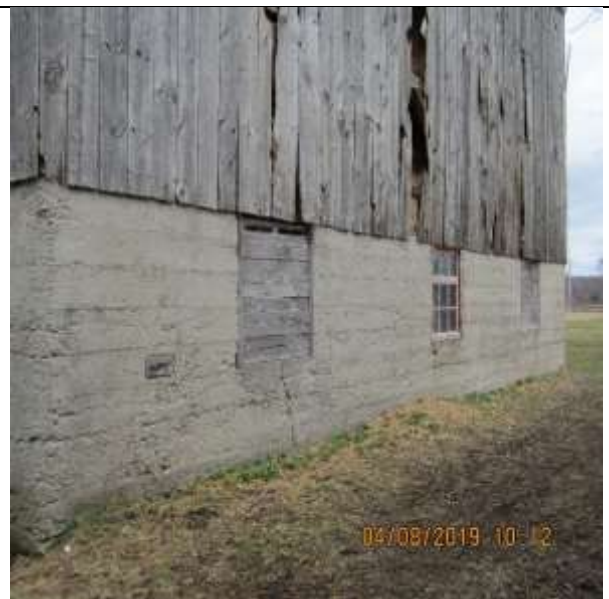
Image 29. Parged concrete foundation. Barn 1 located at 3303 Westdel Bourne. April 2019.

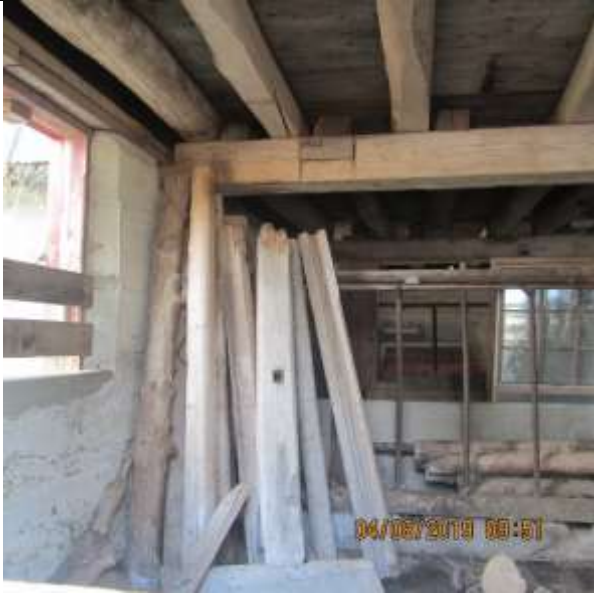
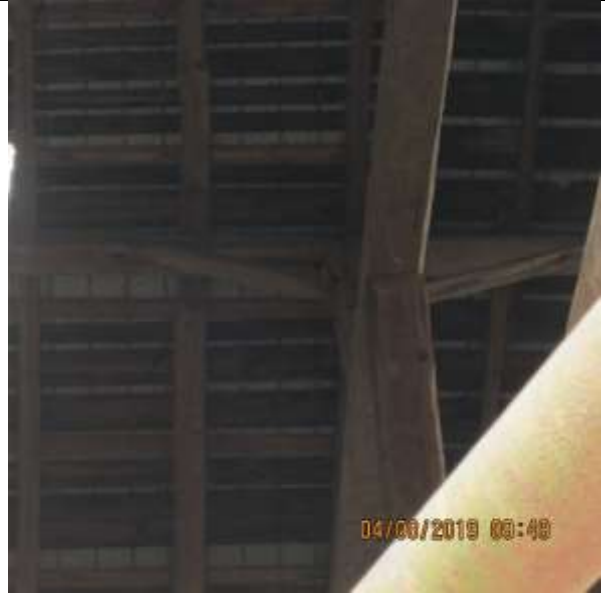
Image 30. Interior of Barn 1 located at 3303 Westdel Bourne. April 2019.

Image 31. Interior of Barn 1 located at 3303 Westdel Bourne. April 2019.

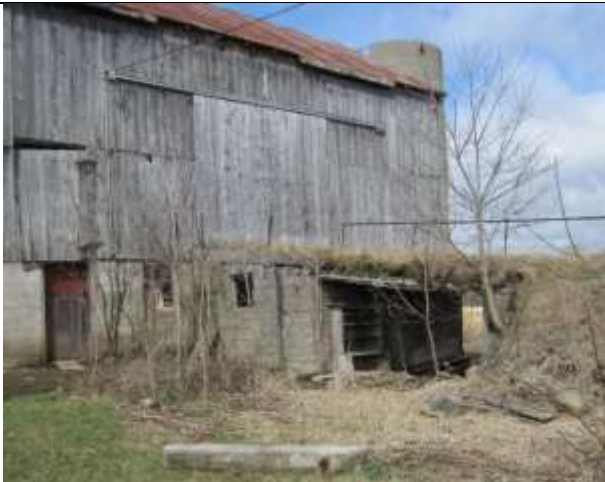
Image 32. Photo of the Barn Hill. Barn 1 located at 3303 Westdel Bourne. April 2019.

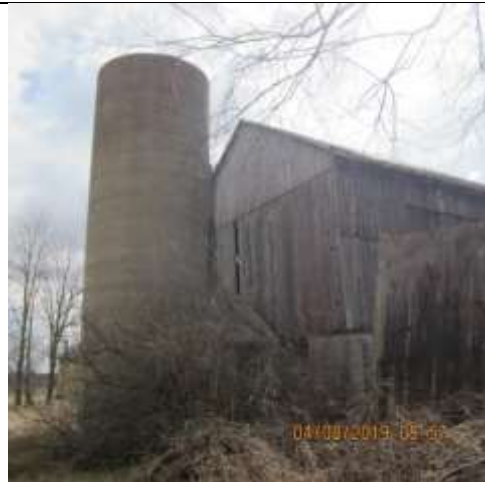
Image 33. North façade of Barn 1 located at 3303 Westdel Bourne. April 2019.

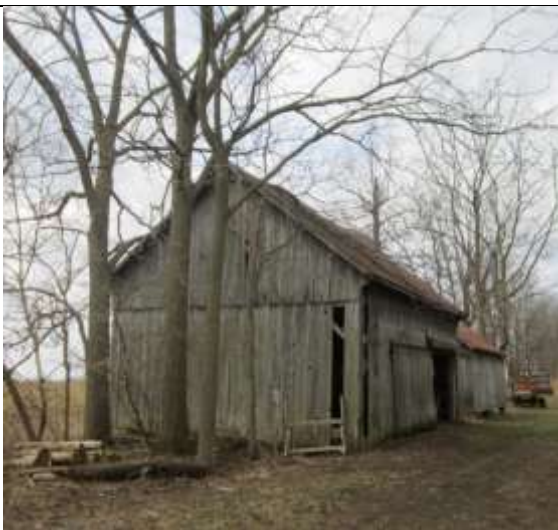
Barn 2 is just south west of the large barn. Similar to the largest barn, the barn is also a timber frame with a gable roof and vertical barn board siding (Appendix C, see Barn 2). The beams in the barn are a mix of hand hewed and machine cut with a typical diagonal post and beam brace connection. The beams are connected to the post with mortise-and-tenon joints.

Image 34. East façade of Barn 2 located at 3303 Westdel Bourne. April 2019.

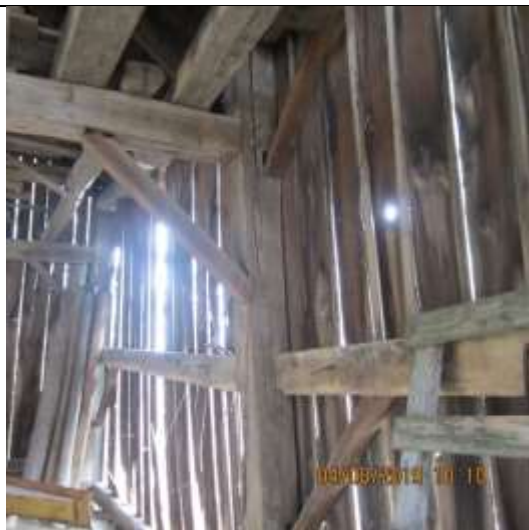
Image 35. Interior of Barn 2 located at 3303 Westdel Bourne. April 2019.

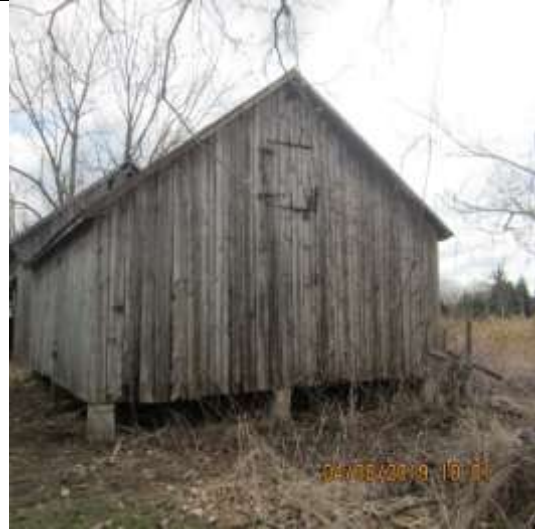
Barn 3 is directly west of the second barn. Barn 3 sits on top of concrete piers is also a timber frame with a gable roof and vertical barn board siding (Appendix C, see Barn 3). The inside was unable to be viewed as the door was pad locked shut, so the construction method of the barn was unable to be confirmed.

Image 36. West façade of Barn 3 located at 3303 Westdel Bourne. April 2019.

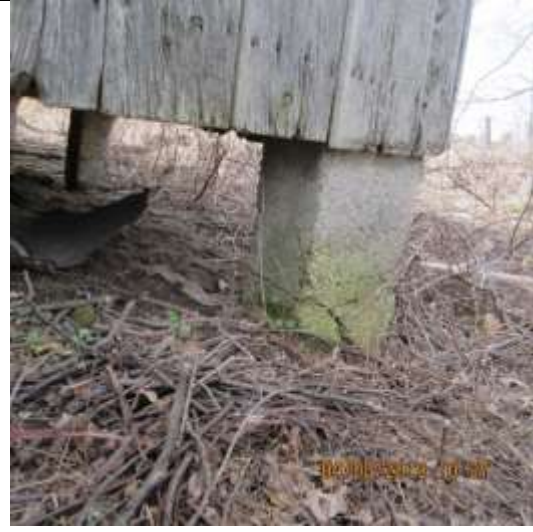
Image 37. Close up of concrete pillars. Barn 3 located at 3303 Westdel Bourne. April 2019.
