Report to London Advisory Committee on Heritage

Subject: Heritage Alteration Permit Application by S. Granger at 504-506 Maitland Street, West Woodfield Heritage Conservation District

Meeting on: Wednesday November 13, 2019

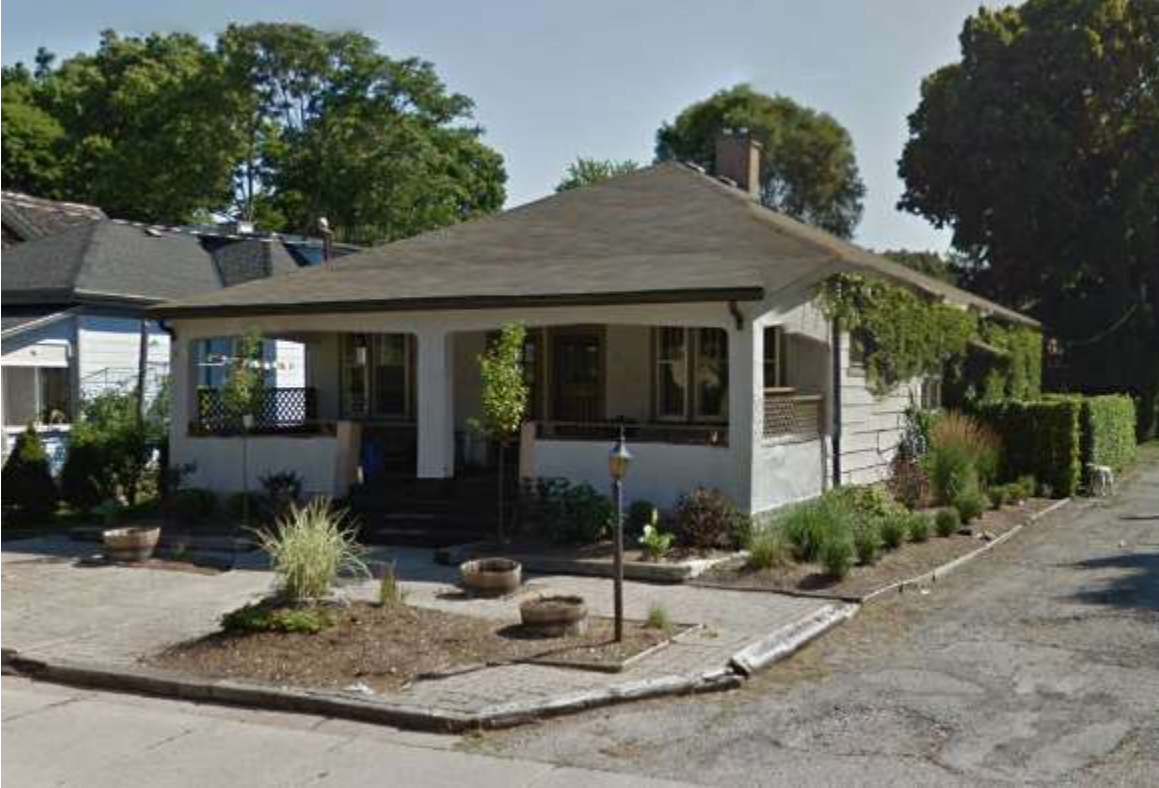
Image 1: Image of the property at 504-506 Maitland Street in 2016, prior to alterations (courtesy Google).

The existing semi-detached dwellings at 504-506 Maitland Street are a modest, vernacular cottage form constructed in circa 1884 (Appendix B). The semi-detached dwellings are mirror images; a doorway, with a historic wooden front door, flanked by a

triplet window to the side. Both of the semi-detached units are accessed by a porch which spans the building's façade and features a shed style roof extending from the hipped or cottage roof of the main building.

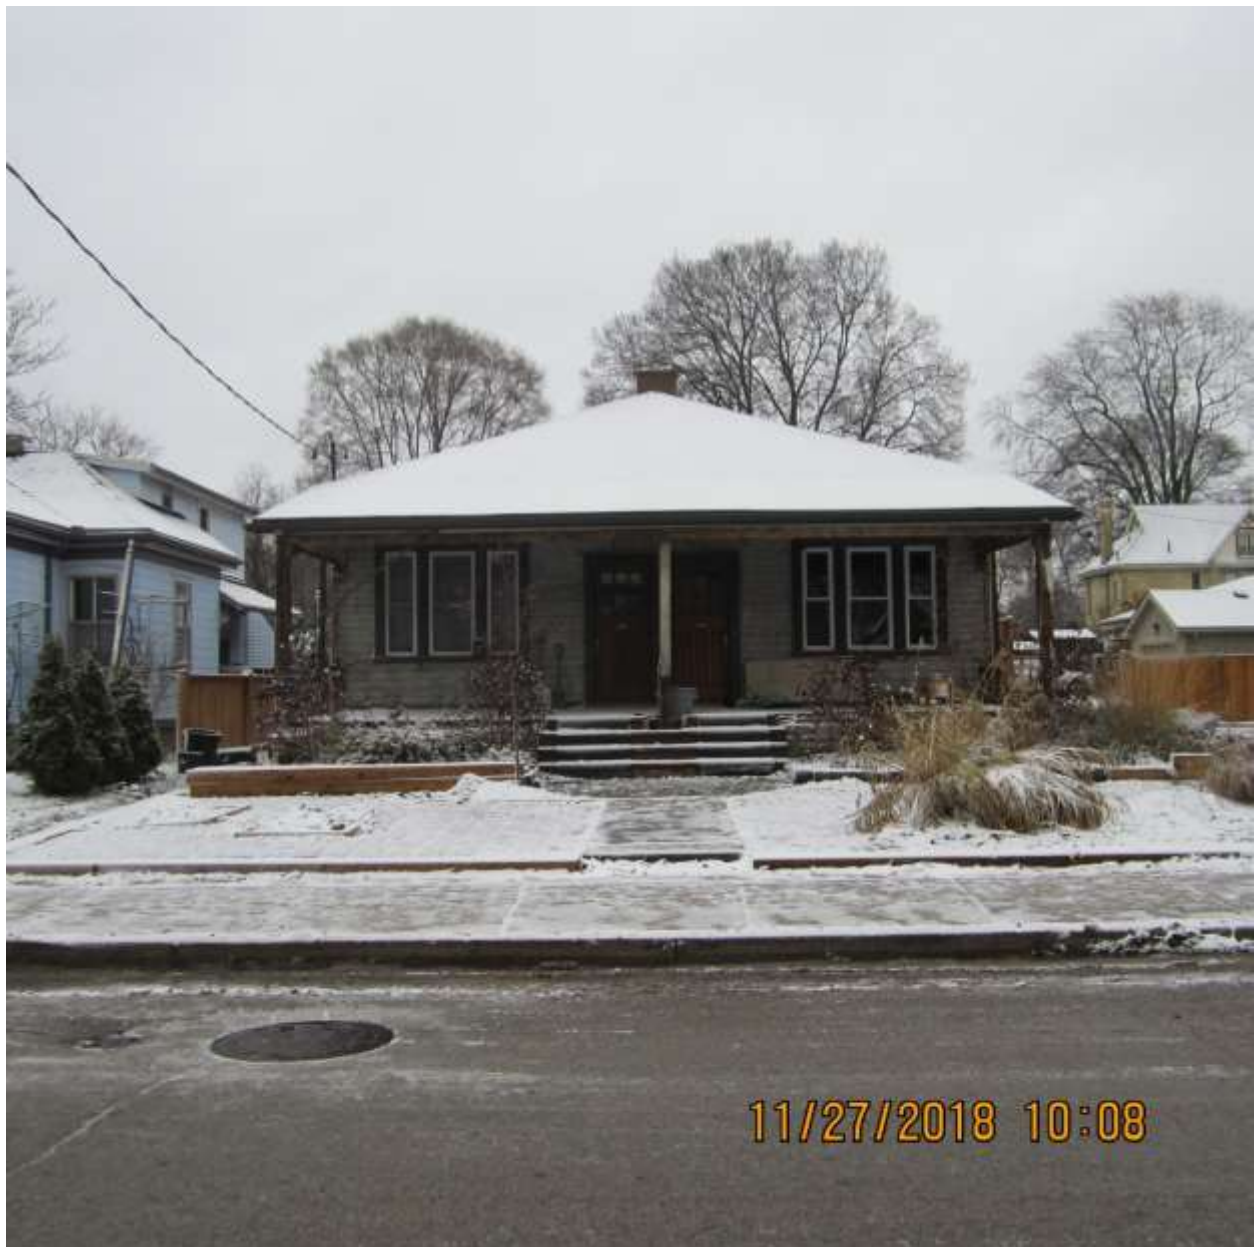
Image 2: Photograph of the property at 504-506 Maitland Street on November 27, 2018 showing unapproved alterations.

Forensic evidence, as exposed by previous unapproved alterations to the semi-detached dwellings, have exposed the horizontal tongue and groove wood siding that is believed to be original. Previous alterations, including the application of stucco cladding, has compromised this material. In addition to the stucco cladding of the porch and front façade, horizontal siding (believed to be aluminum) formerly clad the sides and rear of the building. Wood windows were formerly in the window openings, but were replaced by vinyl windows.

The removal of the former cladding of the semi-detached dwelling, particularly the former stucco cladding on the porch structure, has identified deficient structural elements. This identification eliminates the feasibility of maintaining the existing porch; reconstruction of the existing porch is required.

The unapproved alterations, which removed the exterior finishes from the porch of the existing semi-detached dwelling at 504-506 Maitland Street, exposed structural deficiencies which render the existing porch unsuitable for rehabilitation. The Heritage Alteration Permit application proposed the removal and reconstruction of the porch, maintaining the same size, shape, and general design.

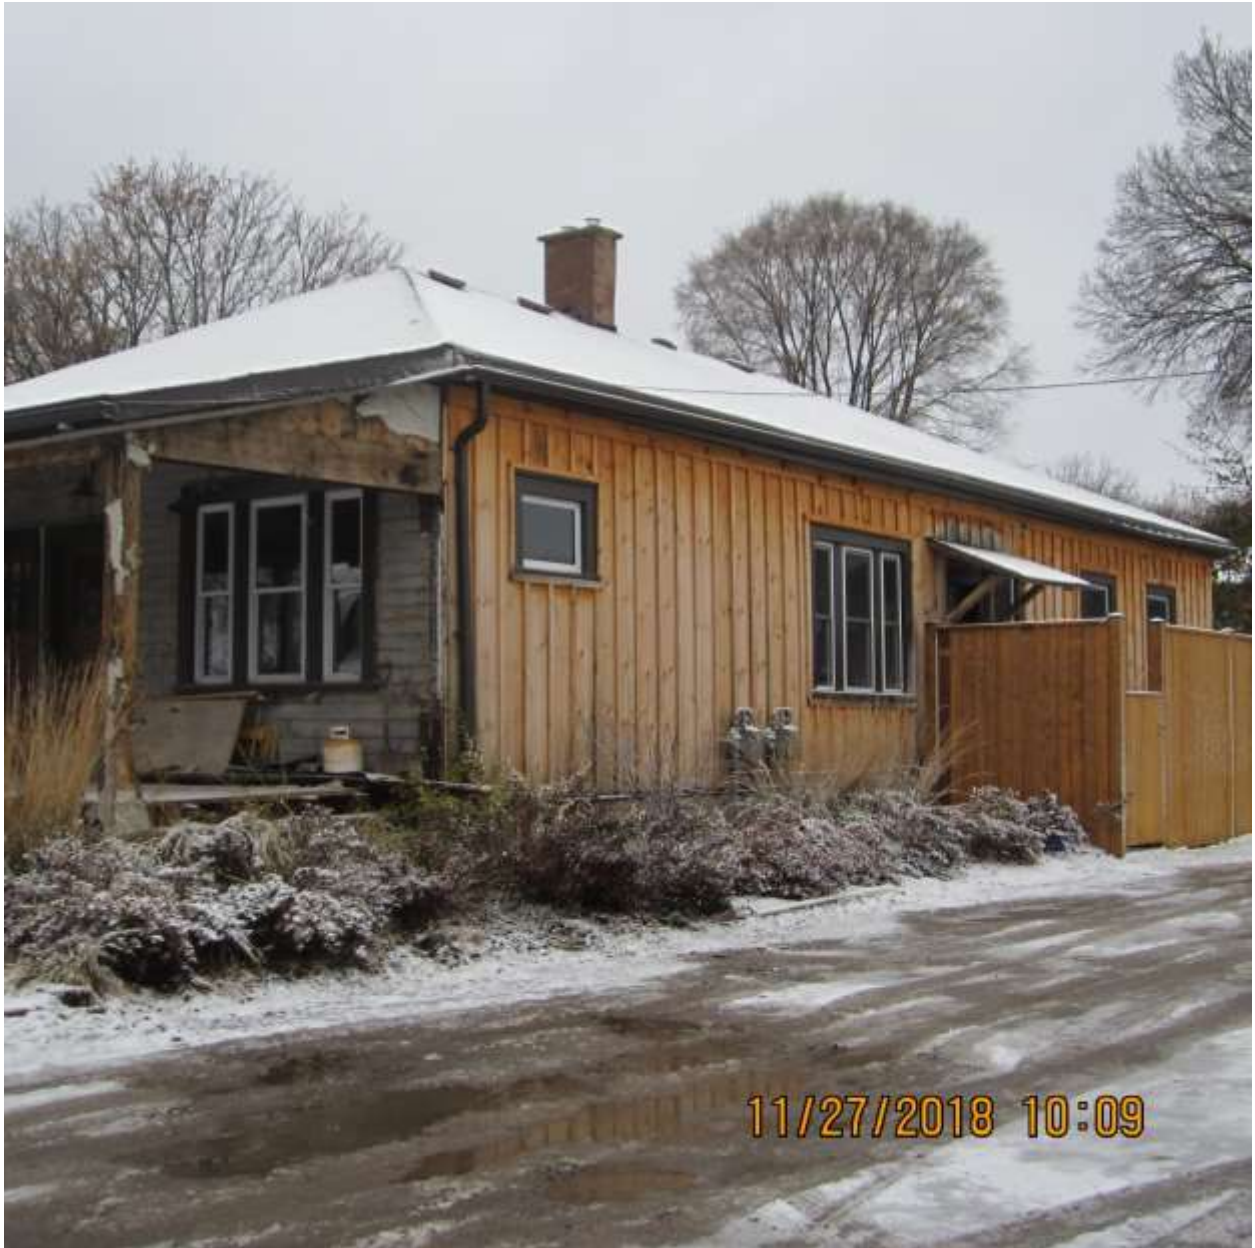
Image 3: Photograph of the property at 504-506 Maitland Street on November 27, 2018 showing unapproved alterations.

The former wood windows were removed and replaced by the existing vinyl windows without Heritage Alteration Permit approval. The guidelines of Section 10.6 discourage the replacement of wood windows with vinyl or aluminum windows.

The replacement windows maintained the style (hung/sash), size, and location of the former windows. The replacement windows did not maintain the proportion of the former wood windows, as the vertical divided upper sash was not replicated in the vinyl window. Faux grilles or "snap-in" muntins poorly replicate the details of historic wood windows.

The board and batten wood siding was installed on the side and rear elevations of the existing semi-detached dwelling at 504-506 Maitland Street without Heritage Alteration Permit approval. Reference to the board and batten style in Section 10.4.5 of the *West Woodfield Heritage Conservation District Plan* demonstrates the historic appropriateness of this material. The modest scale of the existing semi-detached dwelling at 504-506 Maitland Street lends itself to the suitability of the board and batten wood cladding, which would not be appropriate on a grander or elaborate structure.

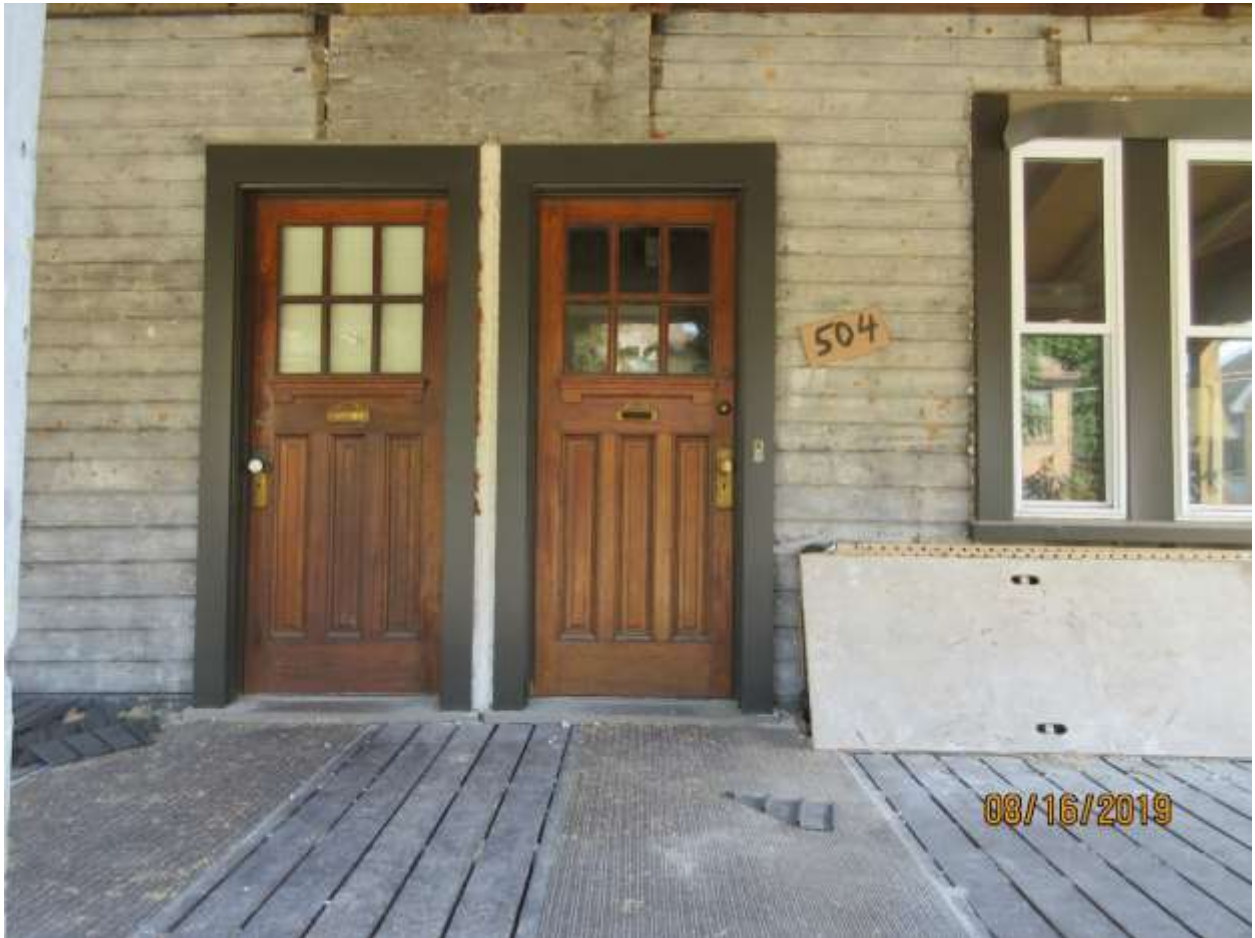
Image 4: Photograph showing the historic front doors of the semi-detached dwelling at 504-506 Maitland Street. Note: the doors will be retained and not altered.

The existing, historic front doors will be maintained with no alterations proposed.

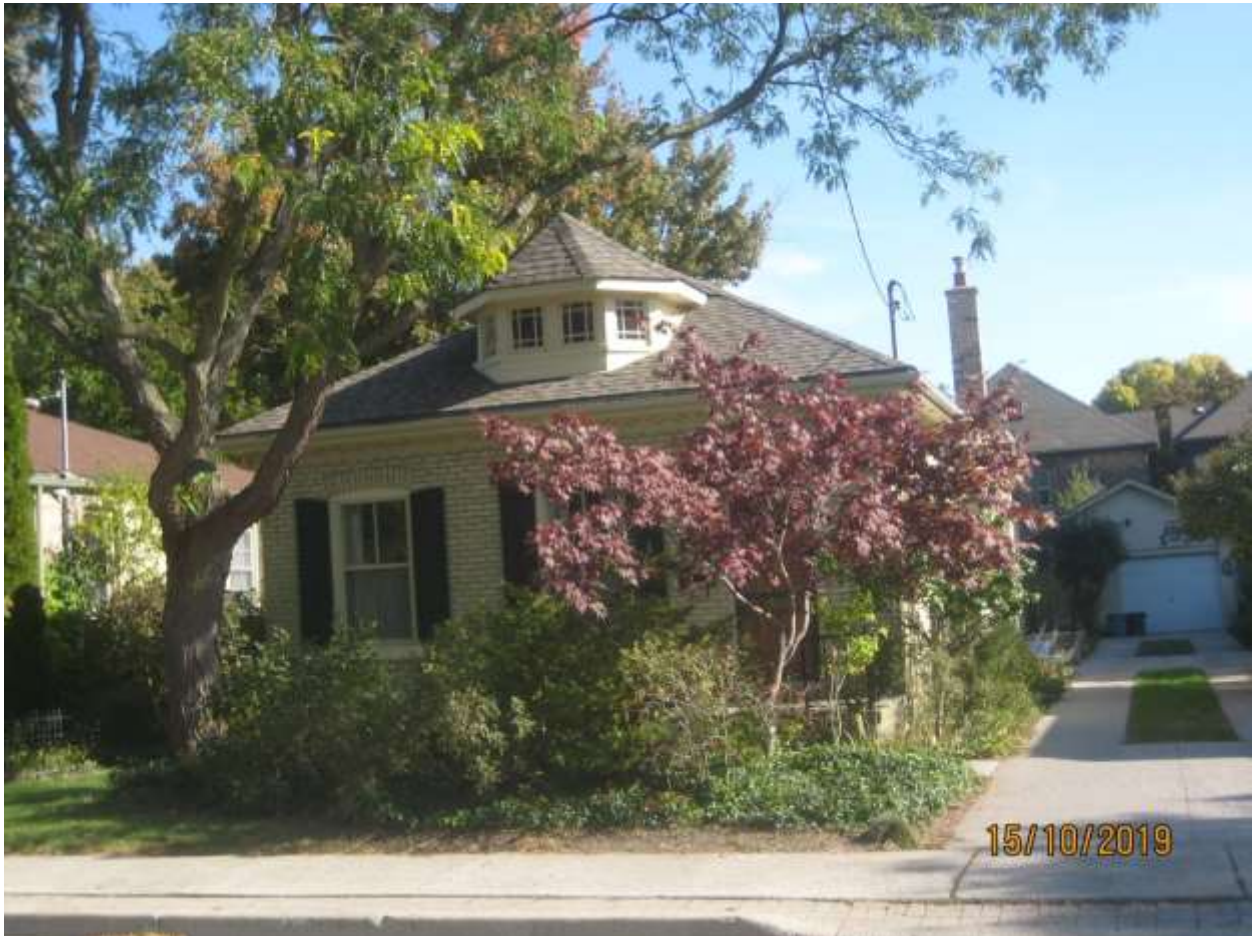
Image 5: This side hall plan cottage (1881) at 16 Cartwright Street, West Woodfield Heritage Conservation District, includes a unique four-light dormer.

Dormers are a common and historically-appropriate design intervention within the context of the West Woodfield Heritage Conservation District. Numerous examples of varying detail can be found through the West Woodfield Heritage Conservation District, as well as in London's other Heritage Conservation Districts. To inform the design of the proposed dormer, other examples of dormers should be considered. See Appendix D.

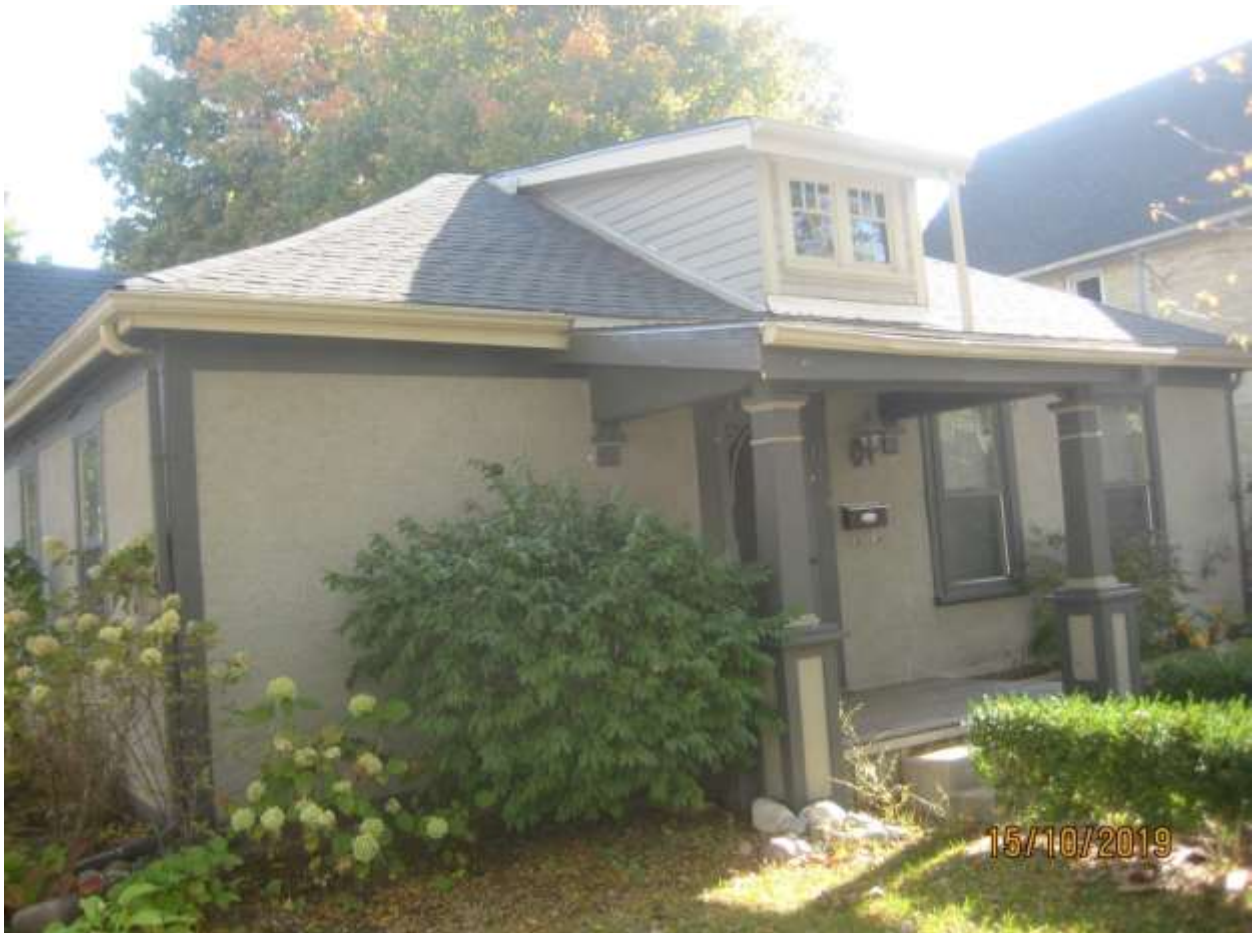
Image 6: The slope of the shed roof of the dormer on the cottage (c.1860) at 66 Palace Street, in the East Woodfield Heritage Conservation District, matches the ridge line of the hipped roof of the cottage.

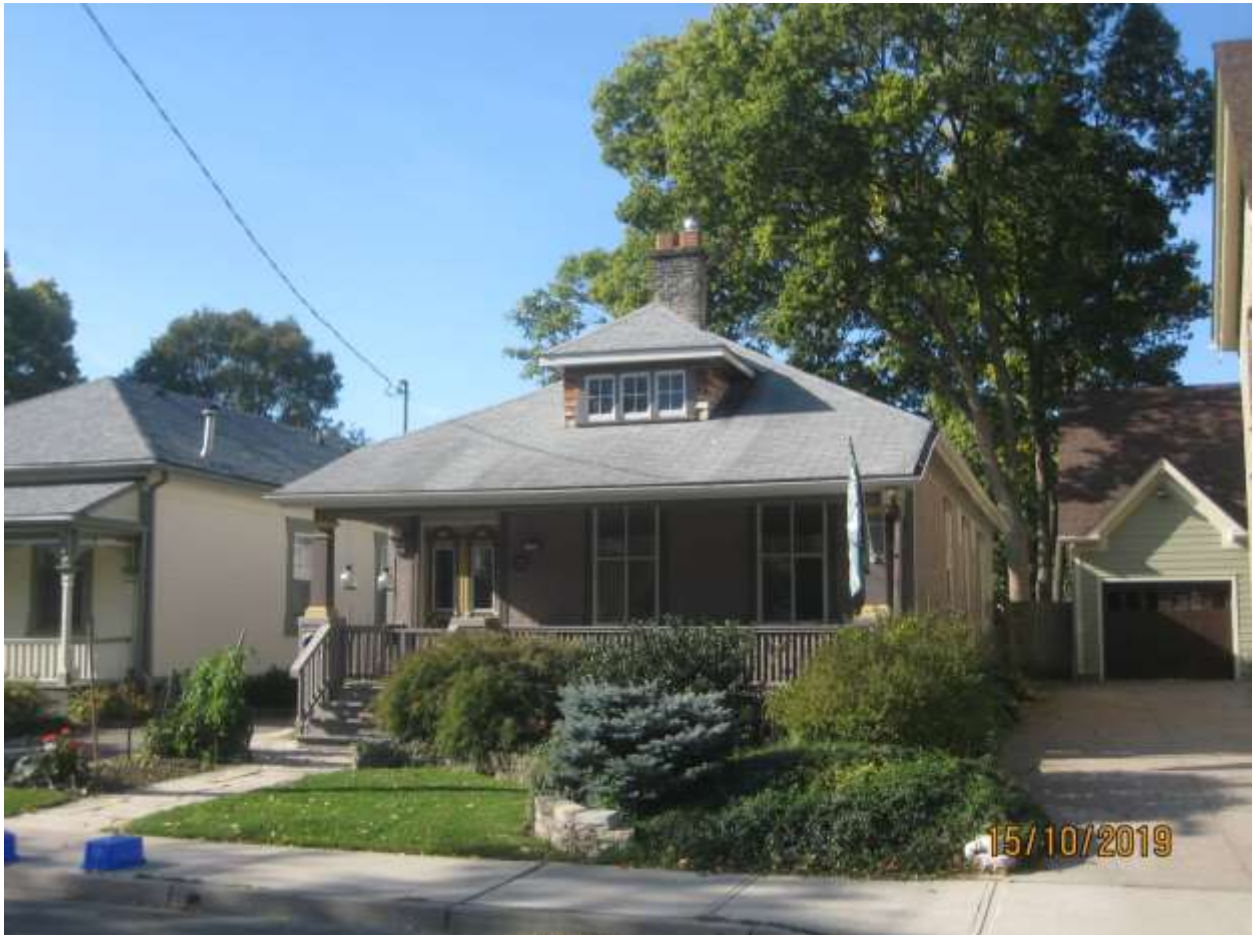
Image 7: A hipped roof dormer is featured on the cottage (c.1883) at 9 Prospect Avenue, designated under Part IV of the Ontario Heritage Act. Note: the dormer shown here on the cottage at 9 Prospect Avenue is smaller in size than the proposed dormer at 504-506 Maitland Street.

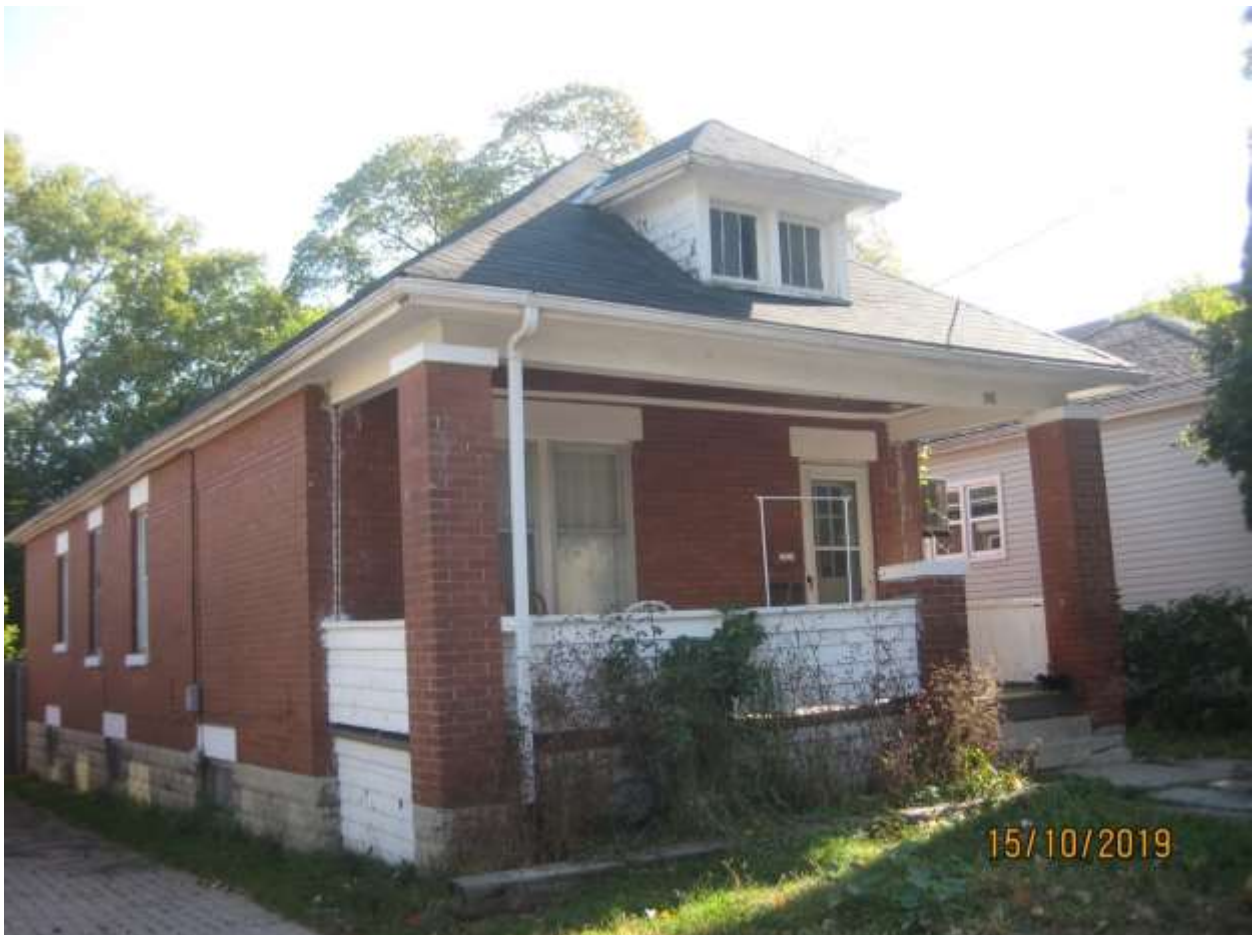
Image 8: The dormer on this cottage (1925) at 98 Cartwright Street, West Woodfield Heritage Conservation District, projects over the front porch as does the proposed dormer at 504-506 Maitland Street. Note: the dormer shown here on the cottage at 98 Cartwright Street is smaller in size than the proposed dormer at 504-506 Maitland Street.
