## Report to London Advisory Committee on Heritage

**To:** Chair and Members  
London Advisory Committee on Heritage  
**From:** John M. Fleming  
Managing Director, City Planning and City Planner  
**Subject:** Demolition Request for Heritage Listed Property at 2325  
Sunningdale Road East by Lafarge Canada Inc.  
**Meeting on:** December 11, 2019

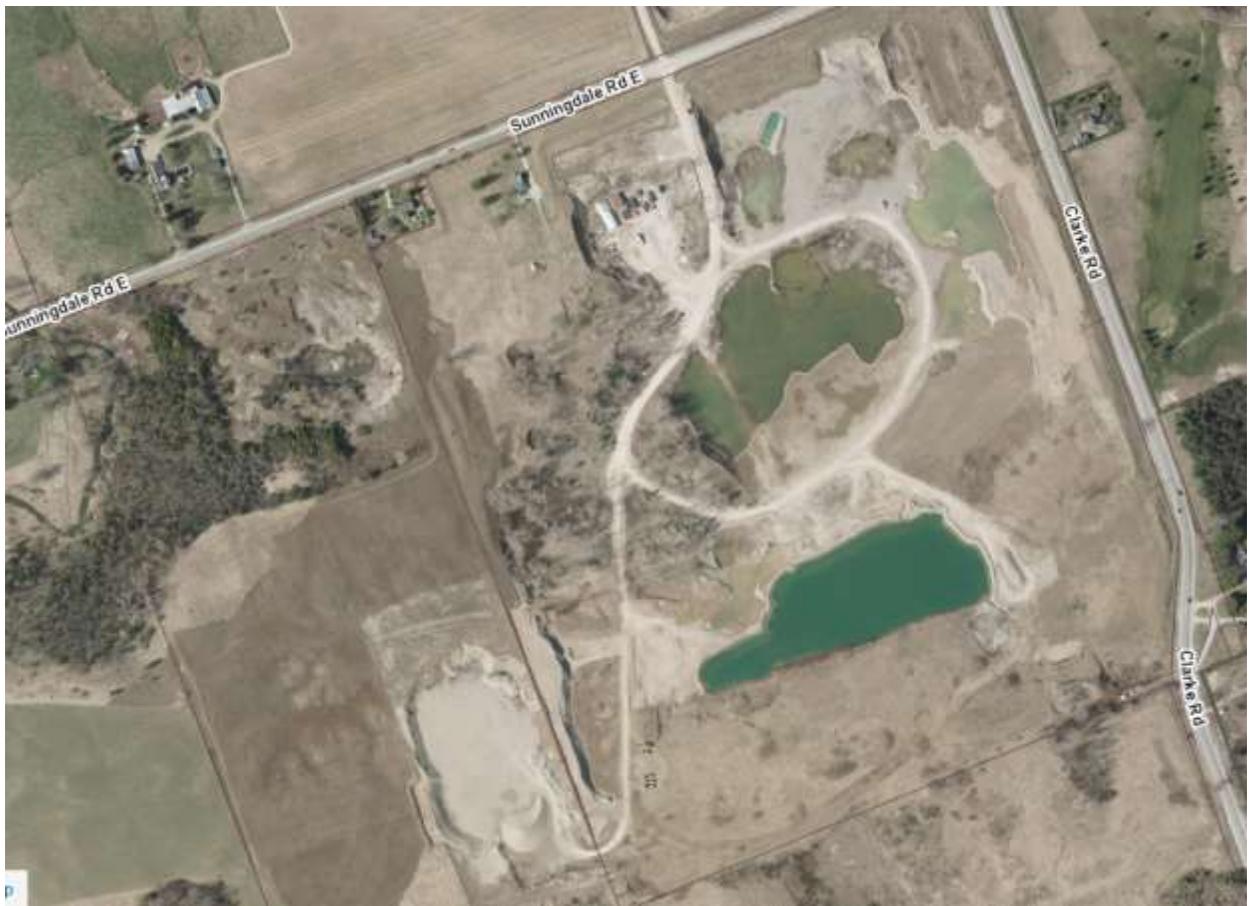
Figure 6: Aerial view showing current land use and aggregate extraction activity on the property.

Today, the land for the property extending south of the dwelling continues to be used for aggregate extraction, the majority of which is used for the extraction of sand and gravel, known as the Talbot Pit (MHBC 4.0).

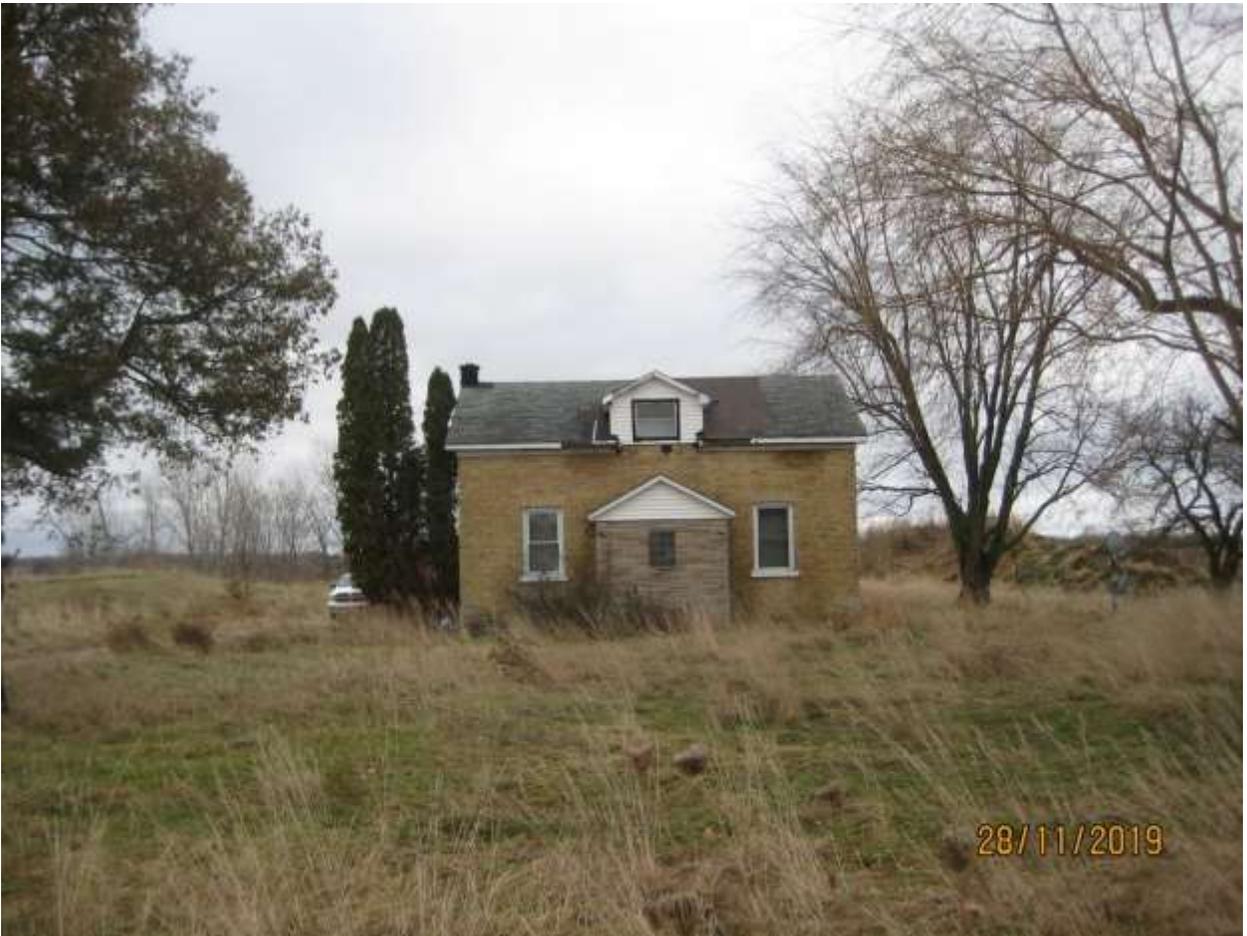
*Image 2: Main (north) facade of the dwelling at 2325 Sunningdale Road East.*

The original window openings on the main façade have been retained including the segmental arch brick voussoirs. However, the windows have been replaced. A gable dormer is centrally located on the main façade, also clad with vinyl siding. The front corners of the house have been rebuilt and re-clad with angelstone.

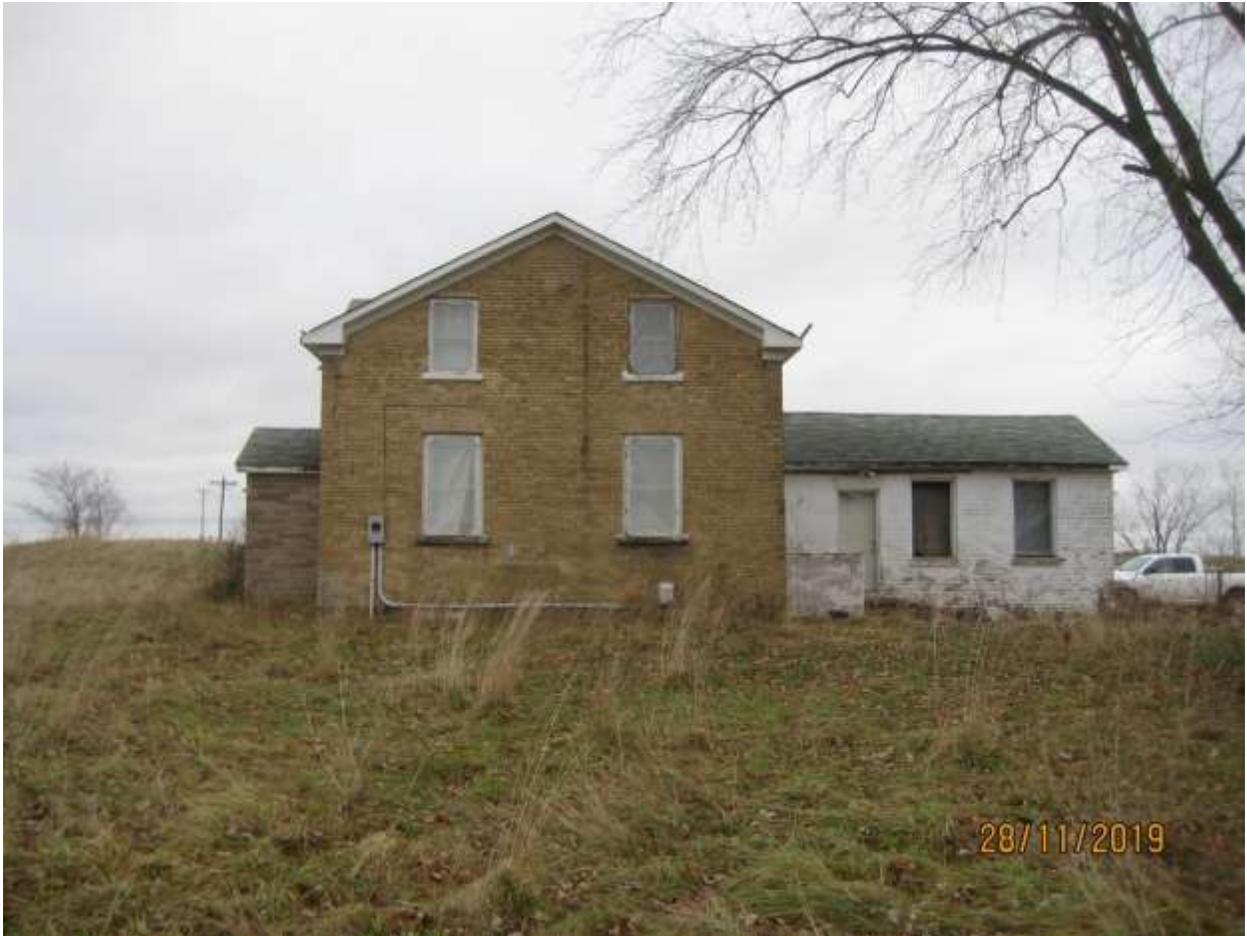
*Image 3: West facade of the dwelling at 2325 Sunningdale Road East, showing the main house, front entrance at left, and rear addition at right.*

The east and west facades of the dwelling consist of buff brick exterior walls with a set of window openings located on the first and second storeys. The brick lintels and concrete sills are still visible on the west façade, along with portions of the original rubble stone foundation. One of the first floor windows has been filled in on the east façade. A brick chimney is located in between the sets of the windows on the east façade. A black tar/sealant has been used to cover the entire chimney, along with the second storey sills and perimeter of the window openings.

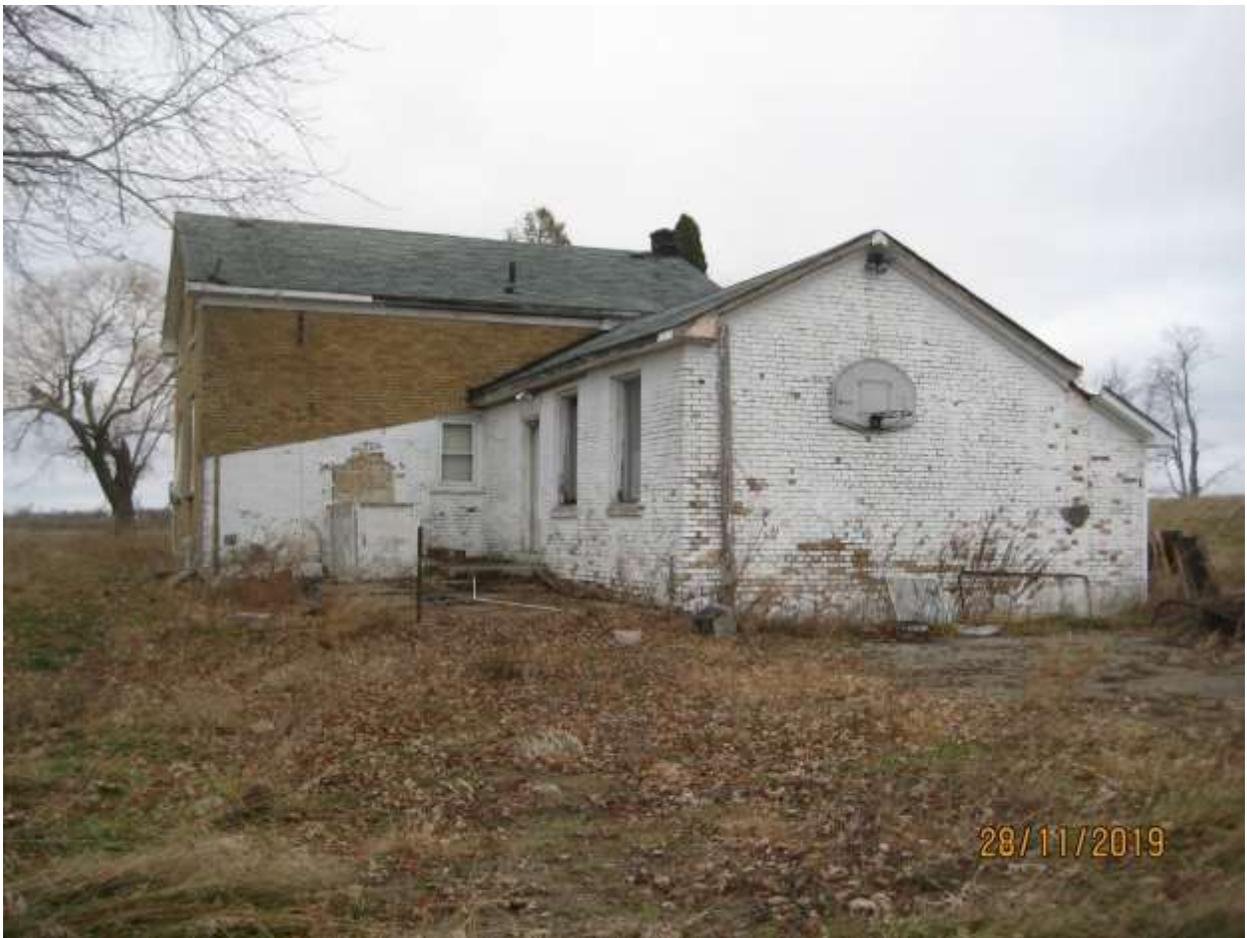
*Image 4: Rear (south) facade of the dwelling at 2325 Sunningdale Road East showing main house and rear addition.*

The rear (south) façade of the dwelling consists primarily of buff brick exterior walls, with a small first storey window. A single storey addition has also been constructed onto the rear of the building. The rear addition is clad with brick, however it has been painted white. Evidence of the original buff brick is present, and portions of the foundation indicate its material consists of rubble stone, suggesting that the rear wing is an early addition. This portion of the addition may have functioned as an early summer kitchen for the dwelling. A garage addition has also been constructed onto the rear of the dwelling. The east side of the addition is clad in vinyl siding.

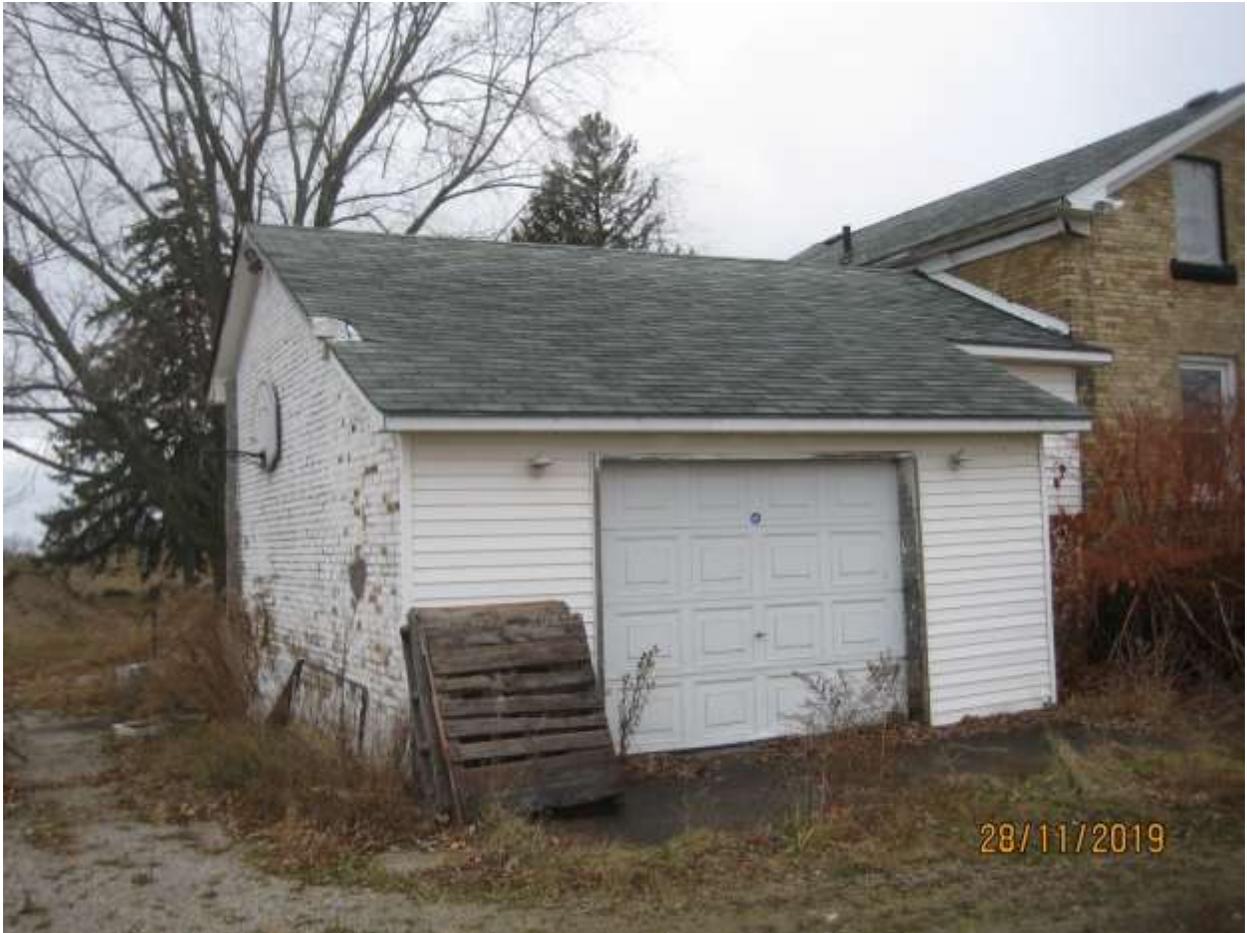
*Image 5: Rear addition to the house at 2325 Sunningdale Road East. Note, a portion of the addition was likely used as an early summer kitchen, and a much large garage has also been added to the rear of the dwelling.*

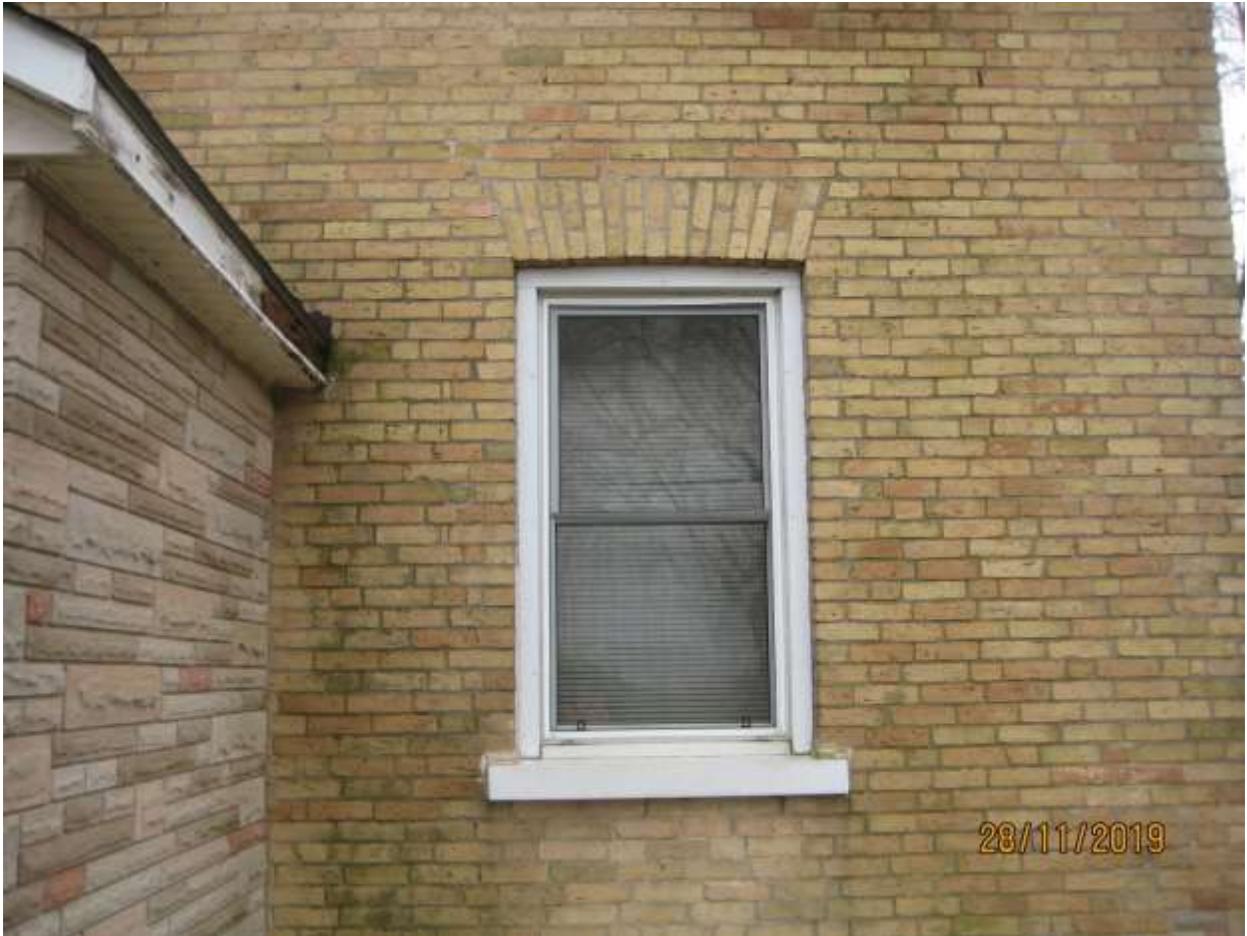
*Image 7: Detail showing window on the main (north) facade. Note, several windows on the dwelling have been replaced with vinyl replacement windows.*

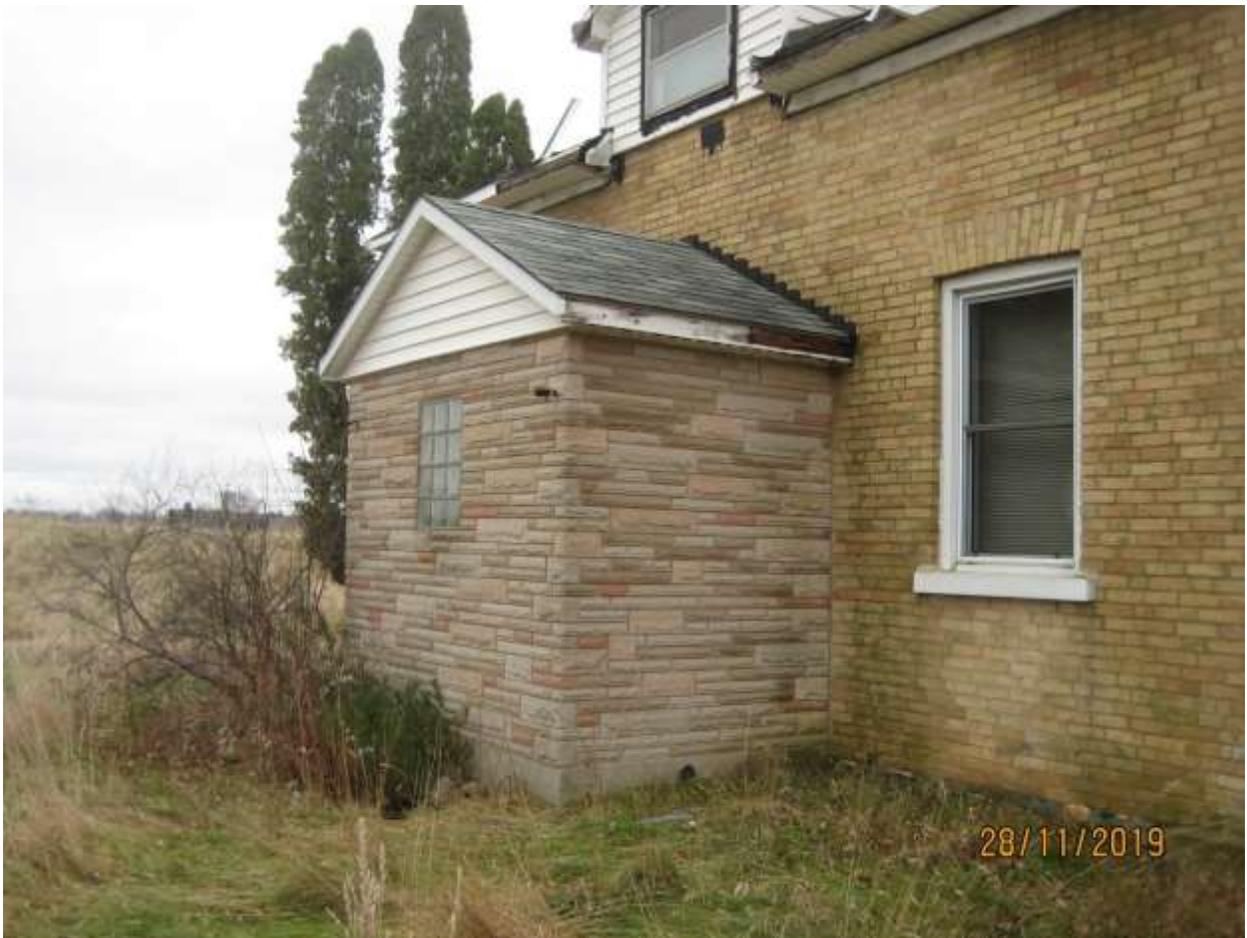
*Image 8: View showing front addition on the house. The date of the addition is unclear, however, the exterior is clad with angelstone and vinyl siding.*

The building located at 2325 Sunningdale Road East is a single storey, buff brick residential structure with a gable roof that is estimated to have been built c.1863 (Appendix B. The main façade of the building faces north to Sunningdale Road East, with its main entry located within an enclosed vestibule addition that is centrally located on the façade. The vestibule addition appears to be of frame construction on a concrete foundation, and is clad with an angelstone exterior finish. The vestibule also includes a gable roof, with its gable end facing Sunningdale Road East and is clad in vinyl siding.

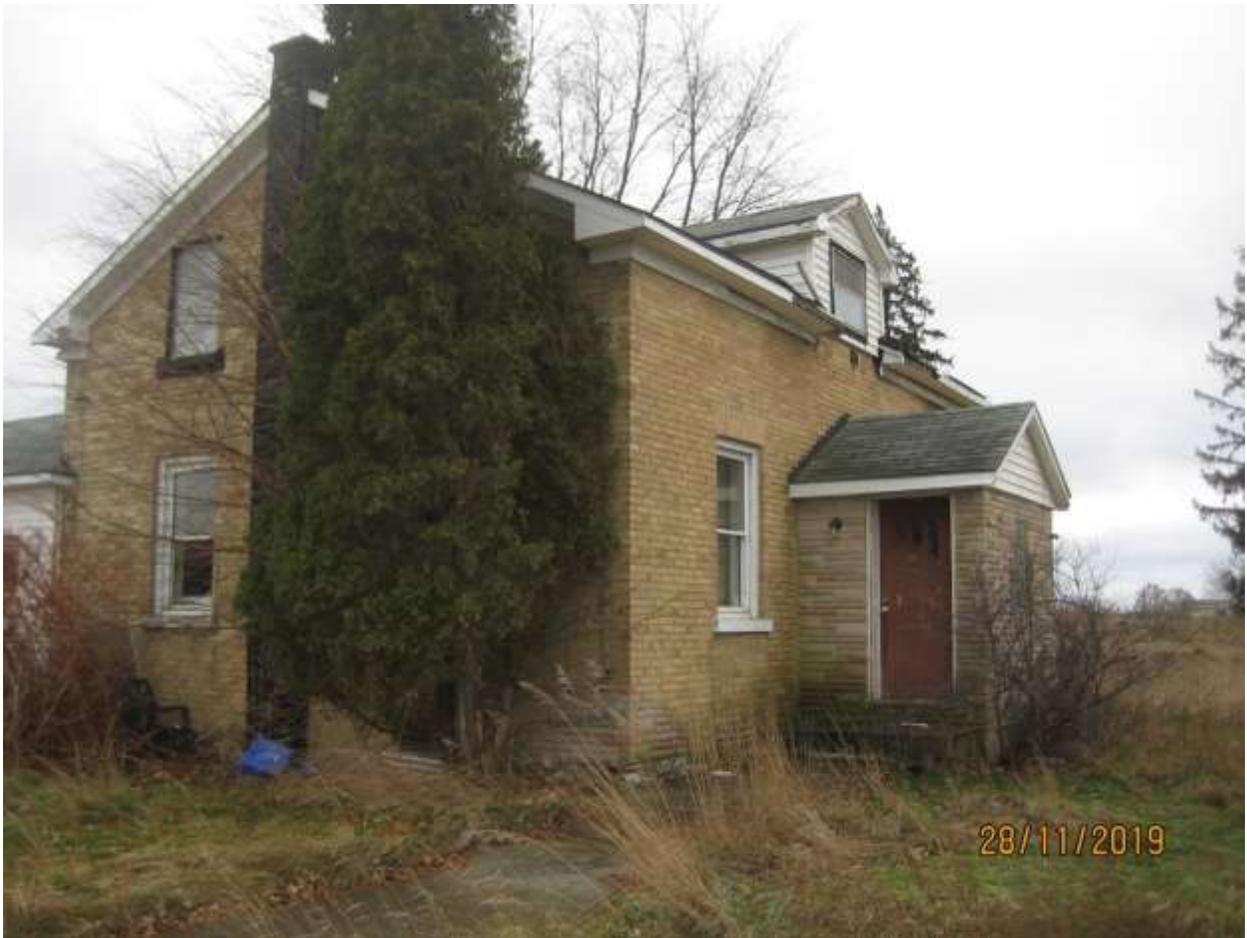
*Image 9: View showing front northwest corner of the dwelling and access provided in front addition.*

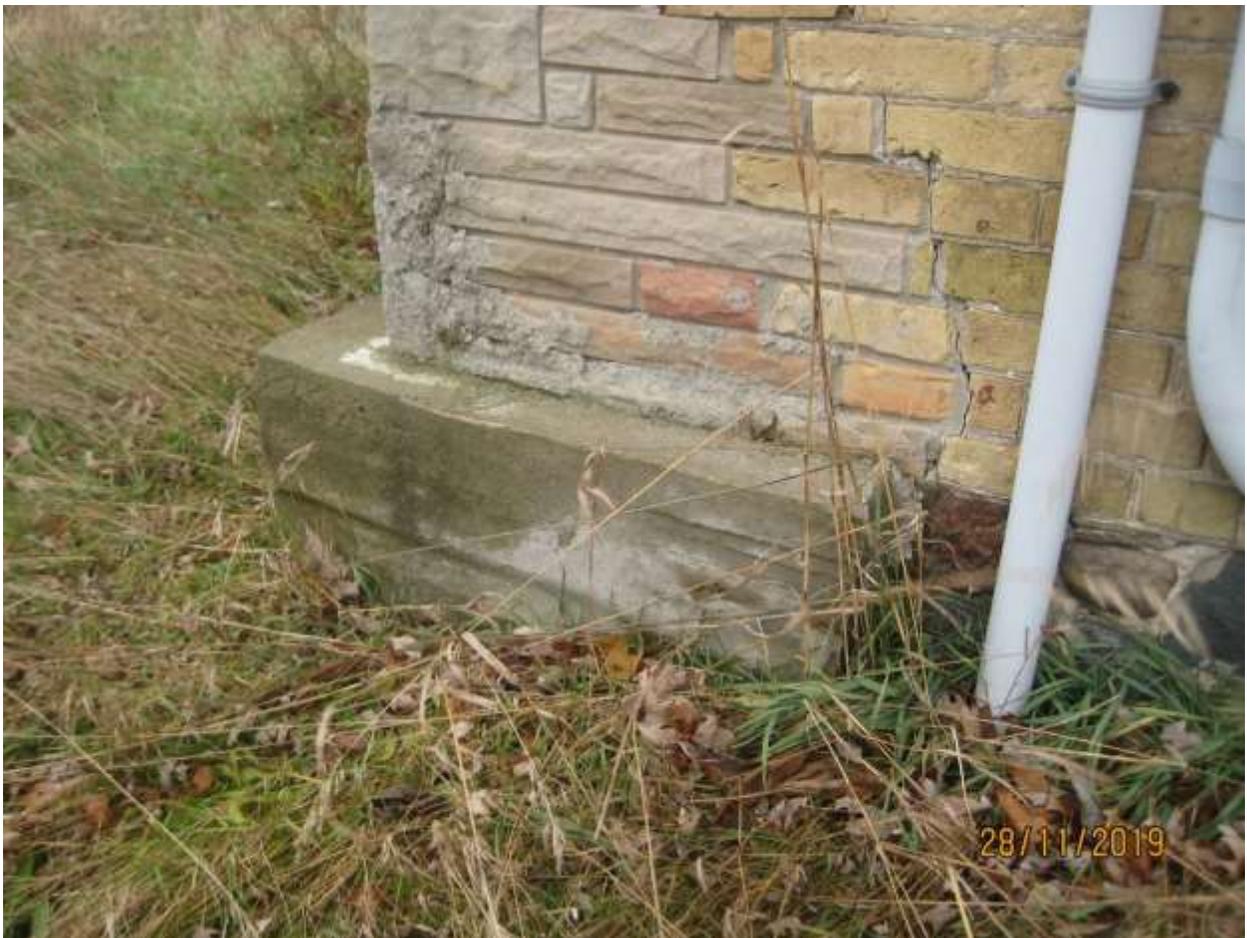
*Image 10: Detail showing southeast corner of the dwelling. The north corners of the dwelling have been altered with concrete and angelstone cladding.*

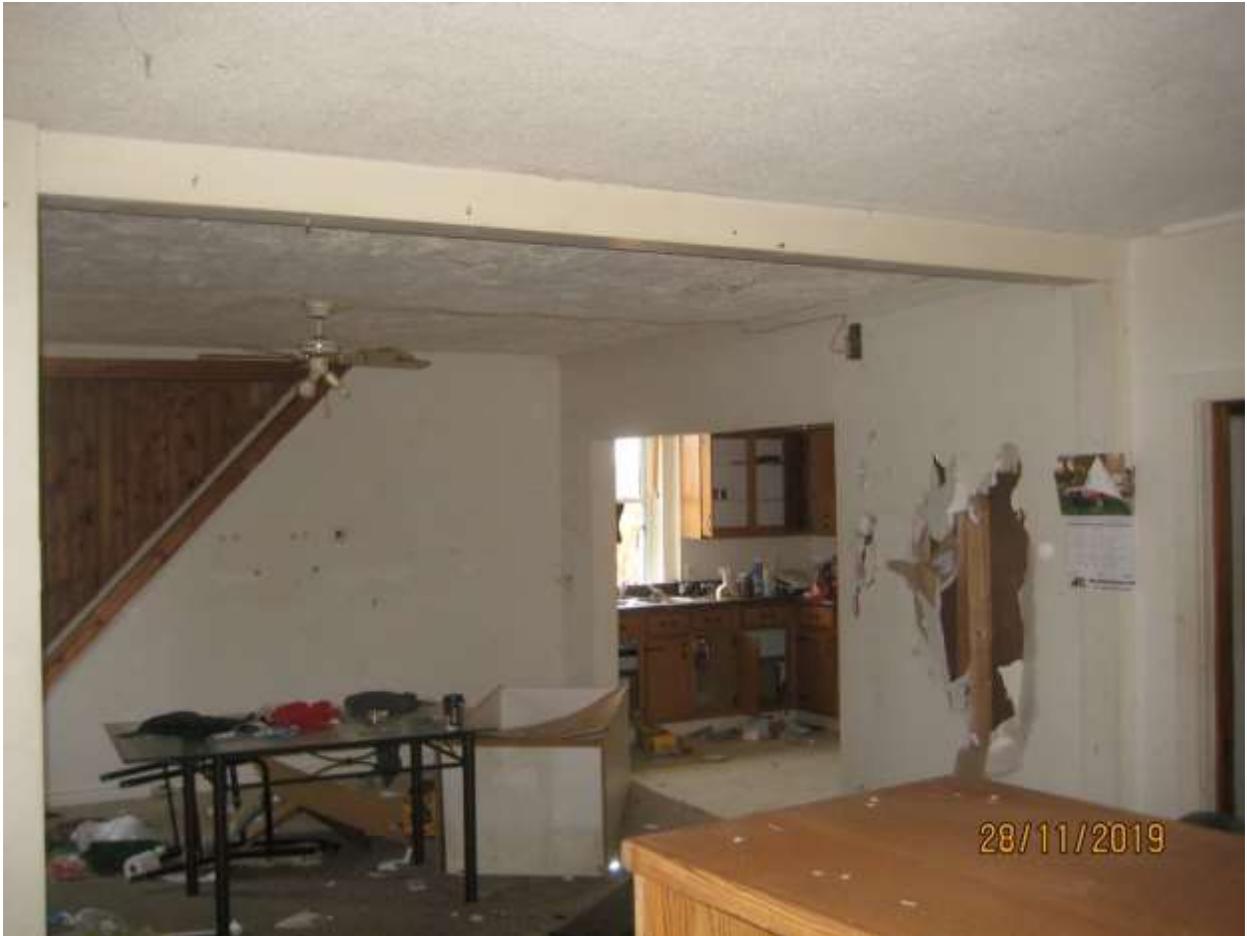
*Image 11: View of the interior of the first floor. The stairs are located at the left of the photograph. The historic floor plan has been extensively altered on the interior of the dwelling.*

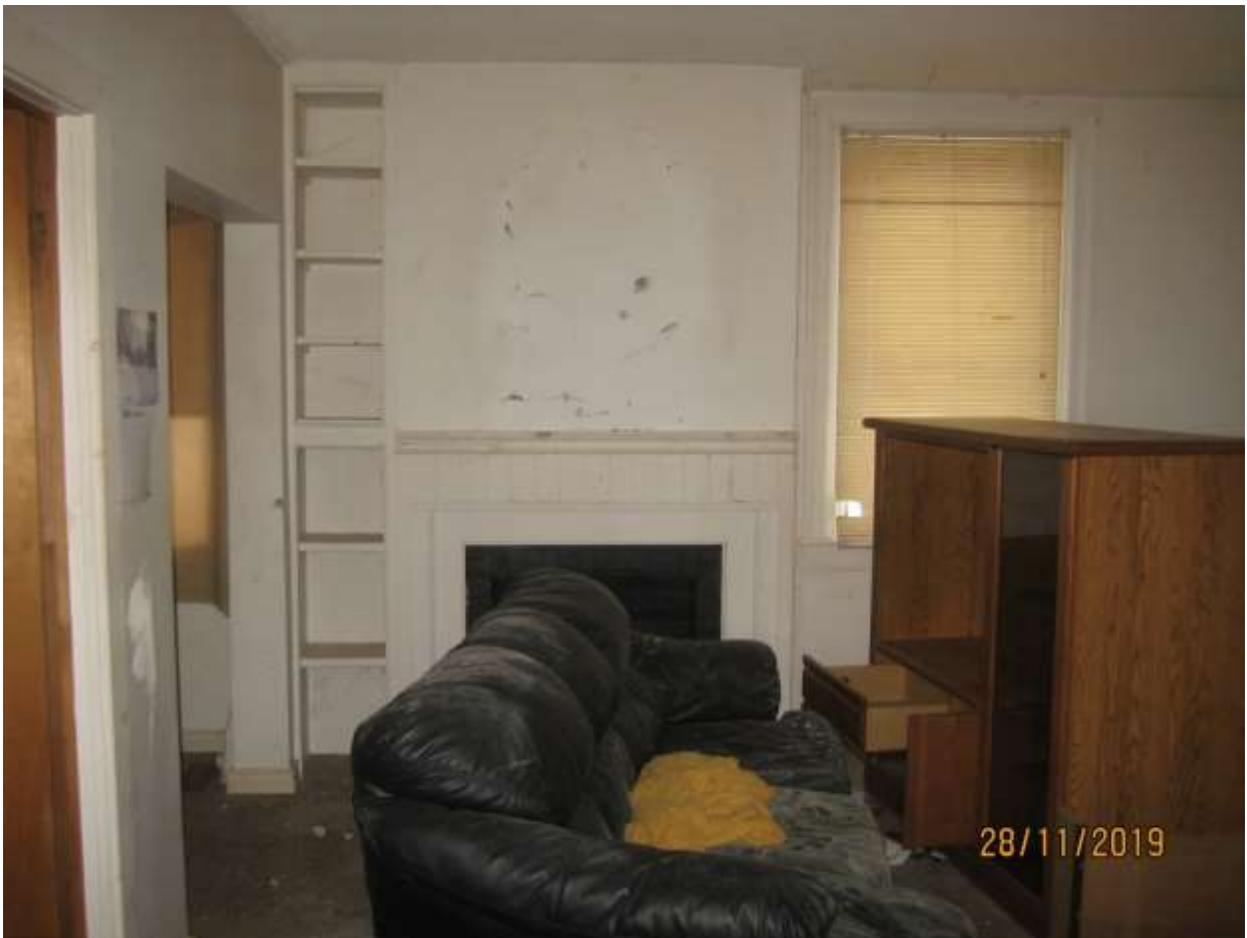
*Image 12: View showing interior of the west wall, showing the location of the fireplace. Note, a chimney is no longer present on the exterior west façade of the dwelling.*

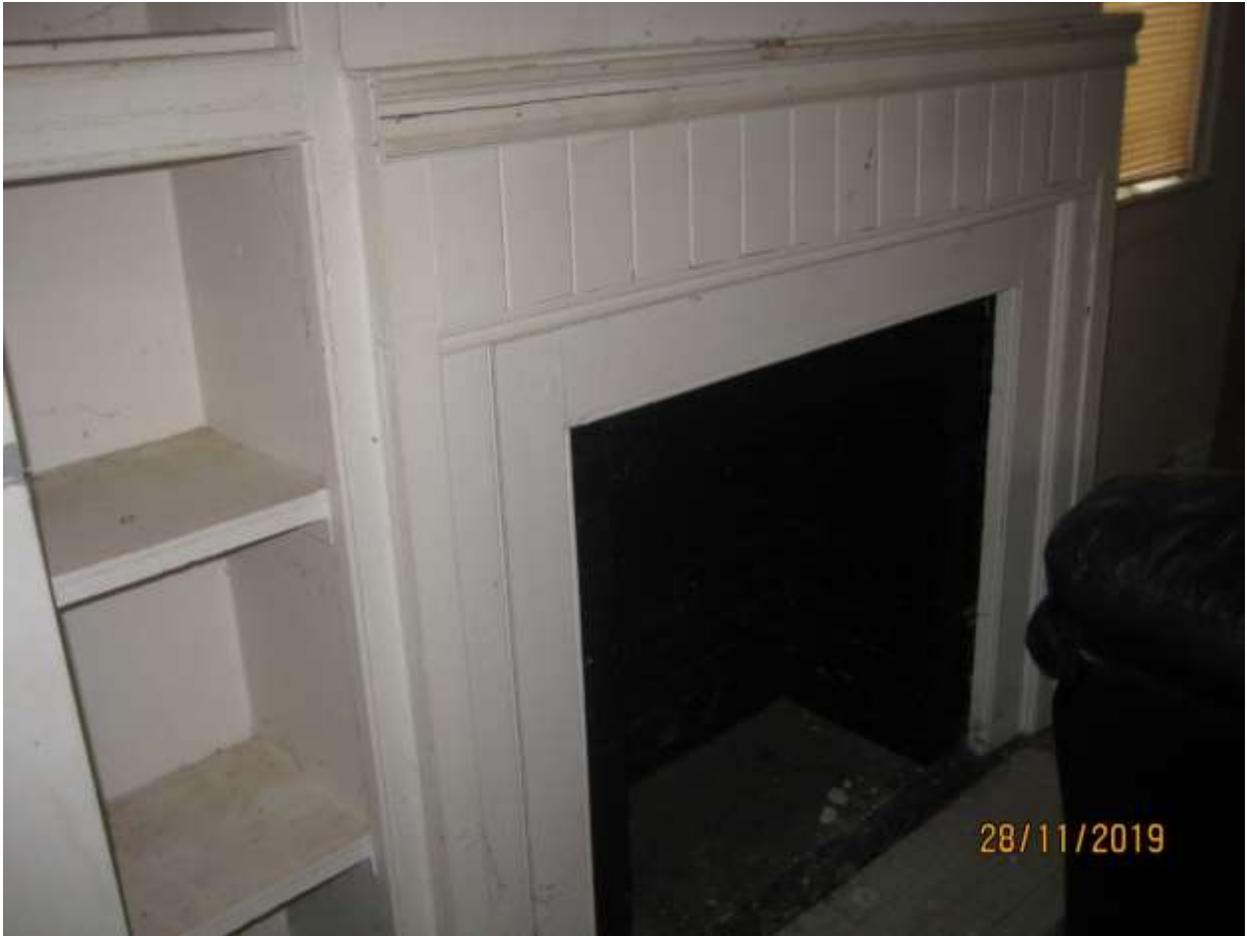
Image 13: Interior detail showing fireplace of the dwelling at 2325 Sunningdale Road East.

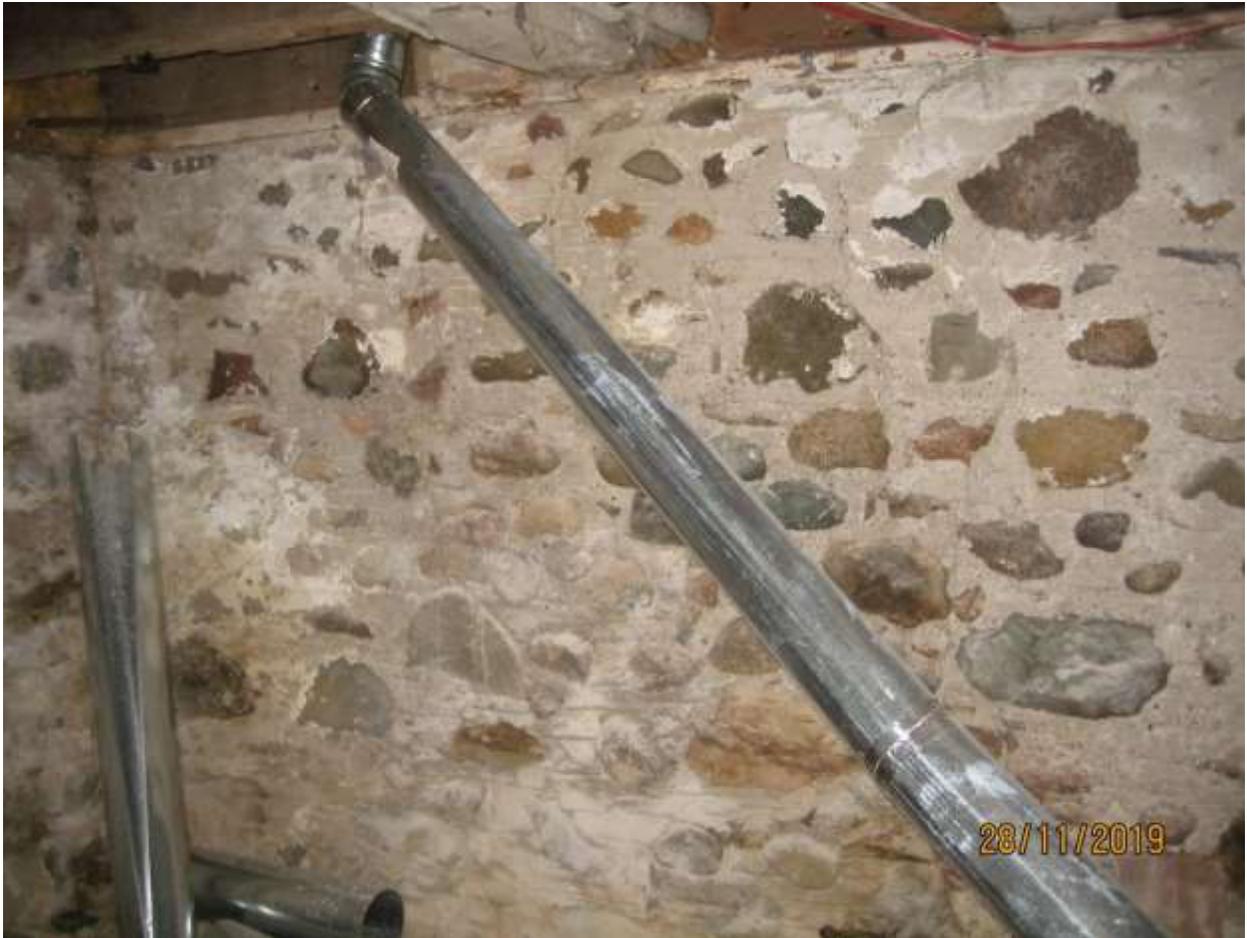
Image 14: Interior detail, showing the field stone foundation walls of the dwelling at 2325 Sunningdale Road East.
