Heritage Impact Assessment **88 Blackfriars Street**

Project Number: TD19-548

Prepared for:
Distinctive Homes London Inc.

Re: 88 Blackfriars Street - Heritage Impact Assessment

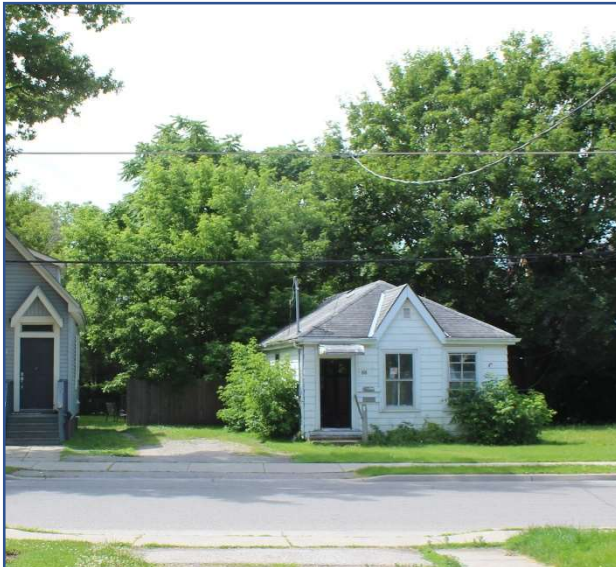
2. No. 88 Blackfriars Street, the subject property. This is identified as a contributing heritage resource to the Blackfriars-Petersville Heritage Conservation District.

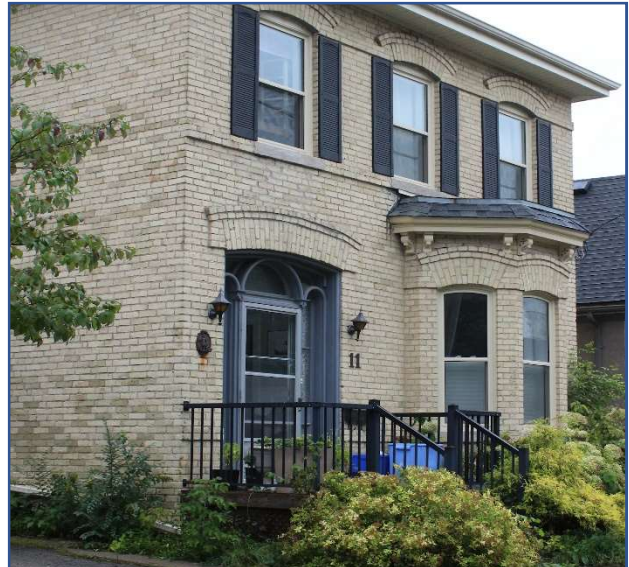
1. No. 11 Leslie Street, c 1887, built by bricklayer Samuel Moore, is another example of a contributing heritage resource in the Blackfriars-Petersville Heritage Conservation

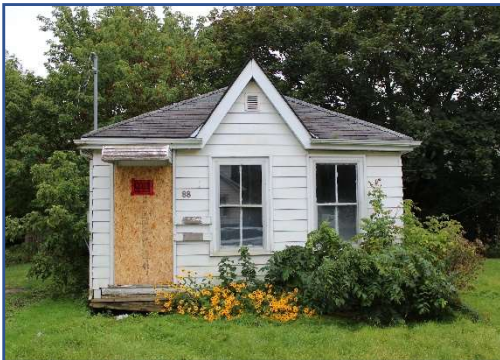
3. (top right) North elevation.

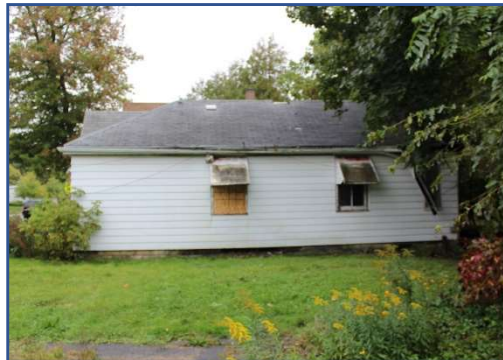
4. (top right) West elevation.

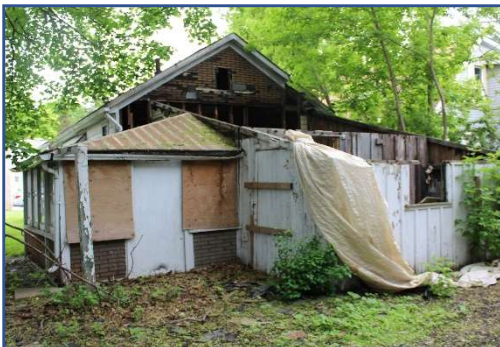
5. (bottom left) South elevation with collapsed rear roof.

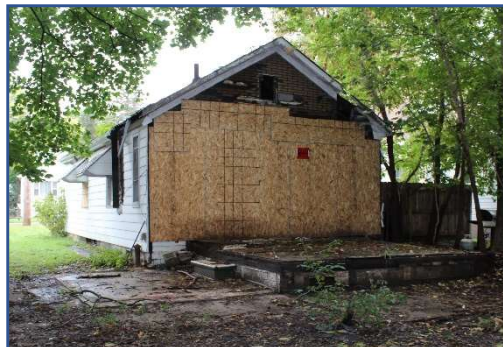
6. (bottom right) South elevation with collapsed portion removed and plywood sheeting.

Since purchasing the building, the owner has secured the envelope. This included the removal of approximately 300 square feet at the rear of the house where the roof had totally collapsed leaving the rear width of the structure open to the weather and to unauthorized entry. At the last date of on-site review by TD-BAS, the envelope has been secured against unauthorized entry with plywood sheeting. Hydro power and natural gas have been disconnected.

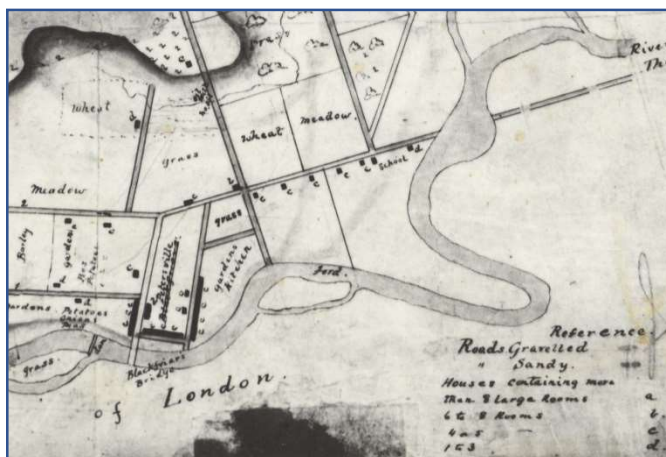
9. Detail of Sketch Map dated 1867 attributed to R.M. Armstrong listing croplands and species of trees in surrounding woodlands. Four categories of house are listed in the legend in the bottom right corner according to the number of rooms from one to more than eight.

The area of the lot at 88 Blackfriars Street (white arrow) does not show evidence of any buildings.

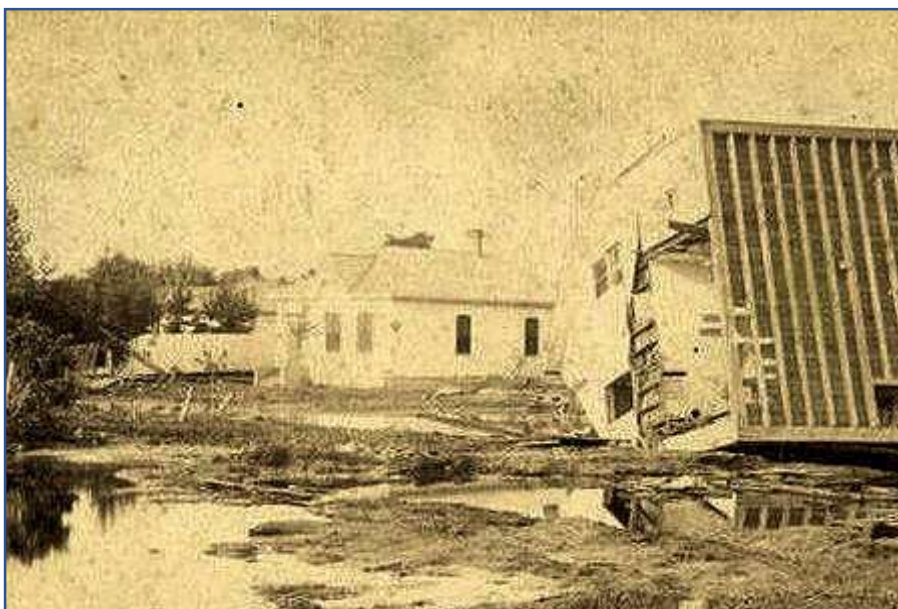
16. This photograph shows the catastrophic damage to homes and property after the flood of 1883. This photograph was taken in the Petersville area. The cottage in the background bears a striking resemblance to 88 Blackfriars Street.

The property at 88 Blackfriars Street has weathered many devastating floods from the Thames River, including the deadly floods of 1883 and 1937. The photograph below, taken along Blackfriars Street, shows how entire wood frame houses and structures could be floated off their foundations by flood waters, then deposited by chance, and sometimes overturned. Early wood frame building technics employed a timber sill plate (mud sill) placed on top of the foundation. The large timber sill provided a solid connection with the wood framed walls above but, it did not lend itself to anchoring against uplift. This construction is well illustrated by the intact condition of the exposed floor framing of the overturned building below. The house at 88 Blackfriars has identical construction.

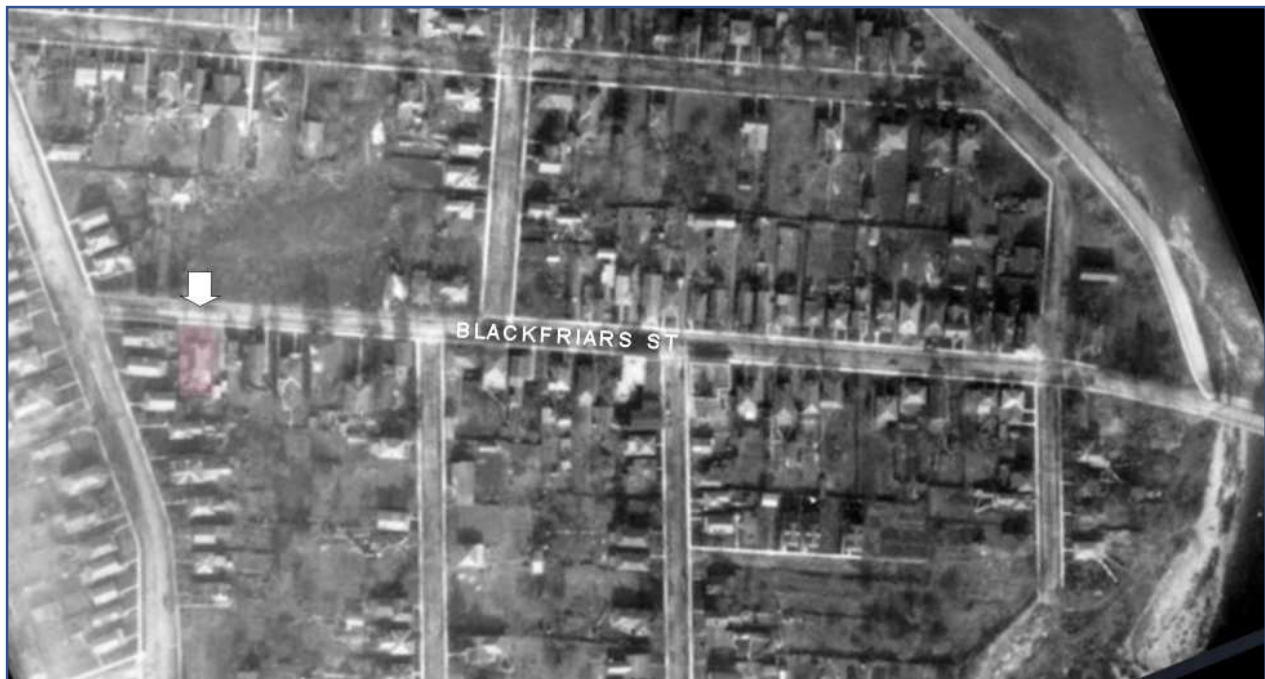
17. Aerial photograph of Blackfriars Street from 1922. Credit: Western Libraries, University of Western Ontario,

The 1922 aerial photograph above illustrates that, after a period of rebuilding following the flood of 1883, the pattern of building placement is remarkably consistent. Even the undeveloped space at the site of the former Empress United Church is apparent in the character of the west end of Blackfriars Street today.

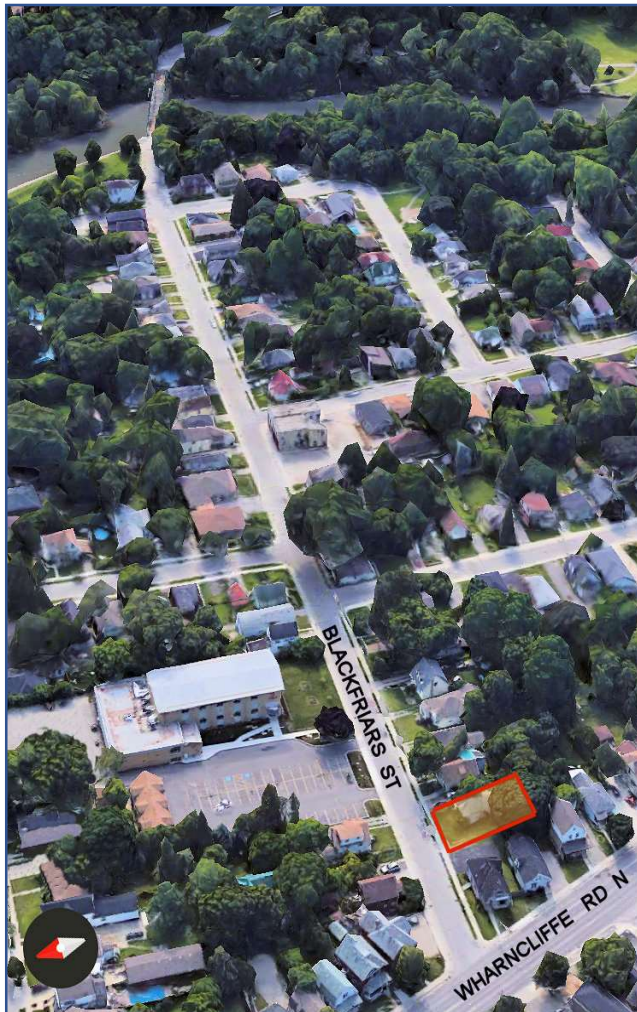
Between Argyle and Wharncliffe there is an absence of a well-defined building street edge across from 88 Blackfriars (shaded in pink). This is due in whole to the parking lot that now serves a converted office building, formerly the Empress United Church.

- 18. Below: Aerial image of Blackfriars Street. credit: Google Earth
- 19. Right: GIS Map with annotations credit: City of London

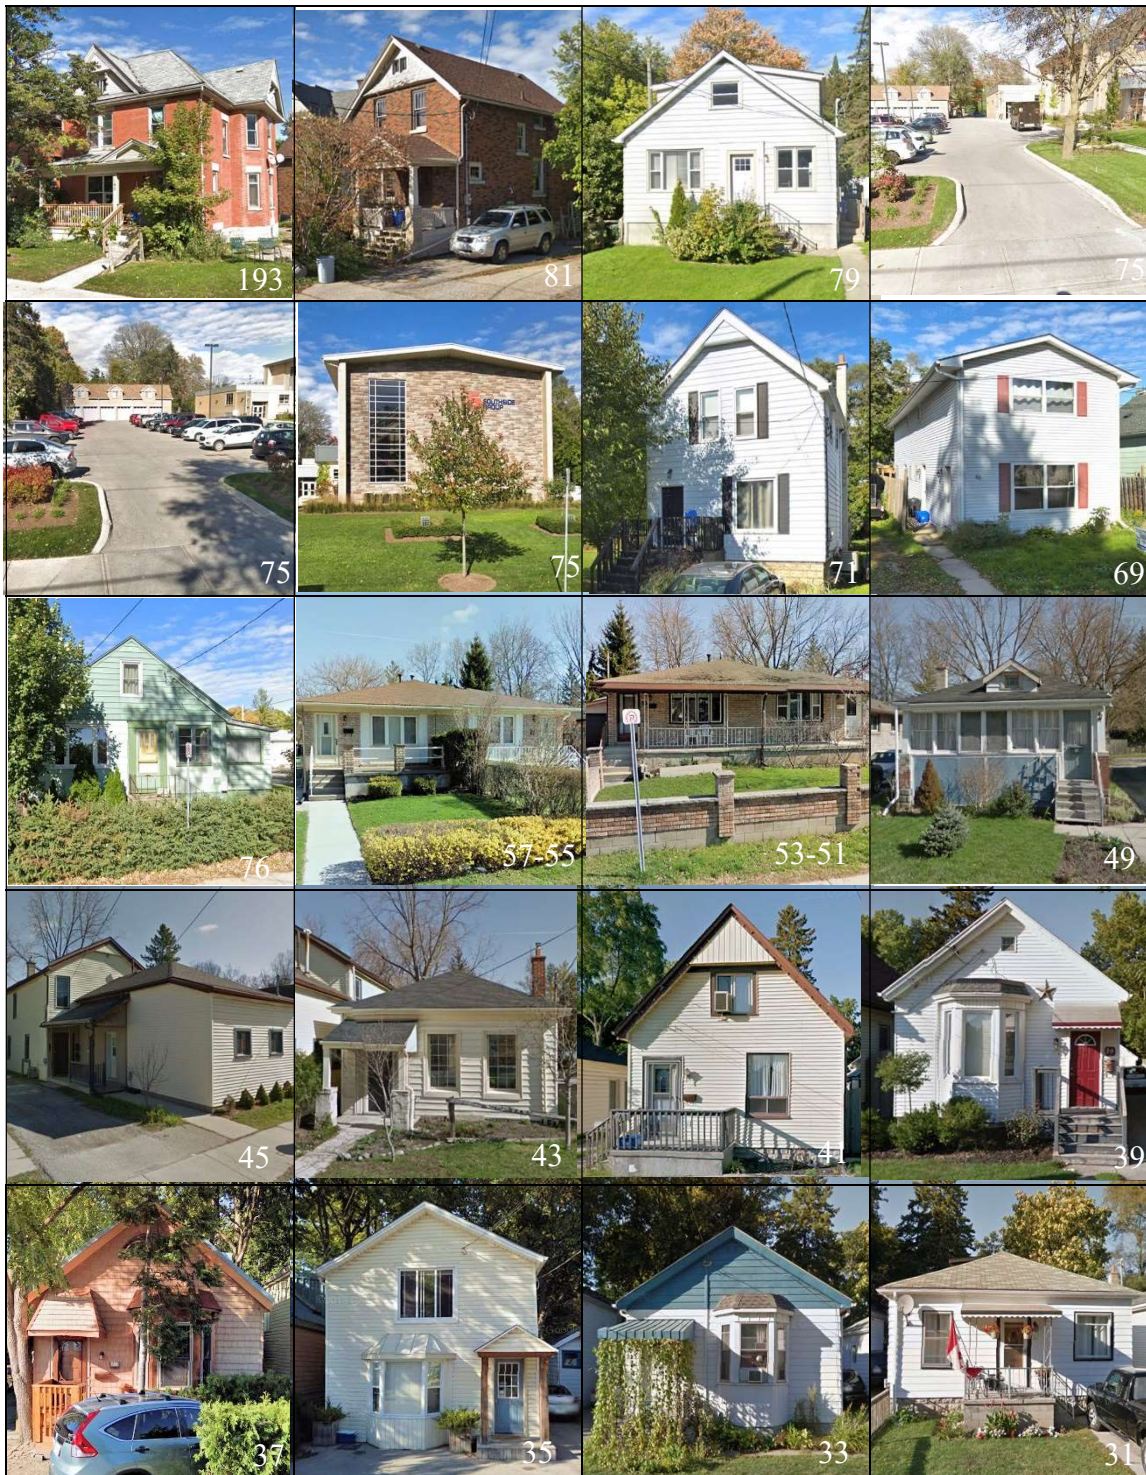
Blackfriars Street Building Inventory Photographs - North Side

Upper left photograph starts at the corner of Wharncliffe and moves eastward to the Thames River.

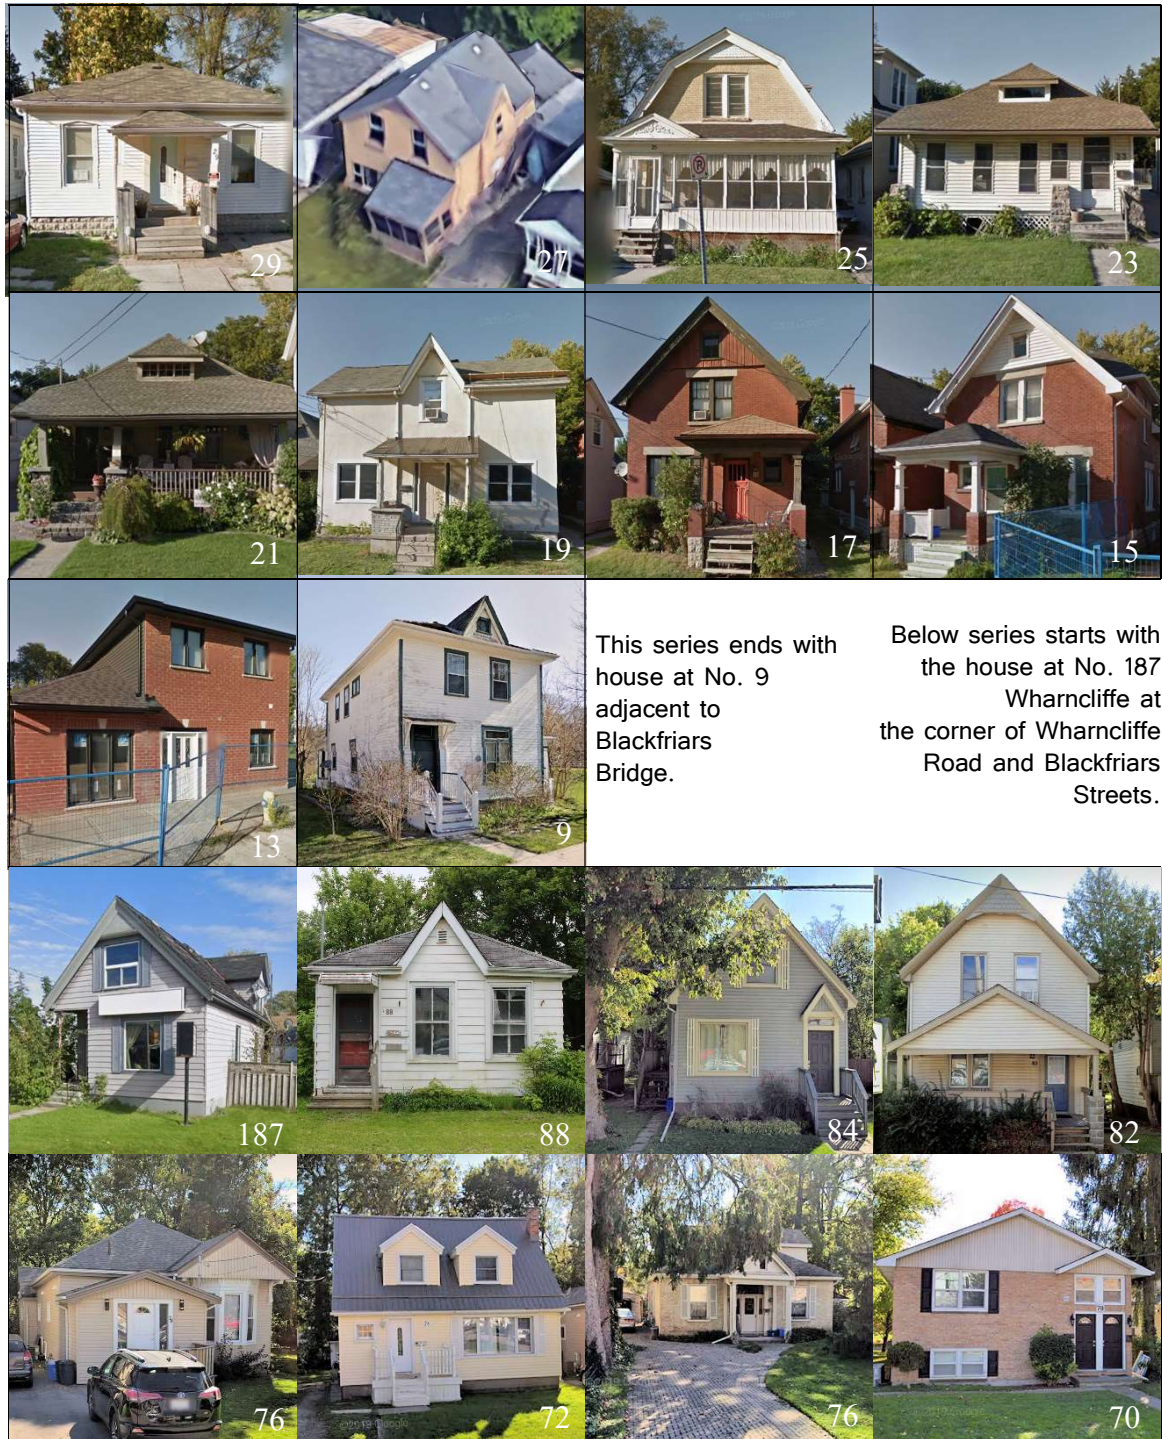
Blackfriars Street Building Inventory Photographs - North & South Side

The upper left photograph starts at 29 Blackfriars St and moves eastward to the Thames River.

This series ends with house at No. 9 adjacent to Blackfriars Bridge.

Below series starts with the house at No. 187 Wharncliffe at the corner of Wharncliffe Road and Blackfriars Streets.

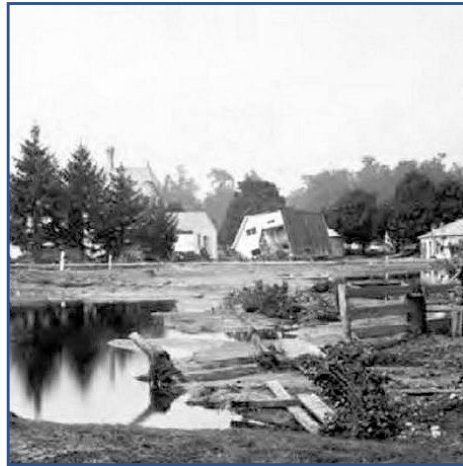
20. Photograph after the 1883 flood looking westward from Argyle Street towards Blackfriars Street. Credit: Western Archives, University of Western Ontario.

It is interesting to note that seven of the buildings from the 1870s are located on the south side of Blackfriars Street. The disastrous and deadly flooding of the Thames River in 1883 caused catastrophic damaged and the flood is likely responsible for the loss of the entire building stock on the north side of Blackfriars Street between Napier and Argyle Streets. This is possibly due to the north side of the street being exposed to up stream pressure. Construction of all of the existing buildings along this block date from after the flood of 1883.

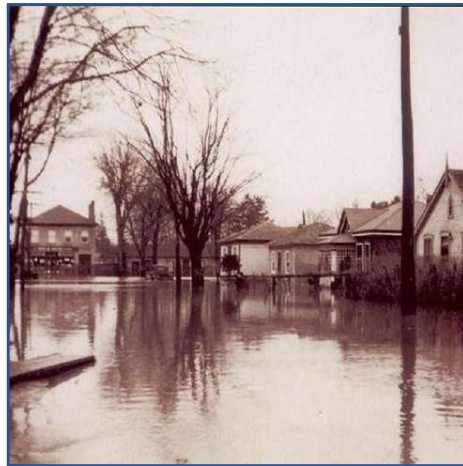
21 Photograph looking south along Argyle Street during the flood of 1937. Credit: University of Western Ontario.

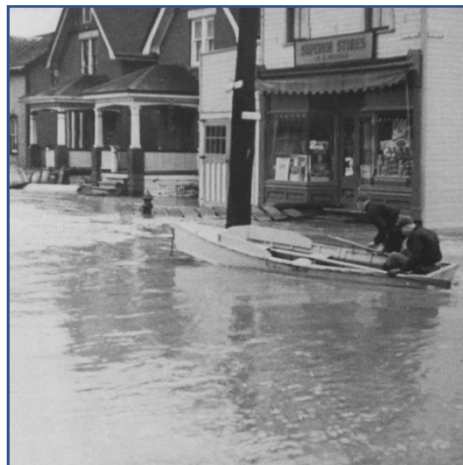
22 Photograph at the corner of Blackfriars and Napier Street during the flood of 1937. Credit: University of Western Ontario.

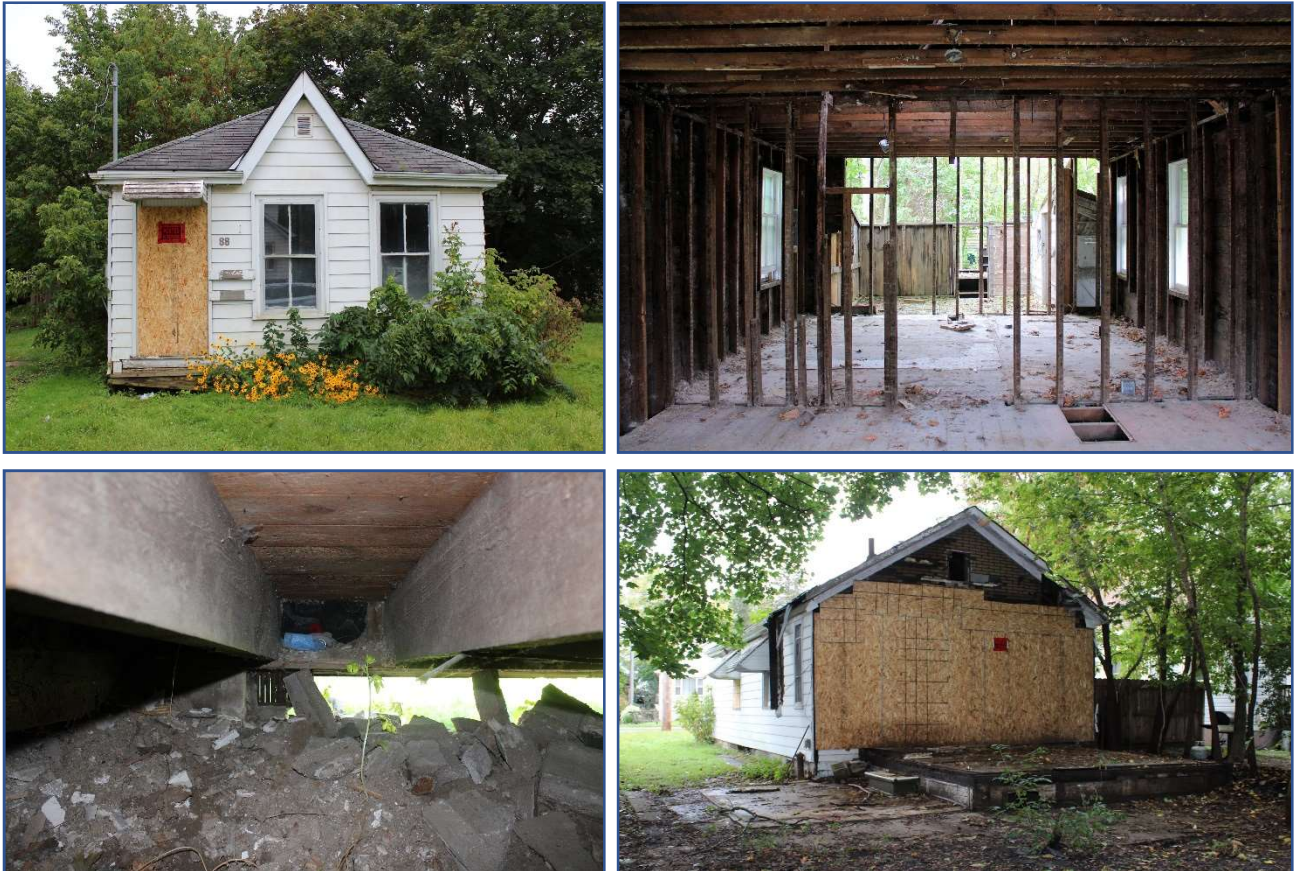
Clockwise from top Left 24. North elevation of 88 Blackfriars Street. 25. Interior view of the gutted interior of 88 Blackfriars, with the partially demolished rear exterior walls and roof. 26. View of the south elevation with temporary plywood sheathing as per City of London unsafe building order. 27. View of crawl space and mud sill floor framing and opening from collapsed foundation.

The condition of the building is in an advanced state of neglect. An engineer's report dated 2016 indicated that the building has not been inhabited for approximately 15 years. The engineer's report states that, at the time of inspection, the floor framing was structurally unsound. The leaking roof had not been repaired for an extensive amount of time. Ongoing rot threatens the roof structure with imminent collapse. In the absence of heat, the foundation has deteriorated to the point that it can no longer be considered structurally sound to support the house.

The long-term neglect has resulted in a structure that is virtually beyond repair or salvage. It is not reasonable to estimate the repair costs since the structure has been condemned as structurally unsound. Therefore, no cost estimate will be provided in the HIA. The bulk of the material remaining of the house is limited to wood framing, several windows, and a rotting roof. From the perspective of a cost feasibility analysis, the repairs are impractical and are not advised.

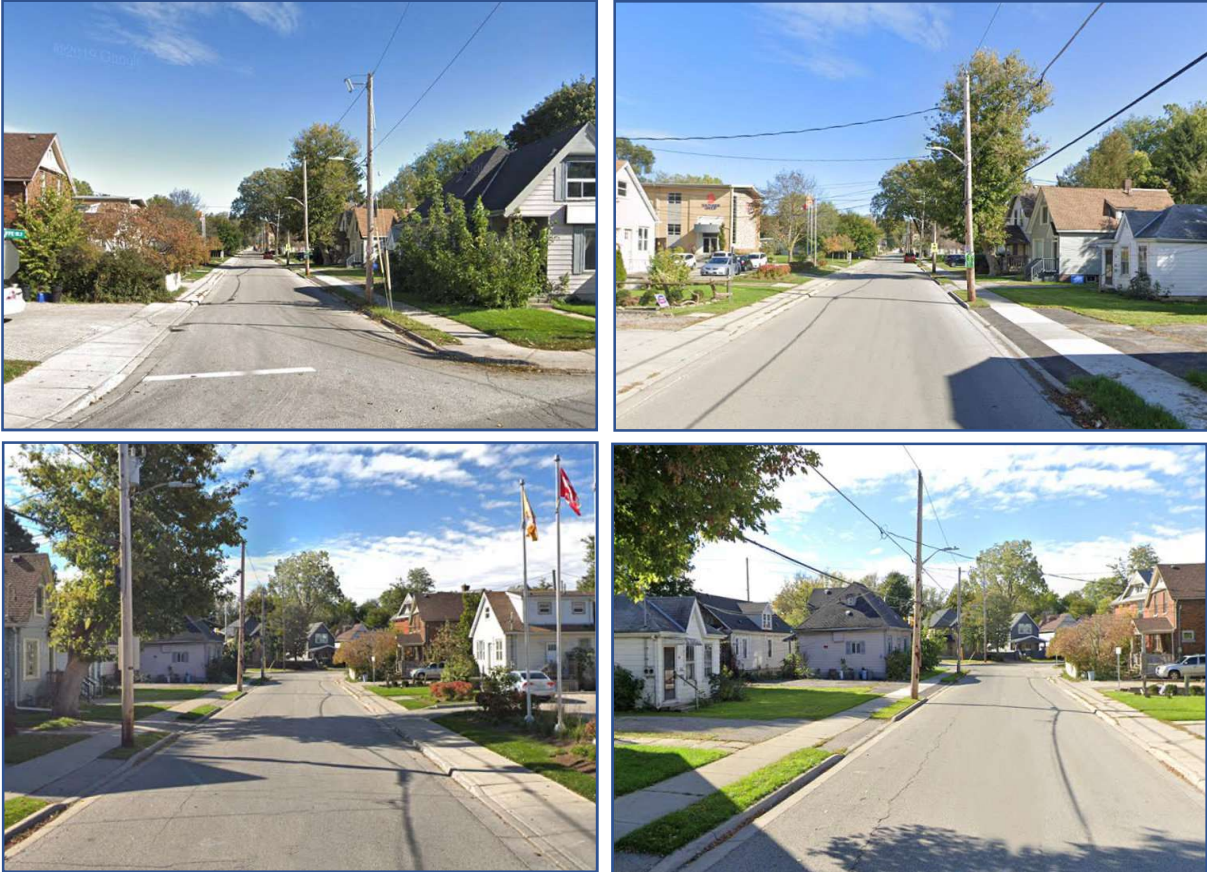
4.2 Blackfriars Street Viewsheds

Viewshed photographs, clockwise from upper left - 28. View from intersection of Wharncliffe and Blackfriars Streets looking east. 29. View at the beginning of Blackfriars Street looking east. 30. View along Blackfriars Street looking west. 31. View along Blackfriars Street in front of the subject property, looking west.

The top two photographs show views facing eastward along Blackfriars Street. The house at 88 Blackfriars is not immediately viewed from Wharncliffe Road when approaching from the west. The close proximity of the corner house to the Blackfriars Street obscures the view of 88 Blackfriars. The west end of Blackfriars Street has a discontinuous building frontage edge which conveys a less discernable street character. Blackfriars Bridge is on the horizon two blocks away. The bridge is at an oblique angle to Blackfriars Street making it difficult to see.

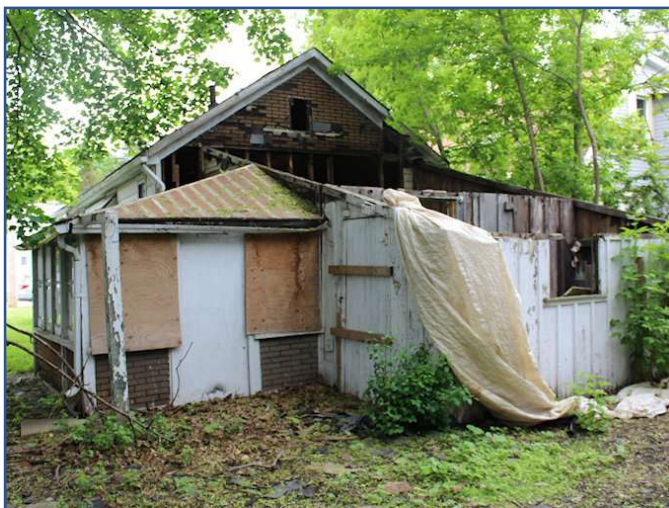
32. The above photograph shows the rear portions of the house in June 2019. These were removed as directed due to concern for public safety.

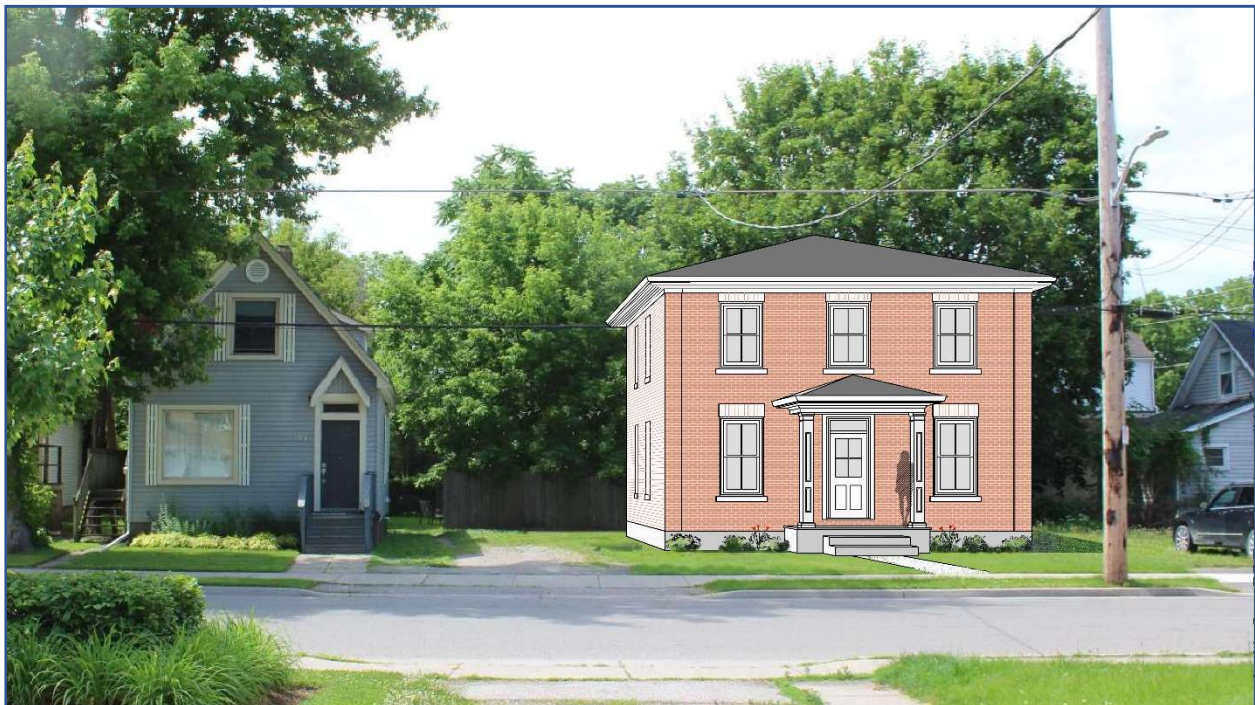
34. Above: Photographic streetscape study montage with a rendering of proposed building at 88 Blackfriars Street.

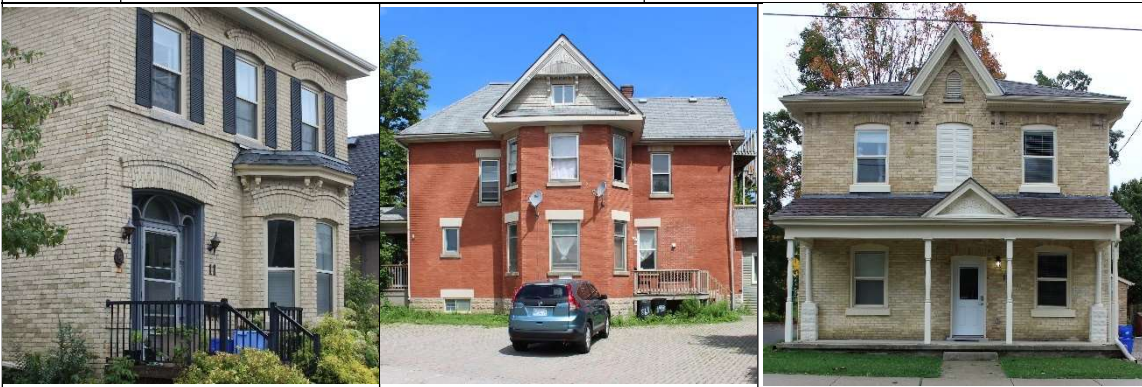
10.2.3	Architectural Style	<p>Loss of the contributing resource has a negative impact.</p> <p>Mitigation: The architectural style is based on a classic, symmetrical 3 bay Italianate residential form with refences within the district.</p>

<p>11 Leslie Street, BPHCD 193 Wharncliffe & Blackfriars, BPHCD 13 Napier Street, BPHCD</p>
