# HERITAGE IMPACT **ASSESSMENT** REPORT

2325 Sunningdale Road East,  
City of London, Ontario

**November 2019**

**MacNaughton Hermsen Britton Clarkson Planning Limited (MHBC)**

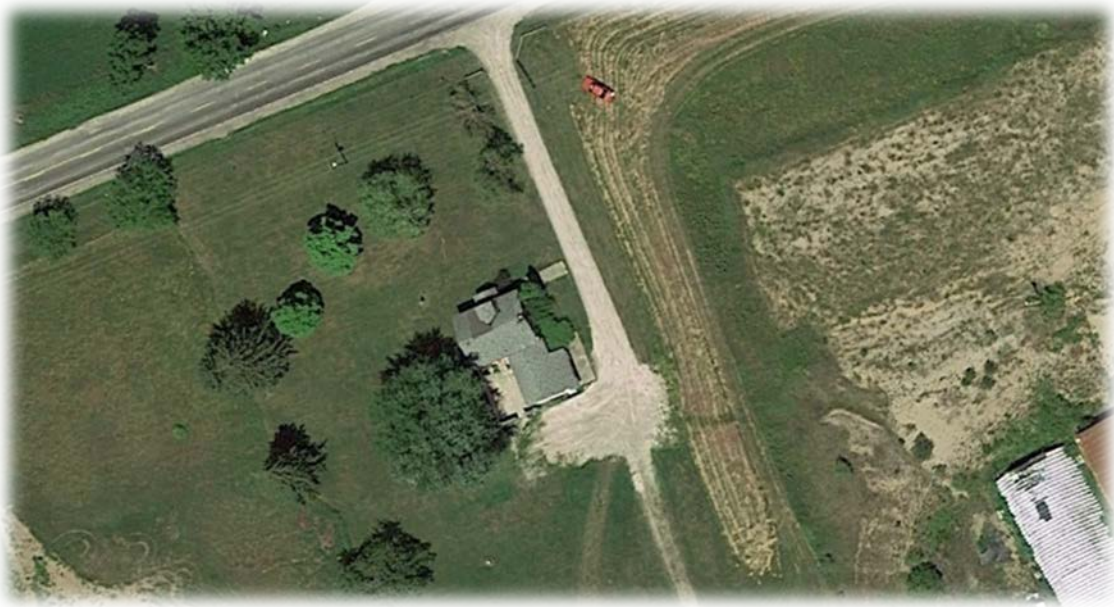
Figure 2: Aerial view of existing house on subject land (Google Earth Pro, 2018)

There is an existing one and half storey brick house with a rectangular floor plan and open, steeply sloped, gabled roof. The house has an addition to the rear which appears to have a salt-box style roof. There is also a wood frame outbuilding to the rear of the immediate property.

A yard area is located around the house on the north, west and south side of the building with active aggregate extraction to the east.

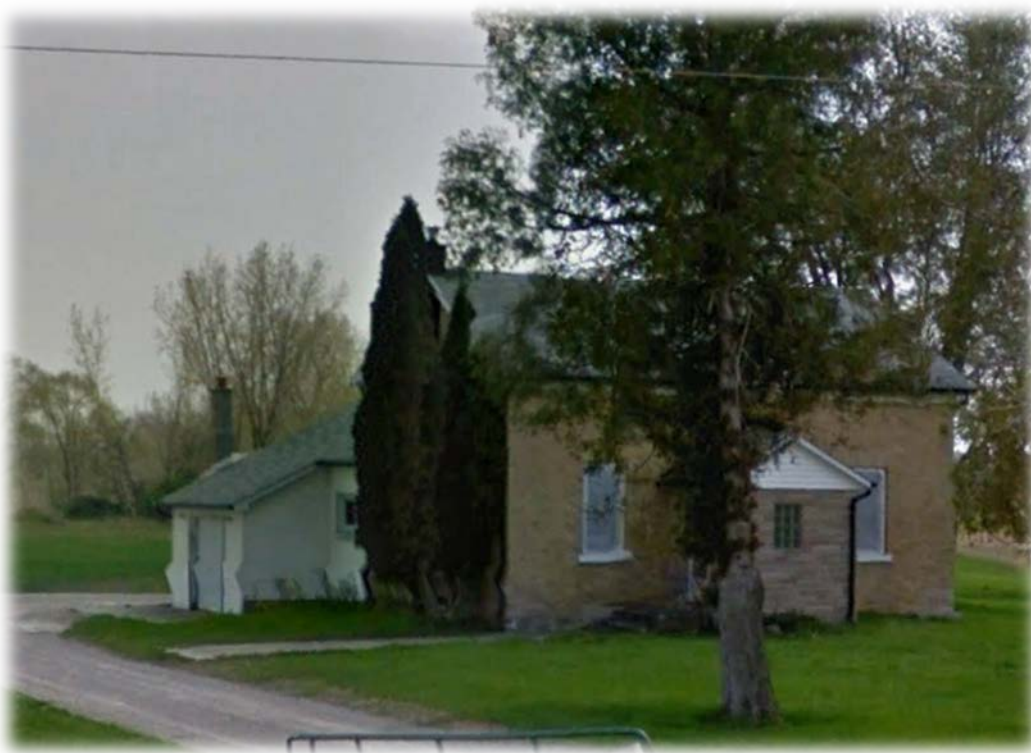
Figure 3: View of front façade of 2325 Sunningdale Road East, London (Google Earth Pro, 2019)

The front elevation of the building has a symmetrical composition. The original window openings remain, as well as the window voussoirs and stone lintels. The windows, however, have been replaced with vinyl, double hung windows. There is a front portico enclosure with stone with a concrete foundation sill and includes a cubed glass window opening centred in on the front façade of the enclosed portico. The pediment has been covered with vinyl siding.

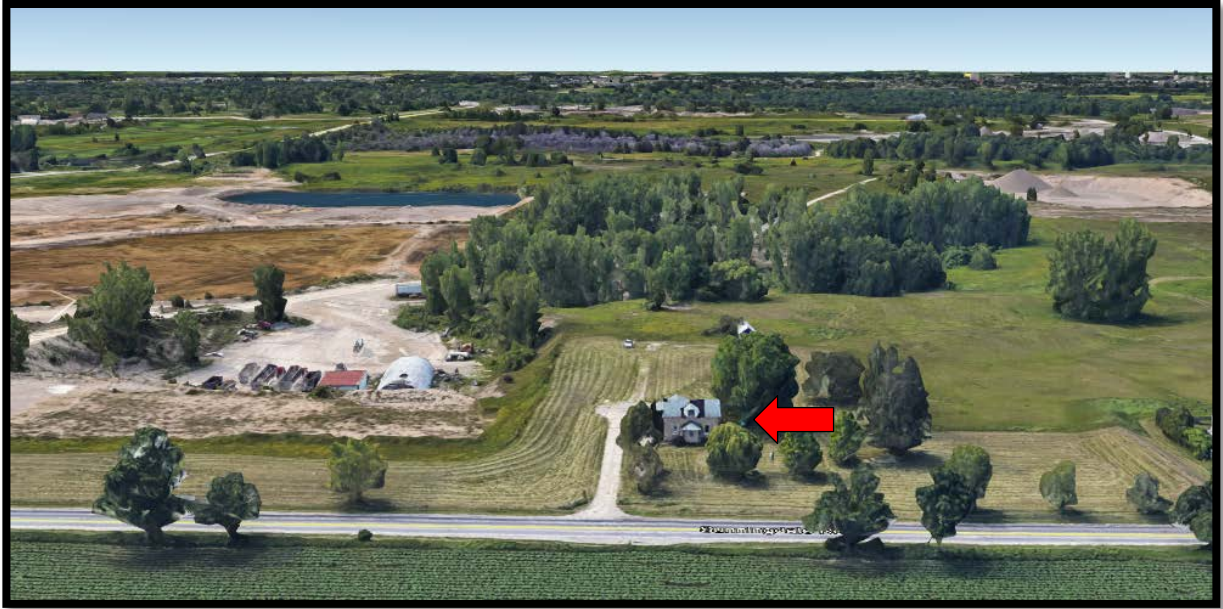
Figure 9: Aerial of subject land and surrounding area; Red arrow indicates building on subject land (Source: Google Earth Pro, 2019)

The property has since included aggregate extraction operations beginning in the latter half of the 20<sup>th</sup> century, and the majority of the land is used for the extraction of sand and gravel, known as the Lafarge Talbot Pit. **Figure 9**, provides an overall context as to the surrounding land use, in particular its transition from agricultural to rural industrial use.

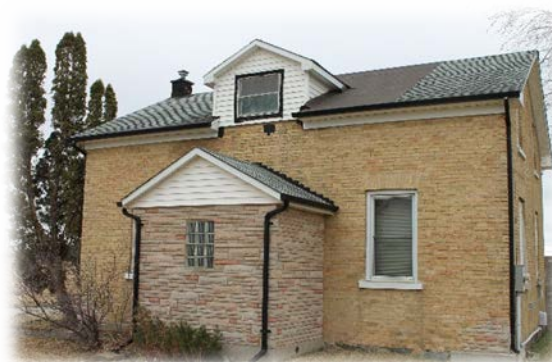
Figures 10 & 11: (Left) Example of other Georgian examples on the Register, street view of 357 Southdale Road East, London (Source: Google Earth Pro, 2019); Photograph of “Georgian” house on the subject lands (Source: MHBC, 2019)

The house is described as a Georgian farmhouse in the Register, however the alterations to the house, in particular the irreversible covering of a large portion of the main façade, has removed its ability to be an exceptional representative of this type of architecture. There are 102 properties on the Register of Cultural Heritage Resources listed as being of a Georgian architectural style; 51 of which are described as “Georgian”. There is one (1) designated Georgian building under Part IV of the OHA and two (2) designated under Part V of the OHA.

The property does not have physical/ design value as it is not rare, unique or clearly representative of a style, type, expression, or construction method. It does not display a high degree of technical or scientific achievement.

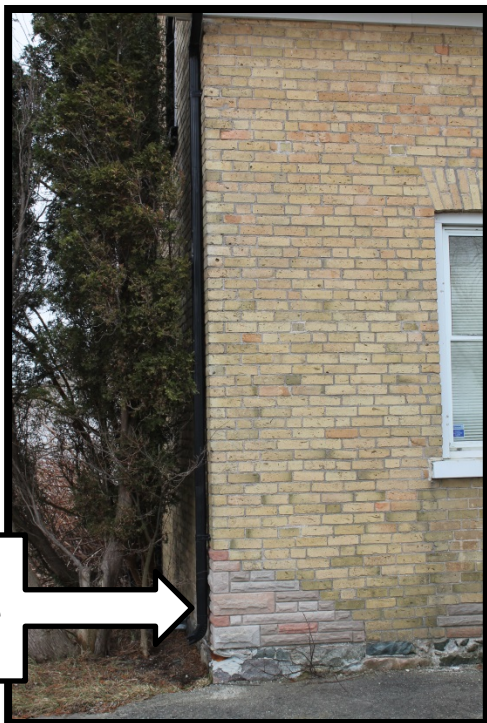
Later stone infill on western corner of the front facade

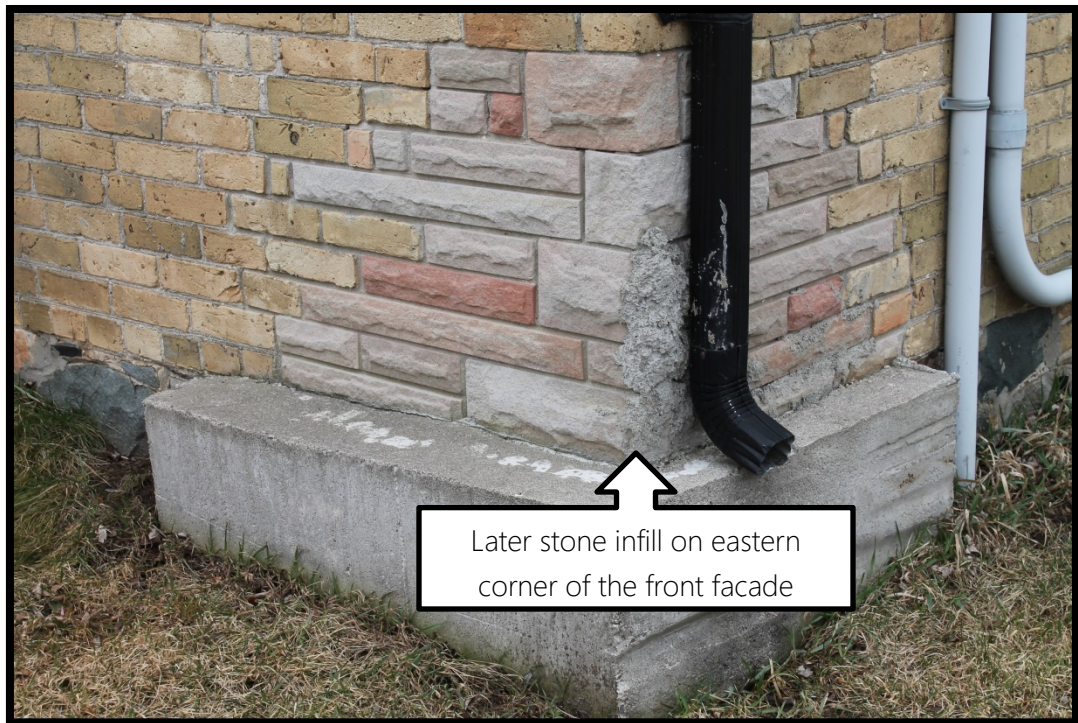
Later stone infill on eastern corner of the front facade

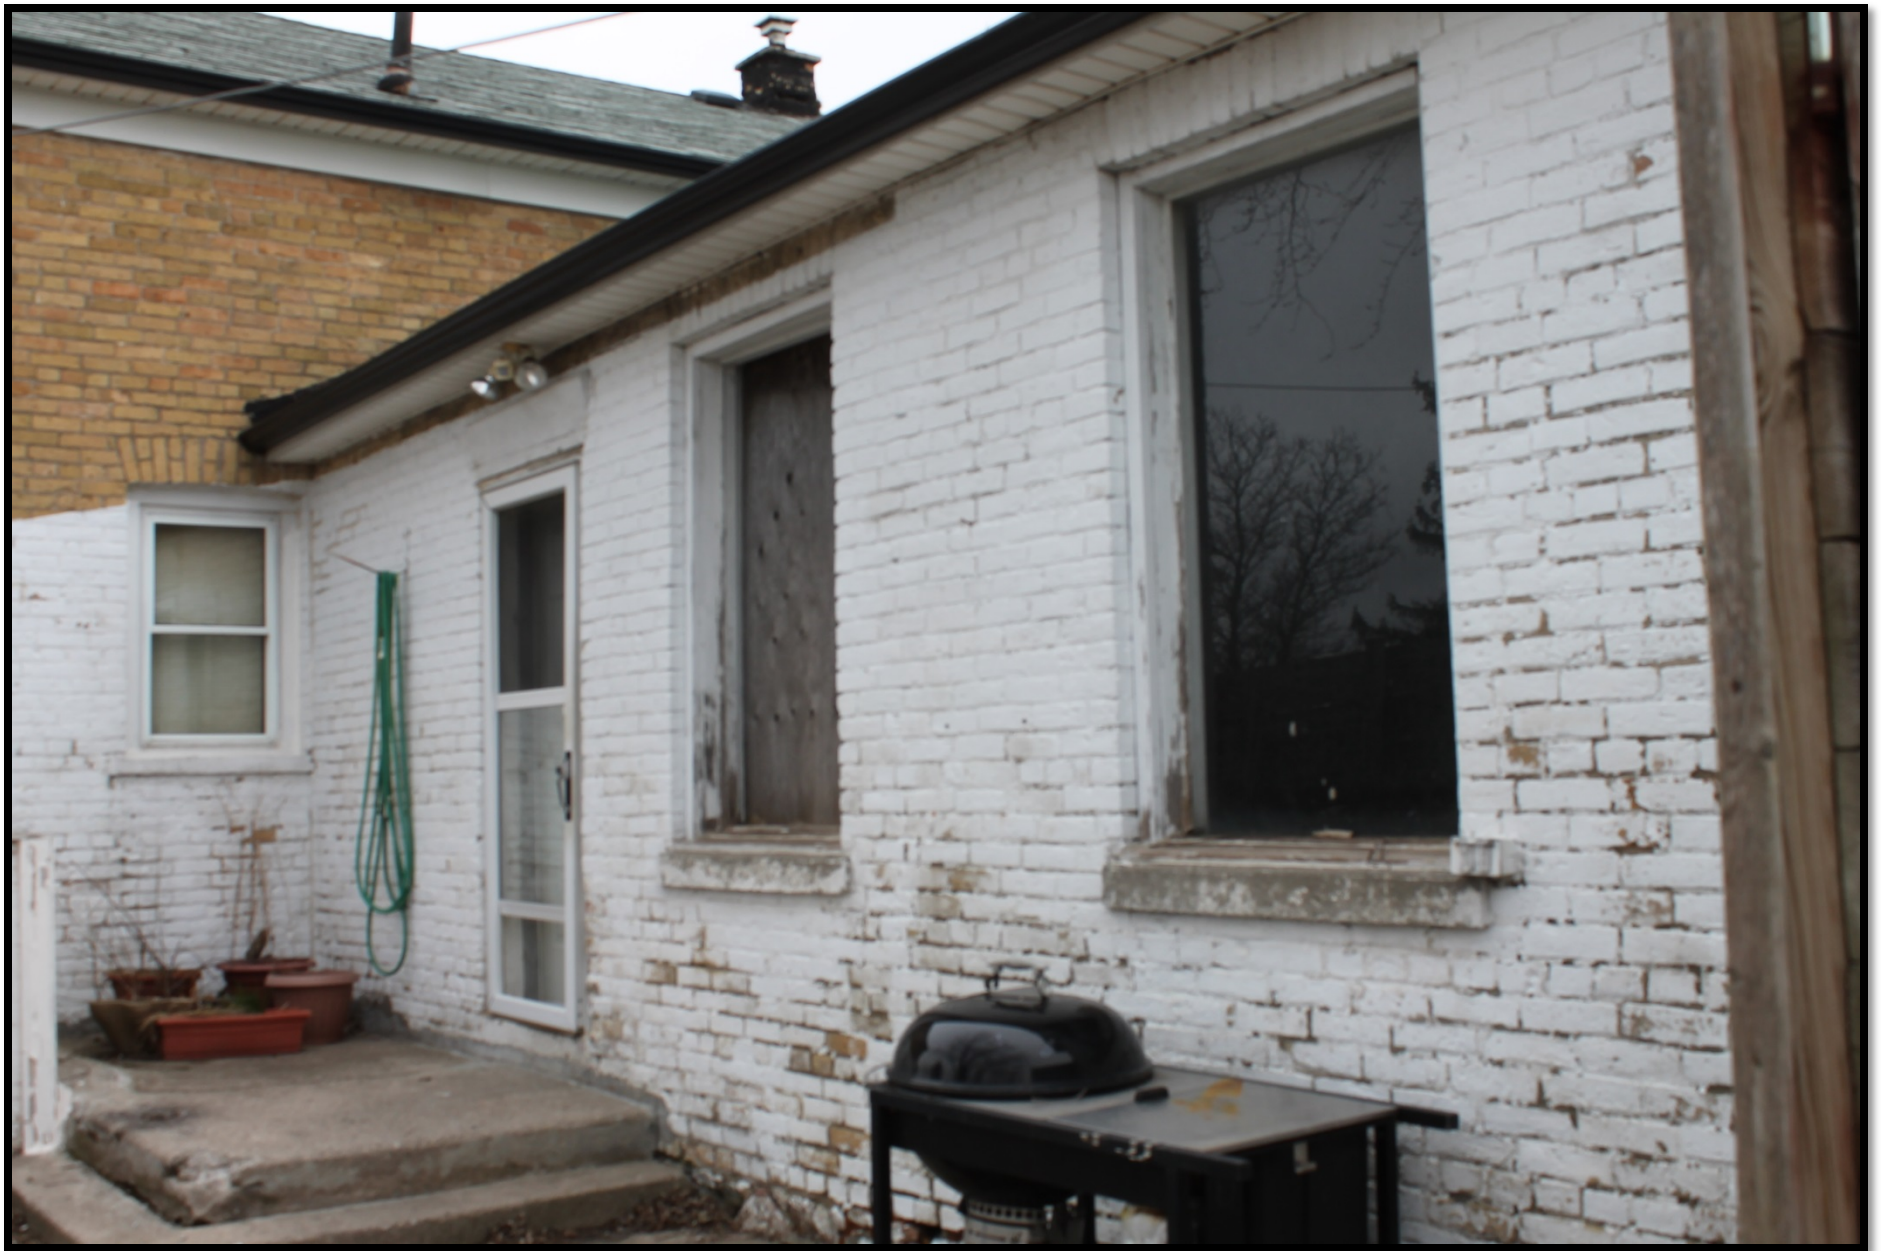
Wood frame outbuilding

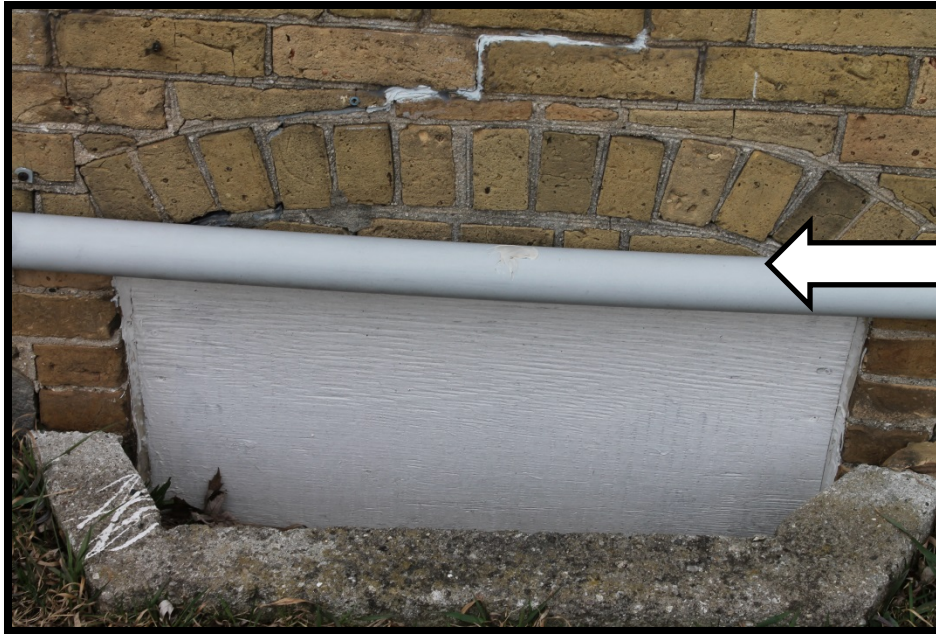
Brick infill in window opening; window boarded up

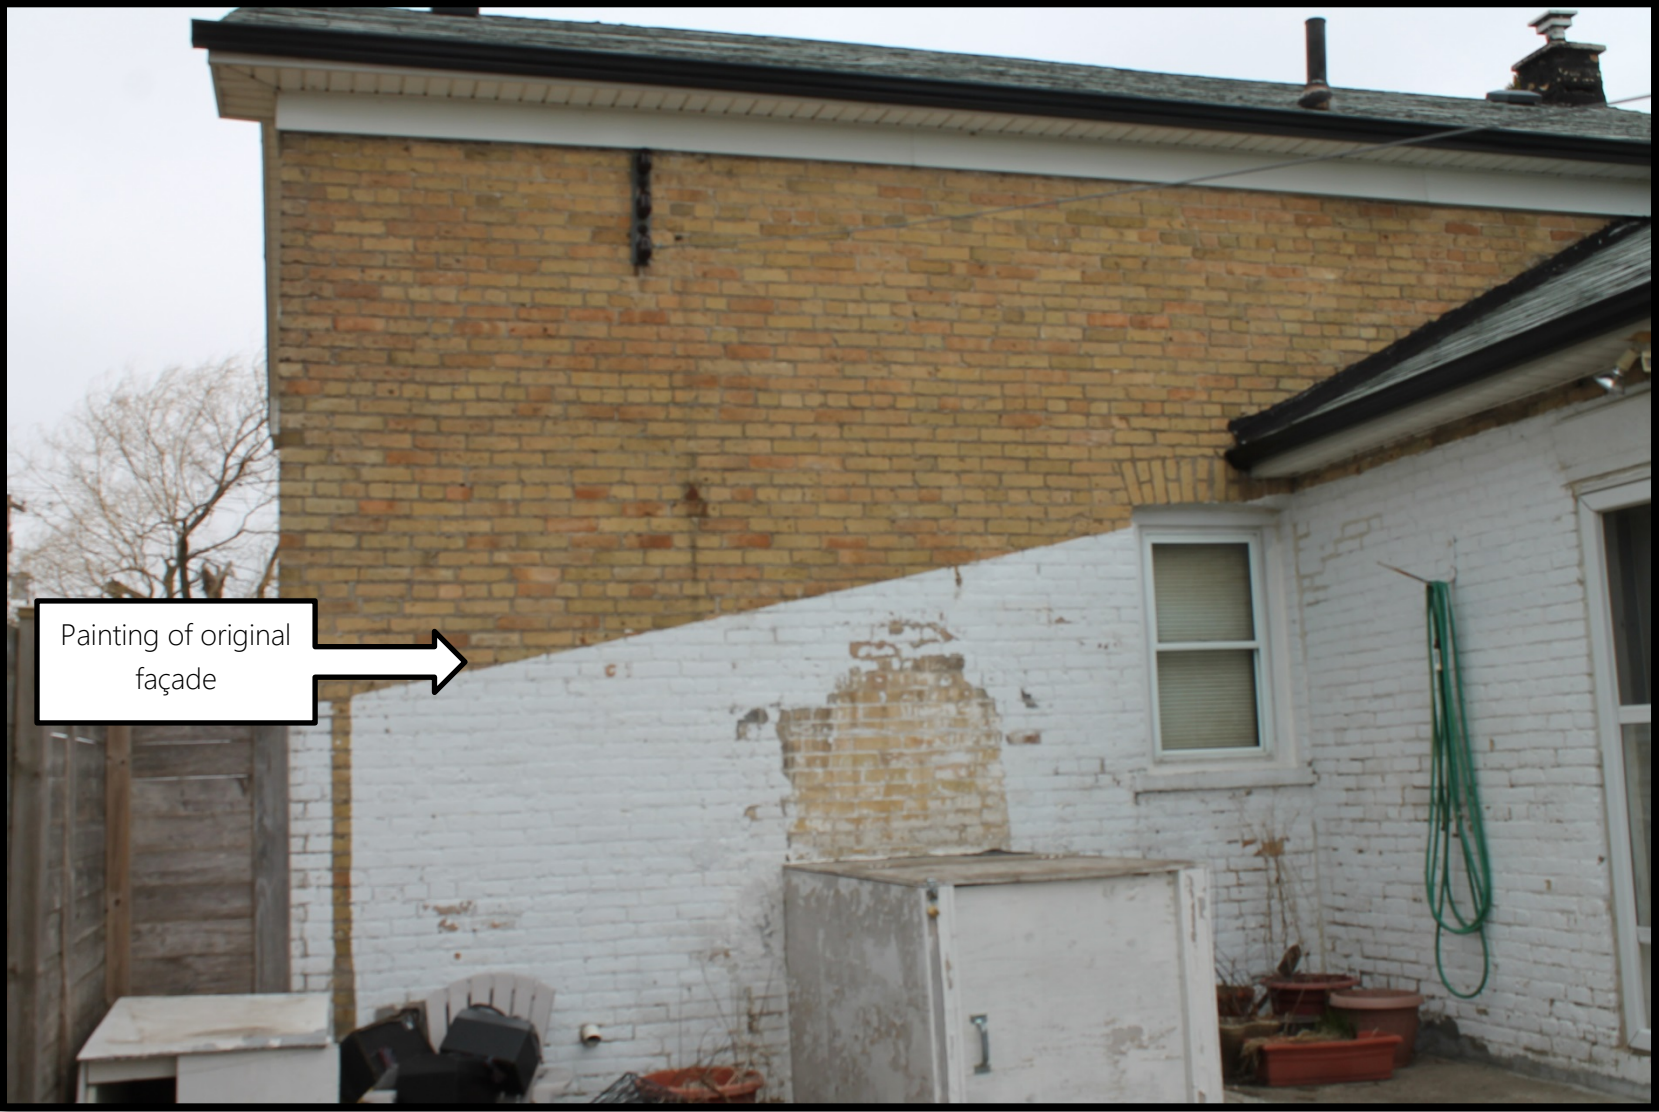
South Elevation

Original rubble  
stone foundation

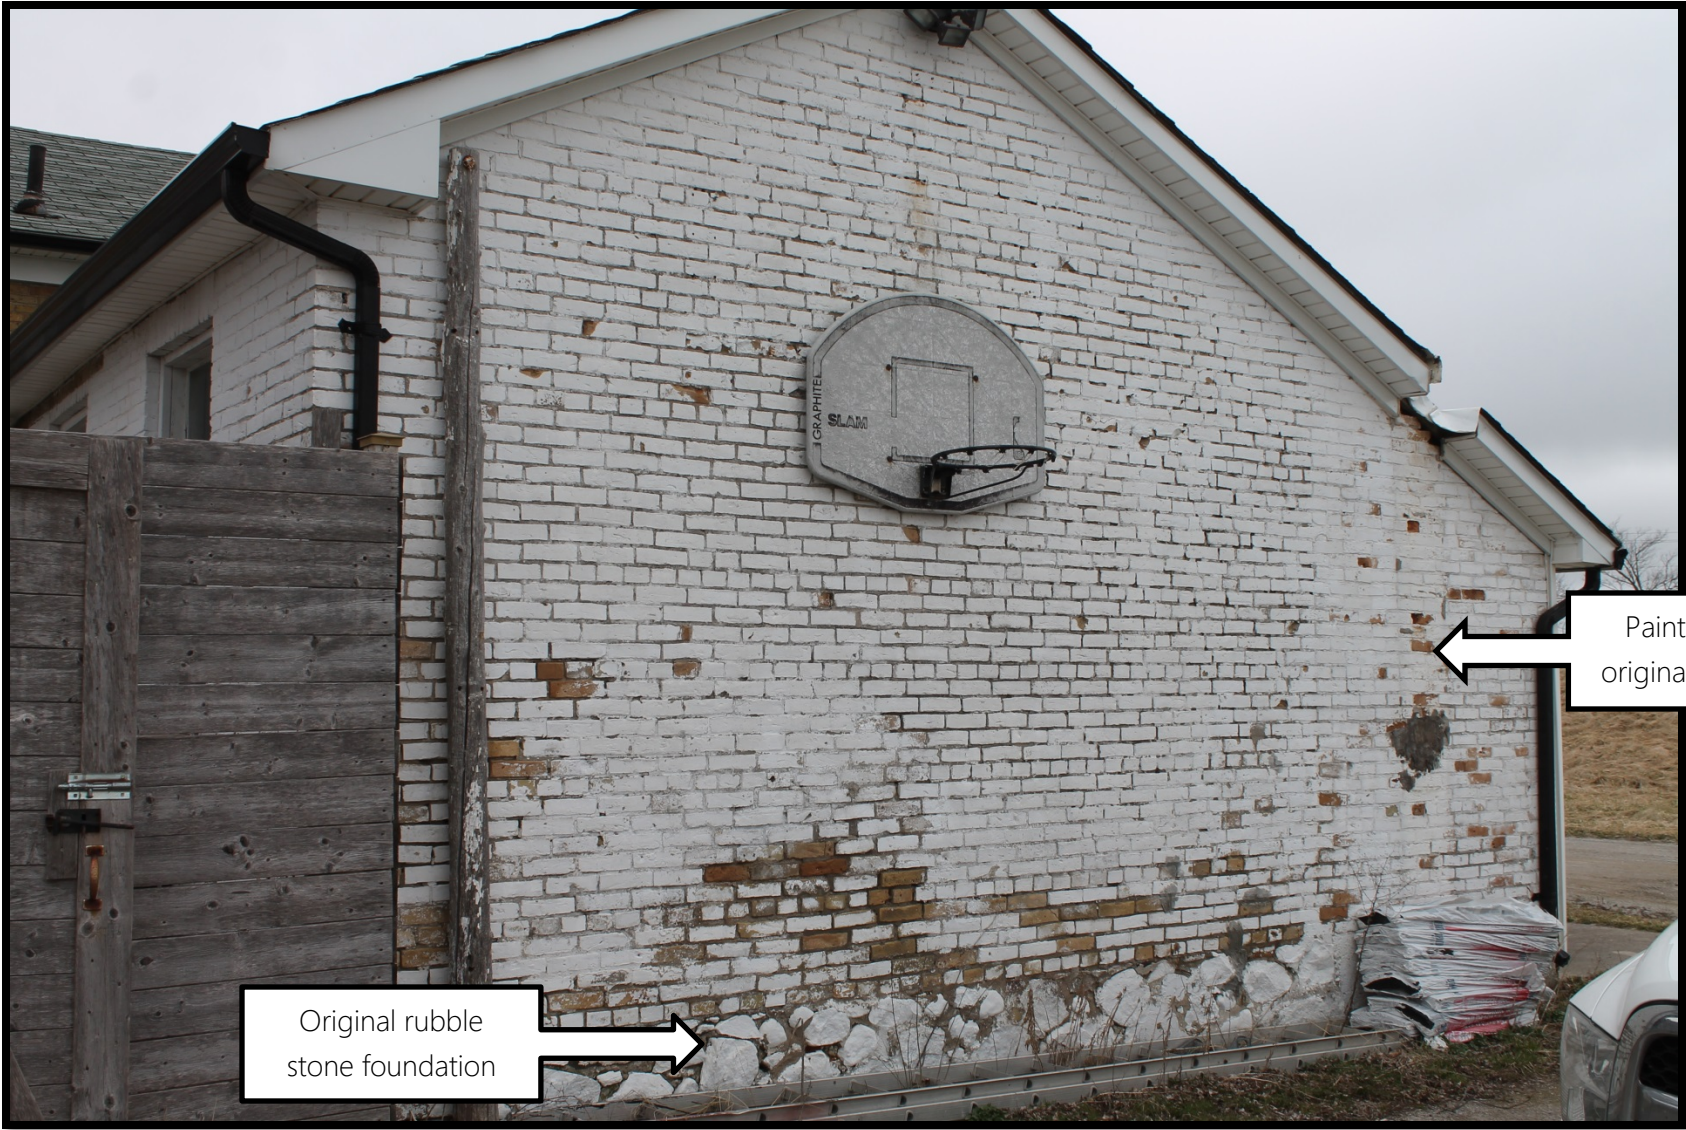
The rear addition includes two windows with voussoirs and stone lintels and a doorway. The window openings appear to be original, however, the windows have been replaced a single pane within wood frames. The west elevation of the rear addition has been painted with white paint concealing the original yellow brick.

Painting of  
original façade

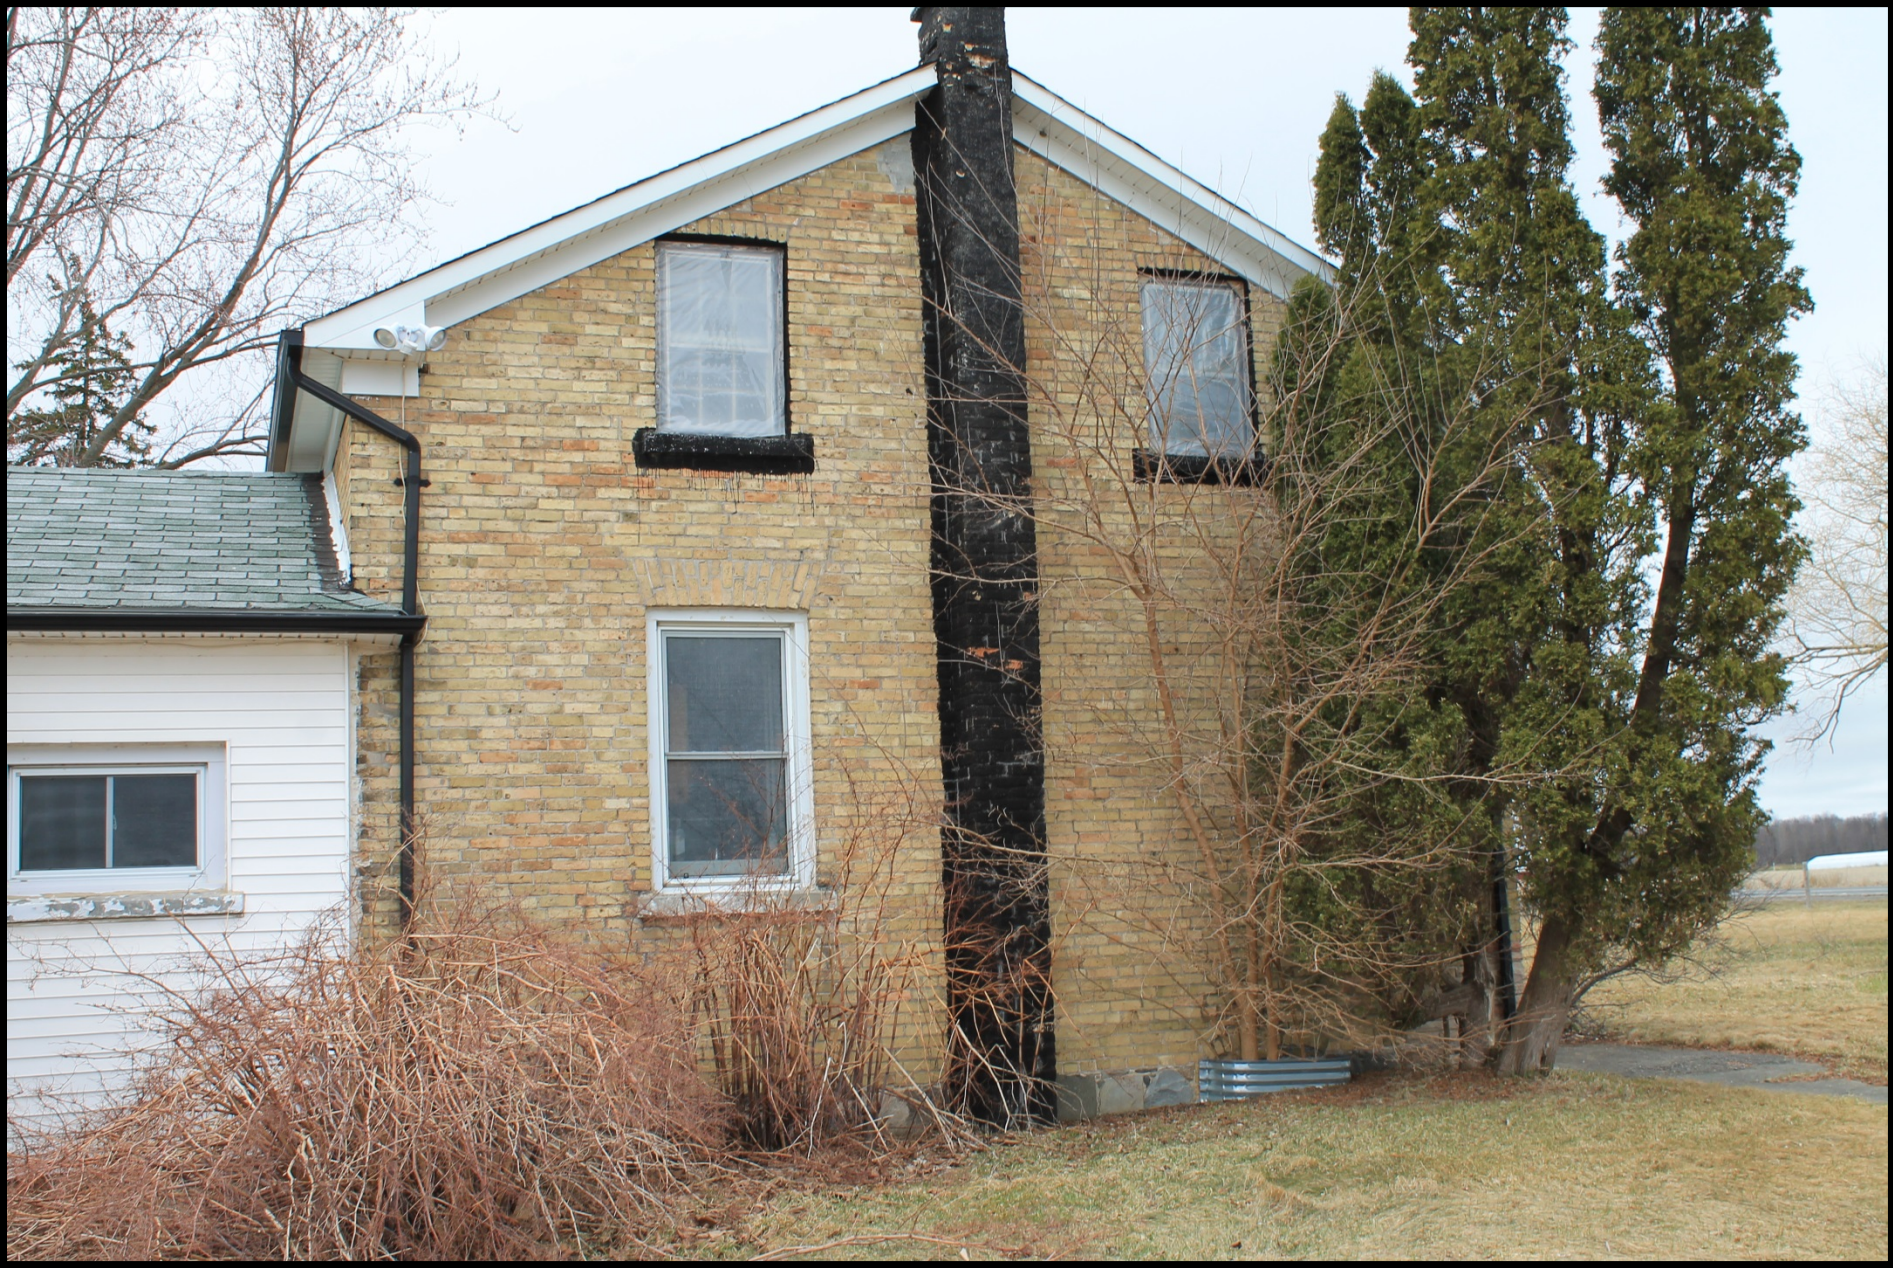
East Elevation

The east elevation of the main home consists of three (3) windows which are the original windows openings including voussoirs and stone sills. The first level window has been replaced with a vinyl double-hung window. The upper two windows appear to be original 4 x 3, double-hung wood framed windows. Both upper windows have been sealed with a black sealant along the window opening and in and around the sill.

There is an original foundation window opening with voussoir along this façade which has been boarded. There is a chimney shaft along this façade that is also covered in a black sealant.

The overall use of waterproof sealing throughout the exterior of the building and the signs of efflorescence on the eastern elevation indicate signs of water damage.

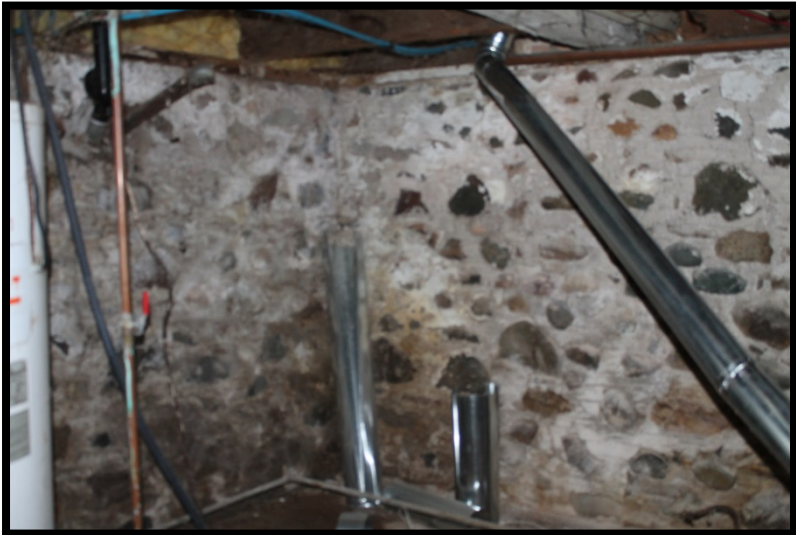
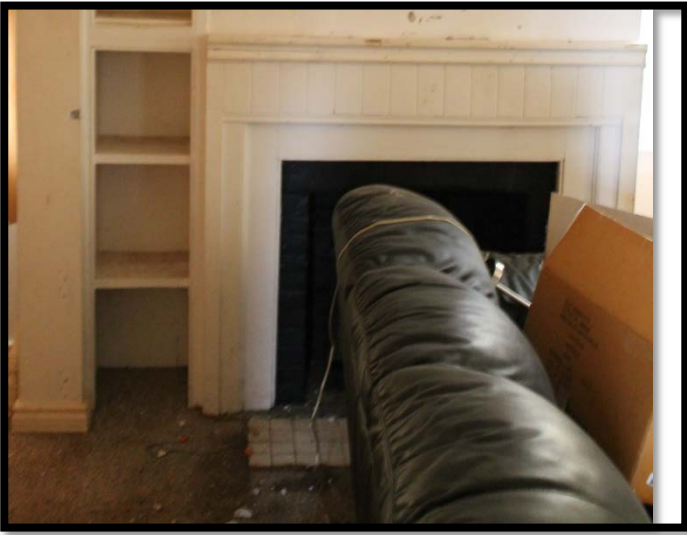
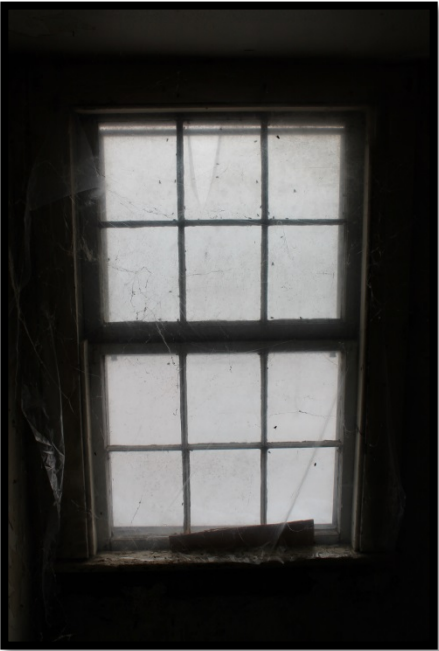
Interior Features

The interior arrangement of the house has been largely altered throughout the years. Only a few features continue to exist; those being the fireplace opening, the rubble stone foundation and the remaining original windows (also exterior feature) on the western and eastern elevations.
