Report to Planning and Environment Committee

Subject: Demolition Request for Heritage Listed Property at 2325 Sunningdale Road East by Lafarge Canada Inc.

Public Participation Meeting on: January 6, 2020

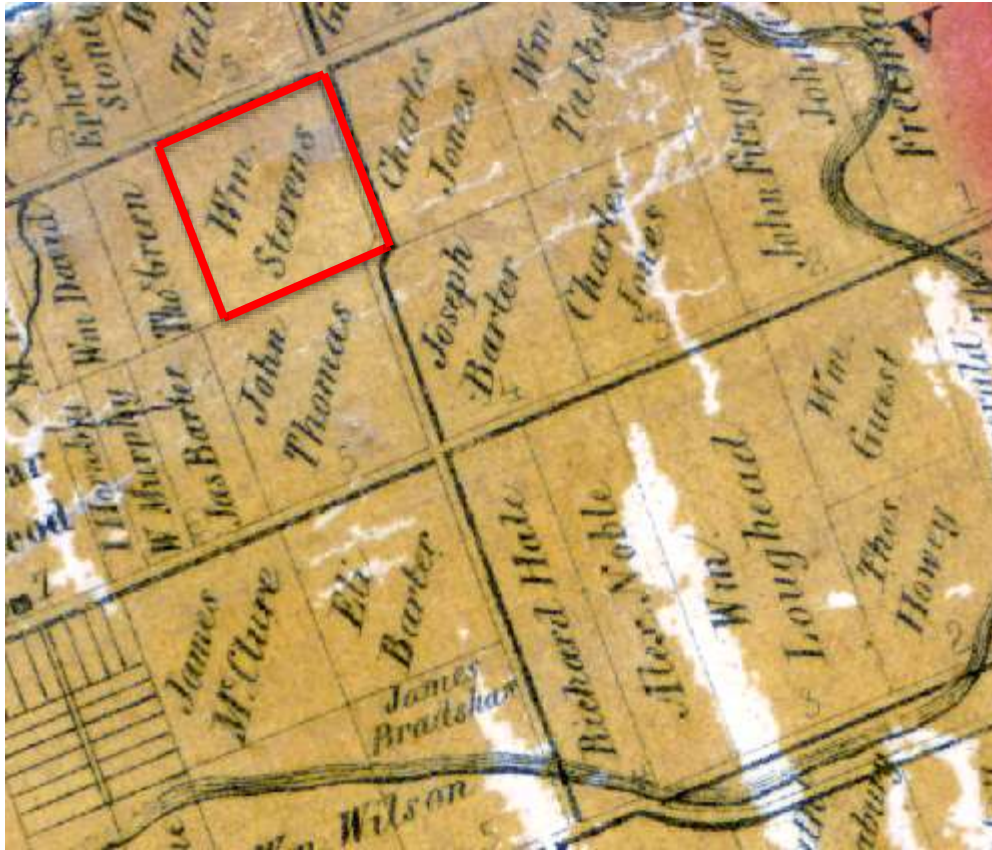
Figure 2: Extract from the Tremaine's Map of the County of Middlesex (1862), showing the north half of Lot 5, Concession V in the former London Township (red square). Wm. Stevens is noted as the occupant.

By 1862 William Stephens is noted as the owner of the north part of Lot 5, Concession V on *Tremaine's Map of the County of Middlesex County* (1862) (Appendix A). In 1878 the property, along with a portion of the adjacent lot at Lot 6, Concession V is noted on the *Illustrated Historical Atlas of Middlesex County* as belonging to the "Heirs of Wm Stevens" (see Appendix A). Based on the analysis of the land registry records and *Tremaine's Map of the County of Middlesex County* (1862), it is likely that the dwelling was constructed c.1862.

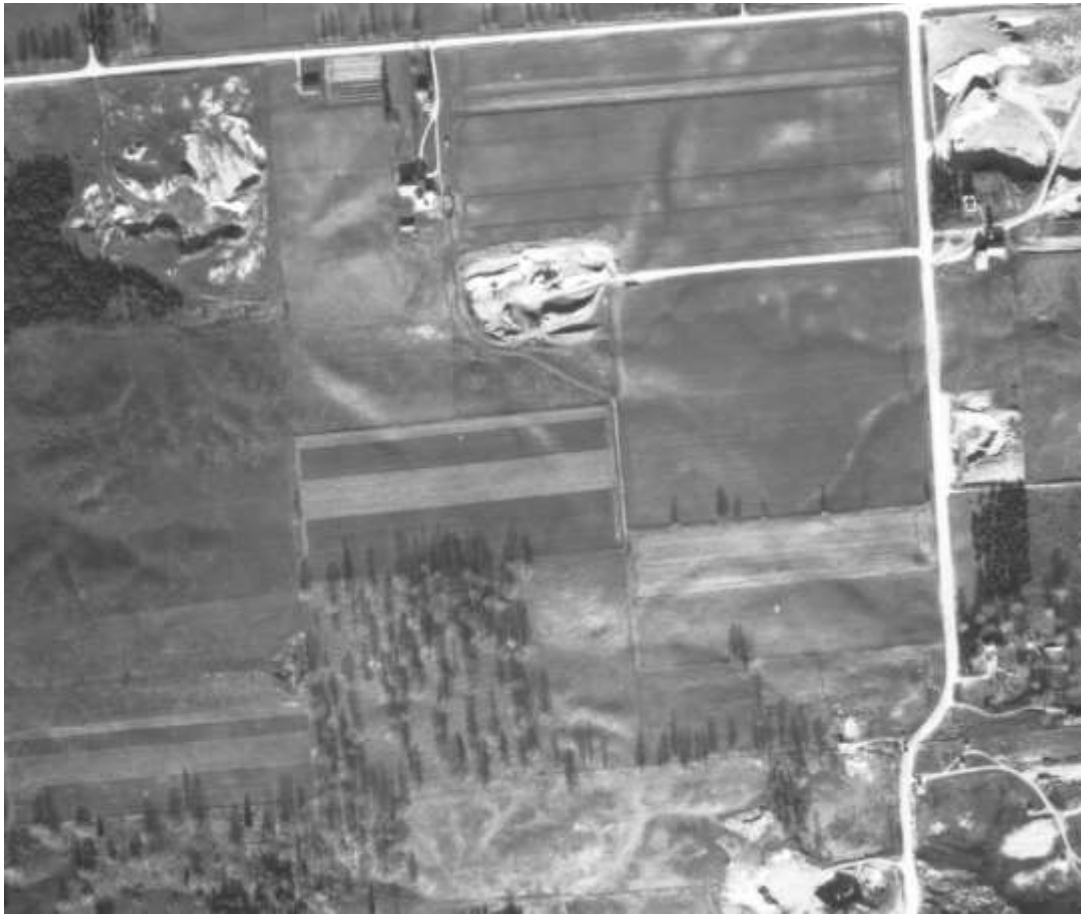
Figure 4: Extract from a 1967 aerial photograph showing the land use of the beginnings of aggregate extraction on the property

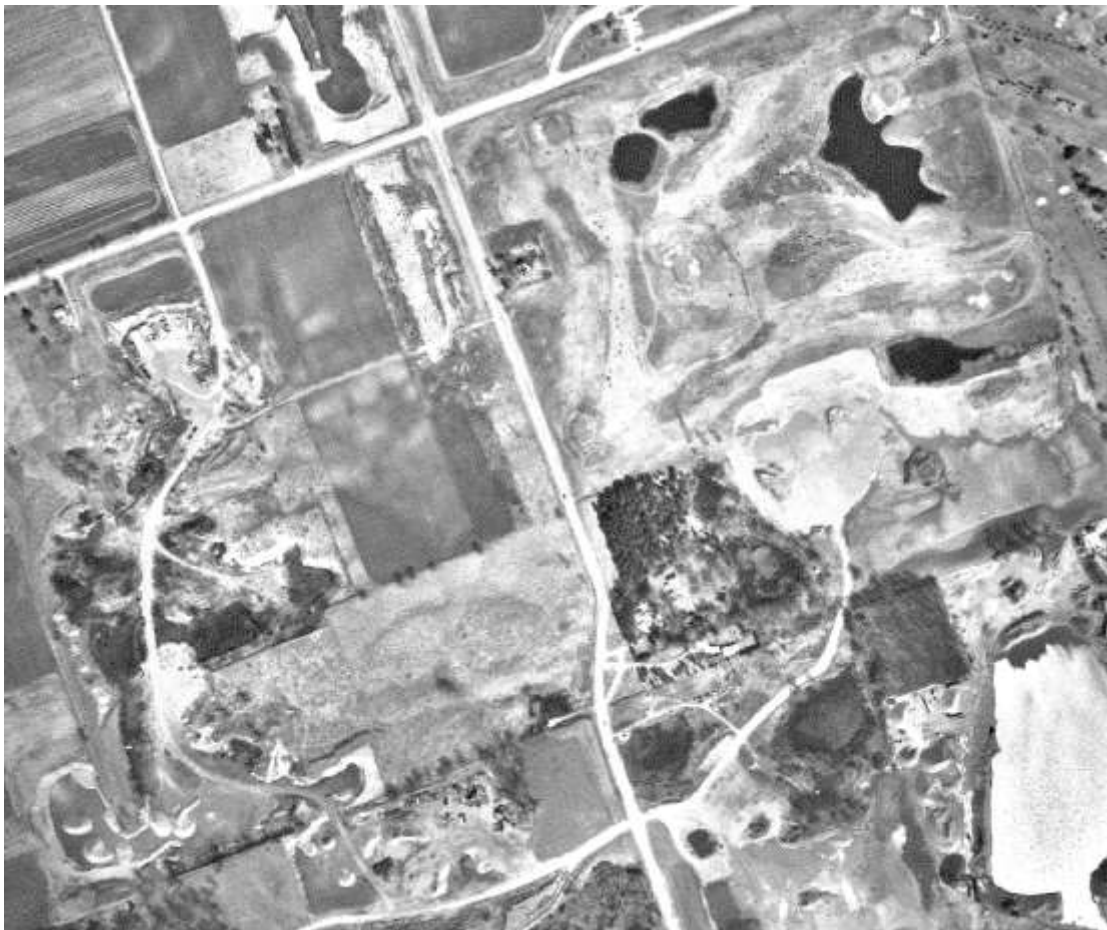
Figure 5: Extract from a 1993 aerial photograph showing the land use on the property transitioning to its current aggregate extraction use

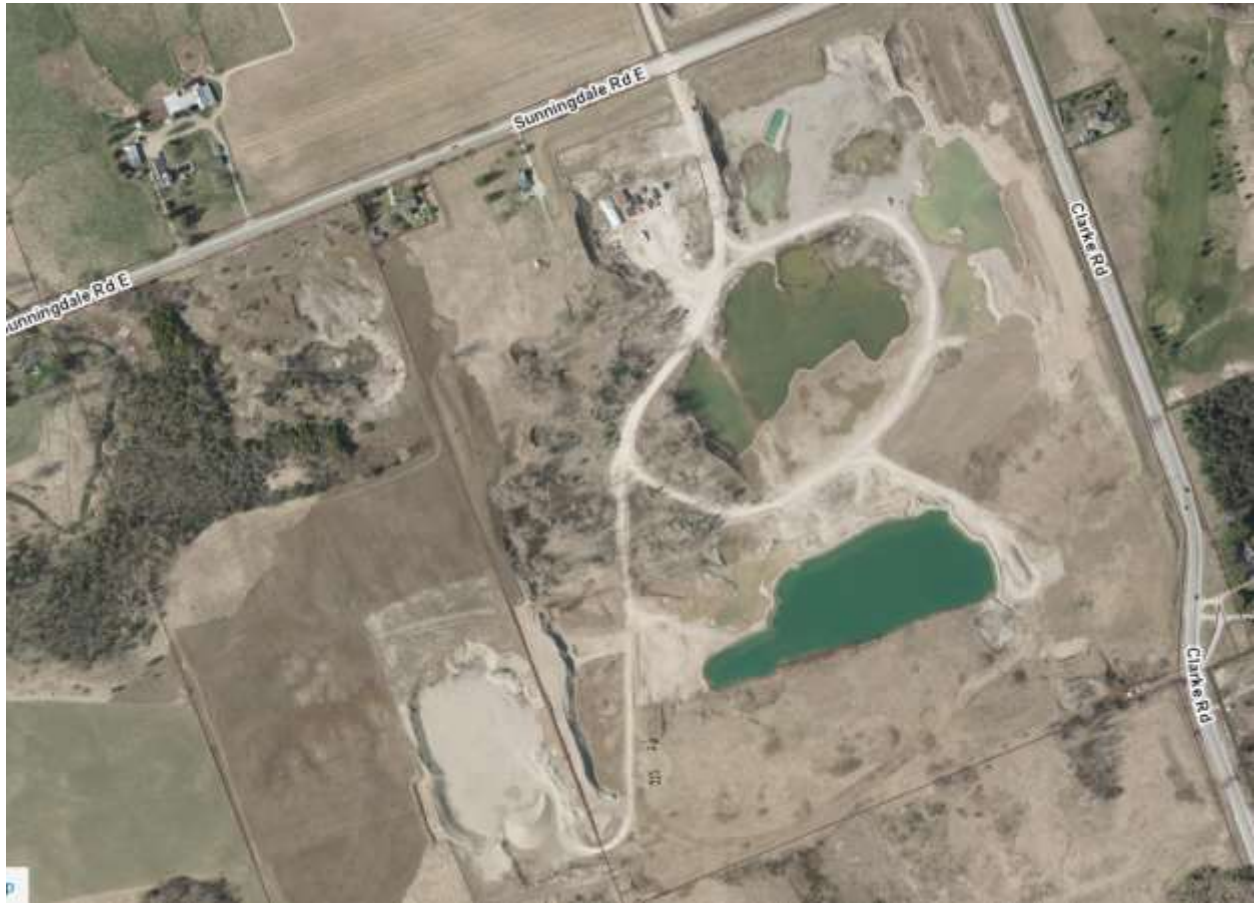
Figure 6: Aerial view showing current land use and aggregate extraction activity on the property.

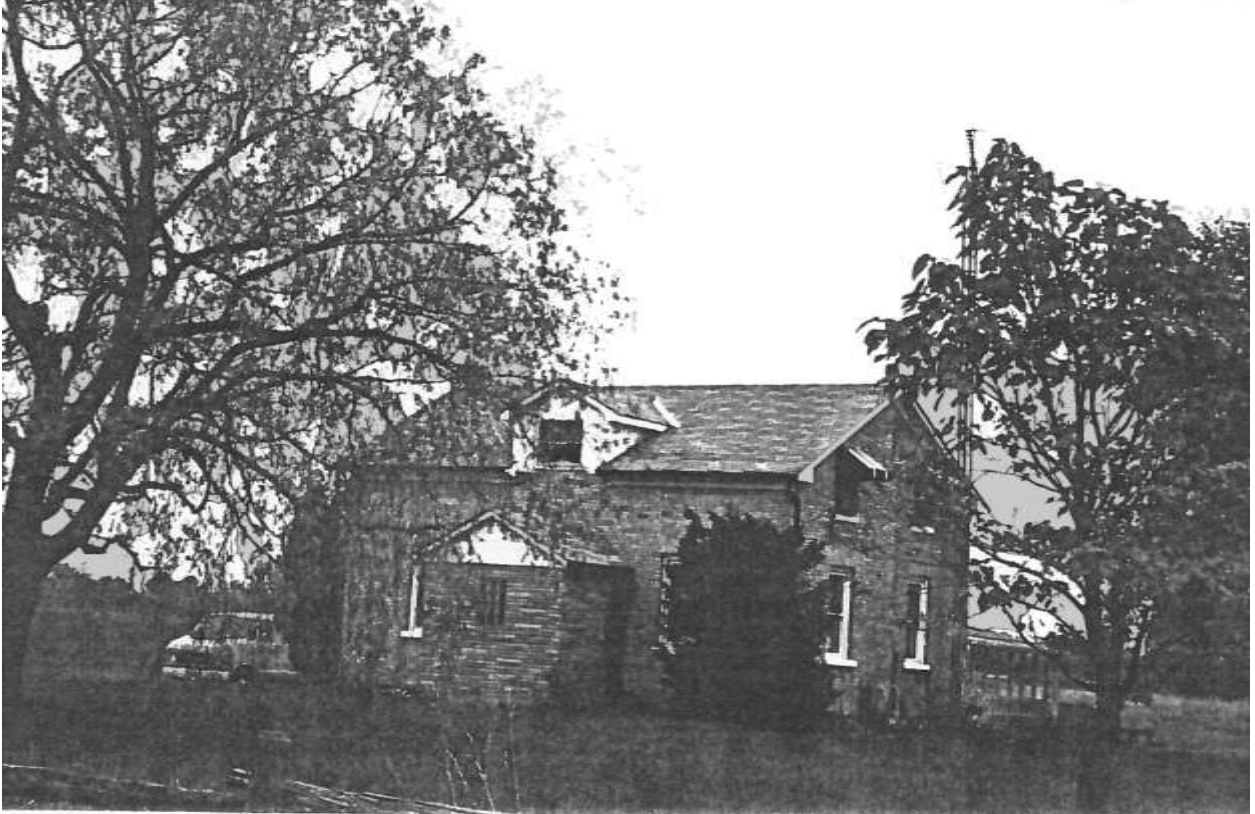
Image 1: Photograph of the dwelling at 2325 Sunningdale Road East, as shown in the 1993 City of London Inventory of Heritage Resources: Annexed Area.

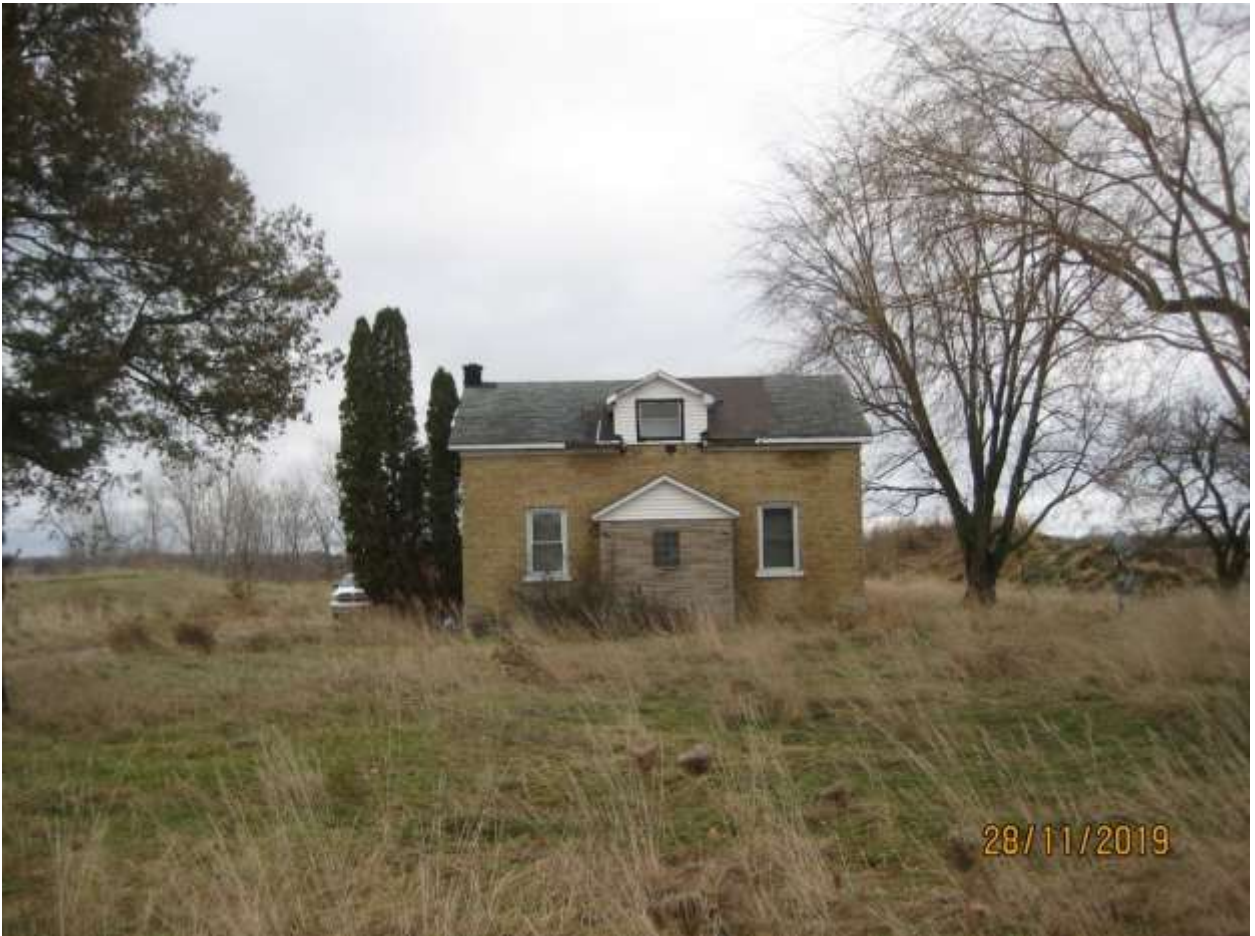
Image 2: Main (north) facade of the dwelling at 2325 Sunningdale Road East.

The original window openings on the main façade have been retained including the segmental arch brick voussoirs. However, the windows have been replaced. A gable dormer is centrally located on the main façade, also clad with vinyl siding. The front corners of the house have been rebuilt and re-clad with angelstone.

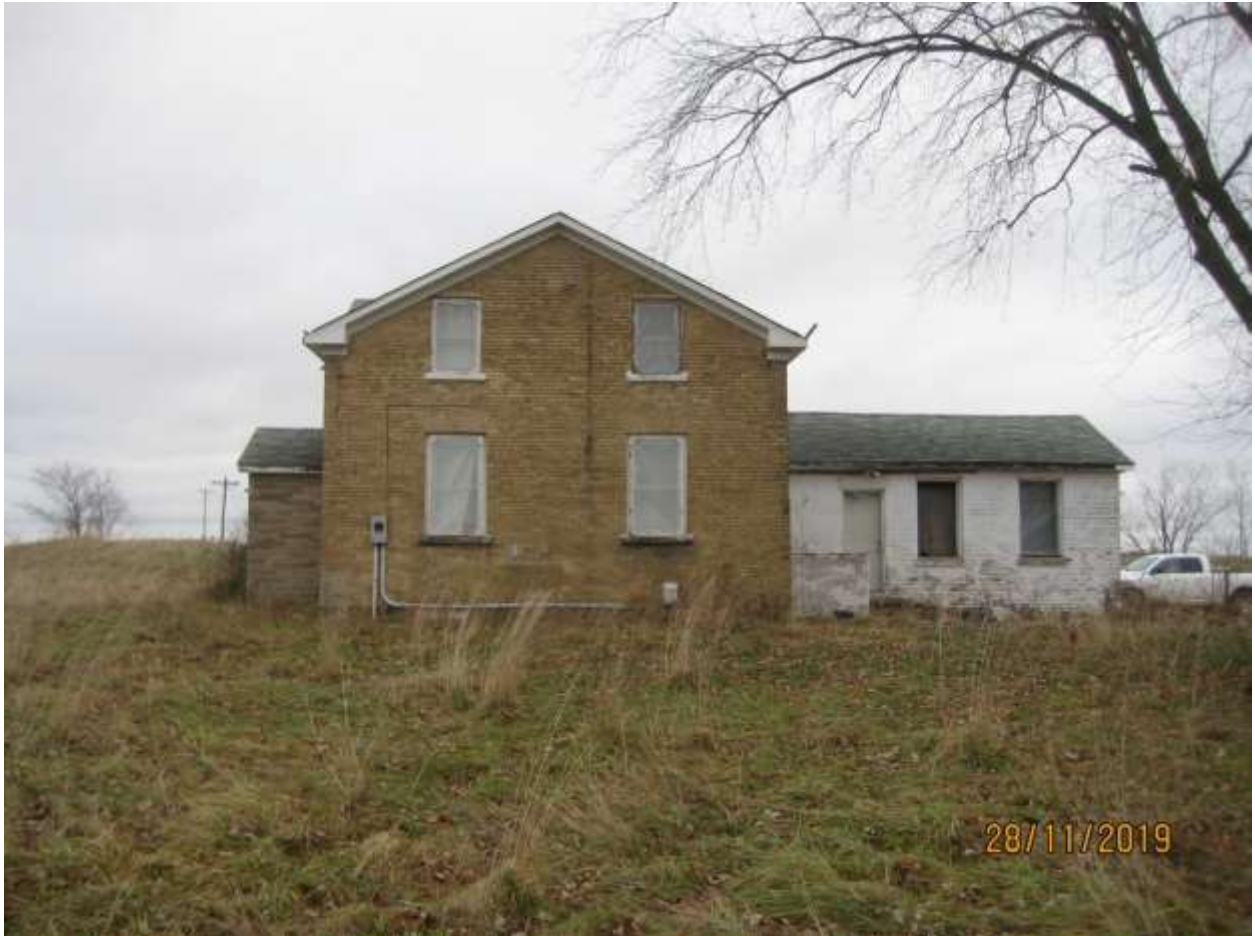
Image 3: West facade of the dwelling at 2325 Sunningdale Road East, showing the main house, front entrance at left, and rear addition at right.

The east and west facades of the dwelling consist of buff brick exterior walls with a set of window openings located on the first and second storeys. The brick lintels and concrete sills are still visible on the west façade, along with portions of the original rubble stone foundation. One of the first floor windows has been filled in on the east façade. A brick chimney is located in between the sets of the windows on the east façade. A black tar/sealant has been used to cover the entire chimney, along with the second storey sills and perimeter of the window openings.

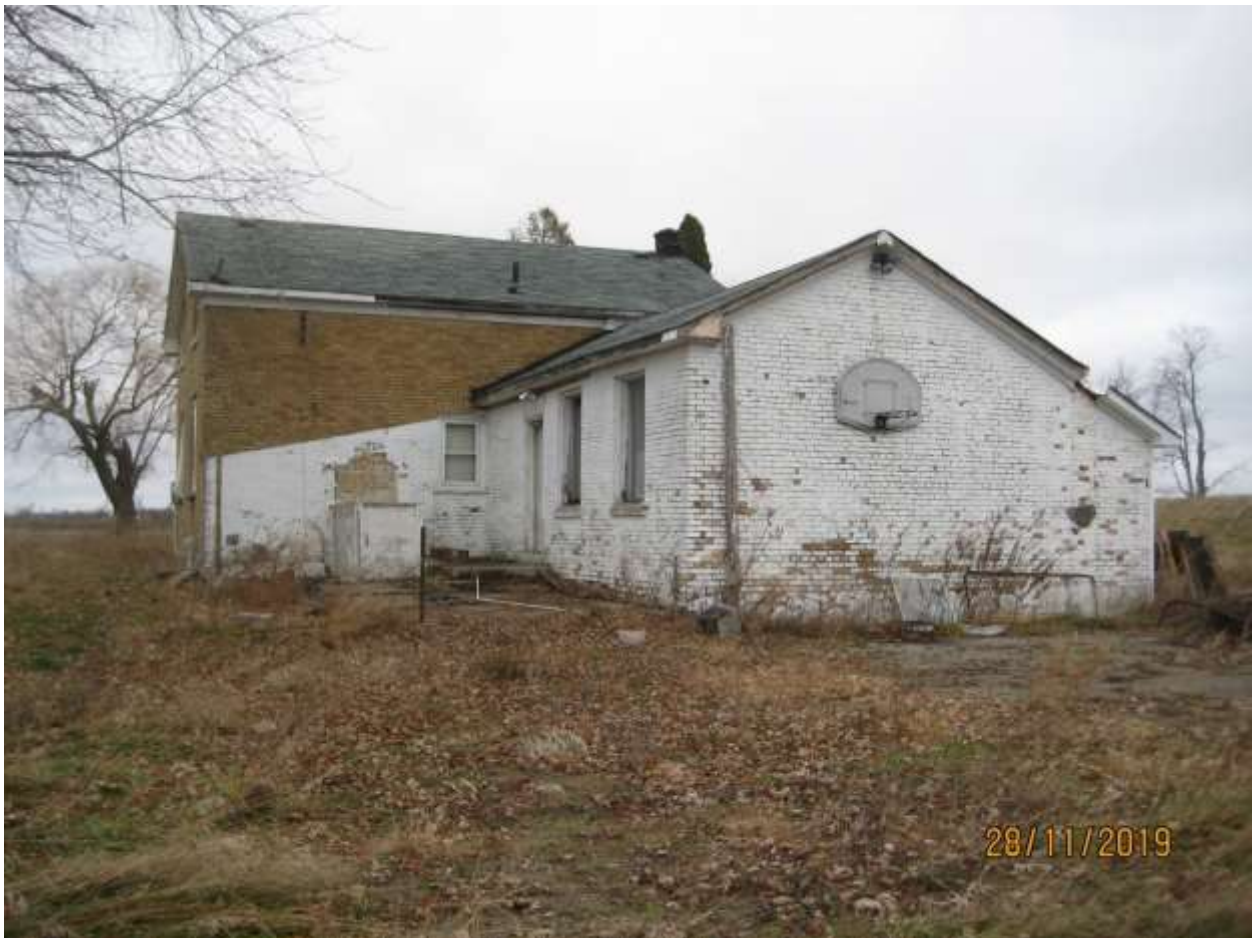
Image 4: Rear (south) facade of the dwelling at 2325 Sunningdale Road East showing main house and rear addition.

The rear (south) façade of the dwelling consists primarily of buff brick exterior walls, with a small first storey window. A single storey addition has also been constructed onto the rear of the building. The rear addition is clad with brick, however it has been painted white. Evidence of the original buff brick is present, and portions of the foundation indicate its material consists of rubble stone, suggesting that the rear wing is an early addition. This portion of the addition may have functioned as an early summer kitchen for the dwelling. A garage addition has also been constructed onto the rear of the dwelling. The east side of the addition is clad in vinyl siding.

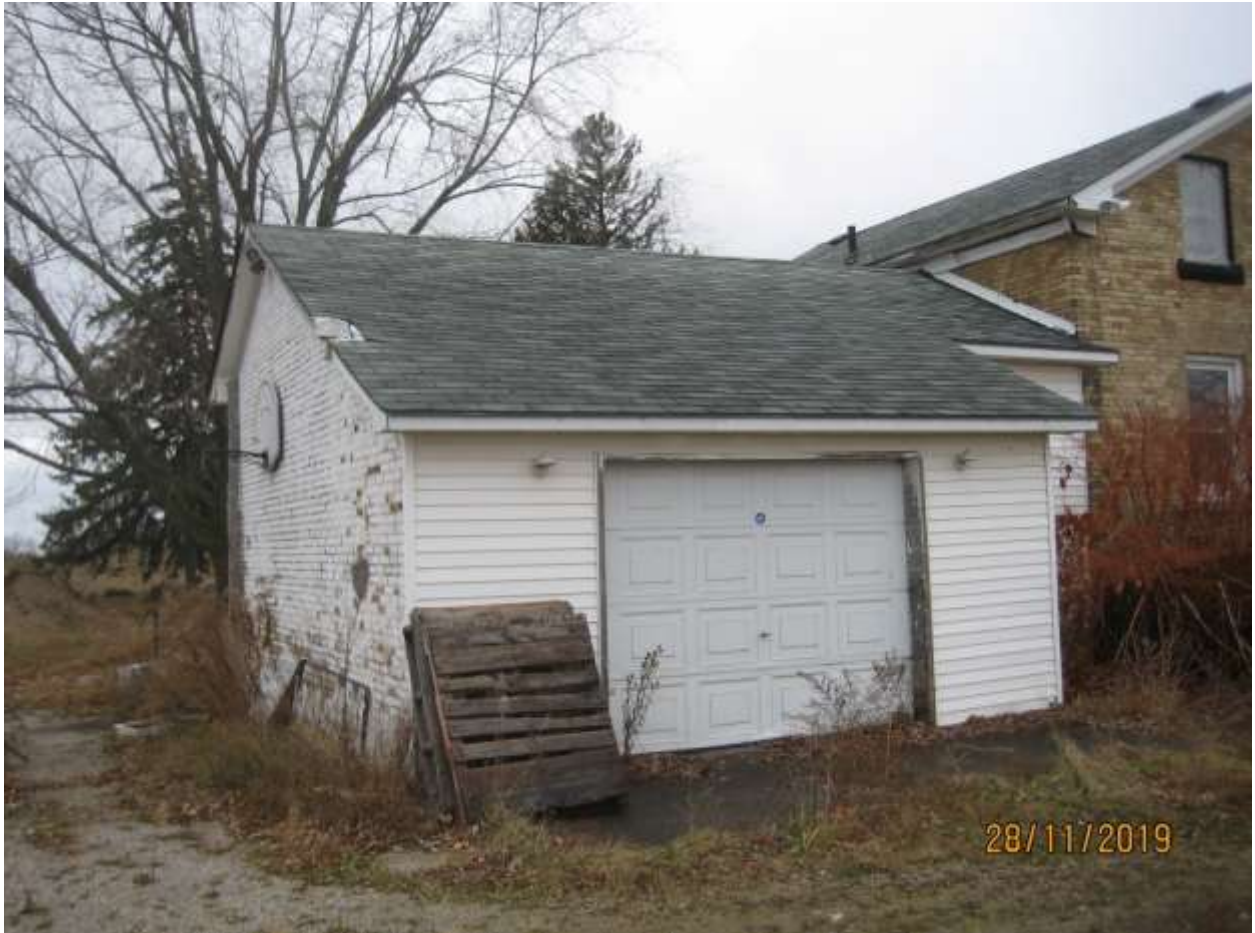
Image 5: Rear addition to the house at 2325 Sunningdale Road East. Note, a portion of the addition was likely used as an early summer kitchen, and a much large garage has also been added to the rear of the dwelling.

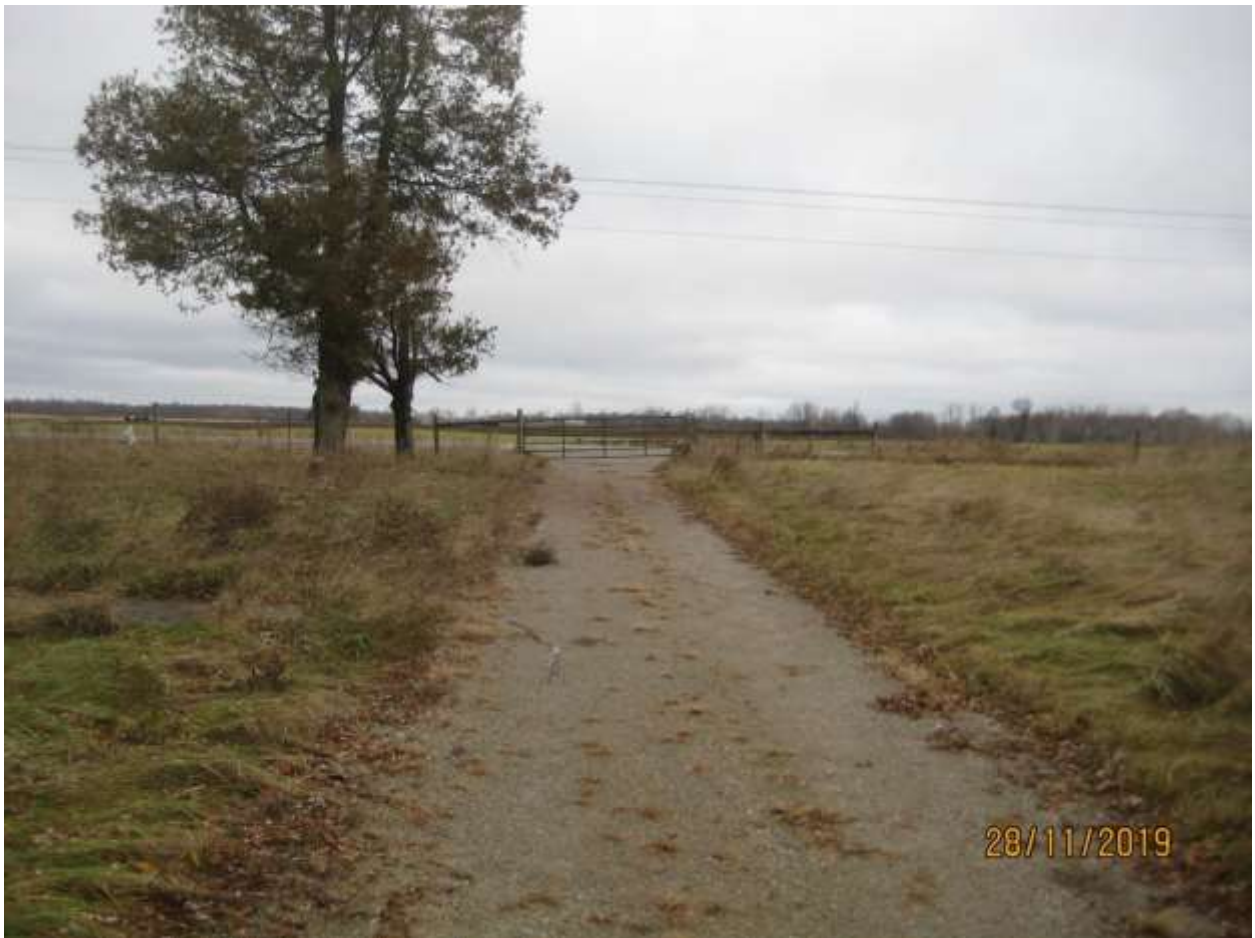
Image 6: View looking north showing the gravel laneway that provides access to the house from Sunningdale Road East

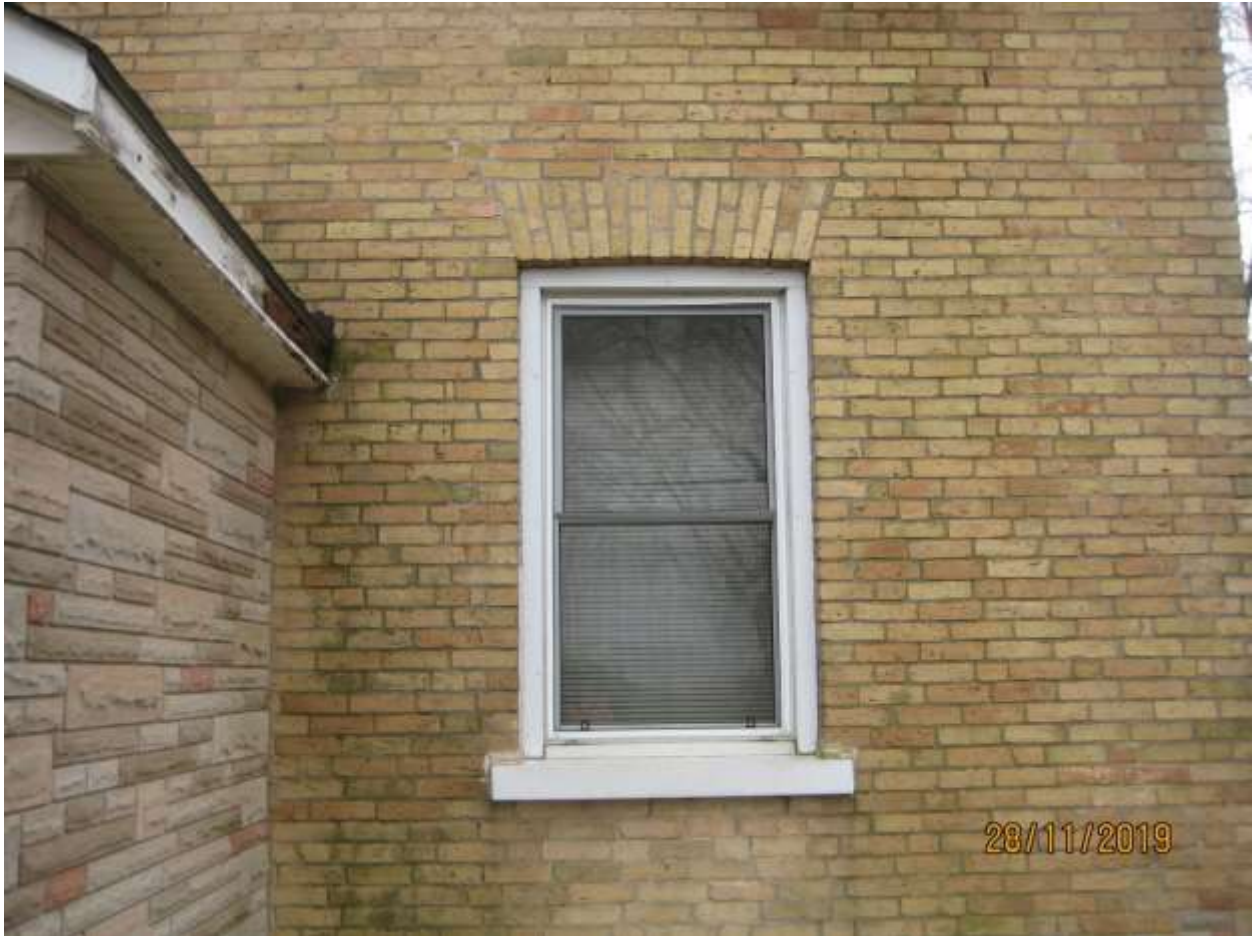
Image 7: Detail showing window on the main (north) facade. Note, several windows on the dwelling have been replaced with vinyl replacement windows.

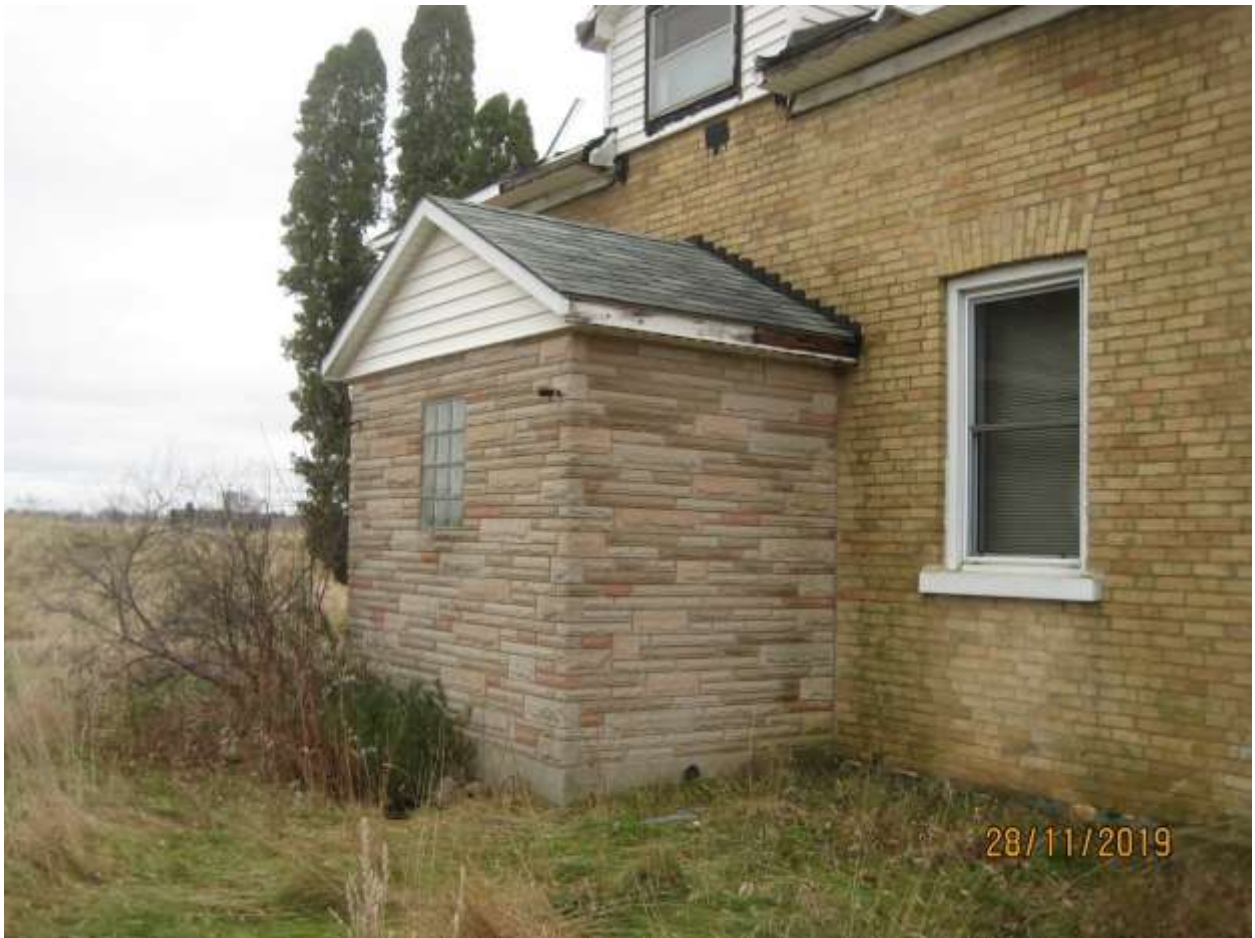
Image 8: View showing front addition on the house. The date of the addition is unclear, however, the exterior is clad with angelstone and vinyl siding.

The building located at 2325 Sunningdale Road East is a single storey, buff brick residential structure with a gable roof that is estimated to have been built c.1863 (Appendix B. The main façade of the building faces north to Sunningdale Road East, with its main entry located within an enclosed vestibule addition that is centrally located on the façade. The vestibule addition appears to be of frame construction on a concrete foundation, and is clad with an angelstone exterior finish. The vestibule also includes a gable roof, with its gable end facing Sunningdale Road East and is clad in vinyl siding.

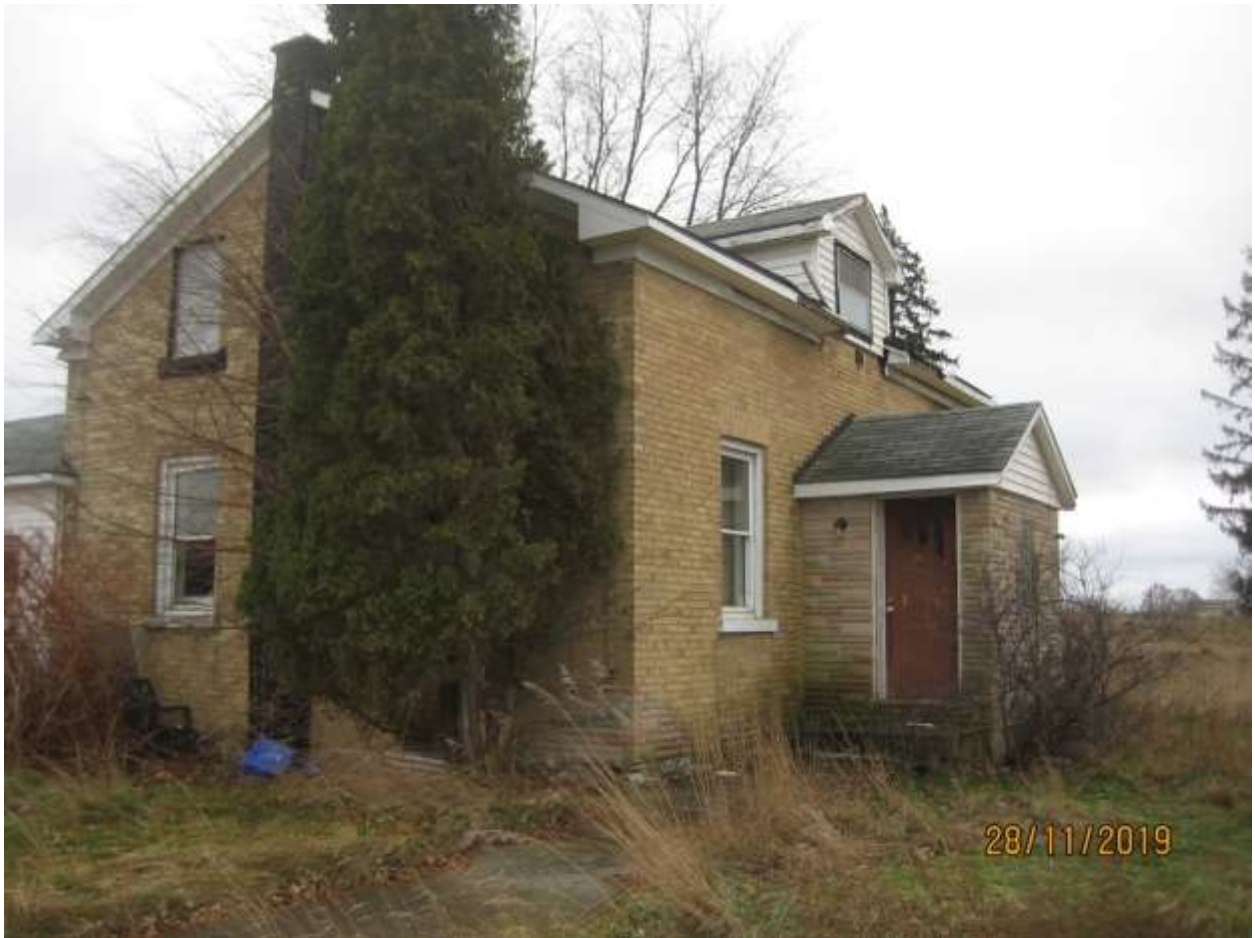
Image 9: View showing front northwest corner of the dwelling and access provided in front addition.

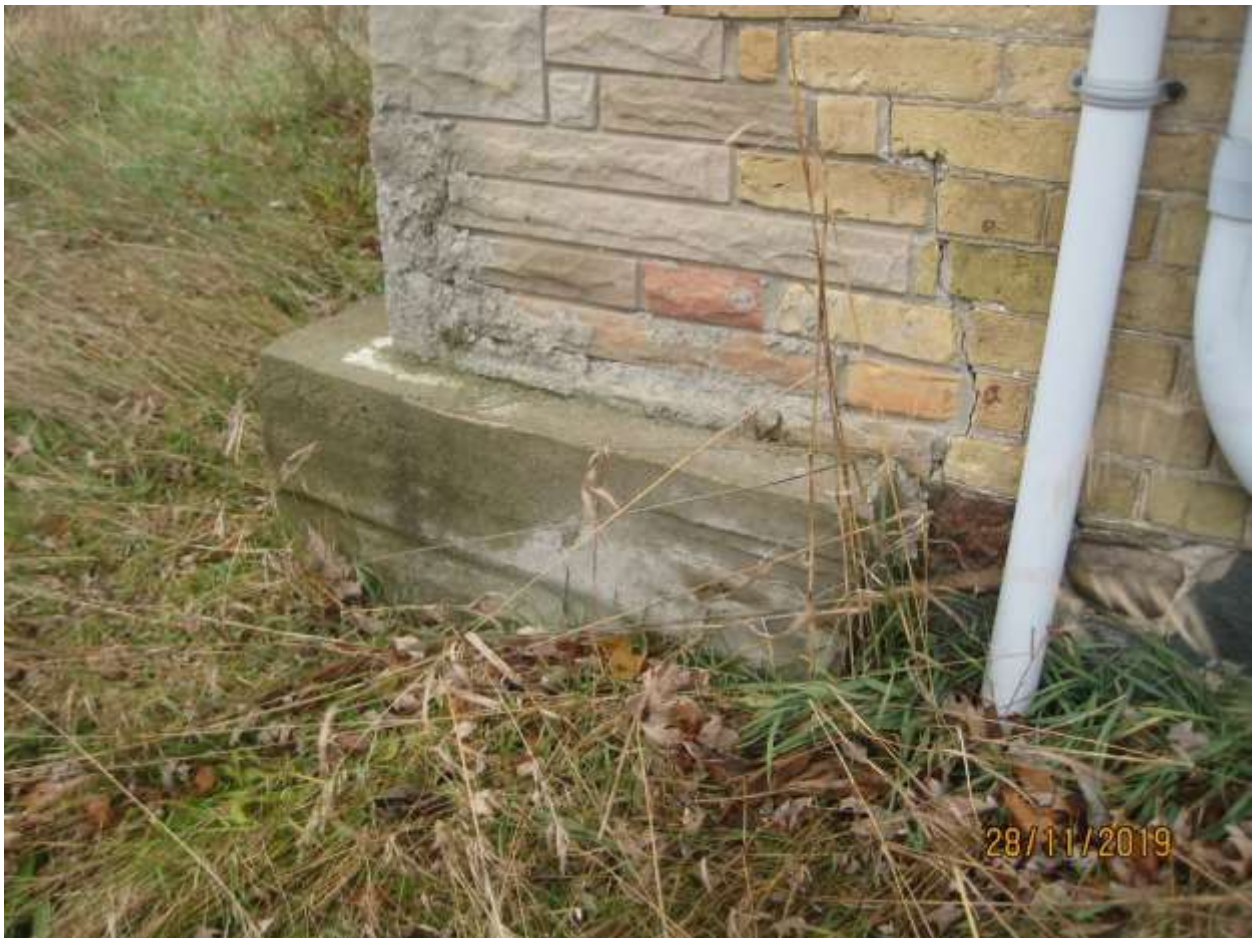
Image 10: Detail showing southeast corner of the dwelling. The north corners of the dwelling have been altered with concrete and angelstone cladding.

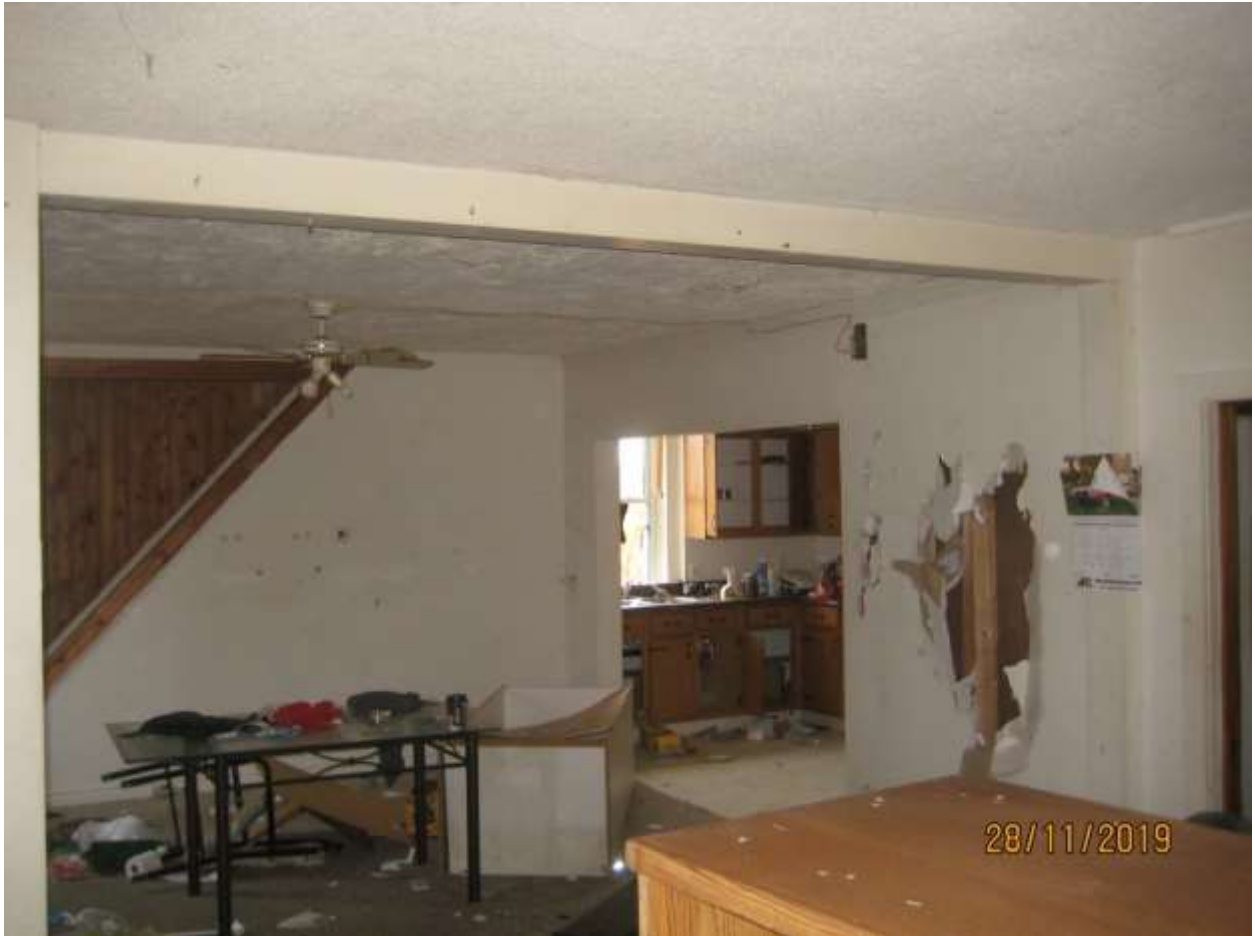
Image 11: View of the interior of the first floor. The stairs are located at the left of the photograph. The historic floor plan has been extensively altered on the interior of the dwelling.

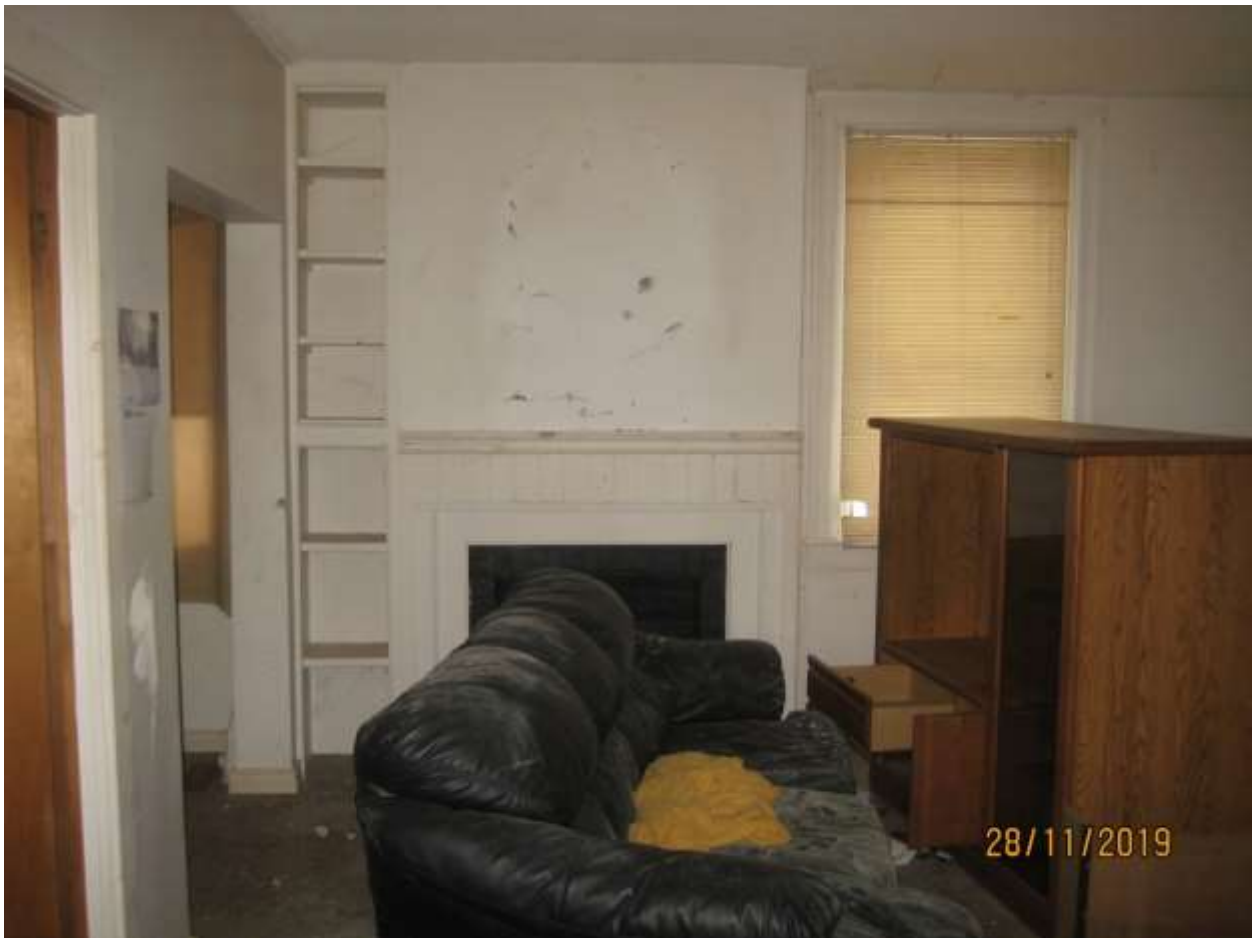
Image 12: View showing interior of the west wall, showing the location of the fireplace. Note, a chimney is no longer present on the exterior west façade of the dwelling.

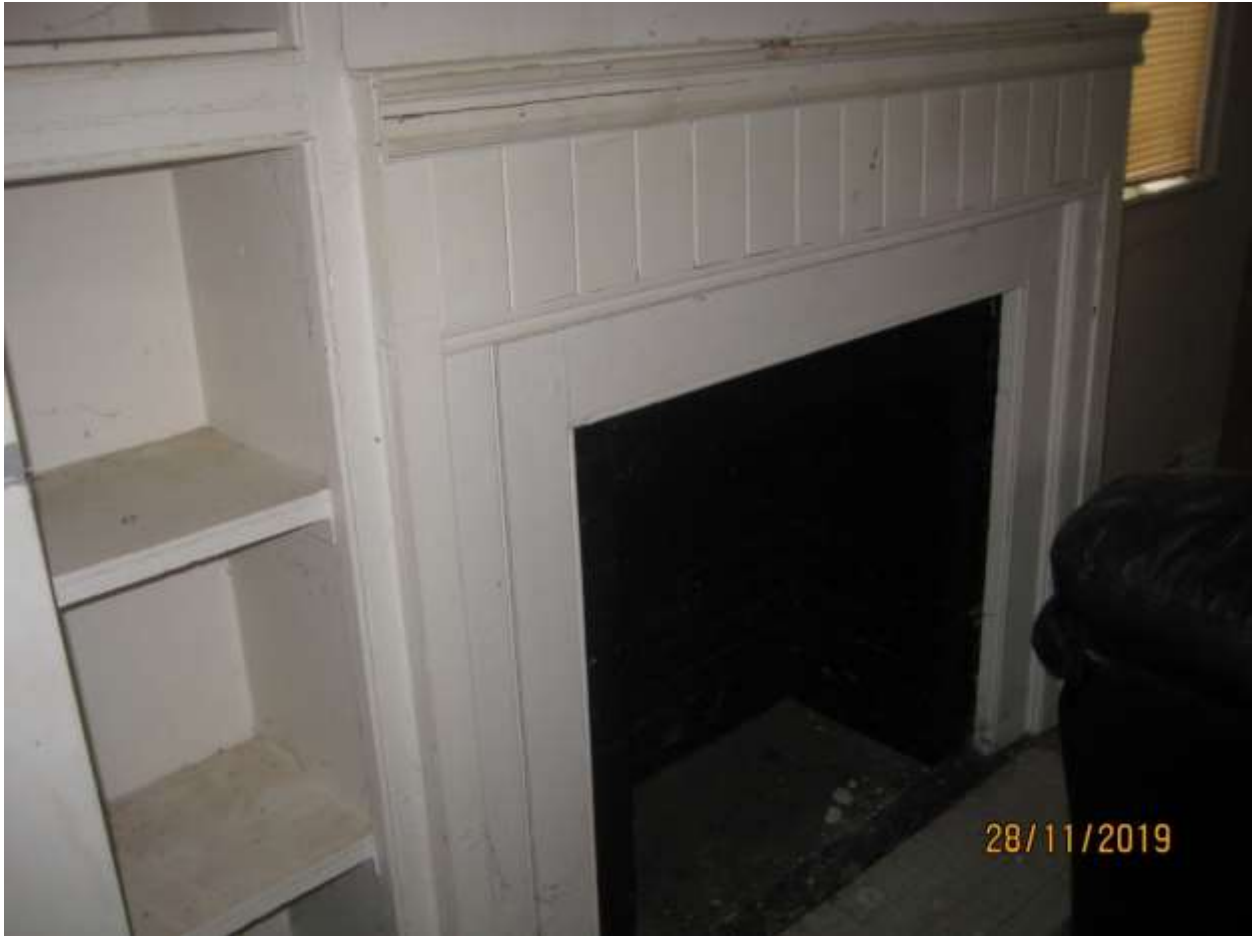
Image 13: Interior detail showing fireplace of the dwelling at 2325 Sunningdale Road East.

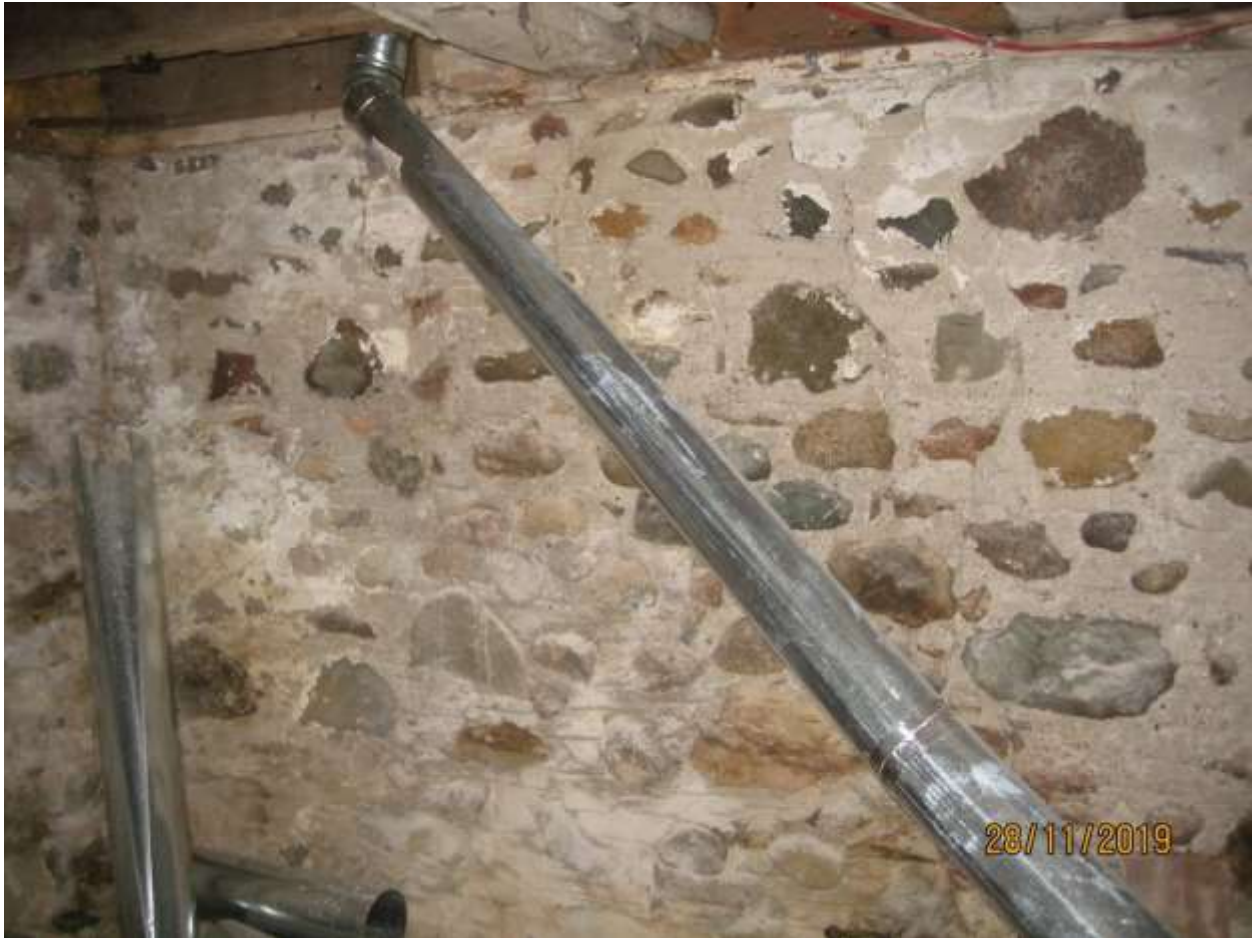
Image 14: Interior detail, showing the field stone foundation walls of the dwelling at 2325 Sunningdale Road East.
