Report to London Advisory Committee on Heritage

Subject: Heritage Alteration Permit Application by J. Banninga and J. Williams at 784 Hellmuth Avenue, Bishop Hellmuth Heritage Conservation District

Meeting on: Wednesday August 12, 2020

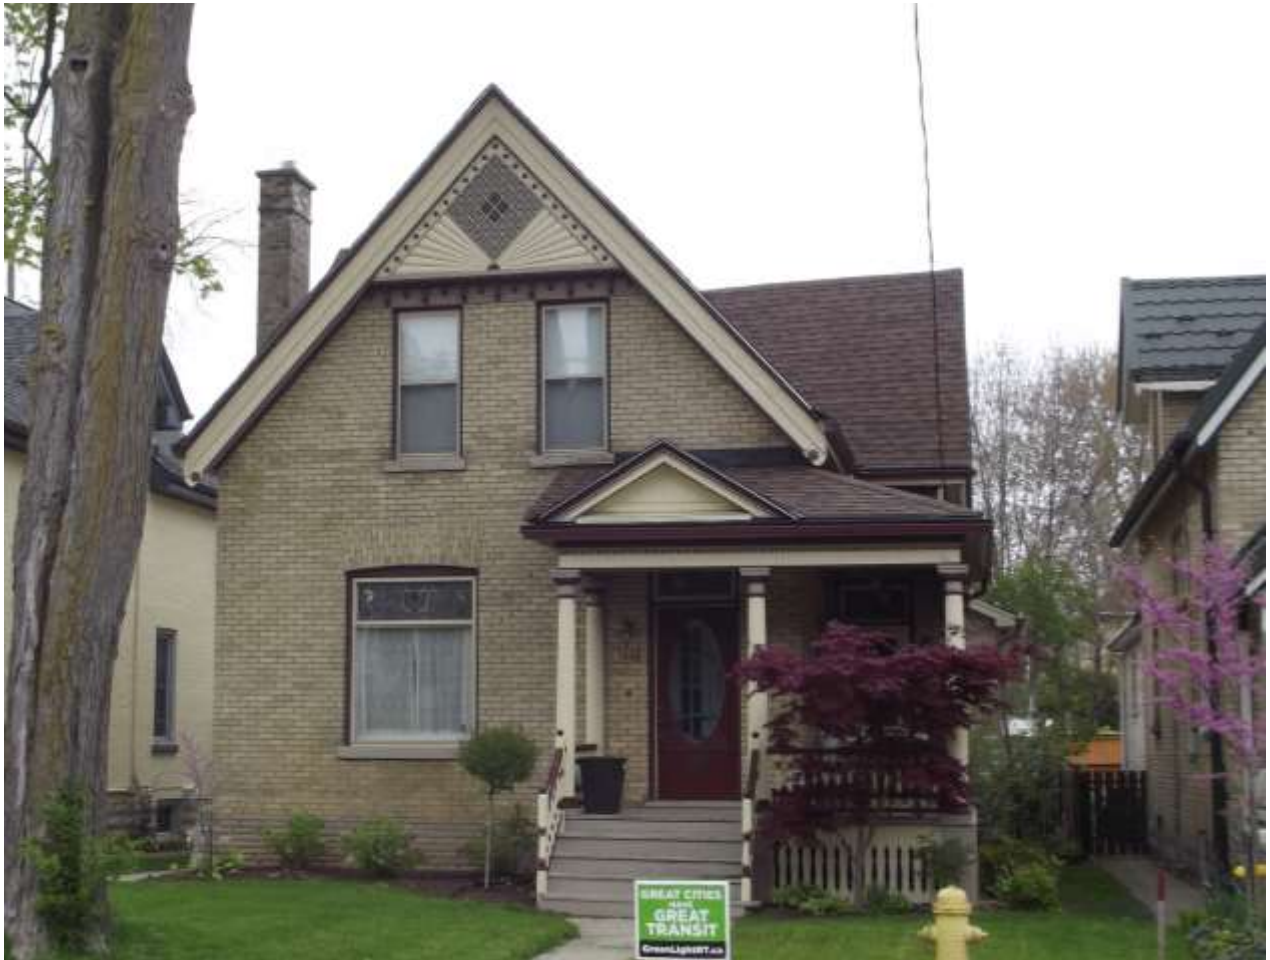
The former windows of the heritage designated property at 784 Hellmuth Avenue were typical of the period and Queen Anne Revival architectural style: painted wood (single or double hung) sash windows with undivided lights (see Appendix B). Aluminum storm windows were added over what may be the original wood windows at some point in the property's history.

Image 1: Photograph of the property at 784 Hellmuth Avenue on May 12, 2017.

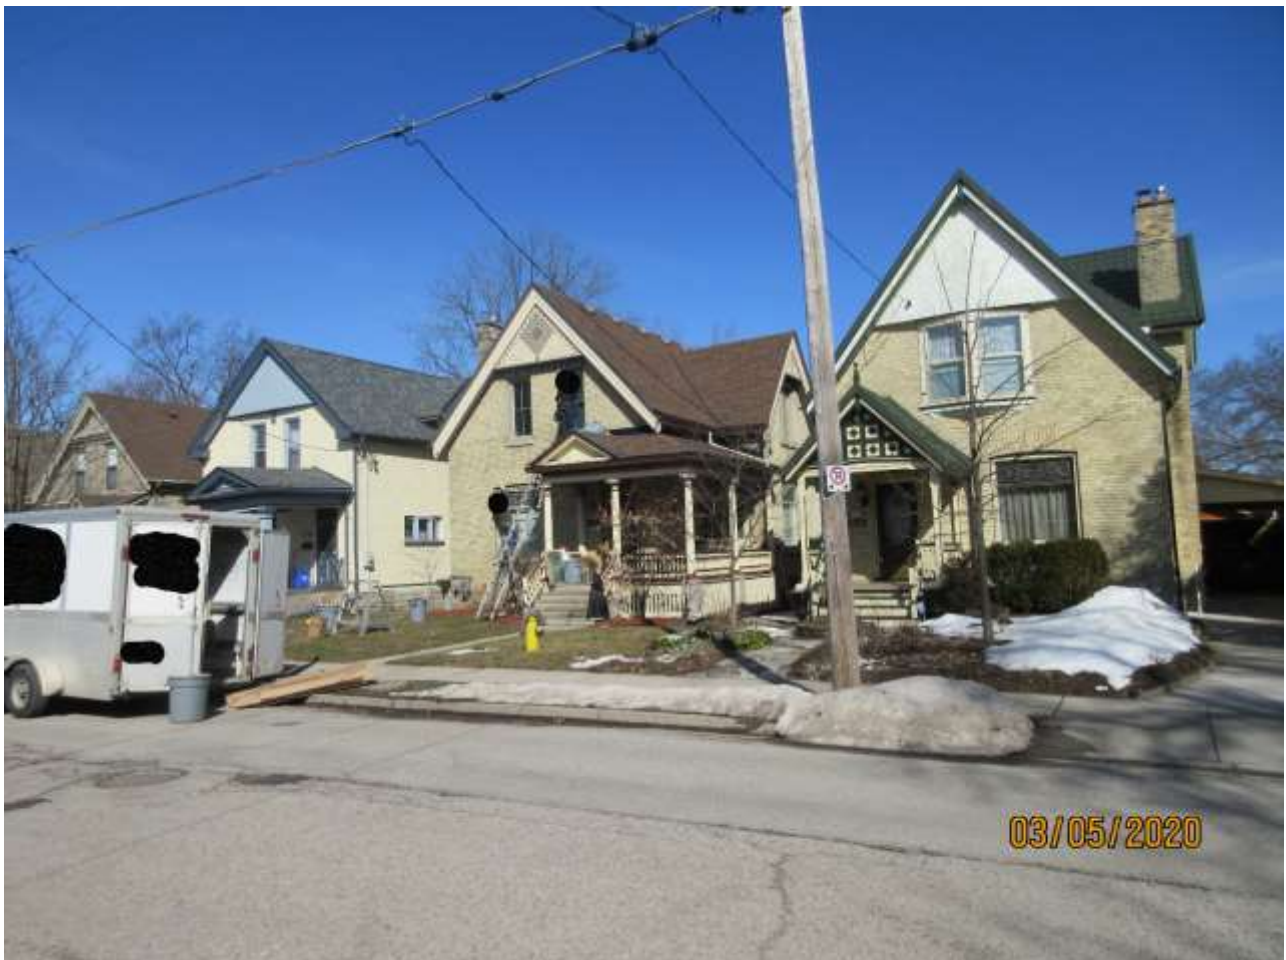
A complaint from the community brought unapproved alterations underway to the property at 784 Hellmuth Avenue to the attention of the City on March 5, 2020. The Heritage Planner went to investigate and observed the windows of the property at 784 Hellmuth Avenue being replaced (see Appendix B, Image 2).

Image 2: Photograph showing the windows of the property at 784 Hellmuth Avenue being replaced on March 5, 2020.

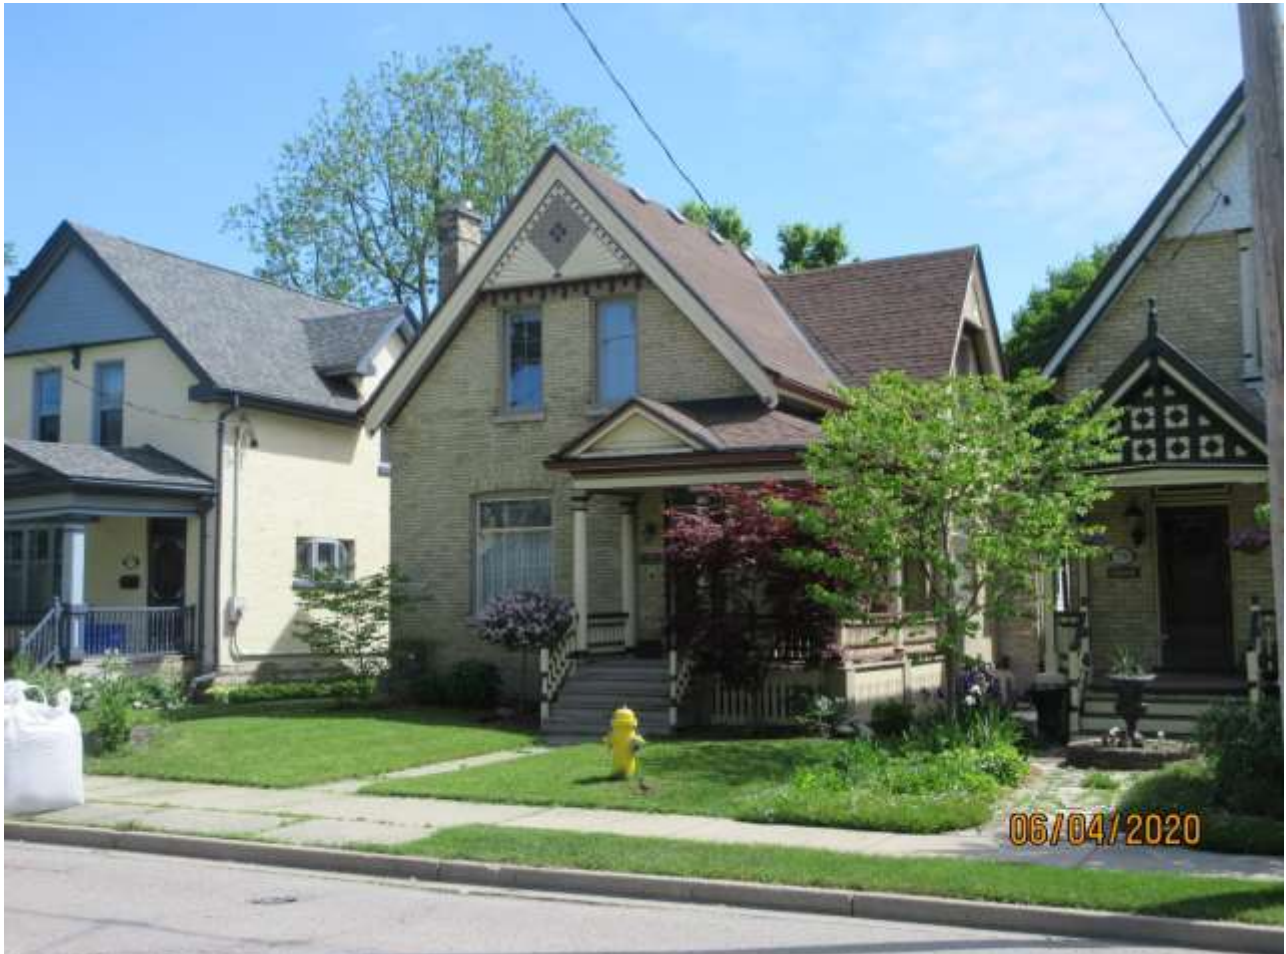
Image 3: Photograph showing the property at 784 Hellmuth Avenue following the replacement of the windows without Heritage Alteration Permit approval.

- Finish: painted wood
- Style: single or double hung sash windows
- Proportions: undivided lights (no faux grilles)
- Placement: within the original openings

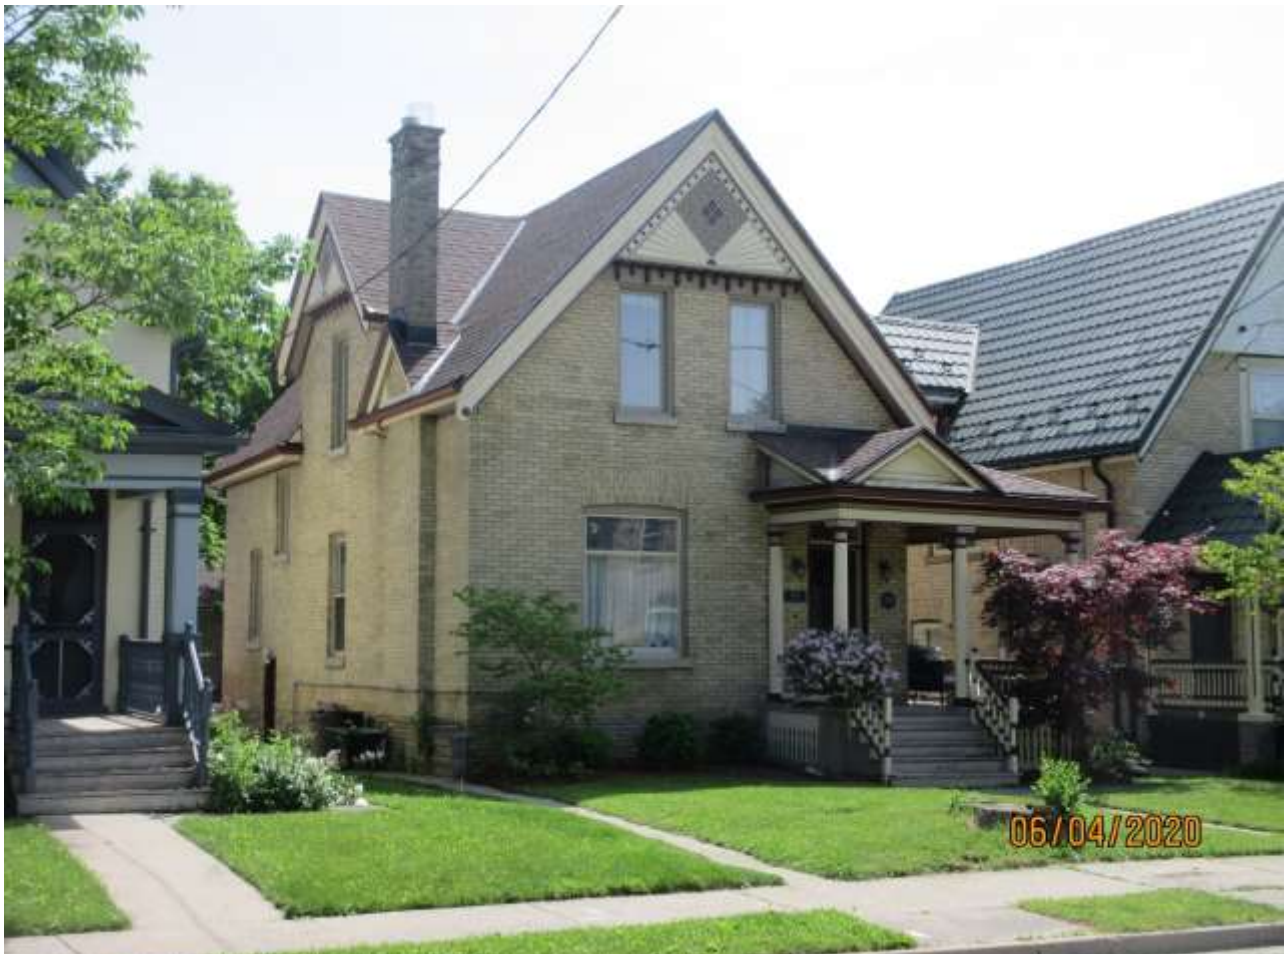
Image 4: Photograph showing the property at 784 Hellmuth Avenue following the replacement of the windows without Heritage Alteration Permit approval.

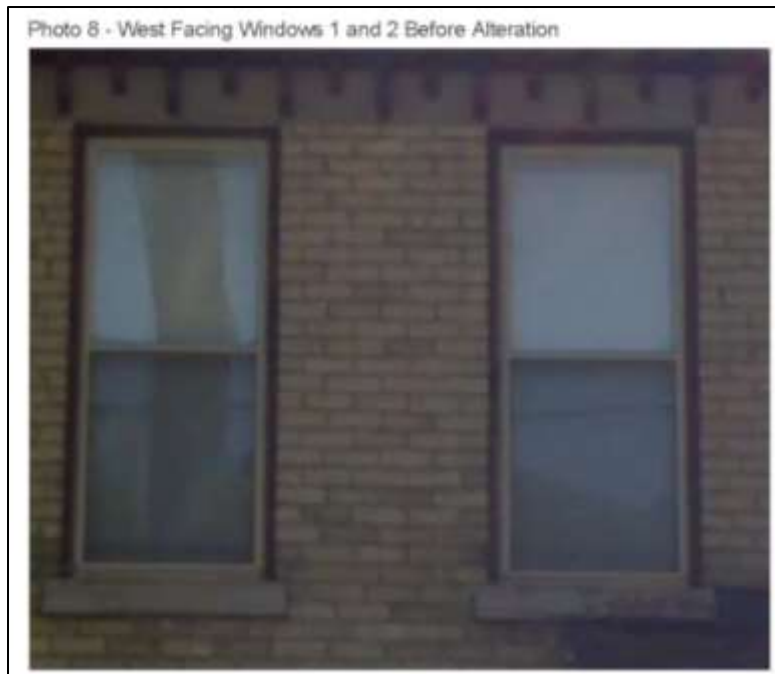
Image 5: Image, submitted as part of the Heritage Alteration Permit application, showing a detail of the upper windows on the west façade of the heritage designated property at 784 Hellmuth Avenue.

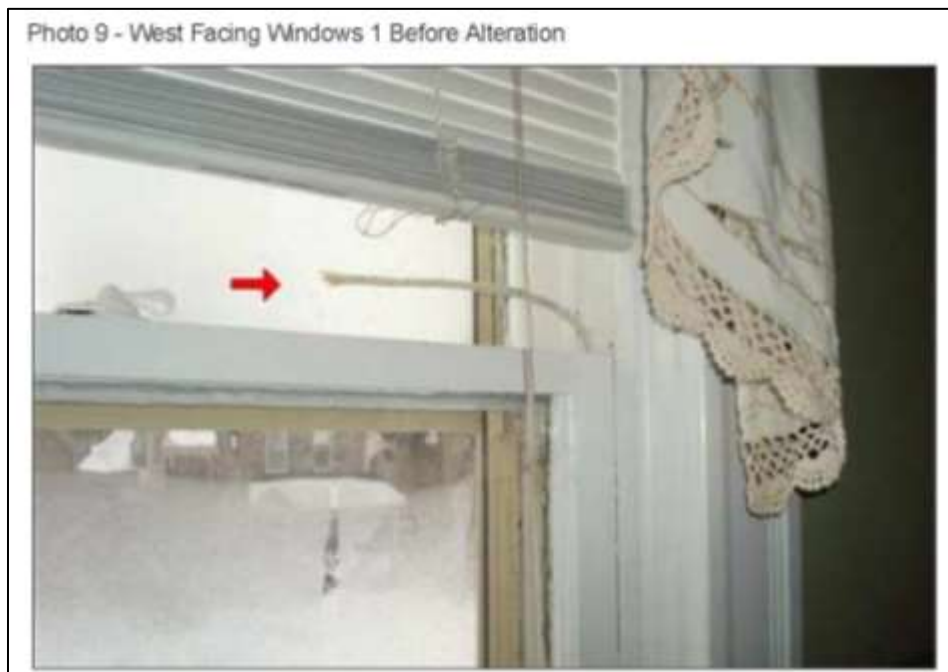
<p>Preserve Historic Architectural Features <i>Alterations should preserve important architectural features of the main building.</i></p>	<p>The replacement of the windows of the heritage designated property at 784 Hellmuth Avenue failed to preserve important architectural features, which includes the windows.</p>
<p>Conserve Rather than Replace <i>Original building materials, features and finishes should be repaired and conserved rather than replaced, when possible. The original has greater historical value.</i></p>	<p>Within their Heritage Alteration Permit application, the property owners stated that the windows that were replaced with not the original windows of the home. This is unclear; aluminum storm windows appear to have been installed over wood windows that are consistent with the age and style of the property.</p> <p>Also within their Heritage Alteration Permit application, the property owners included a photograph of a cracked glass window pane and cut sash cords (see Appendix B, Image 6, Image 11, and Image 12). These are repairable issues.</p> <p>The replacement of the windows fails this principle.</p>

Image 6: Image, submitted as part of the Heritage Alteration Permit application, showing a cut or broken sash cord.

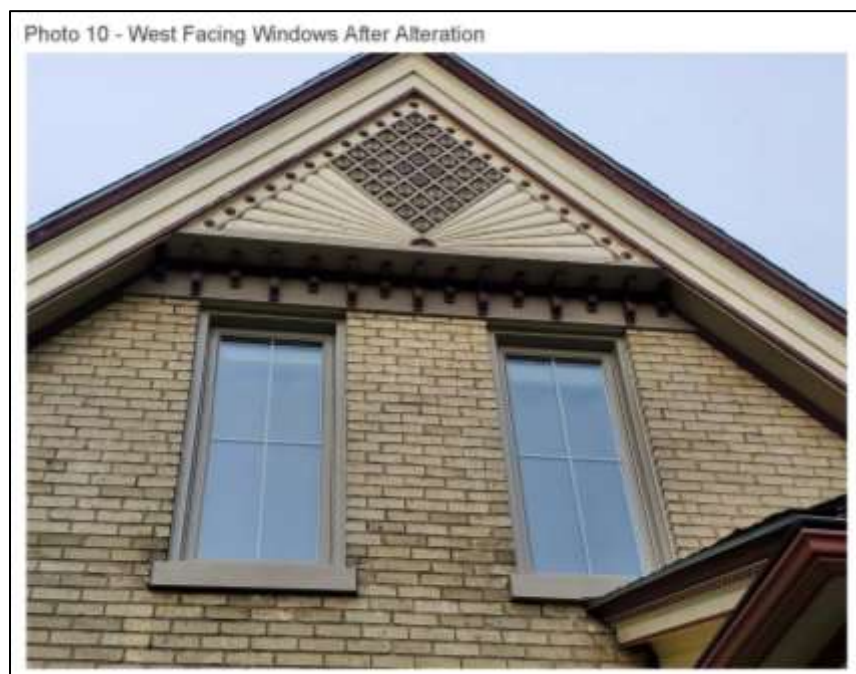
Section 4.2 Building Alteration Policies: Windows	Analysis
Finish	The original windows were painted wood, which is a historically appropriate and repairable material. The replacement windows are vinyl, which is specifically discouraged by the policies and guidelines of the <i>Bishop Hellmuth Heritage Conservation District Plan and Guidelines</i> , as vinyl and aluminum-clad windows “lack historic character.”
Style	The original windows were (single or double hung) sash windows. The replacement windows are casement and awning style. The change in window style is not appropriate.
Proportions	The original windows were undivided sash windows. The replacement windows have a faux grid in an attempt to create the suggestion of a two-over-two fenestration pattern. The faux grid is not successful and not in keeping with the original windows.
Placement	No window openings were altered in the window replacement. The use of vinyl replacement windows is bulkier than the original wood windows.

Image 7: Detail image of the upper windows on the west façade after their replacement, submitted as part of the Heritage Alteration Permit application.

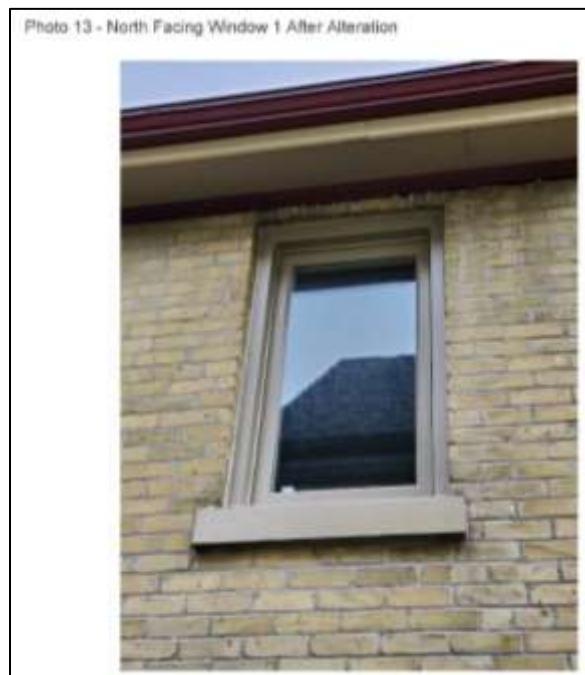
Image 9: Image of the north facing window 1 after alteration (exterior), submitted as part of the Heritage Alteration Permit application.

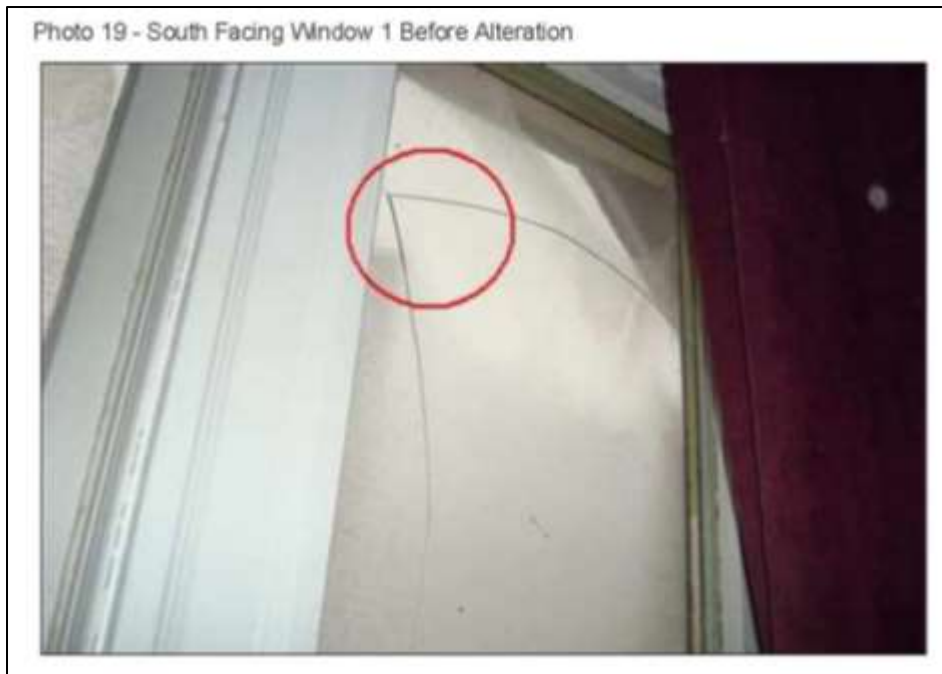
Image 11: Image of the south facing window 1 before alteration (interior), submitted as part of the Heritage Alteration Permit application. Circle on image identifying crack in the glass pane.

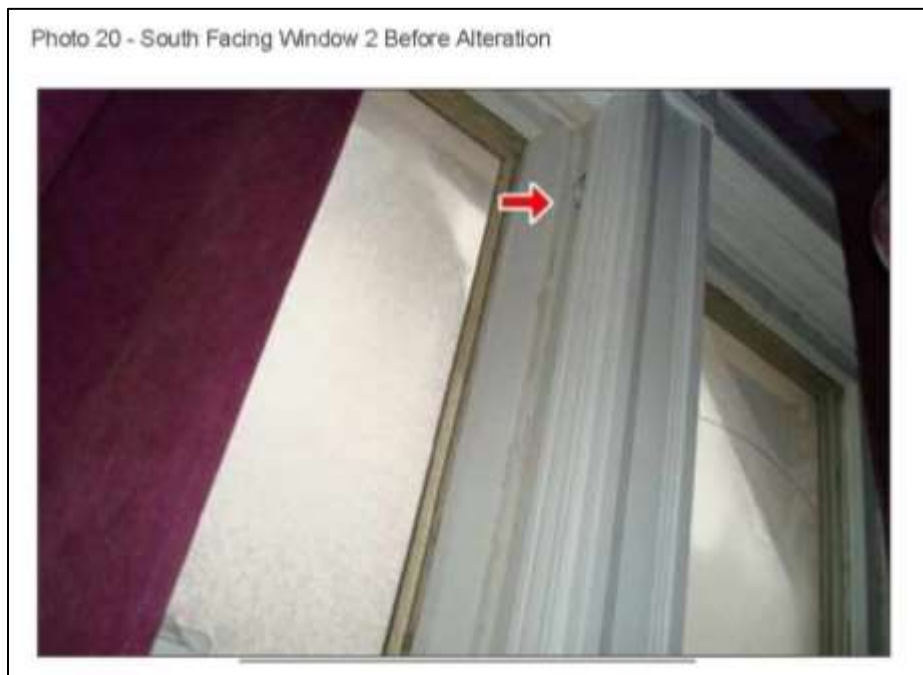
Image 12: Image of the south facing window 2 before alteration (interior), submitted as part of the Heritage Alteration Permit application. Arrow on image identifying missing sash cord.

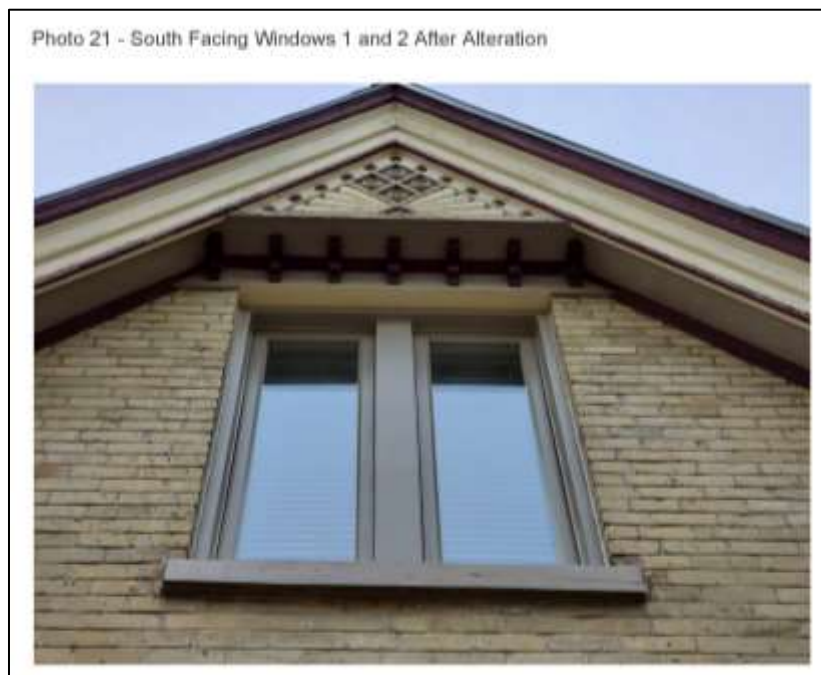
Image 13: Image of the south facing window 1 and 2 after the alteration (exterior), submitted as part of the Heritage Alteration Permit application. The mullion between the windows appears to have been removed or clad in siding.
