Environmental Impact Study: Arva Pumping Station to Huron Street Water Transmission Main Municipal Class Environmental Assessment Master Plan London, Ontario

Date: April, 2021 **Project #:** 60619503

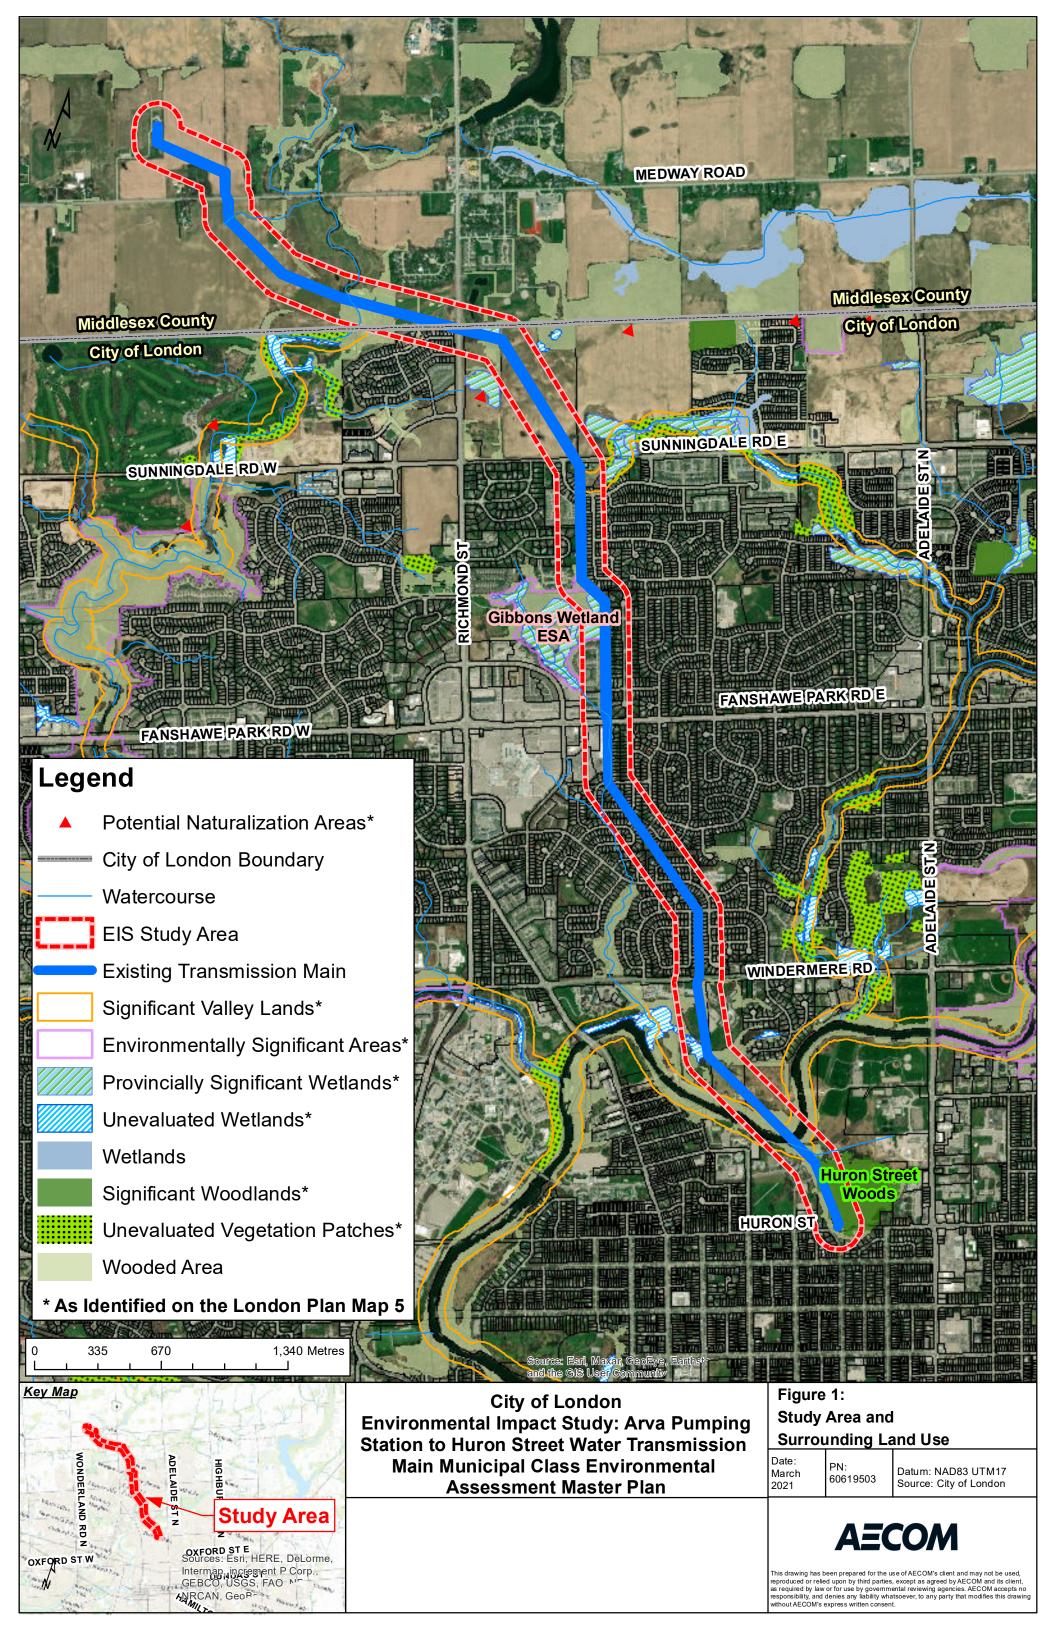
Figure 1: Study Area

The Study Area includes approximately 8 km of water transmission main which extends from the Arva Reservoir and Pump Station to Huron Street plus an additional 120 m (on either side of the transmission main) area of investigation which allowed for the identification of Adjacent Lands as defined by the Natural Heritage Reference Manual (MNRF2005) (see **Figure 1**).

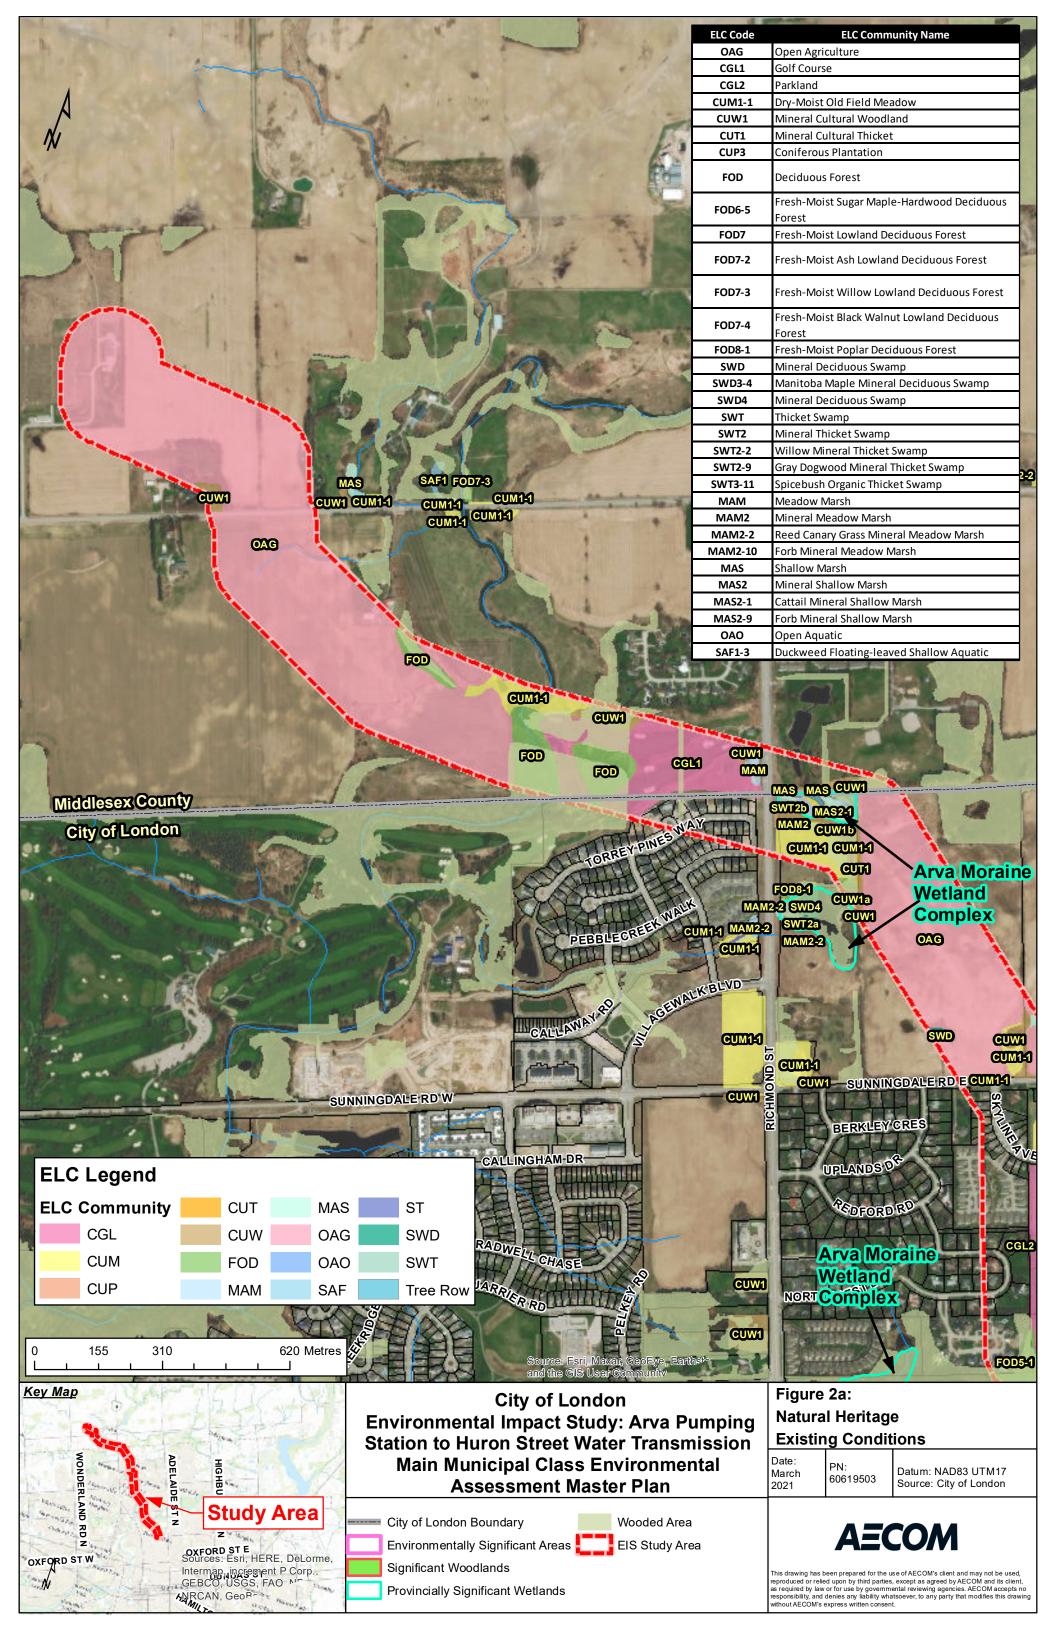
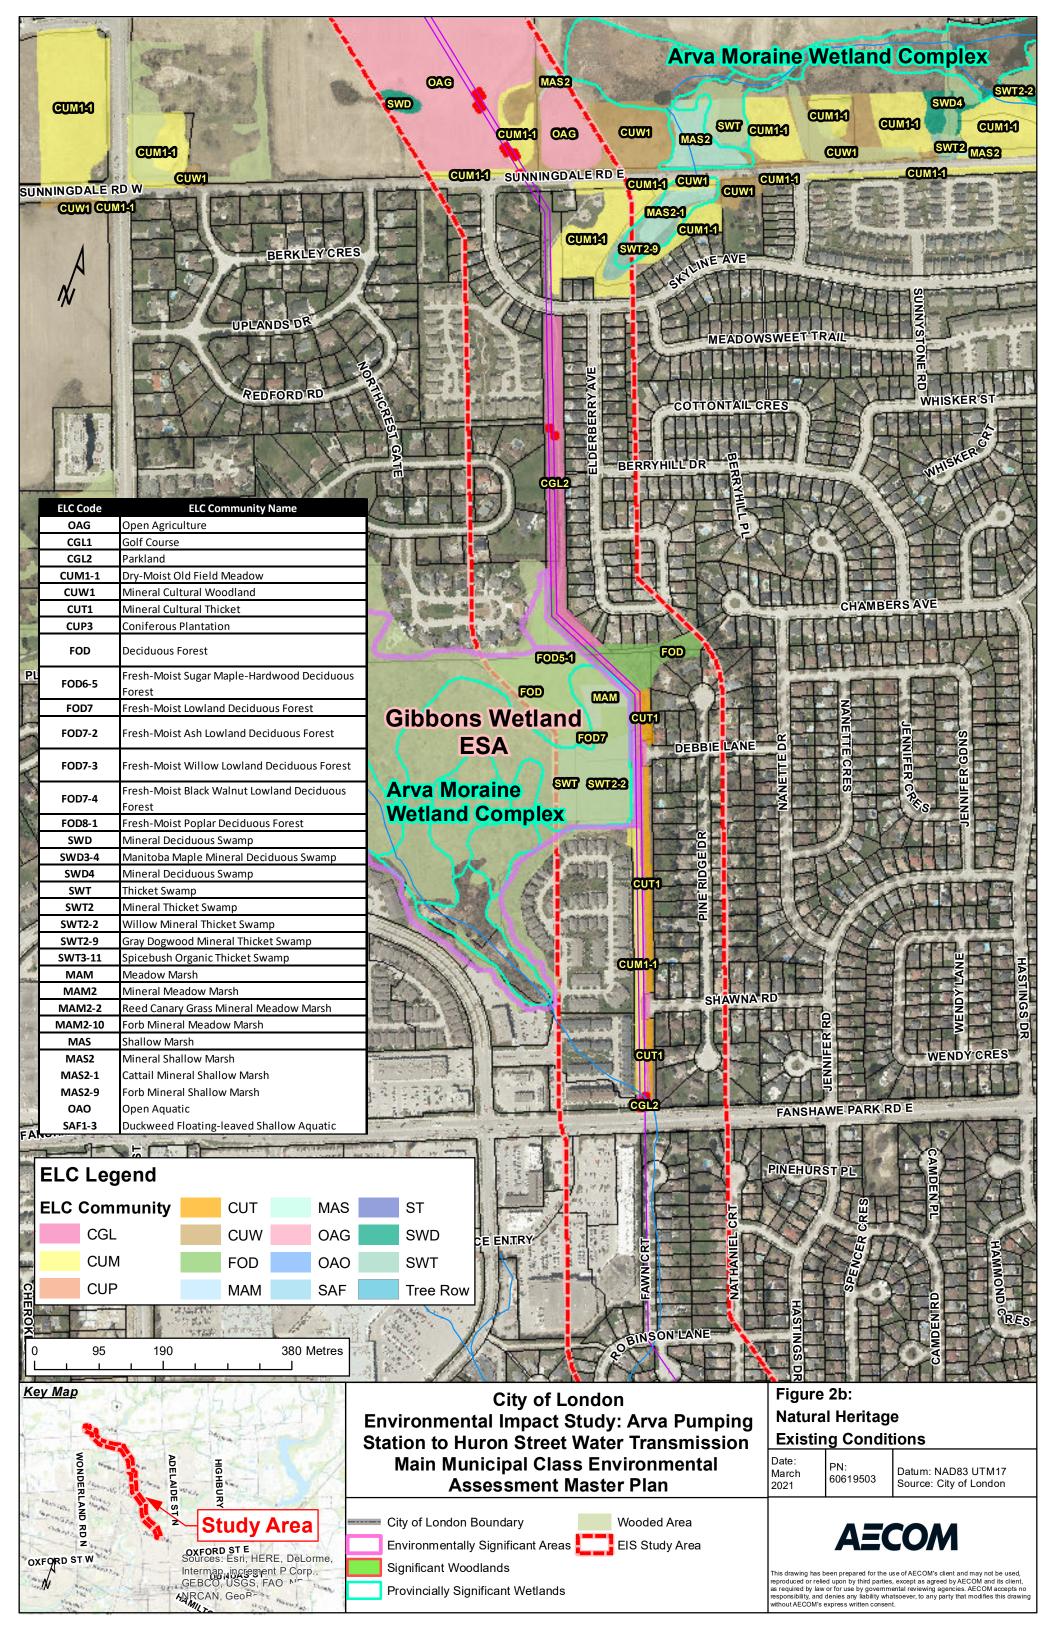
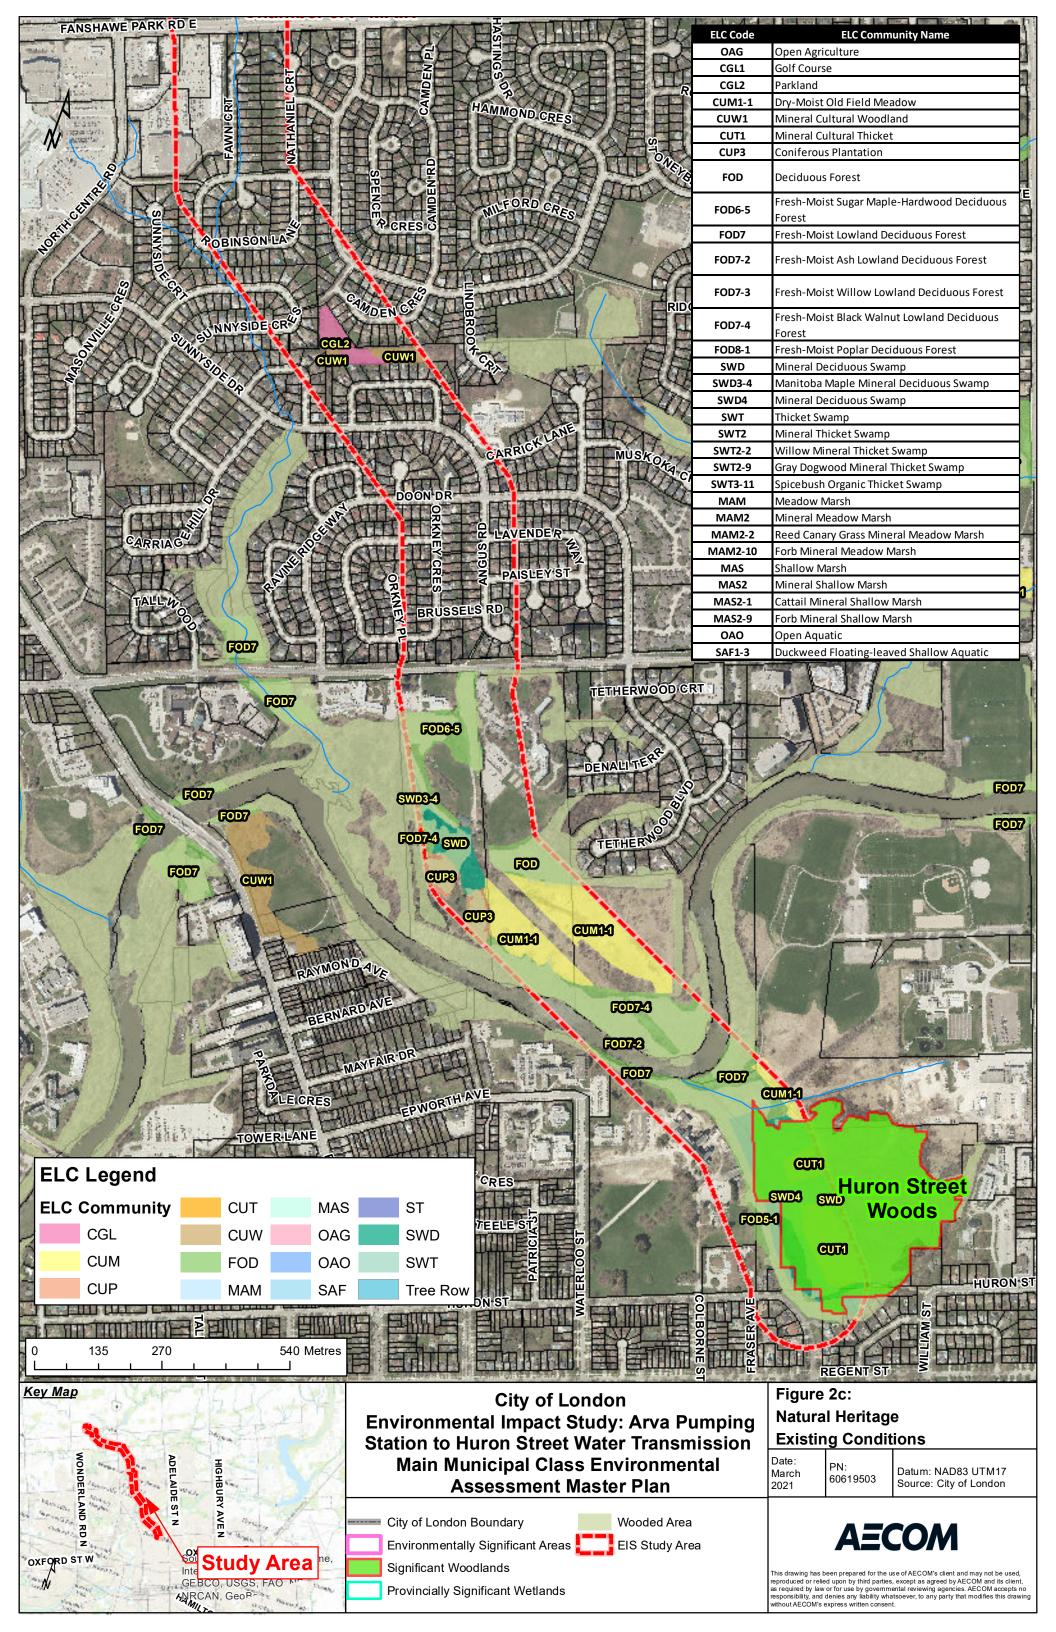
- 1. Aquatic features within the Study Area include the North Thames River, a tributary to the North Thames River, Masonville Creek, Medway Creek and unnamed Municipal Drain 1. Aquatic features within the Study Area are described in detail in Section 3.1 of the NHSR (AECOM 2021b) and are indicated on **Figure 2**.

- 2. Multiple vegetation community types were identified within the Study Area during ELC assessments. These include cultural meadows, cultural woodlands, shallow and meadow marshes, swamp thickets, deciduous swamps as well as deciduous forests and cultural plantations. Vegetation communities identified through a review of background information and field investigations are described in detail in Section 3.2.2 of the NHSR (AECOM 2021b) and are delineated on Figure 2.

- 4. The Gibbons Wetland Environmentally Significant Area (ESA) is present within the Study Area (see Figure 2) and is located east of Richmond Street and north of Fanshawe Park Road East. Portions of the Arva Moraine Wetland Complex are present within the Gibbons Wetland ESA.

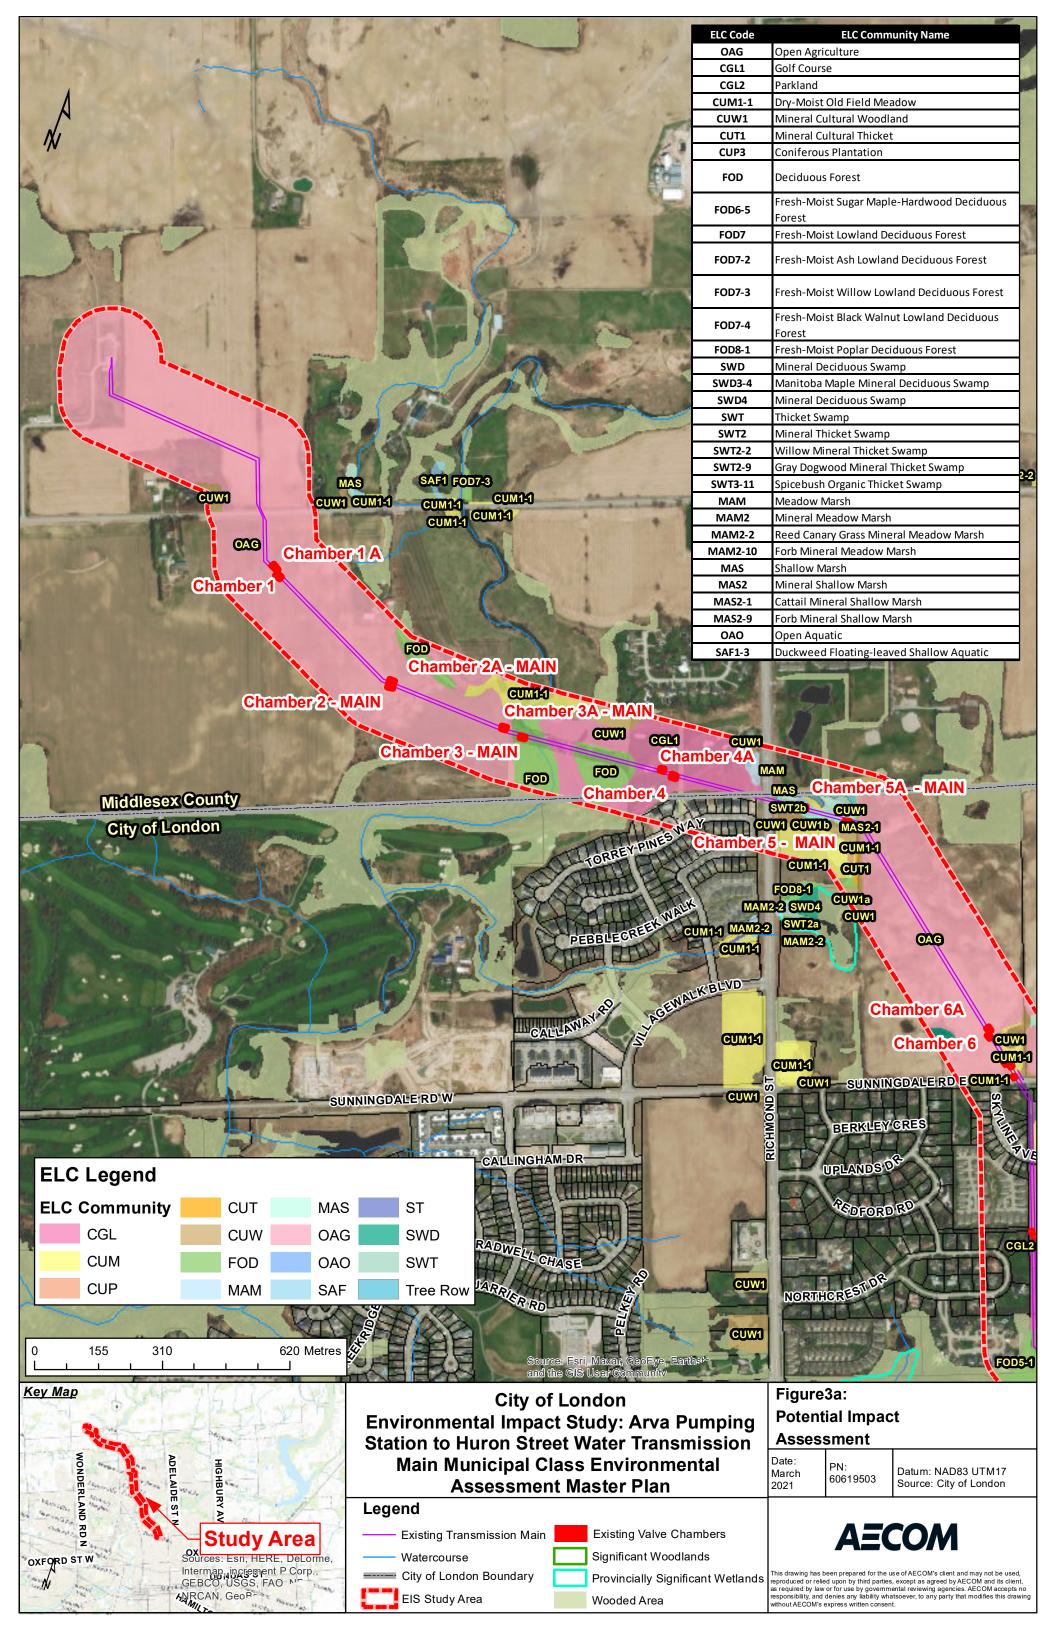
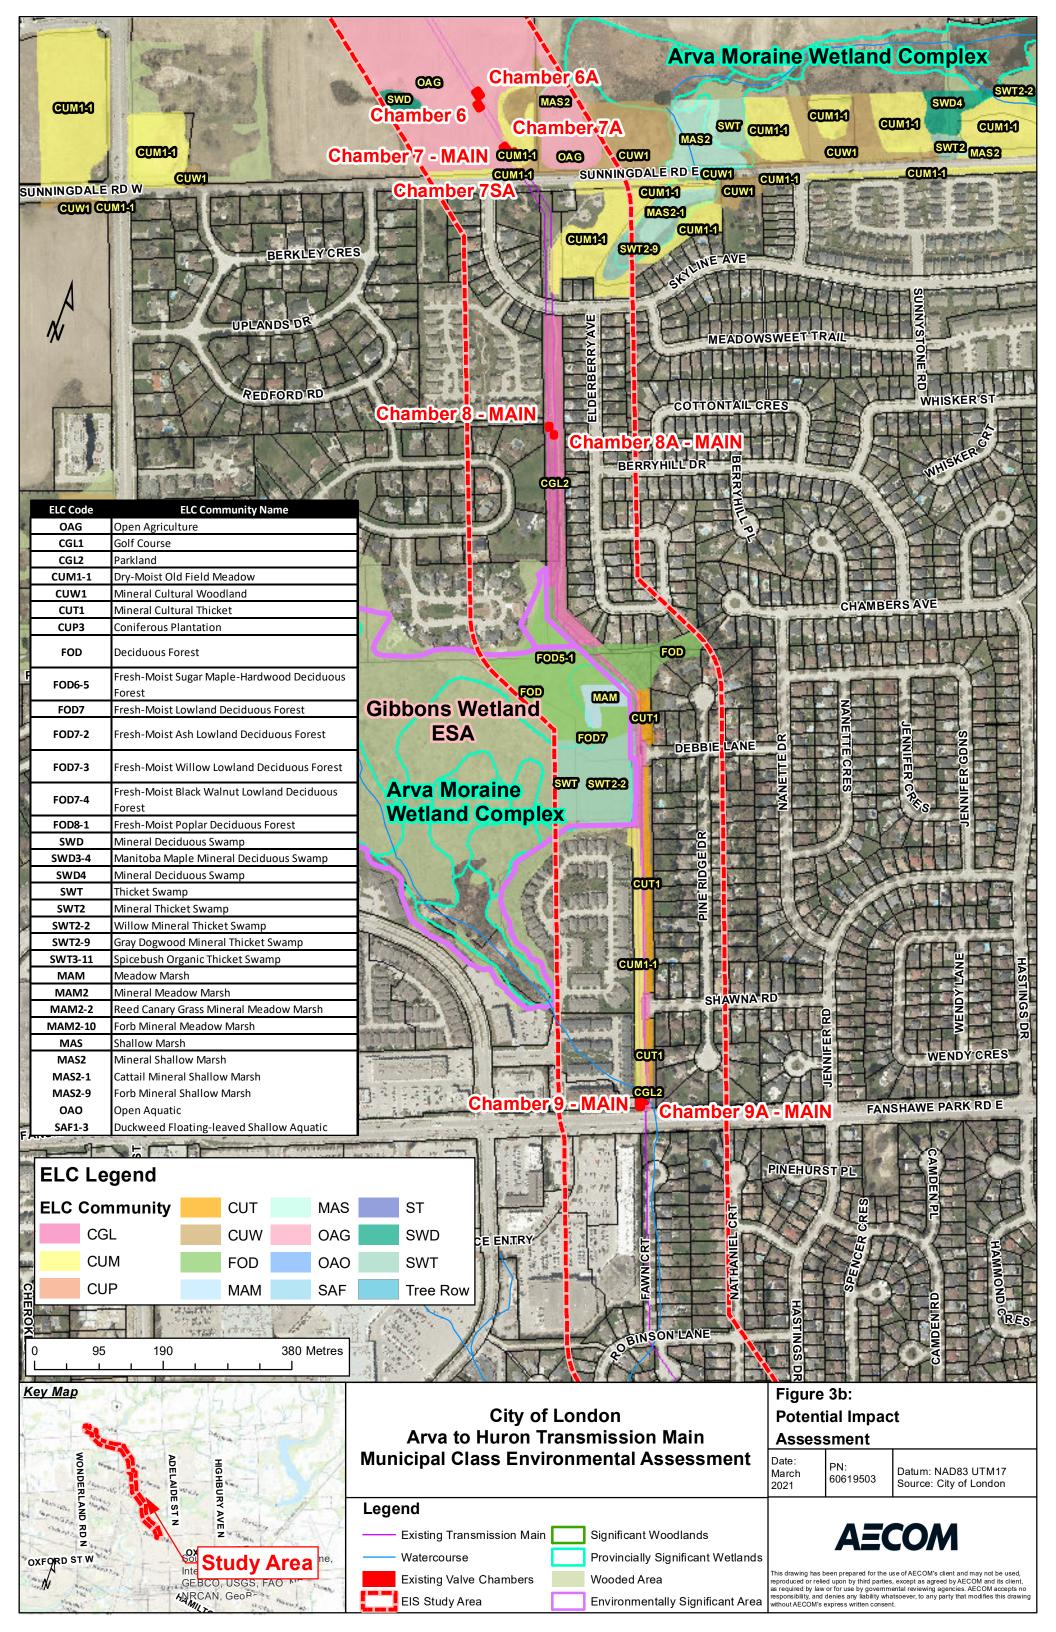
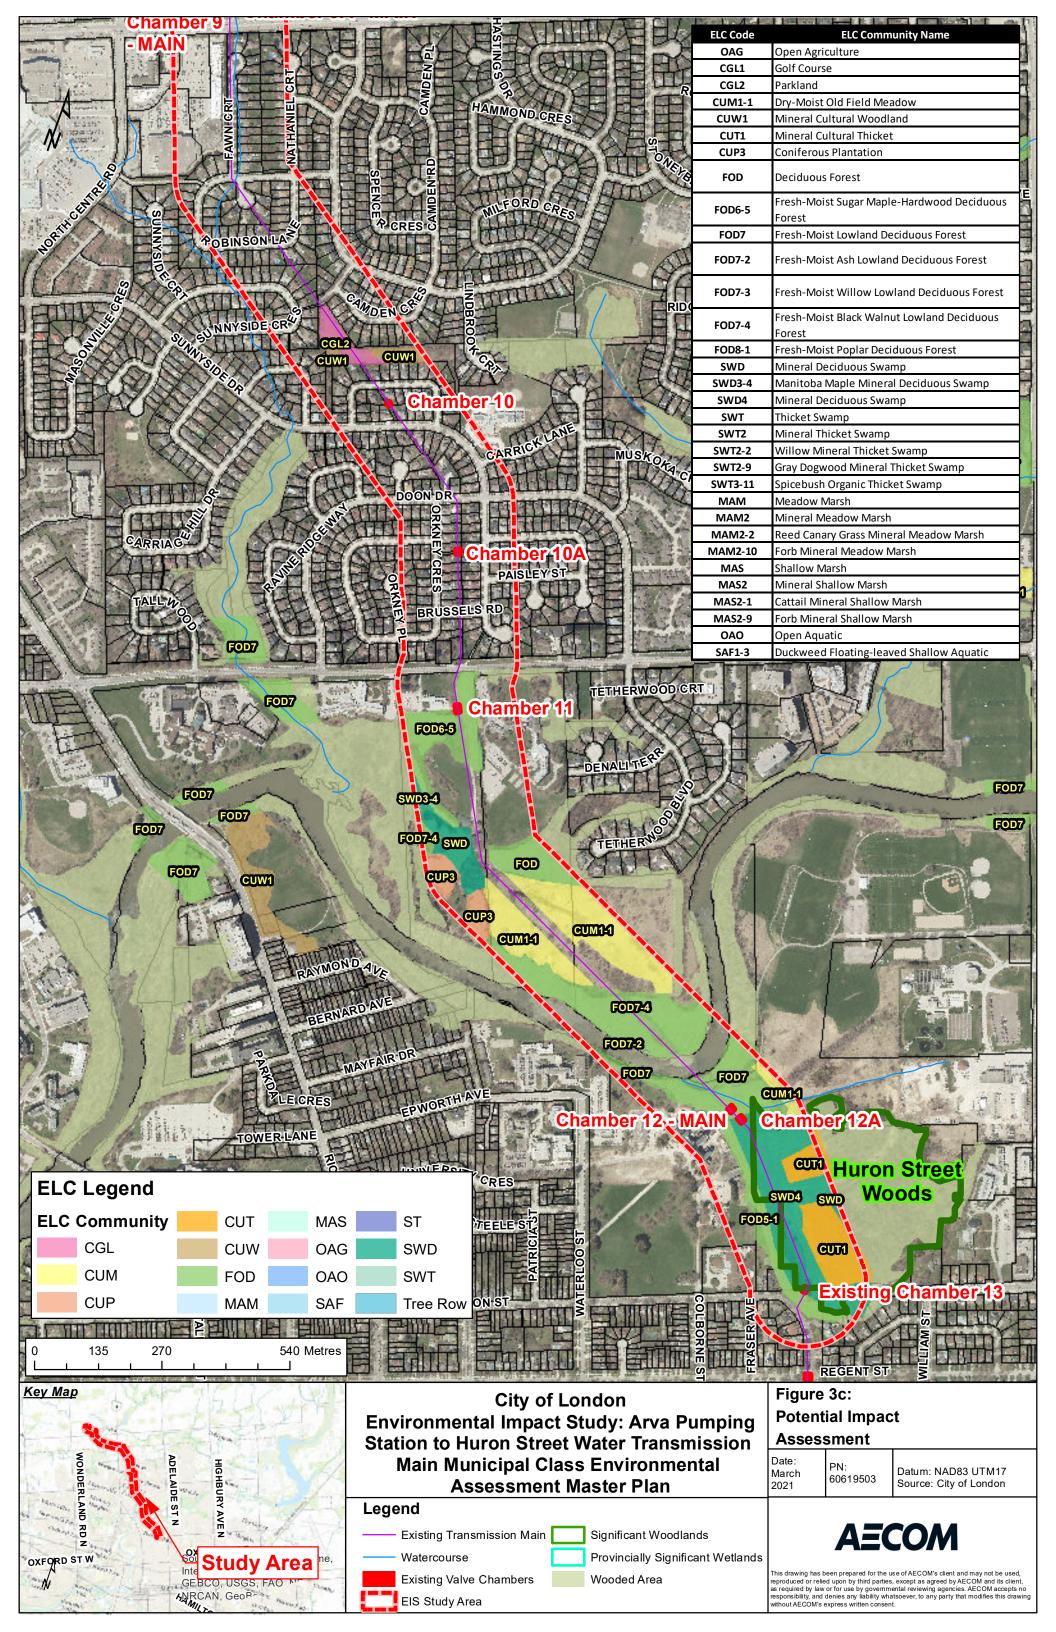
The existing easement was reviewed from the Arva Pumping Station to Chamber 13 near Huron Street. **Table 4** below provides an overview of the infrastructure reviewed and recommended actions to be taken with respect to repairs and/or maintenance and associated potential impacts anticipated as a result of the activity. The location of the transmission line and associated chambers can be found on **Figures 3a, 3b** and **3c.**
