Report to Planning and Environment Committee

Subject: 2355440 Ontario Inc. – Application for Brownfield Community Improvement Plan Incentives – 250-272 Springbank Drive

Date: October 18, 2021

RAND Development
250 to 272 Springbank Drive, London, ON
April 7, 2021

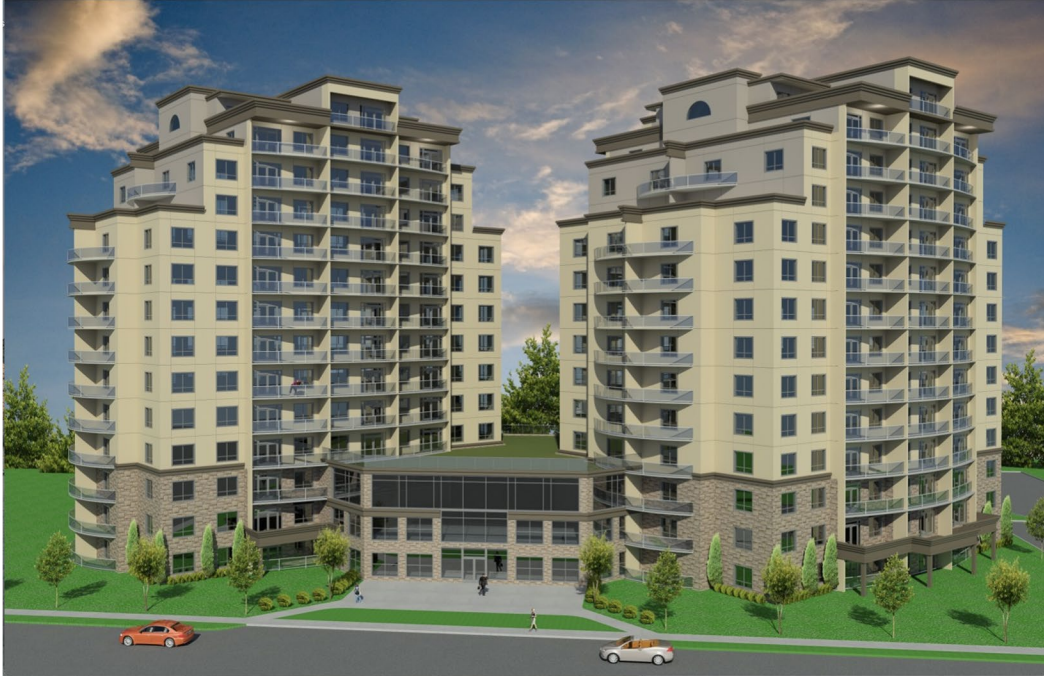
Figure 2. The previously approved twin residential towers proposal bridged by the connecting commercial podium.

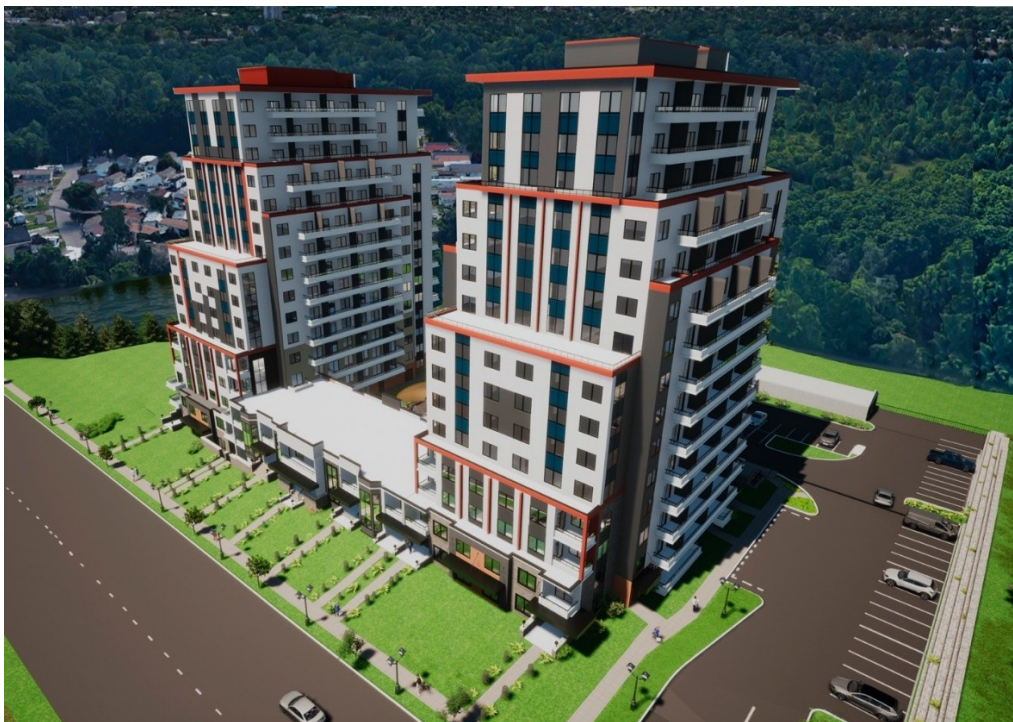
Figure 3. The newly proposed twin residential towers joined by the central residential podium, enhanced by gardening and landscaping to welcome residents.

In February of 2021, the City accepted an application to rezone the site and permit the buildings as depicted in Figure 3 above. One of the requirements that was agreed upon between the developer and the City to allow for the rezoning is to ensure there will be affordable units for consumers (number to be determined). Furthering this planning process, a major change for this development involved the addition of 20 units and the removal of the commercial podium.

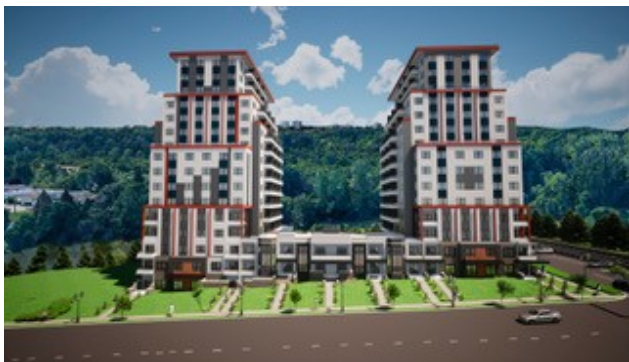
Figure 4. Proposed New Concept with Additional Residential Units between the Towers
