EIS prepared for 179 Meadowlily Road by MTE dated April 30, 2021

Received by EEPAC at its October 2021 meeting

Reviewed by: S. Hall, S. Levin, R. Trudeau, I. Whiteside for EEPAC's Nov 2021 meeting

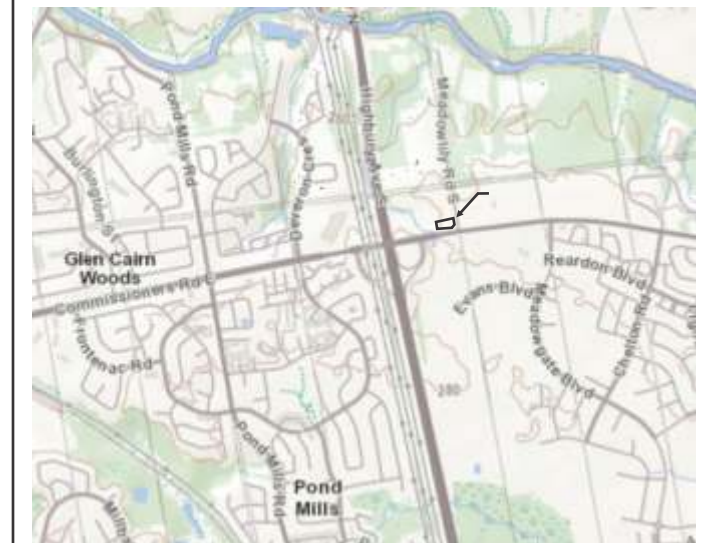
Figure 5: UTRCA Regulated Area
(2019 UTRCA)

- Assessment Parcel (MPAC)
- Legal Parcel
- Watercourse
 - Open (Class F Municipal Drain)
 - Tiled
- Wetland Hazard
- Flooding Hazard
- Regulation Limit 2015

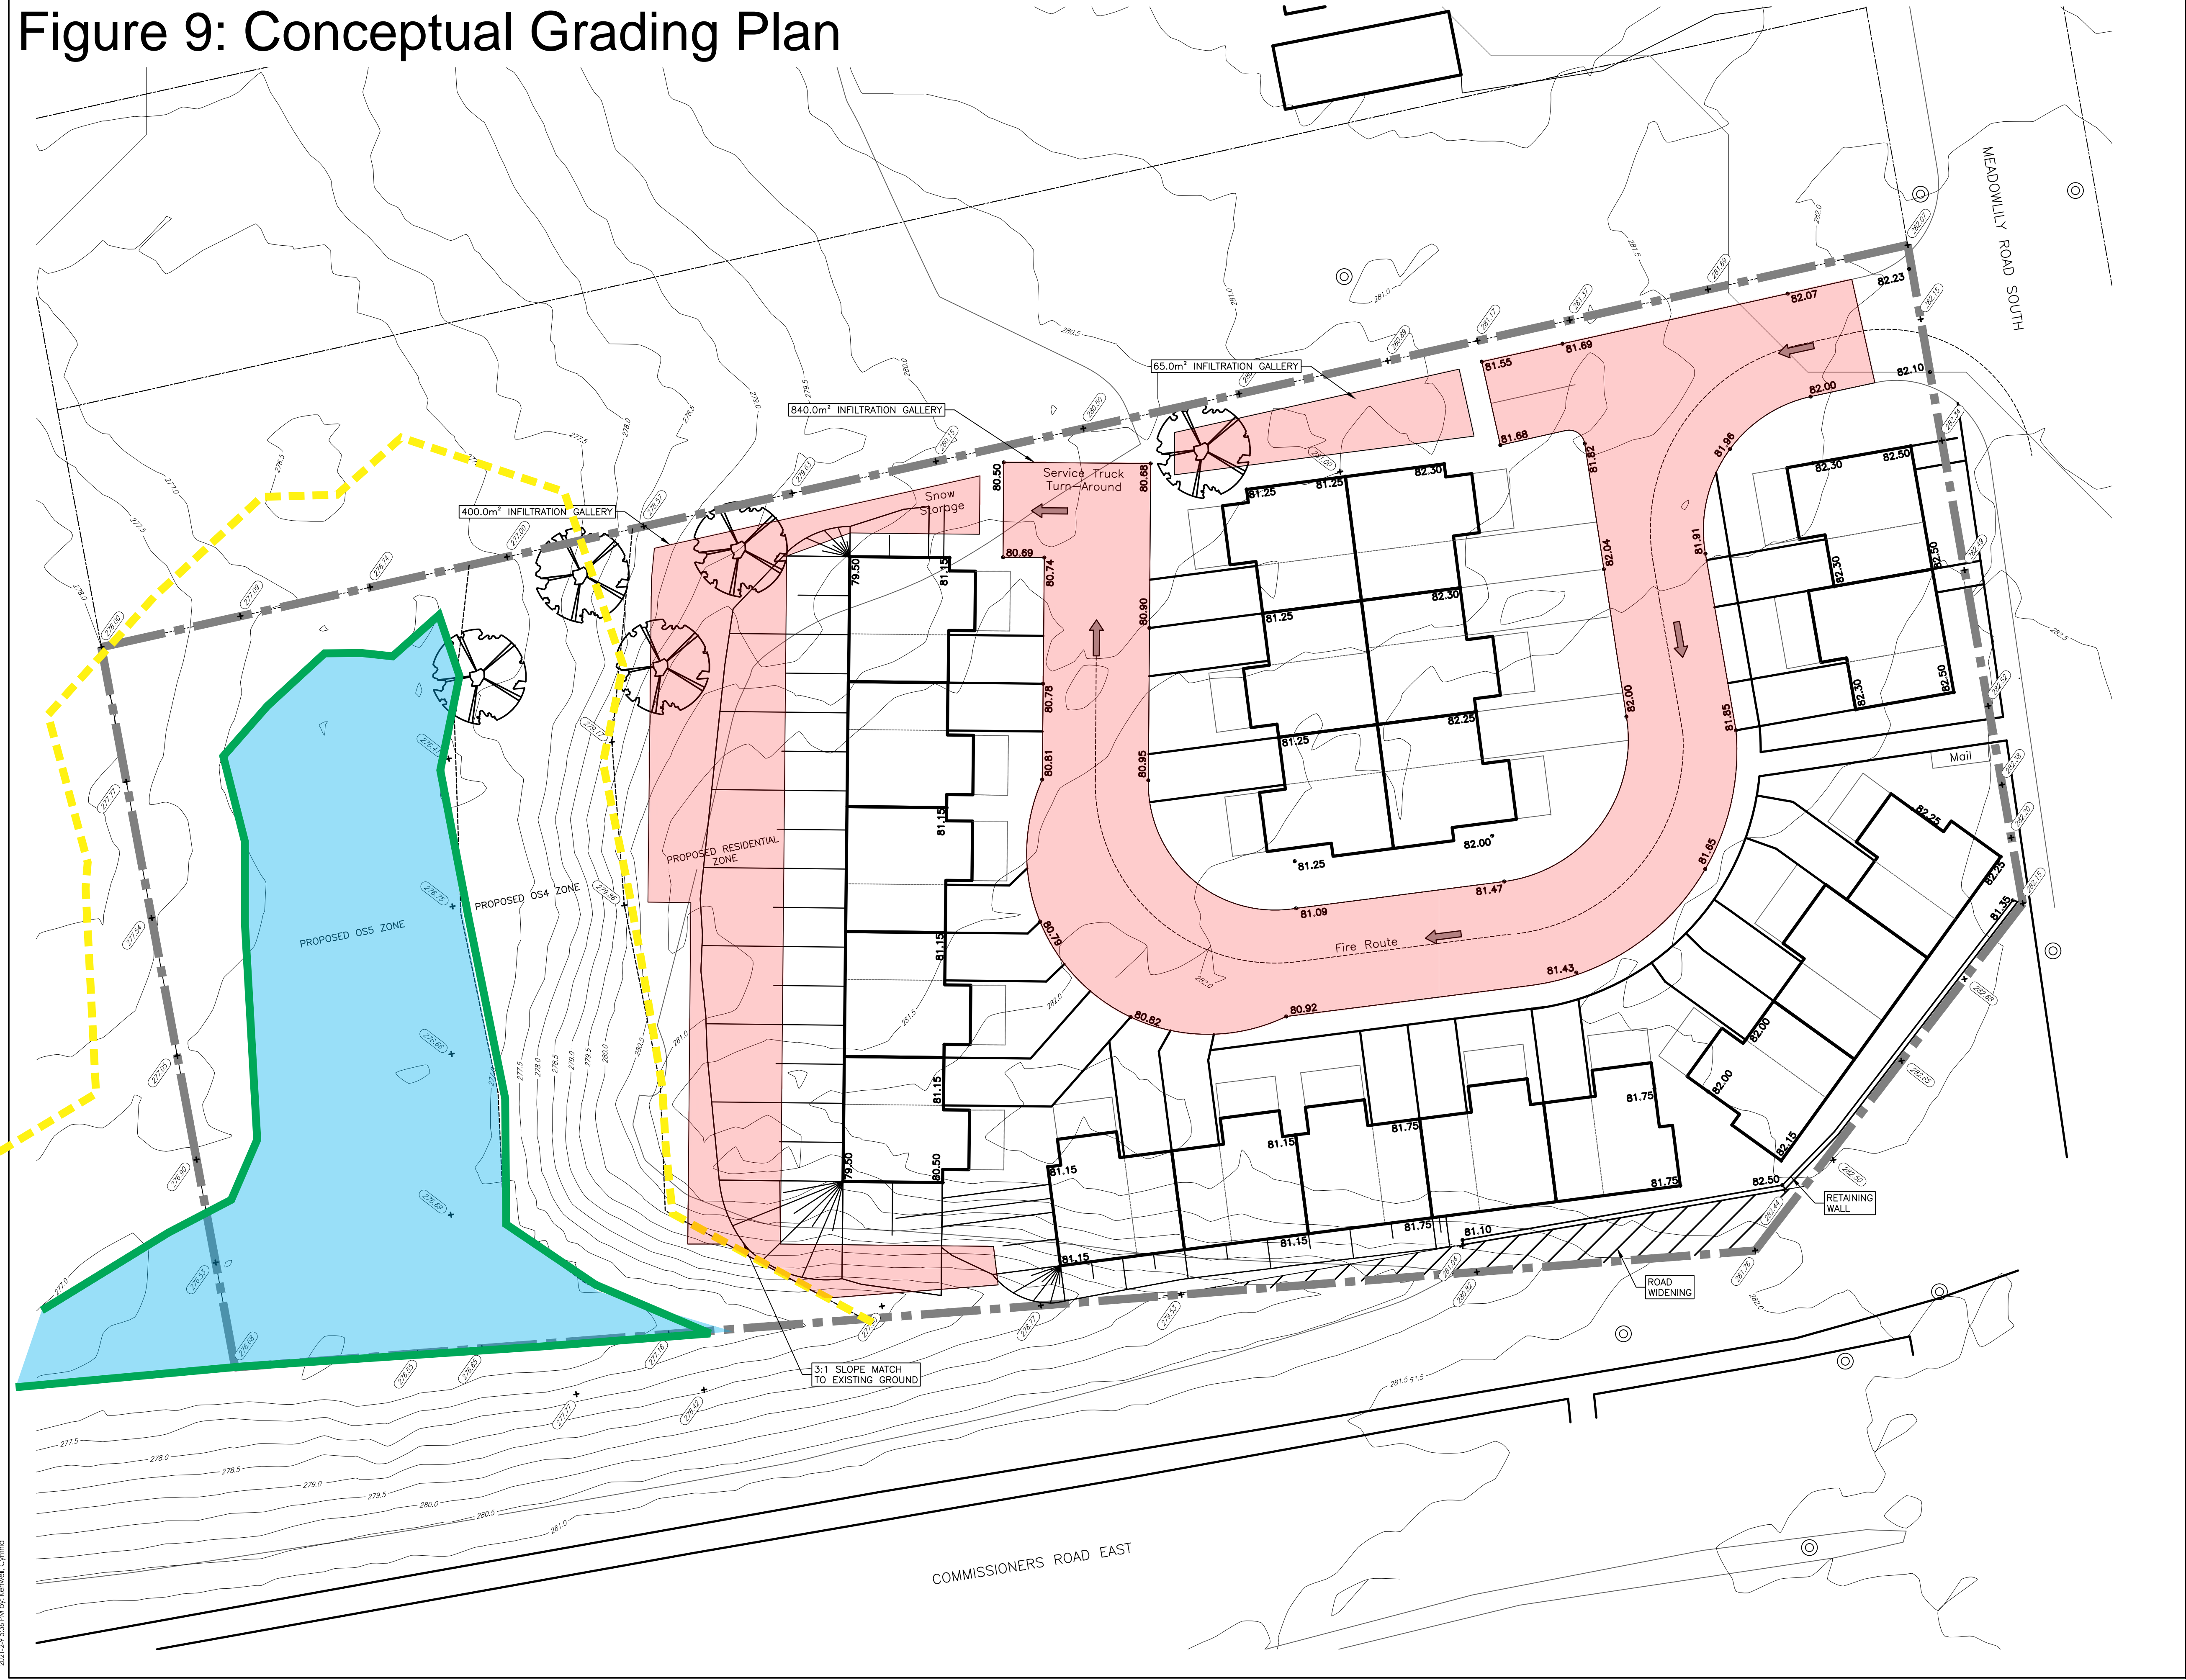
Figure 9: Conceptual Grading Plan

Title
 CONCEPTUAL GRADING PLAN

EEPAC is concerned that the buffer proposed from the ESA and the wetland inclusion is insufficient given the proposed grading to put in a retaining wall on the site. Although the buffer from the flow path of the watercourse appears to be sufficient protection, EEPAC

This is a standard recommendation - there is no detail. As pointed out by Stantec, this is not a standard project. Grading and construction of the retaining wall are proposed to be within the 10 m buffer of the wetland inclusion, which EEPAC does not support.

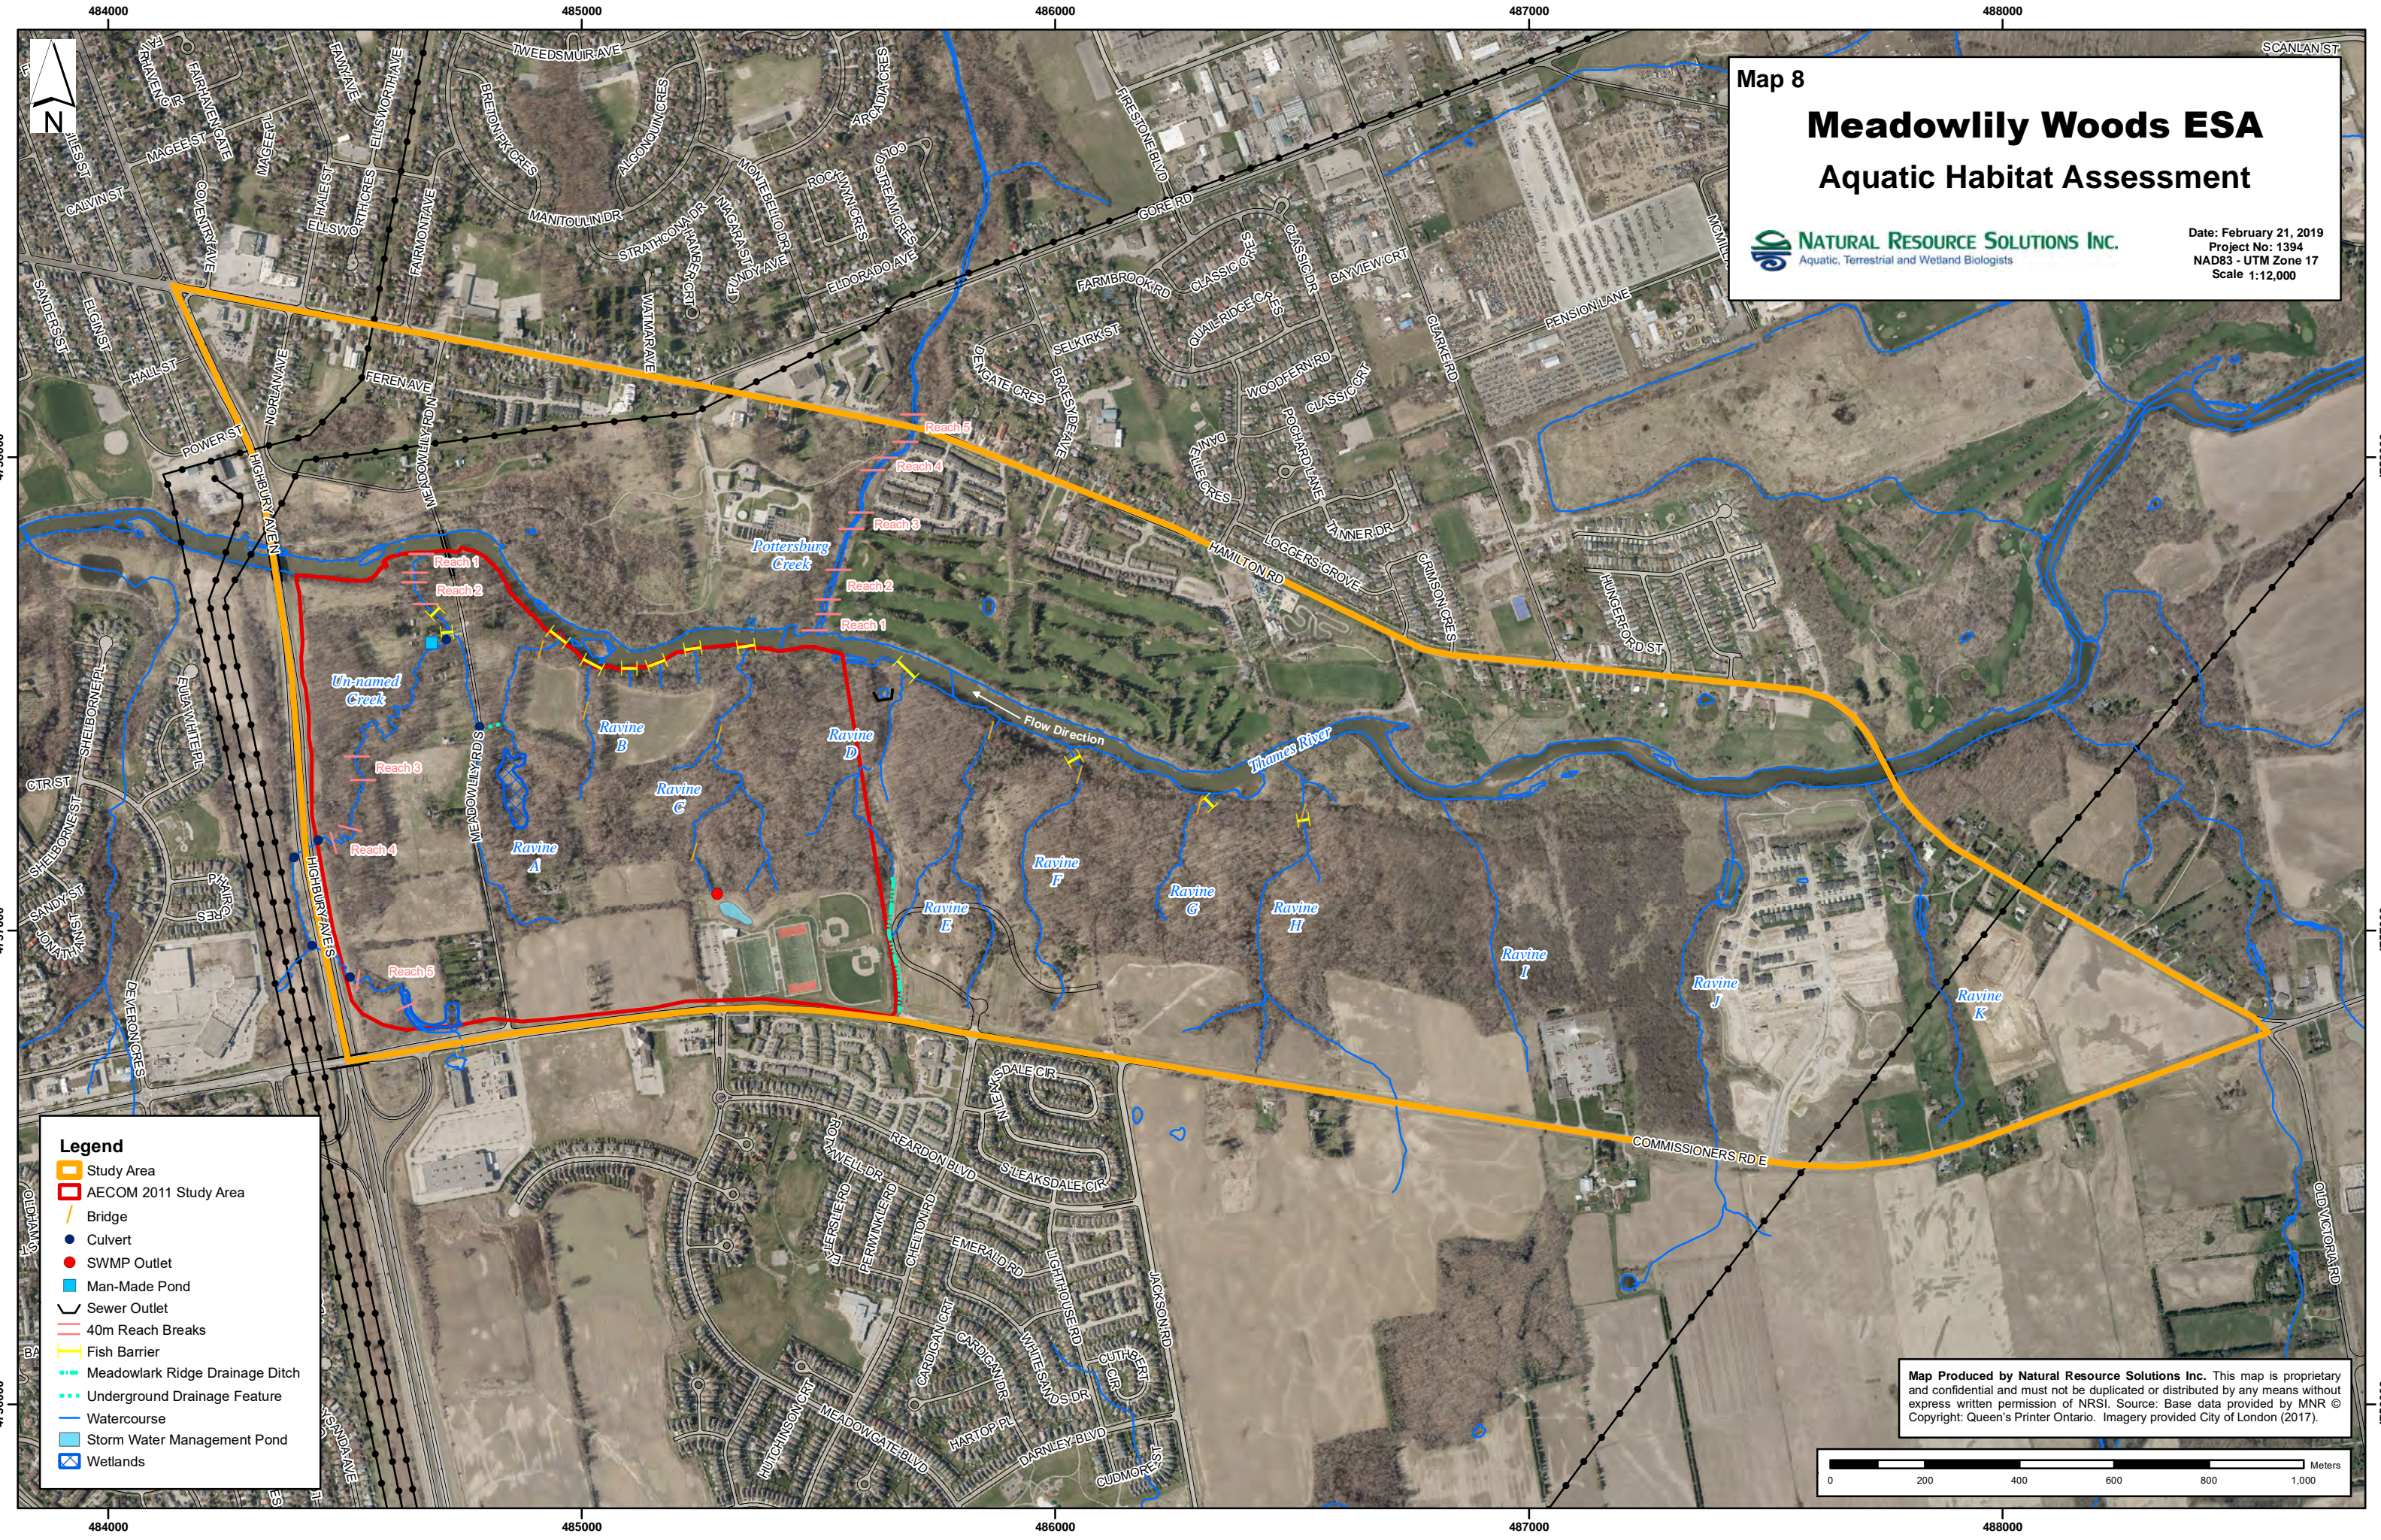
Fish habitat assessments were conducted by AECOM in June 2010 within the selected 40m reaches (Reaches 1, 2, 3, 4, 5) and are discussed further below under each reach (Map 8). The creek was walked in an upstream manner, starting at the confluence with the Thames River to Commissioners Road, which is the study area boundary. Aquatic assessment locations are shown on Map 8.

Aquatic Habitat Assessment

Attached are extracts from Phase 1 of the Conservation Master Plan for Meadowlily Woods ESA by Natural Resources Solutions Inc dated 2019. The watercourse is referenced from AECOM's earlier site work for the City. It is labeled 'Un-named Creek' and appears on the attached Map 8 from the Phase 1 document.
