Report to London Advisory Committee on Heritage

Subject: Demolition Request for Heritage Listed Property at 3700
Colonel Talbot Road by W-3 Lambeth Farms Inc.

Date: Wednesday March 9, 2022

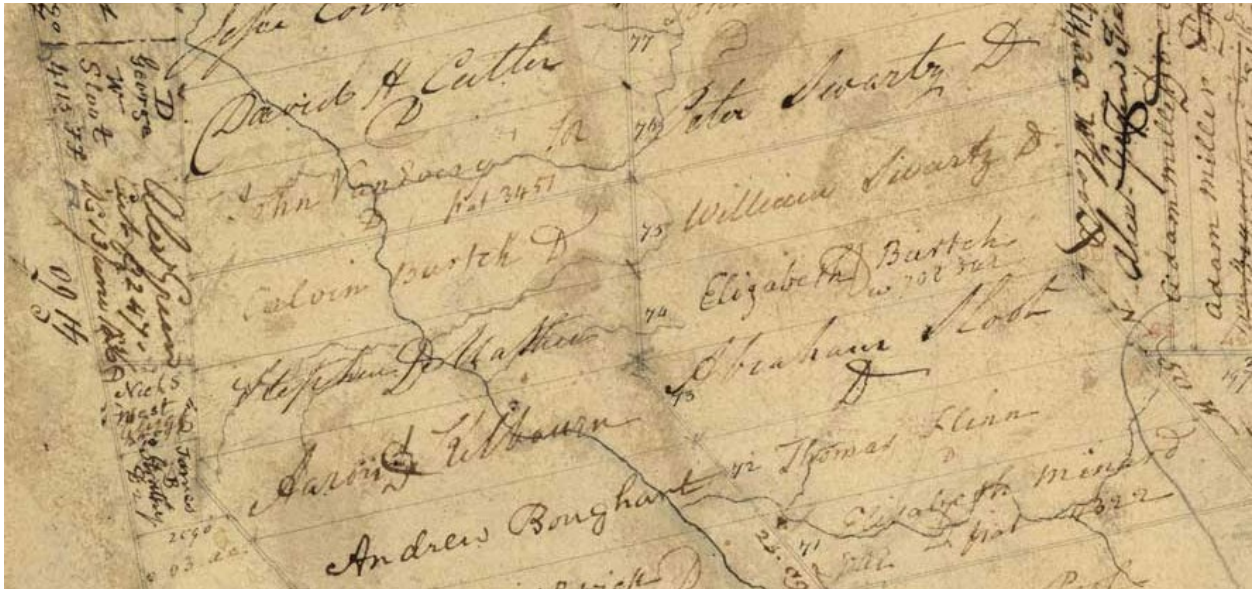
Figure 2: Detail of Westminster Map No. 38 (1843). Elizabeth Burch (sic.) is recorded as the owner of Lot 74 ETR; Calvin Burch (sic.) is recorded as the owner of Lot 75 WTR.

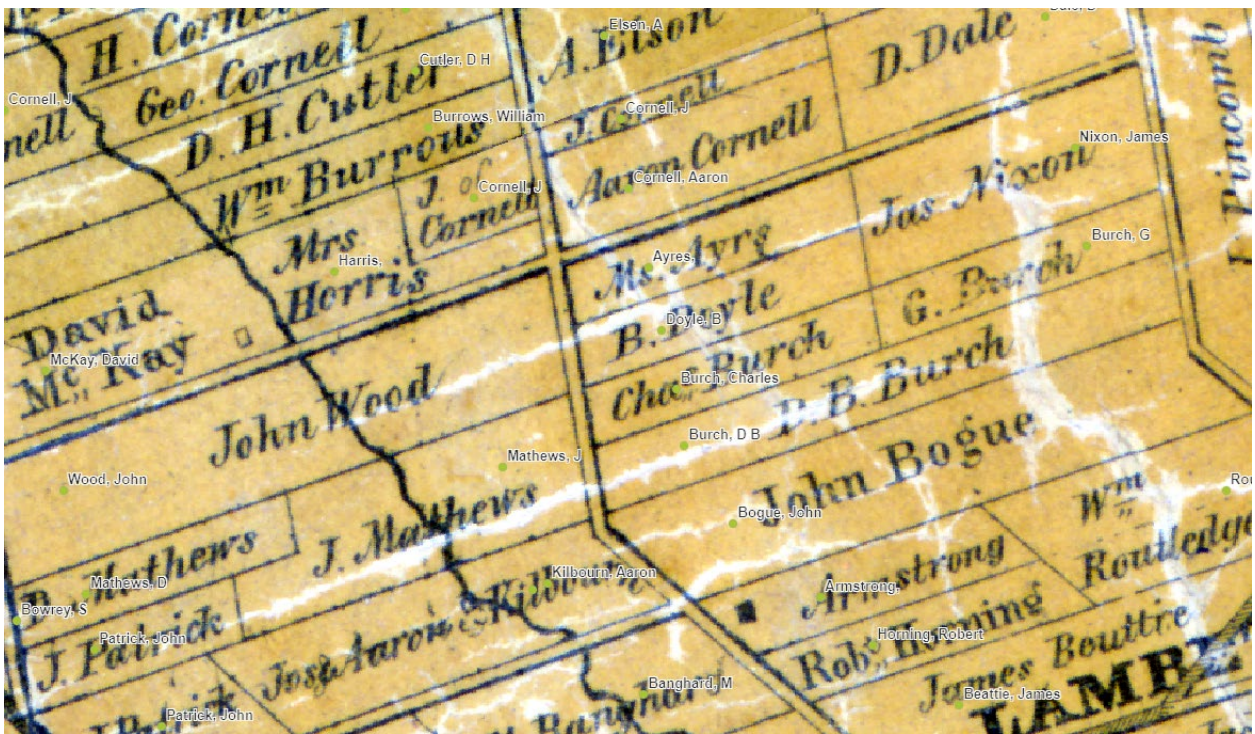
Figure 3: Detail of the Tremaine's Map (1862) for Westminster Township, showing D. B. Burch as the property owner of Lot 74 ETR.

D. B. Burch’s ownership of the property is recorded on *Tremaine’s Map* (1862). The map of Westminster Township included in the *Illustrated Historical Atlas of Middlesex County* (1878) shows a house, as well as cemetery or burial ground, on the property.

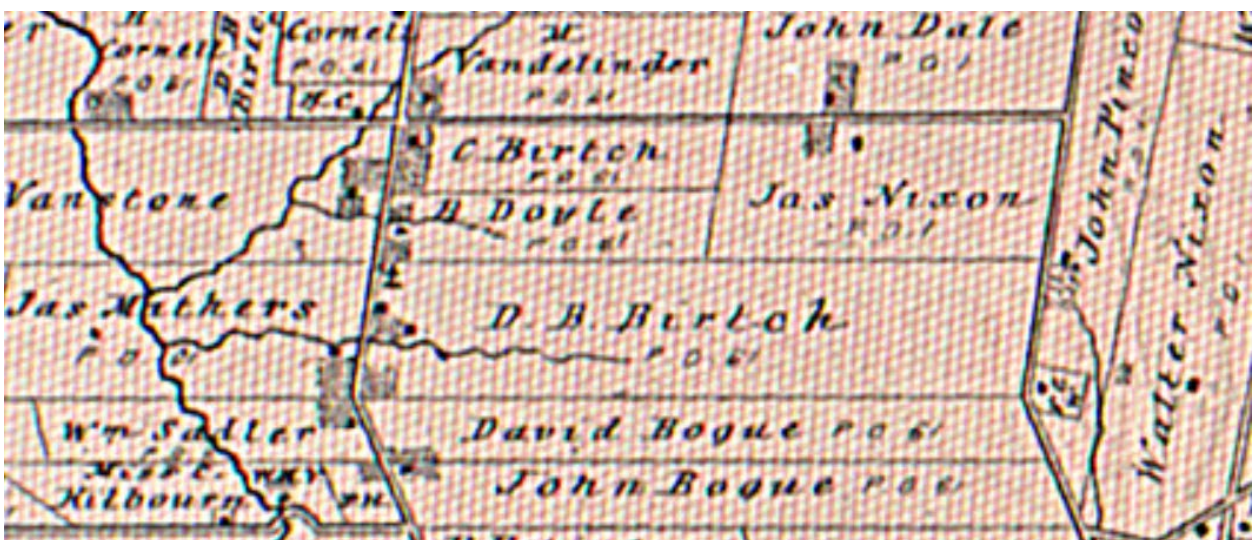
Figure 4: Detail of the Westminster Township map in the Illustrated Historical Atlas of Middlesex County (1878), showing D. B. Birch as property owner. Structures are noted, as well as a cemetery or burial ground.

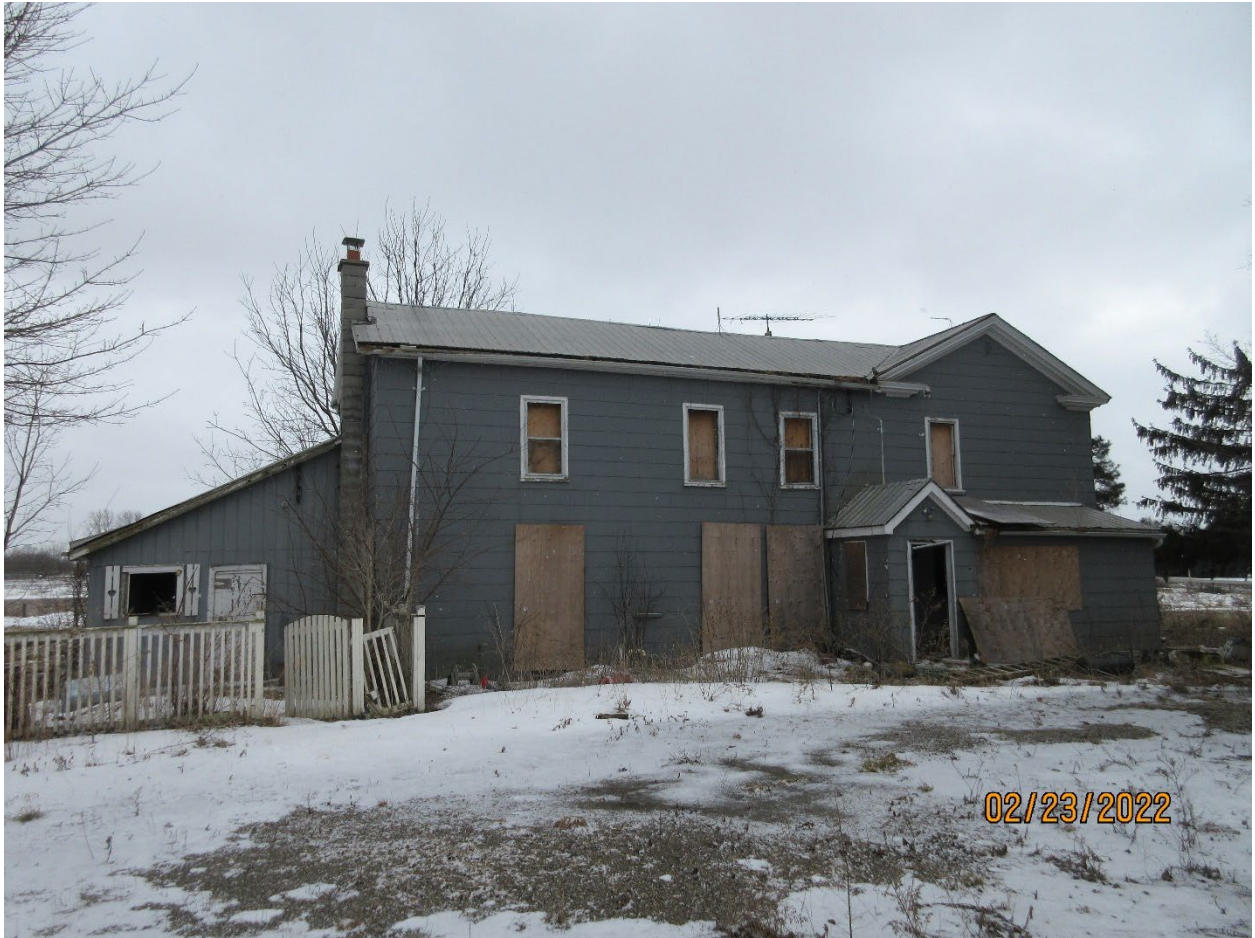
Image 5: View of the north elevation of the farmhouse at 3700 Colonel Talbot Road.

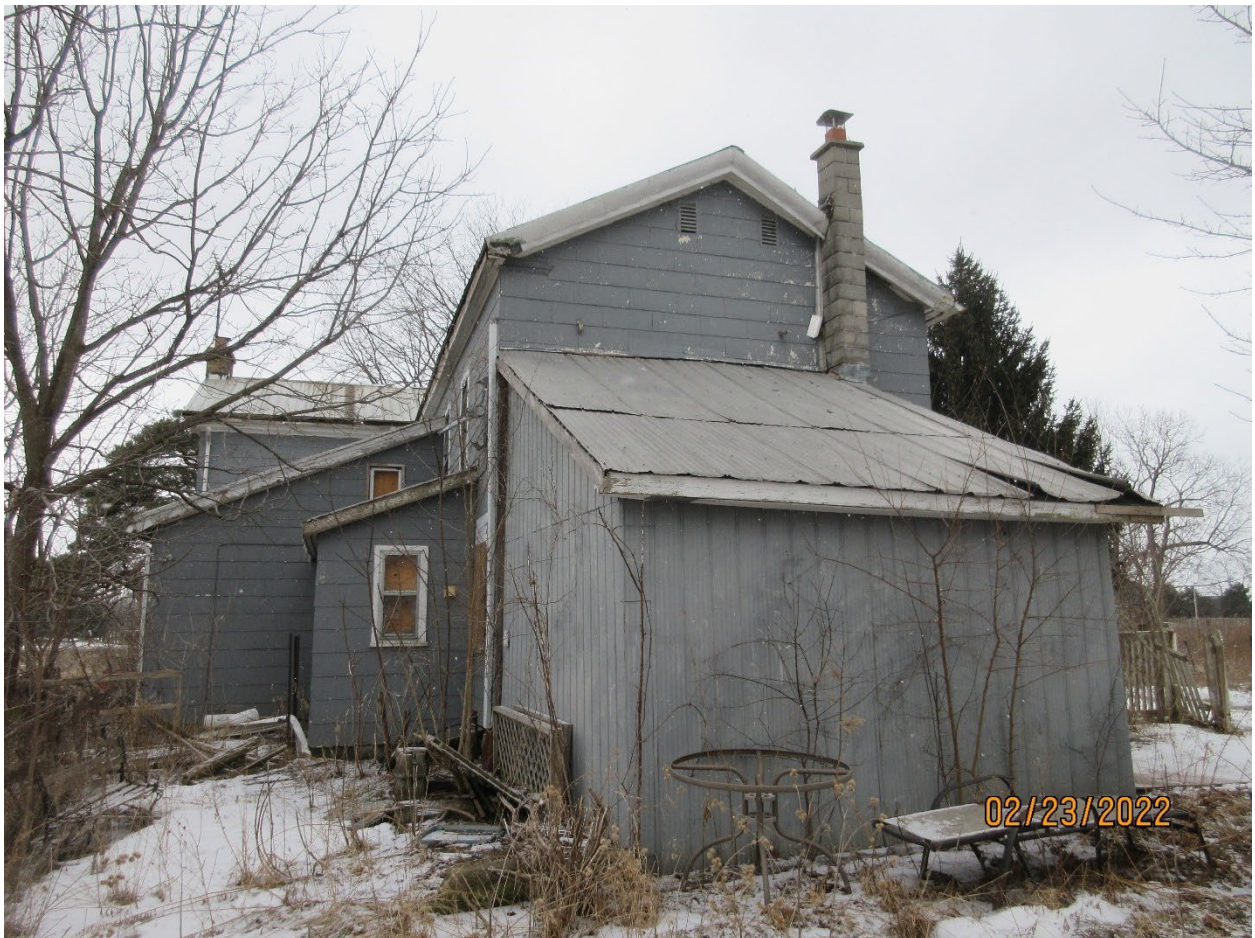
Image 6: View of the east elevation of the farmhouse at 3700 Colonel Talbot Road. Note the additions built onto the structure.

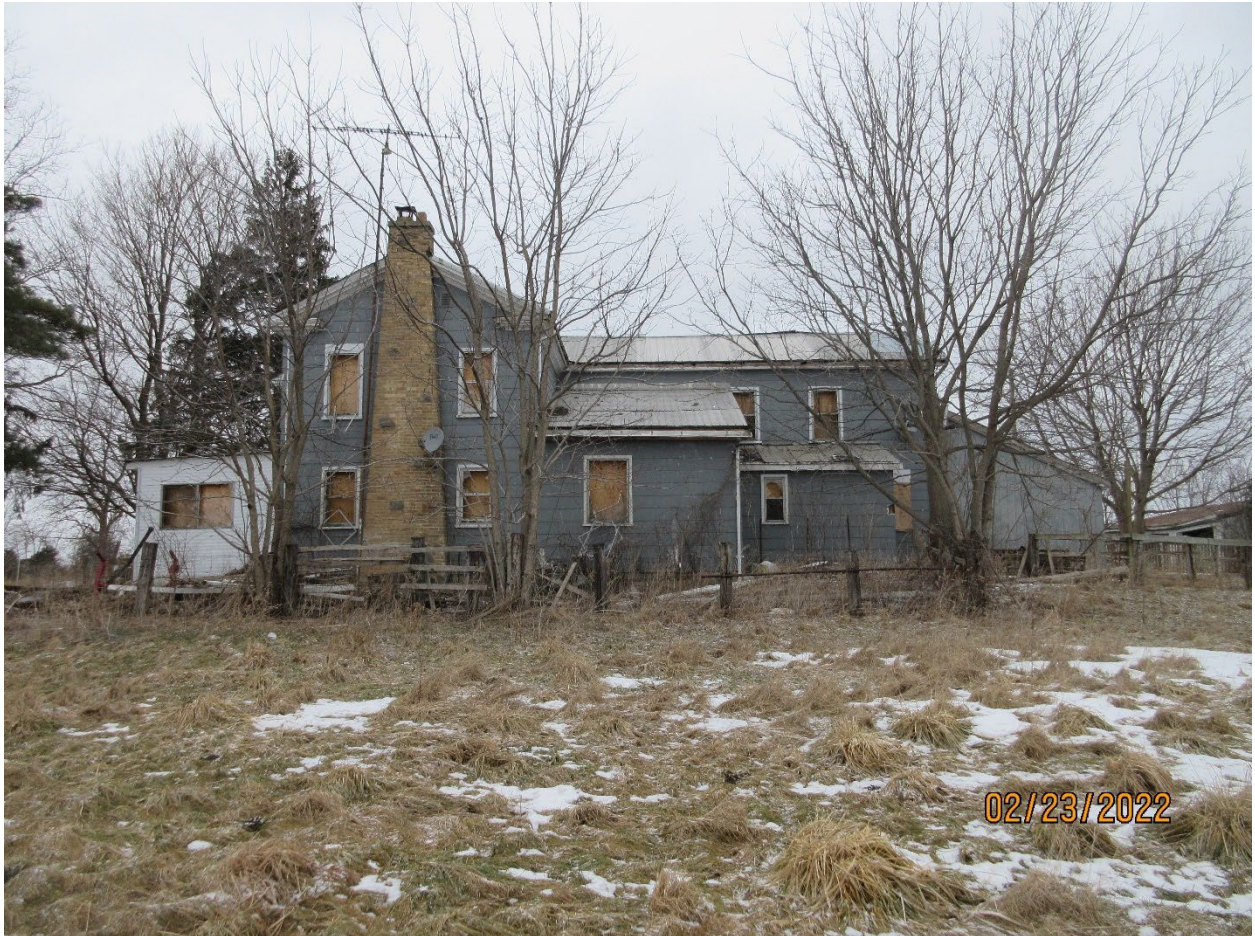
Image 7: View of the south elevation of the farmhouse at 3700 Colonel Talbot Road, seen from the adjacent pasture.

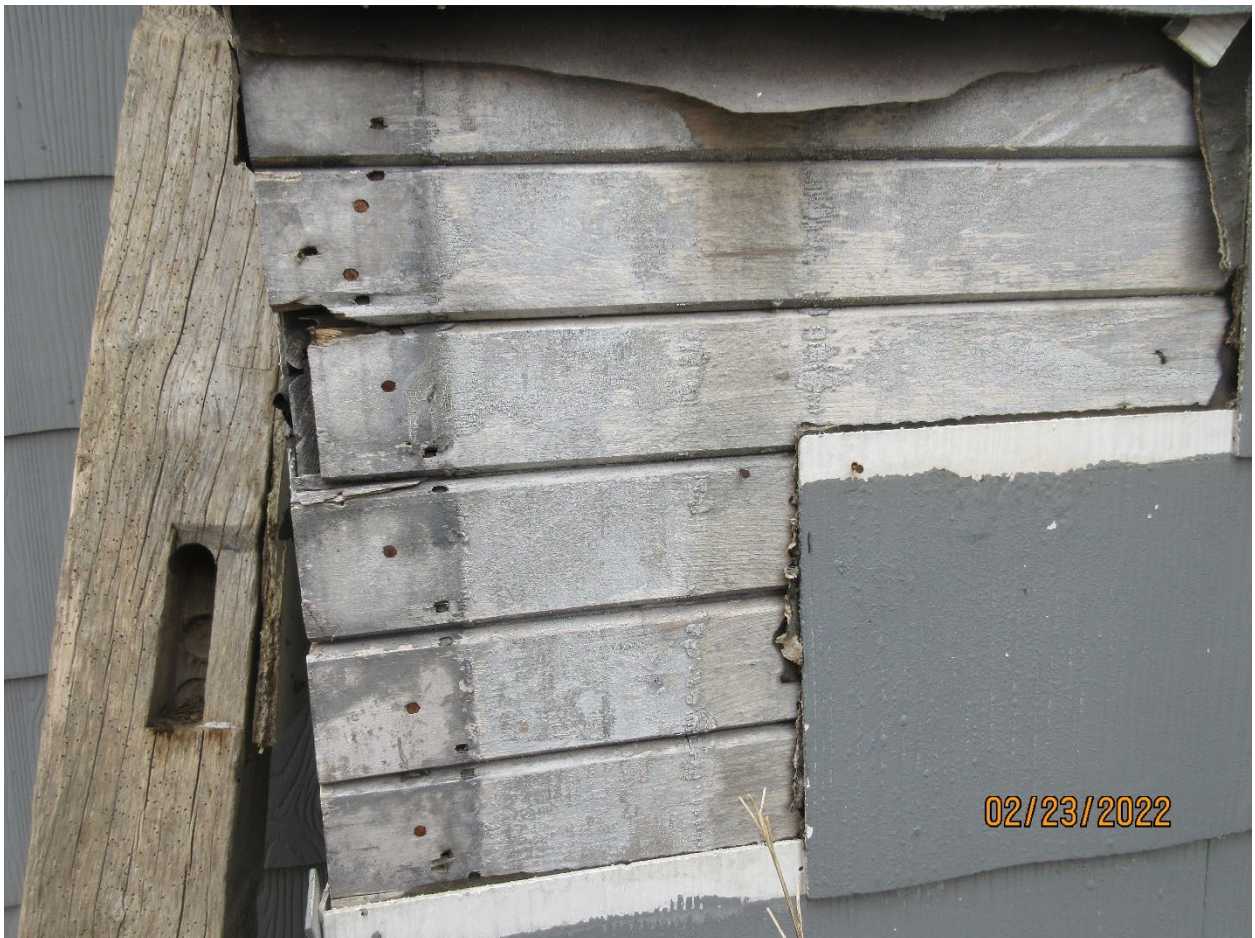
Image 8: Detail of the wood siding under the exterior cladding on the farmhouse at 3700 Colonel Talbot Road. Note the staining from previous paint, suggesting end boards.

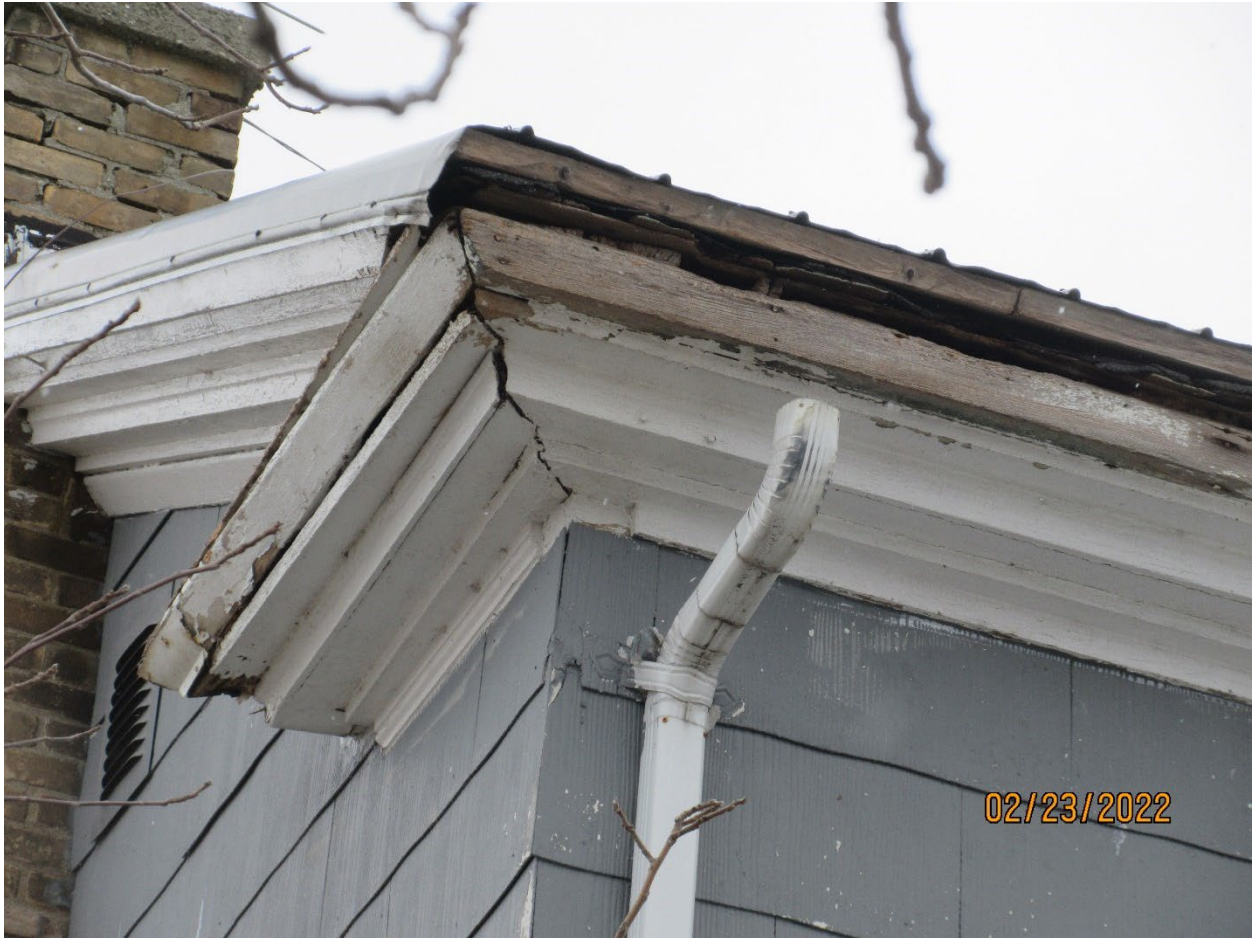
Image 9: Detail of the cornice and return eave of the farmhouse at 3700 Colonel Talbot Road.

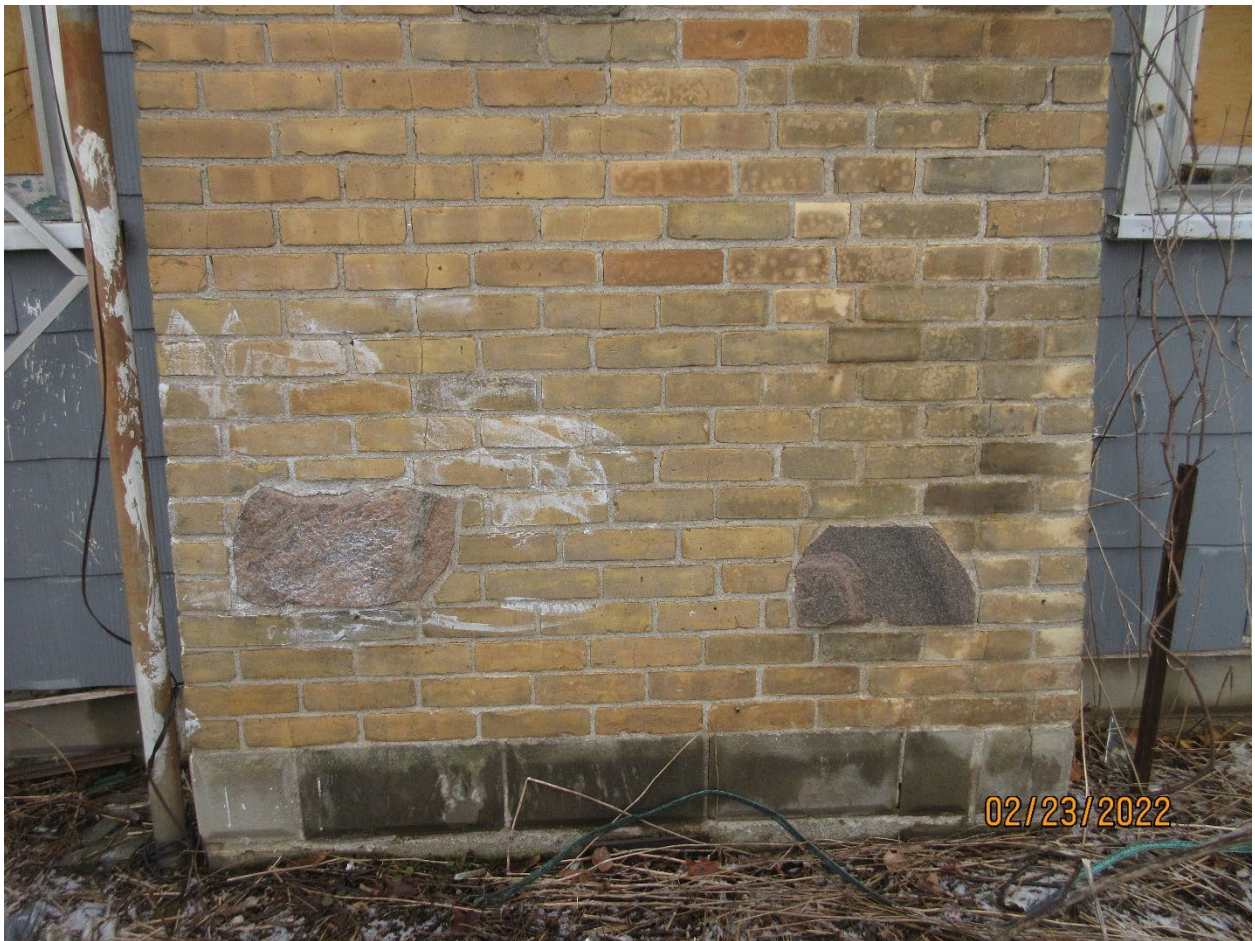
Image 10: Detail of the inset stone detailing in the brick masonry chimney on the south elevation.

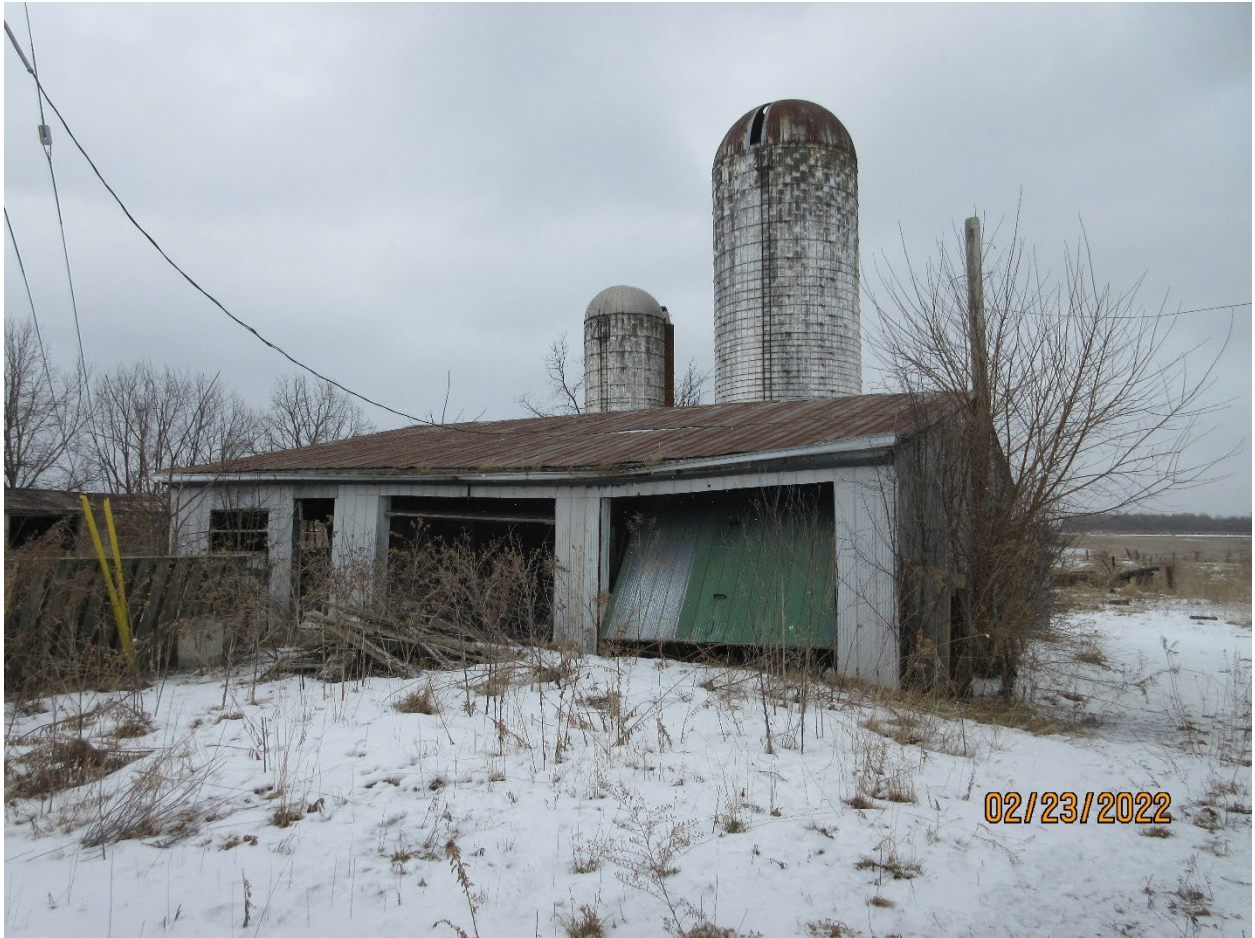
Image 11: View of the detached garage at 3700 Colonel Talbot Road.

In addition to the barn, there is a garage, a driveshed, and a small outbuilding. The garage and driveshed have a poured concrete base with stud-frame wall clad in corrugated metal which also clads the gable roof of each building. The small outbuilding is on a frame base, with stud-frame wall also clad in corrugated metal and a shed-style roof.

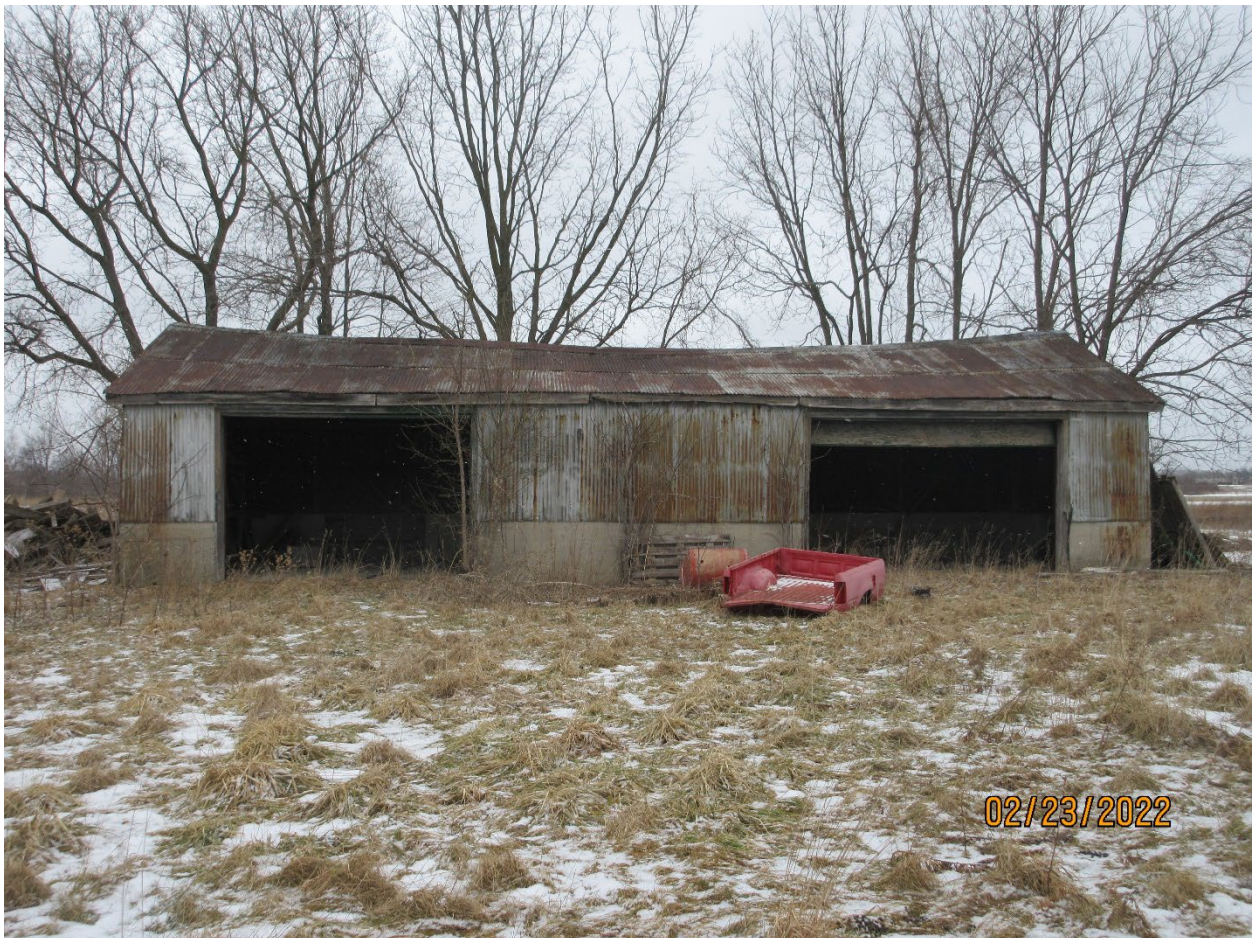
Image 12: Photograph of the driveshed at 3700 Colonel Talbot Road.

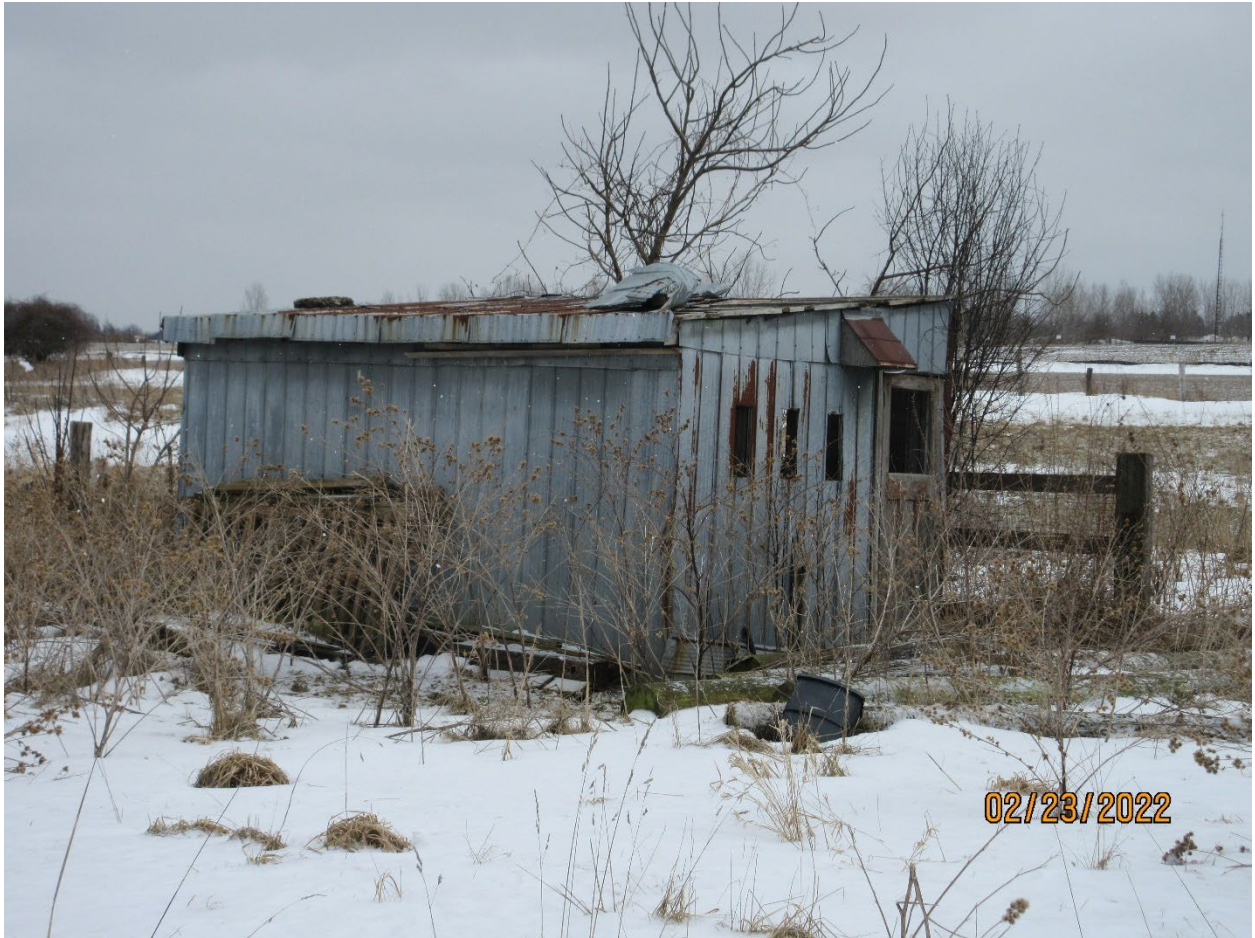
Image 13: View of the shed at 3700 Colonel Talbot Road.

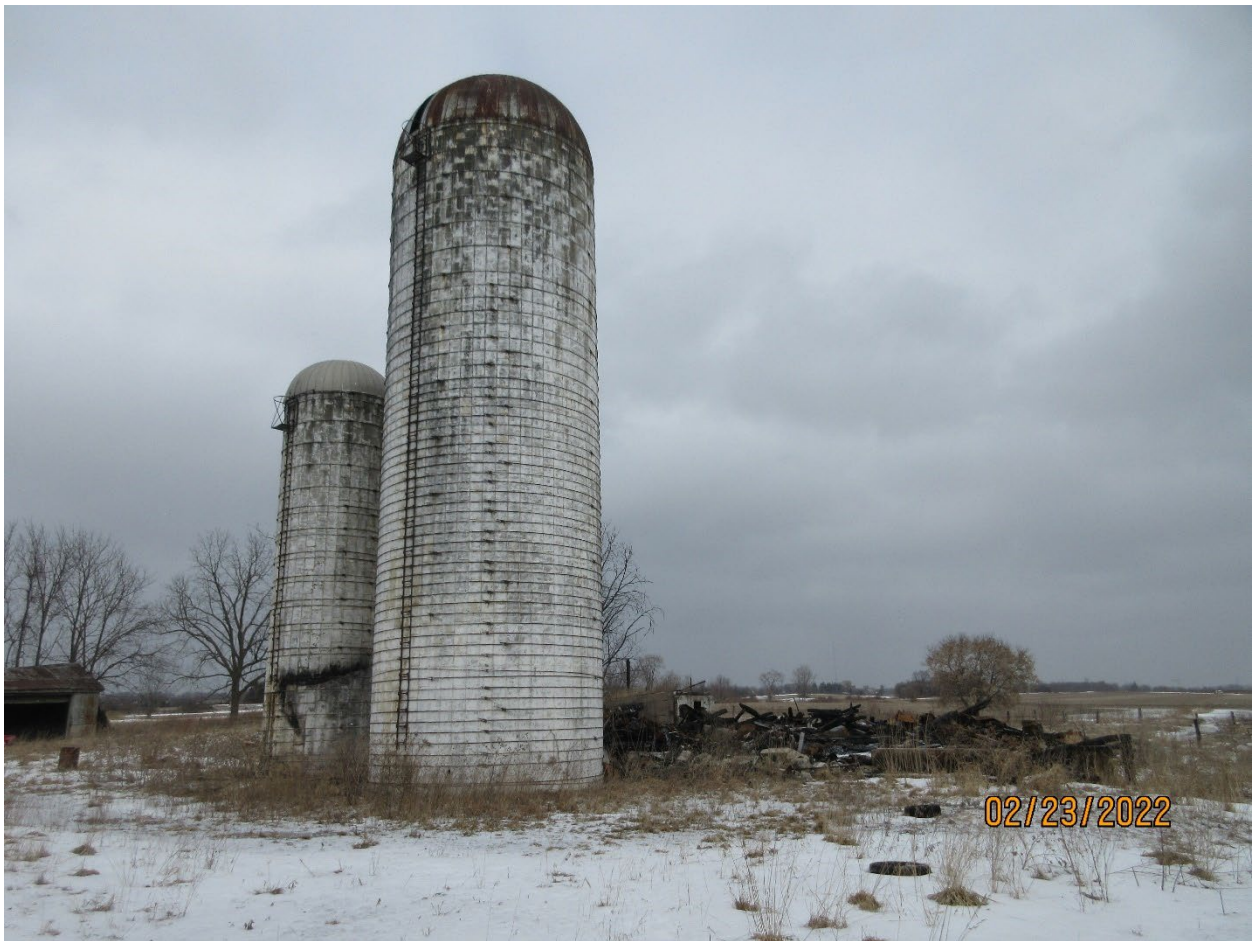
Image 14: Photograph of the two concrete block silos, with the remains of the barn at 3700 Colonel Talbot Road.

The barn was destroyed by a fire on May 18-19, 2021, but its two silos and two concrete gangways remain. The gangways are earthen and poured concrete. The silos are

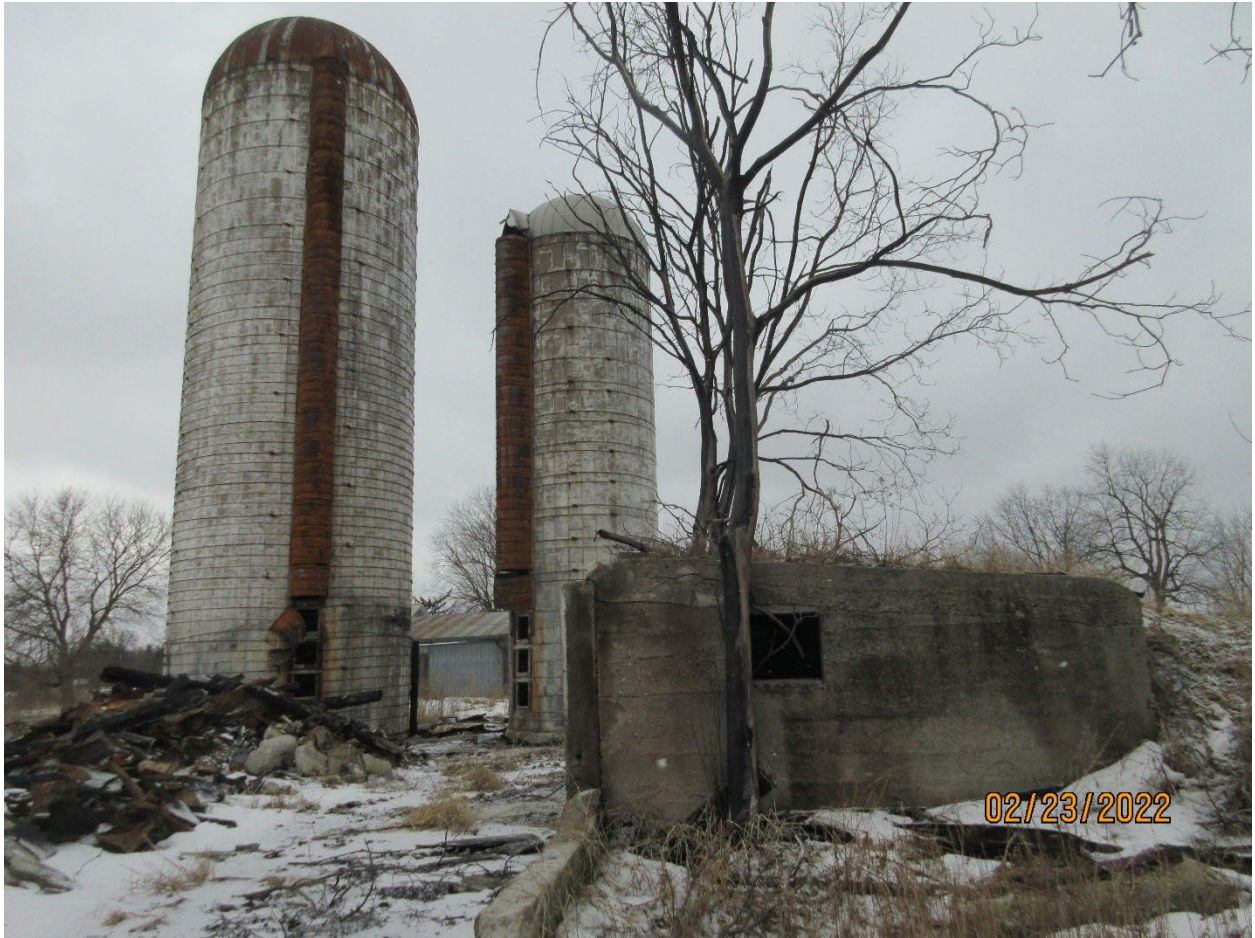
Image 15: View of the silos, showing one of the concrete gangways (barn hill).

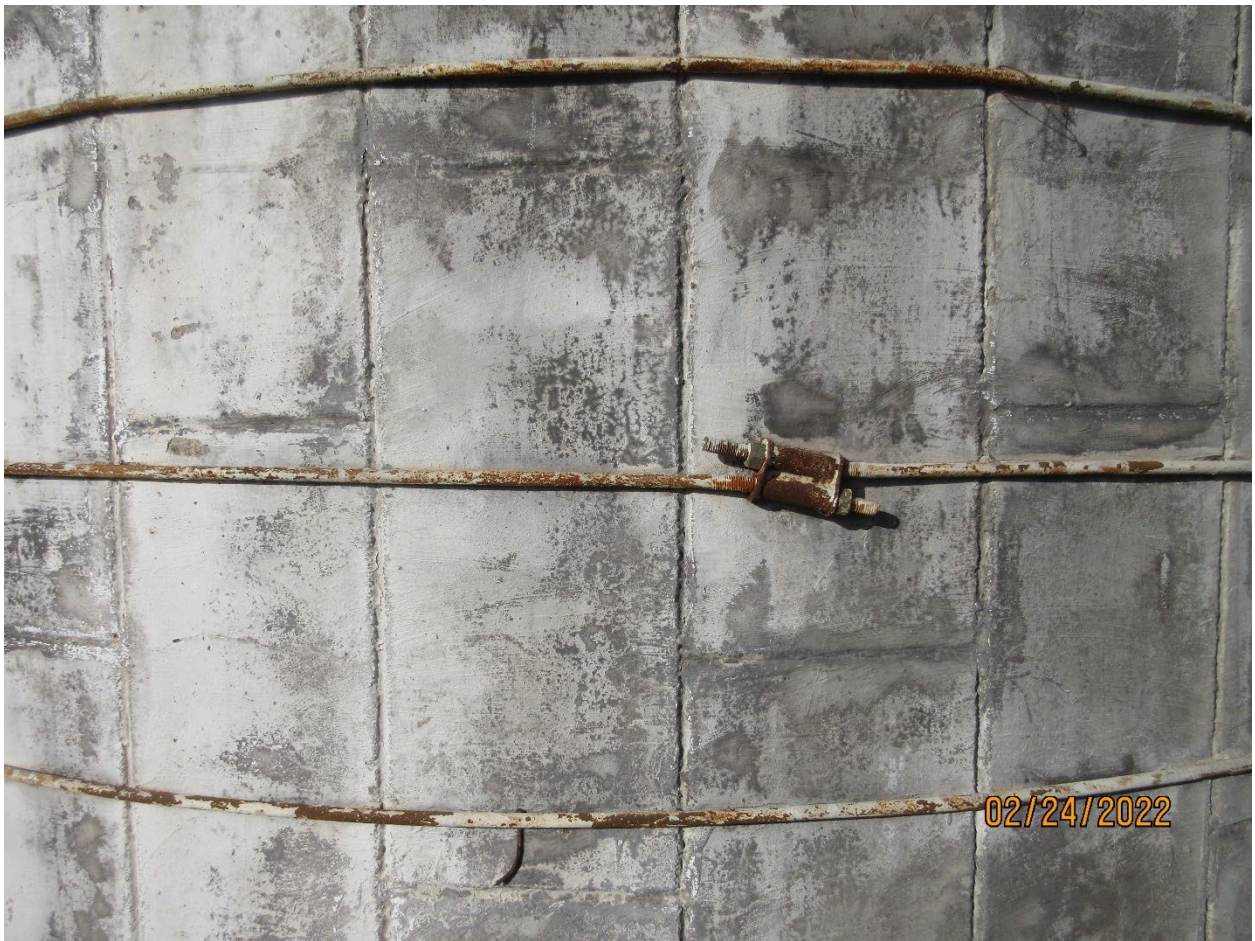
constructed of 30" by 12" concrete block masonry, arranged on their ends on a poured circular concrete foundation (see Appendix B, Image 16). The silos appear to have been previously painted and are weathered. There is iron banding approximately every 12" at the base but increasing in spans between the bracing with the height of the silos. Both silos have a domed metal cap.

Image 16: Detail of the concrete block masonry, approximately 12" by 30", of the silos with the iron banding.

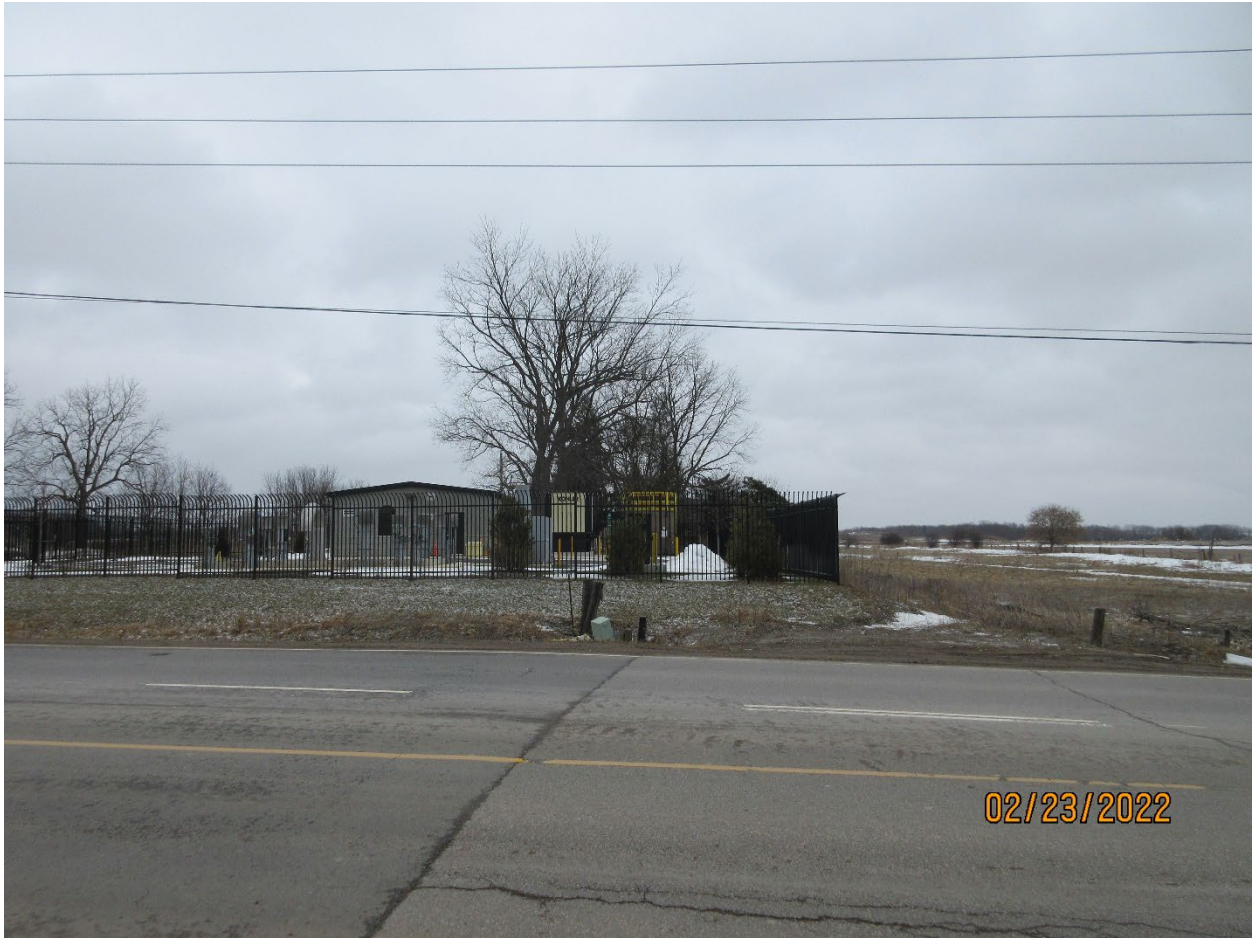
In 2020-2021, the Colonel Talbot Road Pumping Station (3690 Colonel Talbot Road) was constructed. A *Cultural Heritage Assessment Report* (Stantec, 2017) was prepared as part of the Colonel Talbot Road Pumping Station Environmental Assessment. An inventory sheet was prepared for the property at 3700 Colonel Talbot Road, but no additional research was undertaken (Appendix C). The *Cultural Heritage Assessment Report* found there were no direct impacts to any of the existing structures on the property, which were all located outside of a 50m vibration monitoring buffer area. The recommended mitigation was documentation. The pumping station was constructed at the foot of the driveway from Colonel Talbot Road to the farmhouse, which has interrupted its historic relationship to the road (see Appendix B, Image 17).

Image 17: View from the west side of Colonel Talbot Road looking east towards the farmhouse at 3700 Colonel Talbot Road, interrupted by the Colonel Talbot Road Pumping Station.

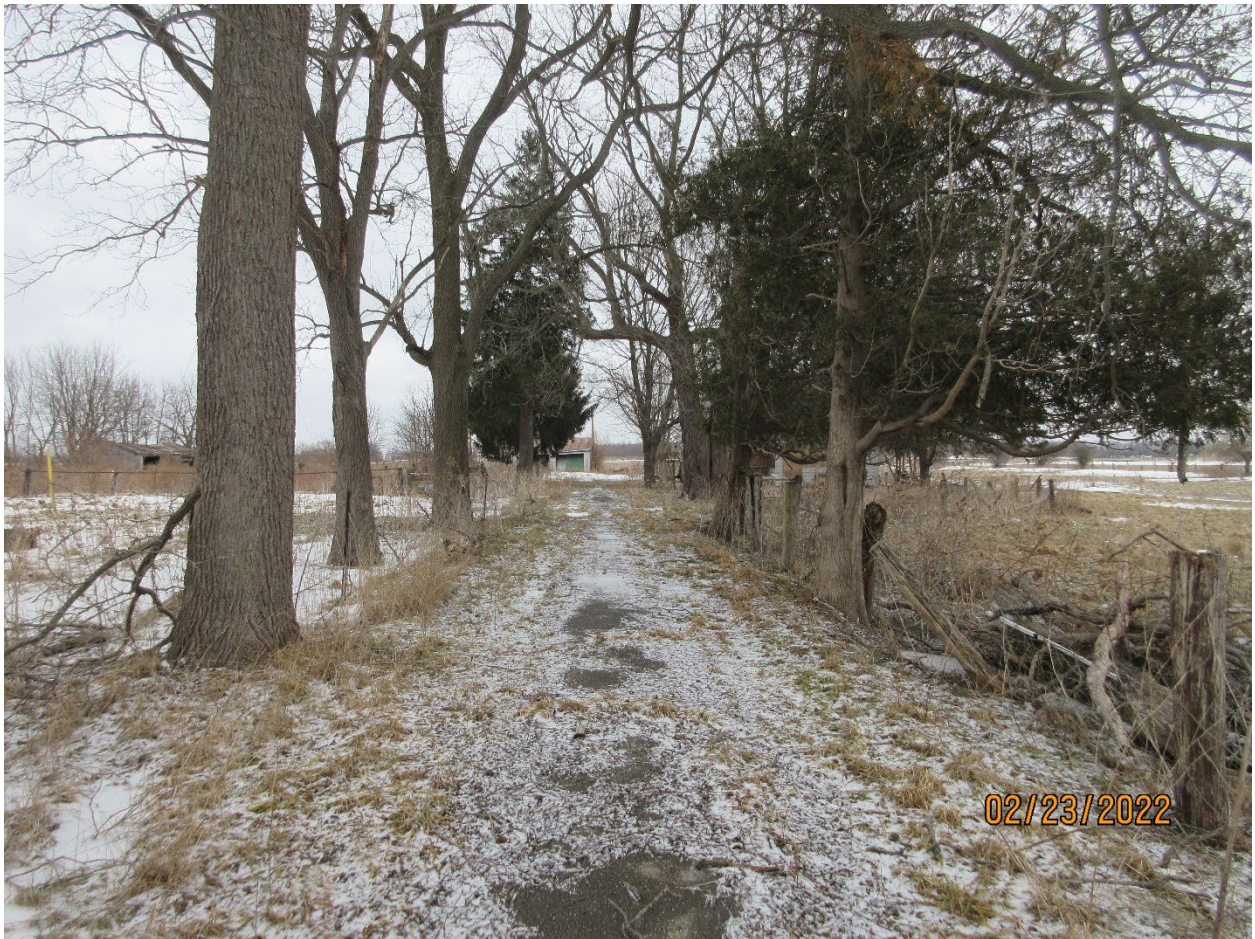
Image 18: View looking east from the fence surrounding the Colonel Talbot Road Pumping Station down the farm lane and towards the farmhouse at 3700 Colonel Talbot Road.

The house was accessed via tree-line driveway from Colonel Talbot Road (see Appendix B, Image 18). The house, its barn, silos, and outbuildings, once operated as a farm as part of the agricultural landscape of the former Westminster Township. The property is surrounded by existing and proposed residential subdivision development, which is also planned for the property (subdivision file 39T-17503).

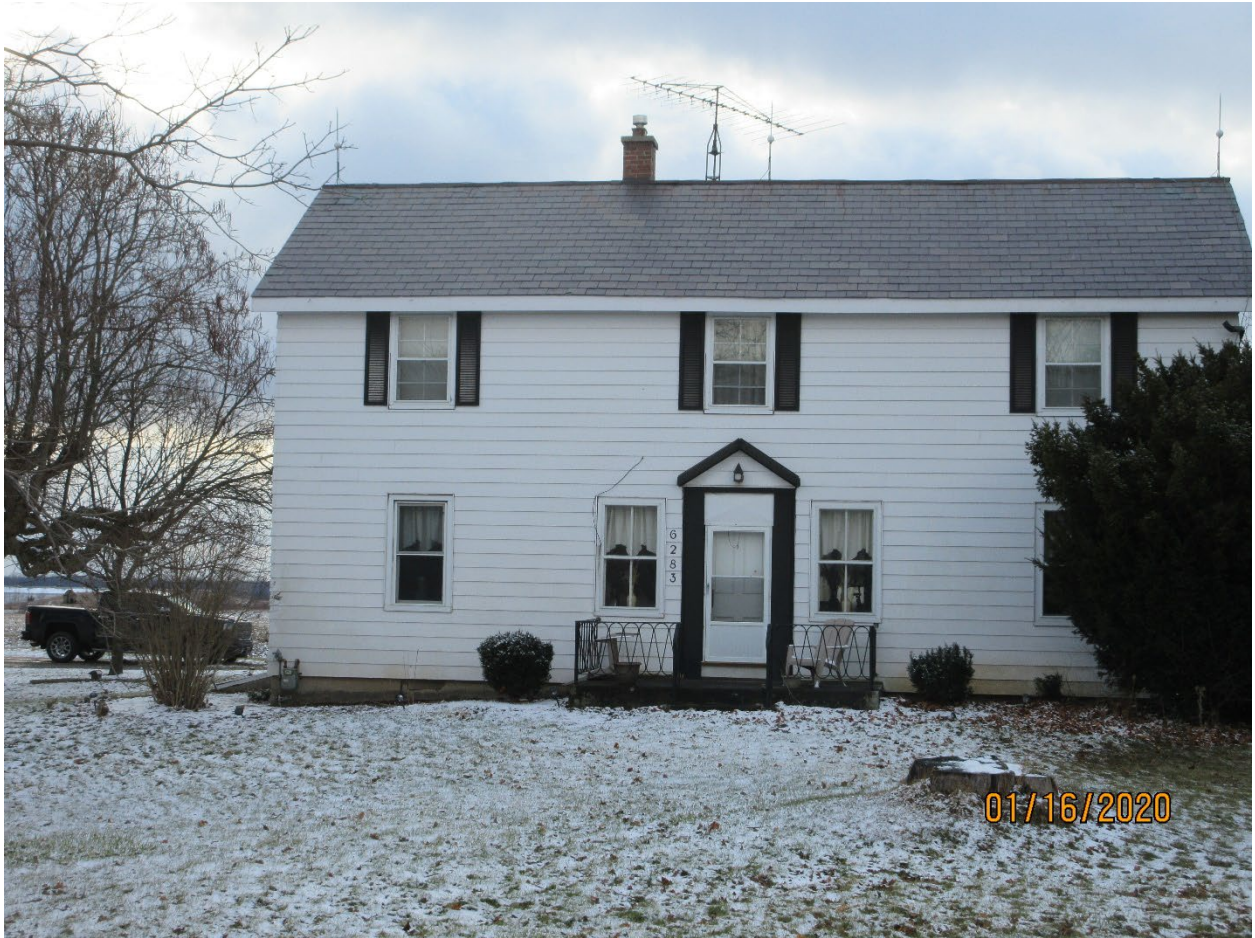
Both properties are also listed on the Register of Cultural Heritage Resources. Both properties demonstrate better integrity in their representation of Georgian architectural influences, through their strong symmetry and balanced proportions. In particular, the windows flanking the front door of the house at 6283 Colonel Talbot Road is a strong demonstration of Georgian architectural patterns.

Image 19: Photograph of a comparison property at 6283 Colonel Talbot Road, which was built circa 1840 and demonstrates elements of the Georgian architectural style particularly in the symmetry and restrained balance of the façade, as well as the windows flanking the front door.

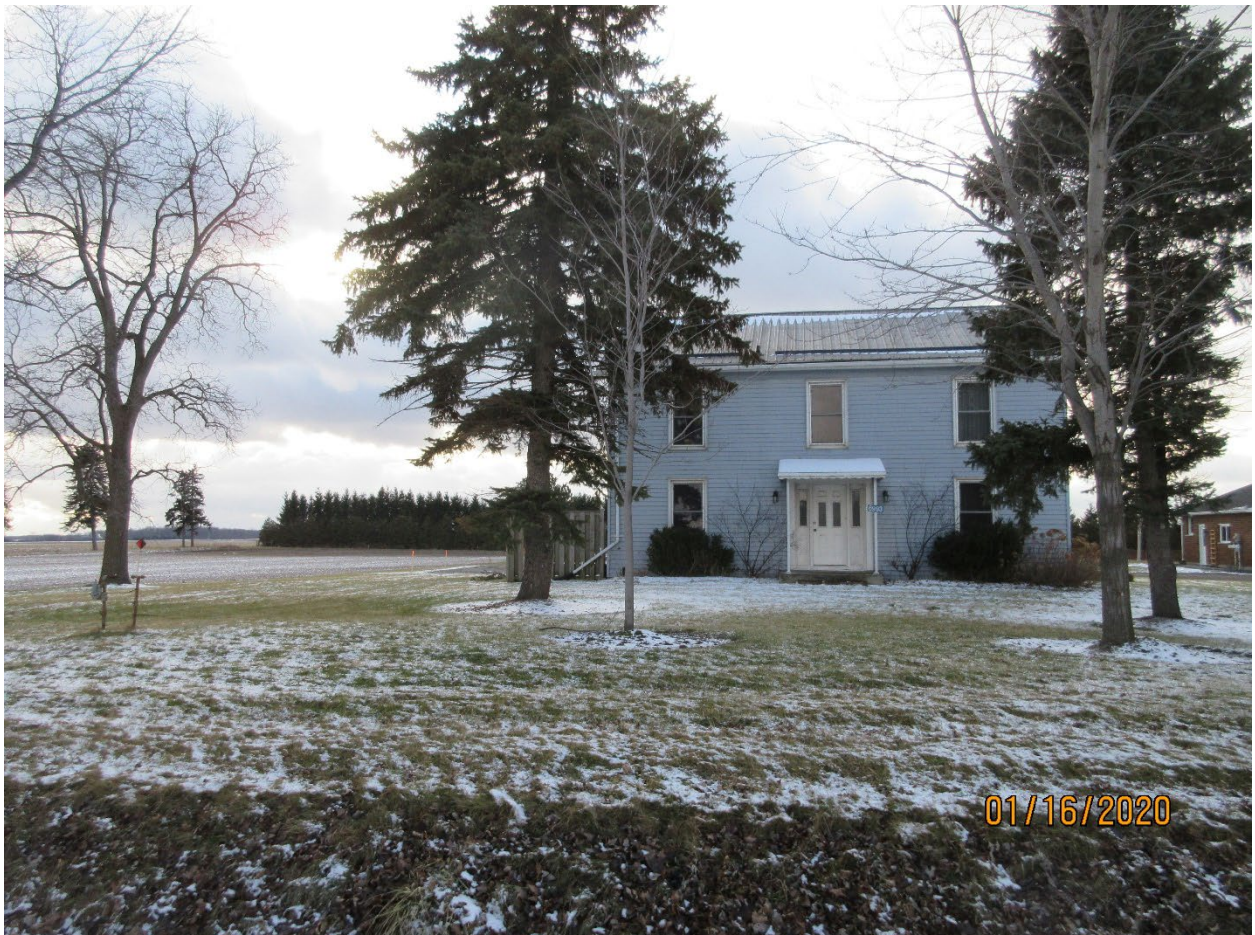
Image 20: Photograph of a comparison property at 6993 Colonel Talbot Road, built circa 1855 and demonstrating some influences of the Georgian architectural style in its proportions and symmetry.
