Report to London Advisory Committee on Heritage

Subject: Demolition Request for Heritage Listed Property at 3700
Colonel Talbot Road by W-3 Lambeth Farms Inc.

Date: Wednesday March 9, 2022

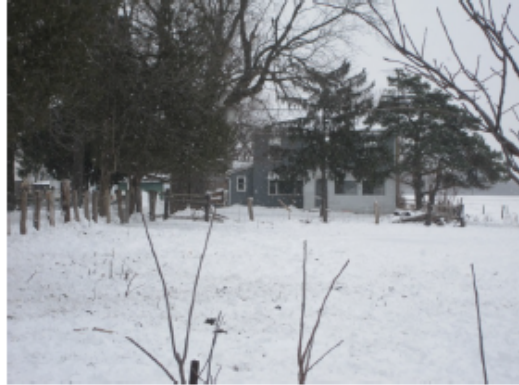
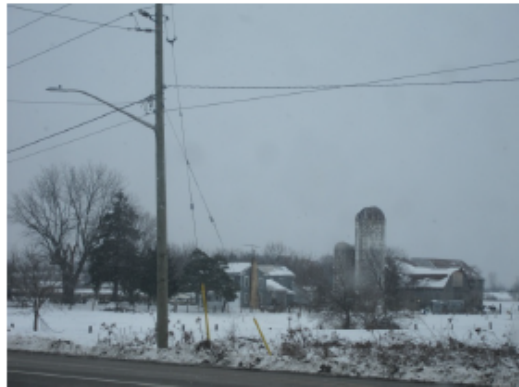
Figure 6: Inventory sheet prepared for the property at 3700 Colonel Talbot Road from the Cultural Heritage Assessment Report for the Colonel Talbot Road Pumping Station Environmental Assessment (Stantec 2017).

In 2020-2021, the Colonel Talbot Road Pumping Station (3690 Colonel Talbot Road) was constructed. A *Cultural Heritage Assessment Report* (Stantec, 2017) was prepared as part of the Colonel Talbot Road Pumping Station Environmental Assessment. An inventory sheet was prepared for the property at 3700 Colonel Talbot Road, but no additional research was undertaken (Appendix C). The *Cultural Heritage Assessment Report* found there were no direct impacts to any of the existing structures on the property, which were all located outside of a 50m vibration monitoring buffer area. The recommended mitigation was documentation. The pumping station was constructed at the foot of the driveway from Colonel Talbot Road to the farmhouse, which has interrupted its historic relationship to the road (see Appendix B, Image 17).
