## Report to Community Advisory Committee on Planning

**Subject:** Demolition Request for Heritage Listed Property at 254 Hill Street, by Level Contracting Inc.

**Date:** July 13, 2022

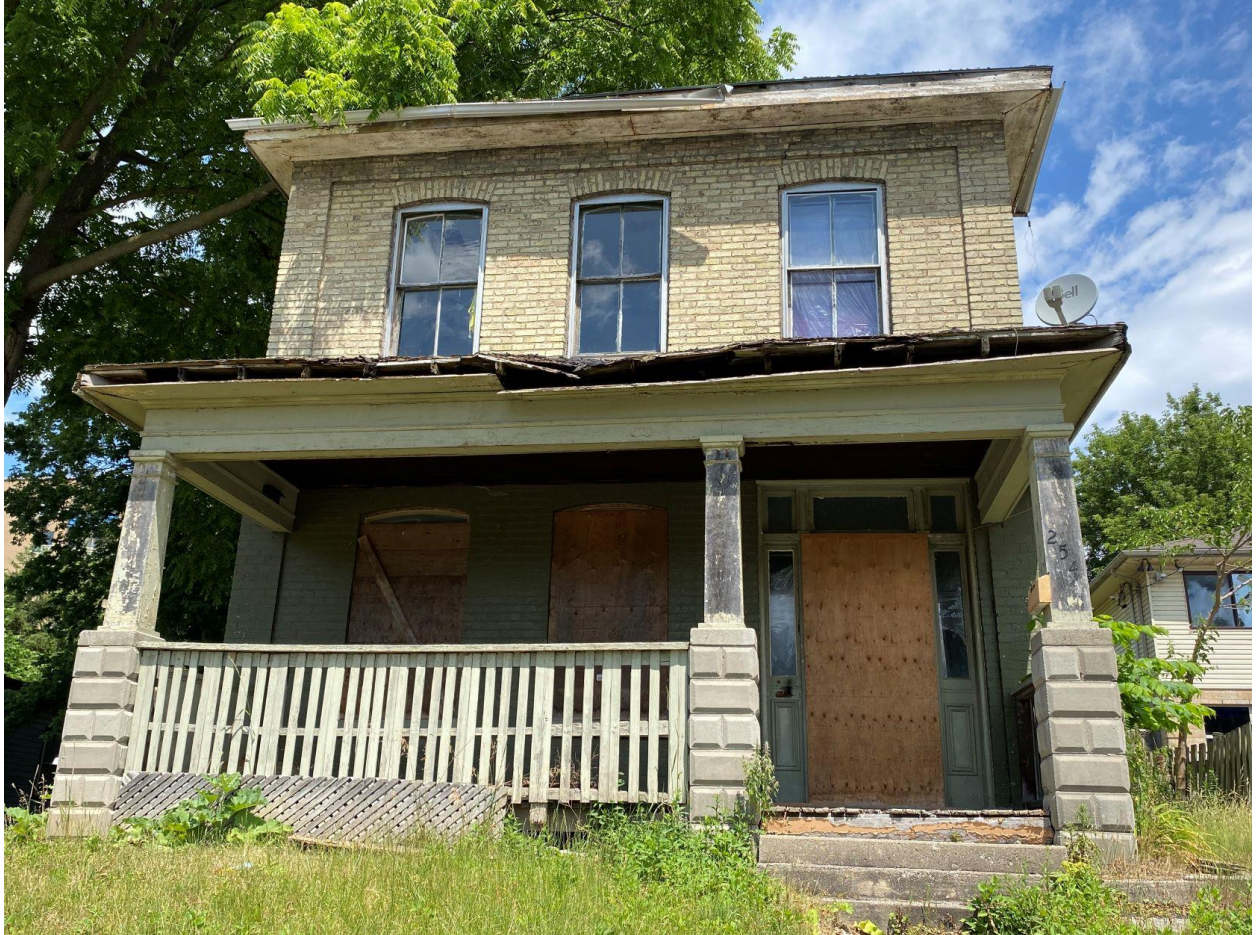
Image 1. Front elevation at 254 Hill Street – facing south

The front (south) elevation is framed by a continuous buff brick pilaster running along the corners of the elevation and just below the overhanging eave. A porch extends across the entire front elevation and is supported by concrete blocks and wooden posts. The primary entrance is from the porch which appears to be an original wooden door and surround unit comprised of sidelites, transom and wooden infill panels. Two rounded pilasters are positioned in the transom and mirror the door and sidelite geometry. The entrance is currently boarded-up.

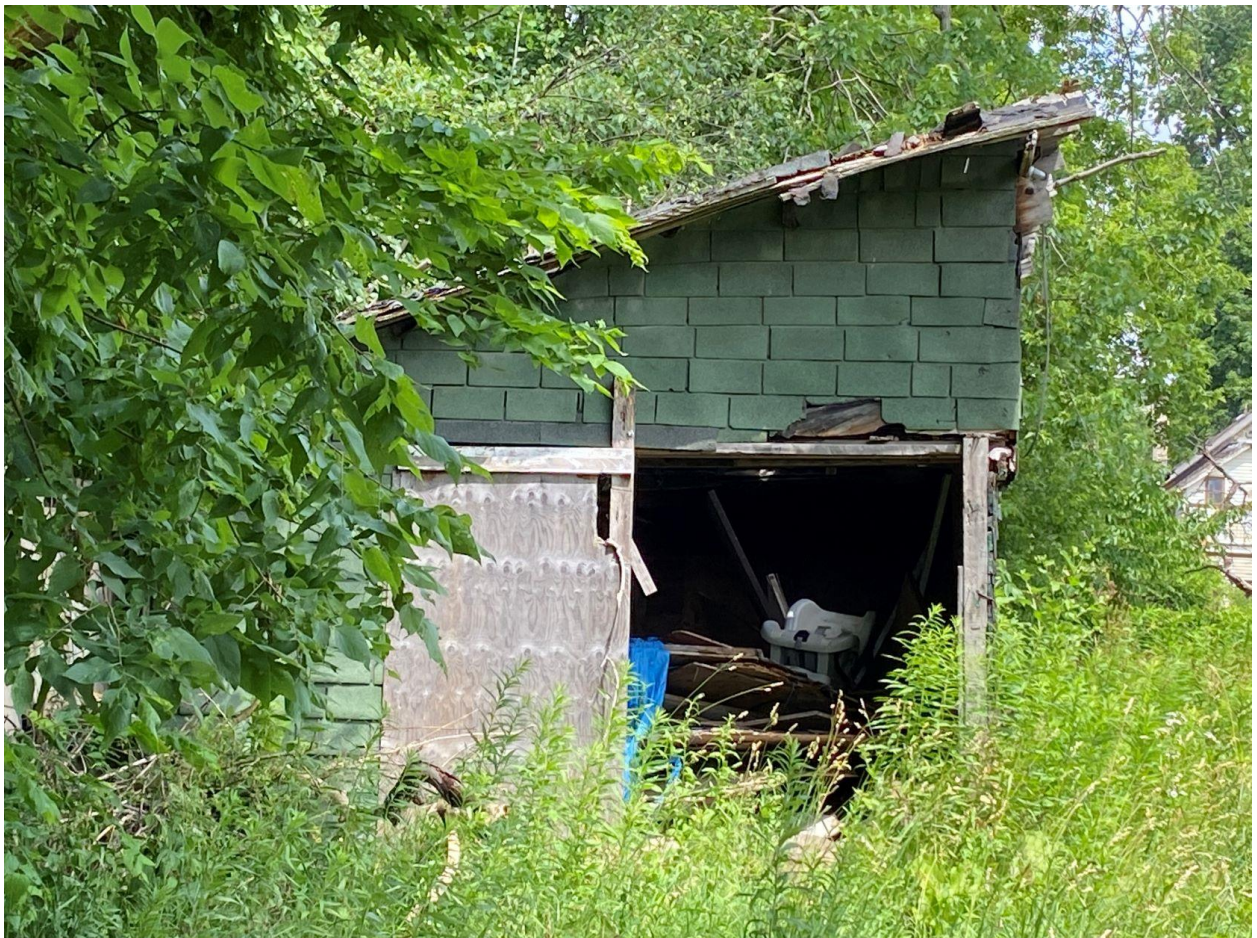
Image 4. Ancillary shed structure in rear yard – 254 Hill Street

The building at 254 Hill Street is positioned at the crest of an embankment on the north side of Hill Street with a concrete drive located on the west side of the property. There is a wooden outbuilding (4m x 6m) located in the rear yard.

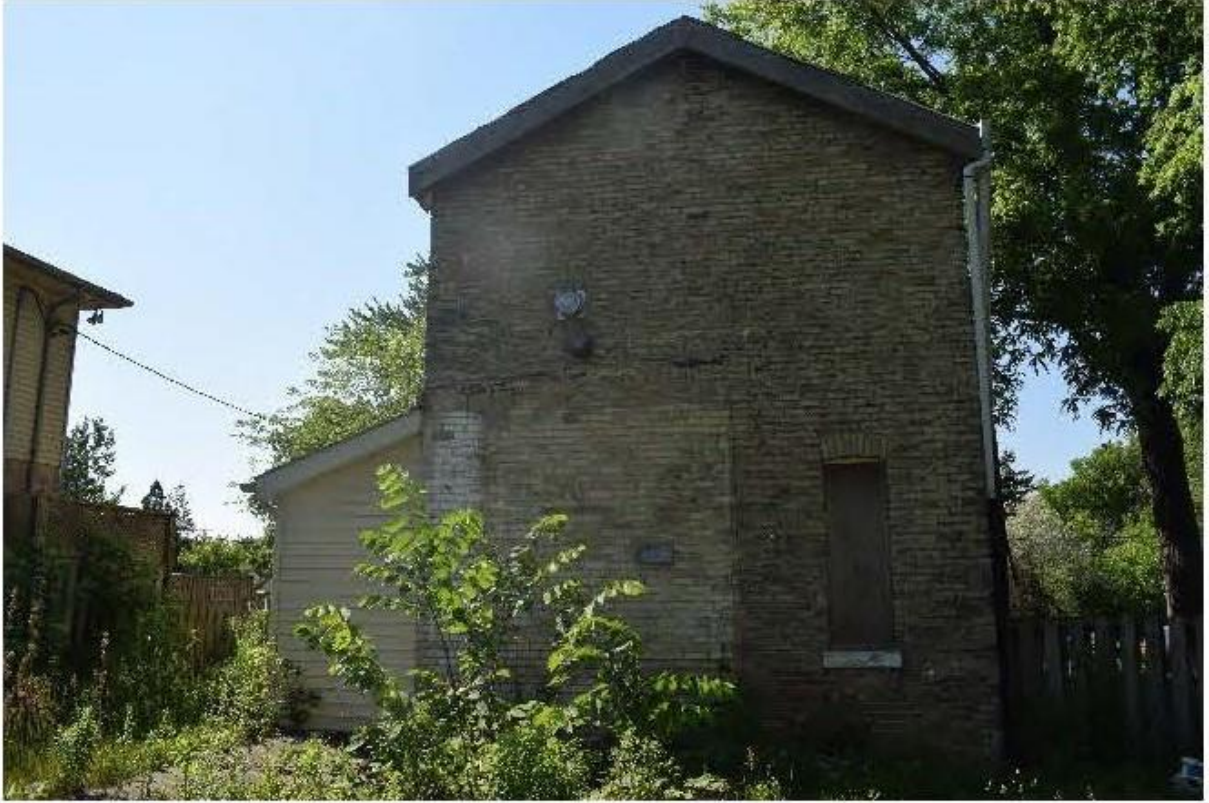
Image 5. Rear (north) projection – 254 Hill Street (Stantec, 2022)

The building on the property is a two-storey, buff brick vernacular house exhibiting Italianate design elements with a low-pitched hip roof and overhanging eaves. There is a rear (north) projection with a medium pitched gable roof, and a small added entrance vestibule on the east side at the rear projection.

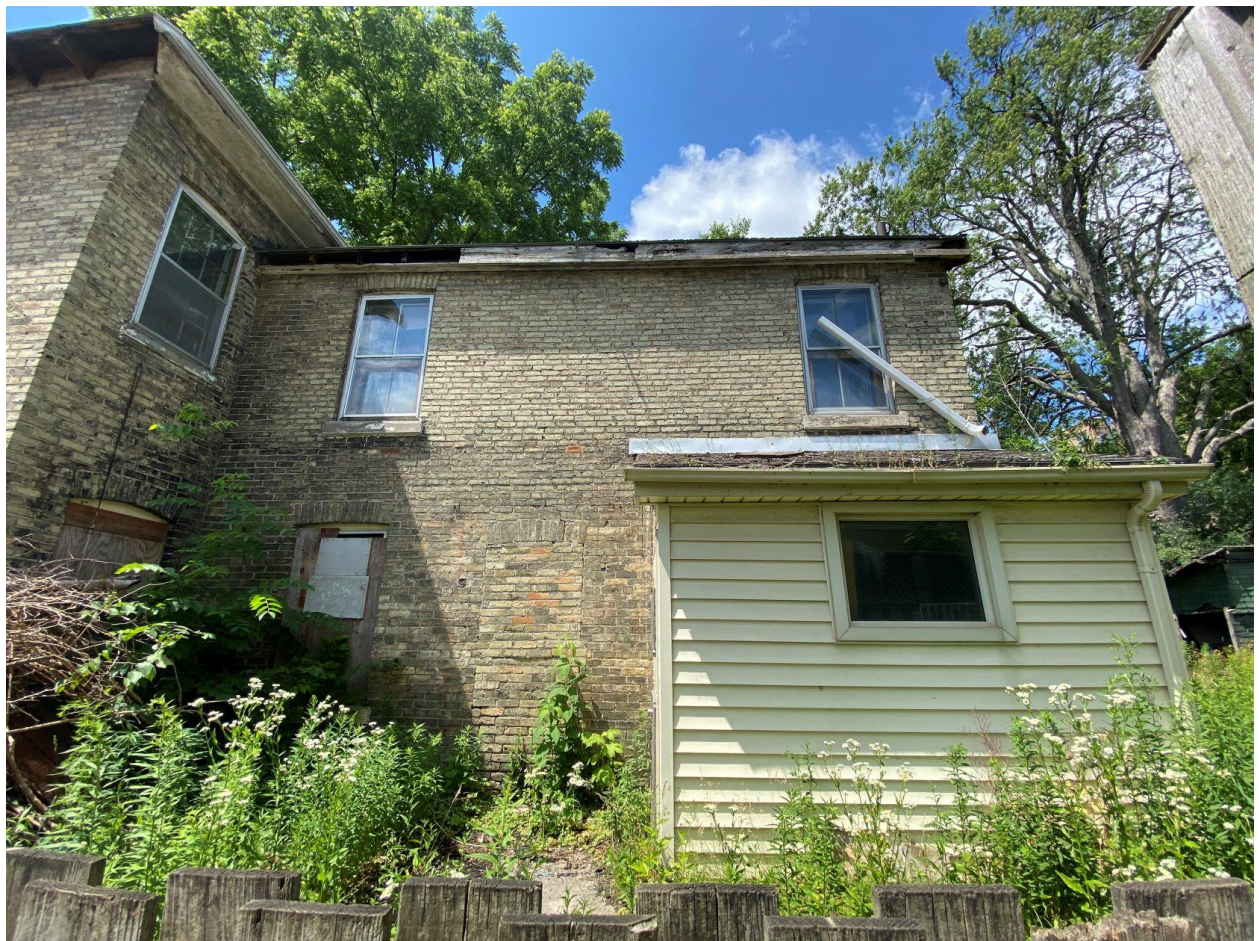
Image 6. East elevation showing rear (north) projection and added entrance vestibule

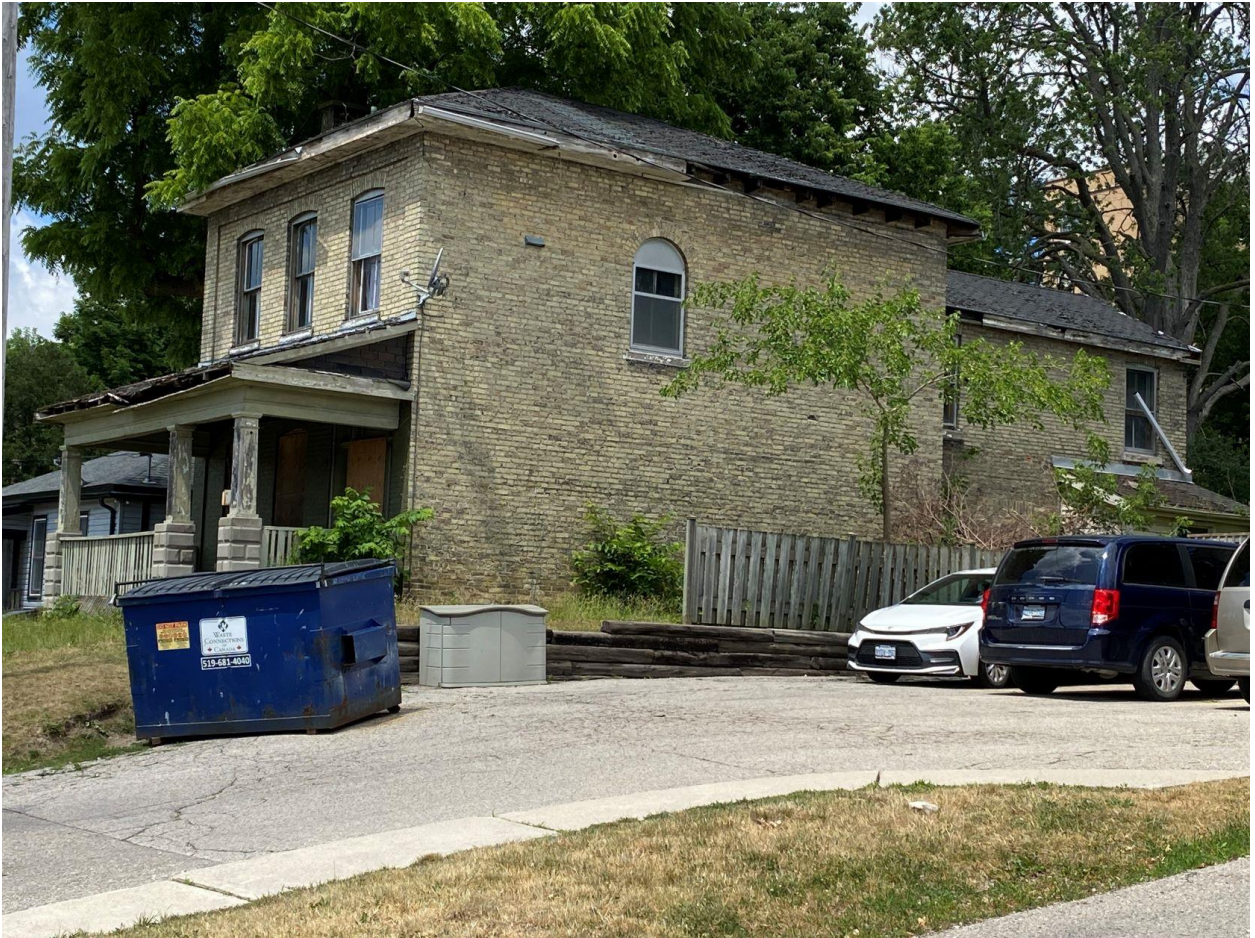
Image 7. East and south elevations featuring arched window and front porch

Most all windows openings throughout consist of shallow-arch openings with brick voussoirs and wood sills. A singular arched window opening is located on the east elevation and contains a double row of brick voussoirs. Some existing window openings have been blocked in with brick, and openings on the first floor have been boarded up. Many of the window frames that are visible appear to be two-over-two (2/2) wooden frames; many of these have been installed with aluminum storms. The building on the property is currently vacant and is in a deteriorating condition.

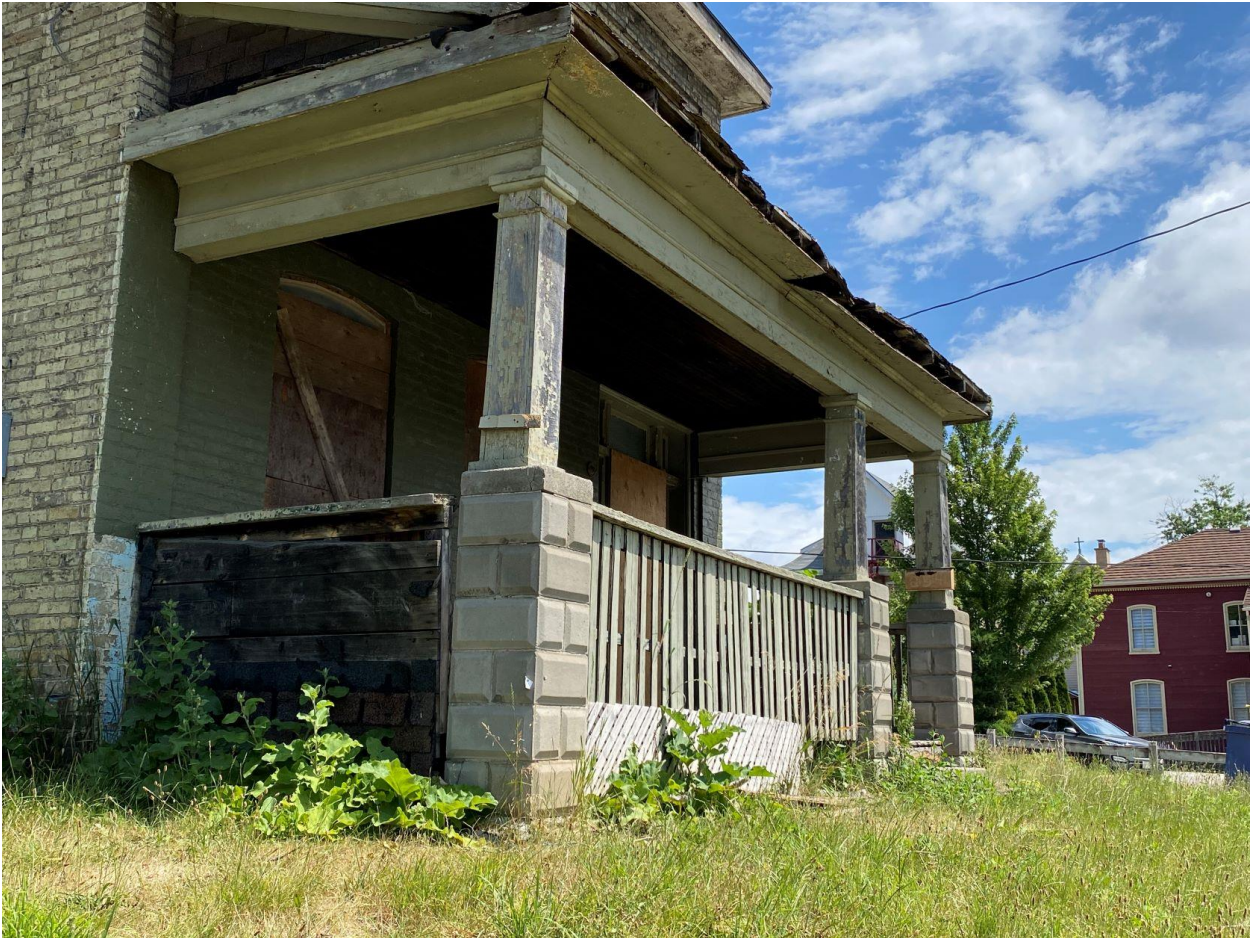
Image 8. Front elevation showing porch positioned across the full width of the residence

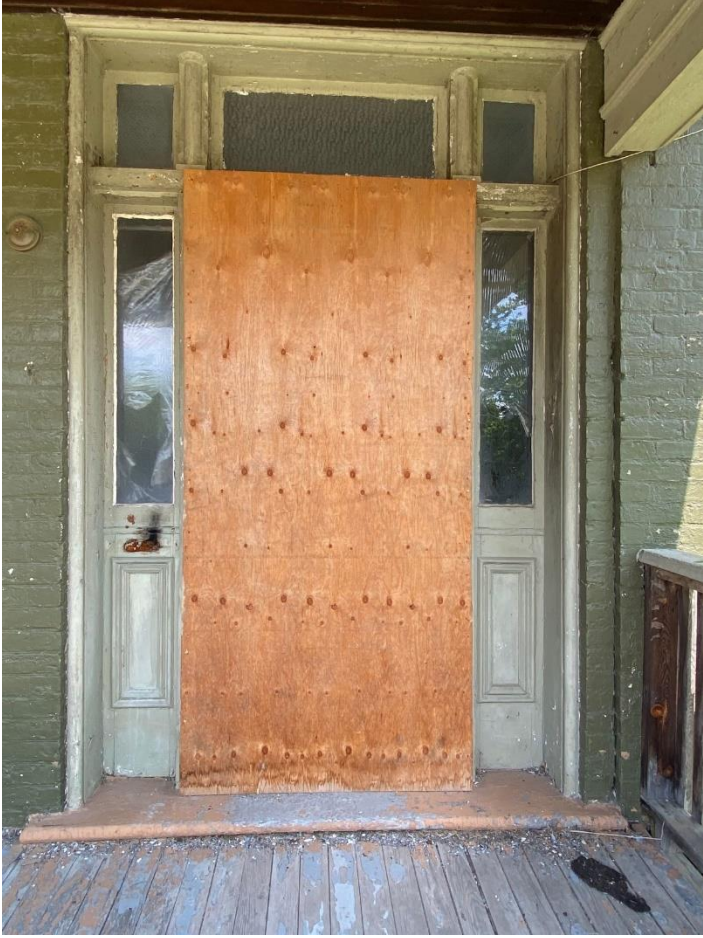
Image 9. Front entrance door surround with transom and sidelites

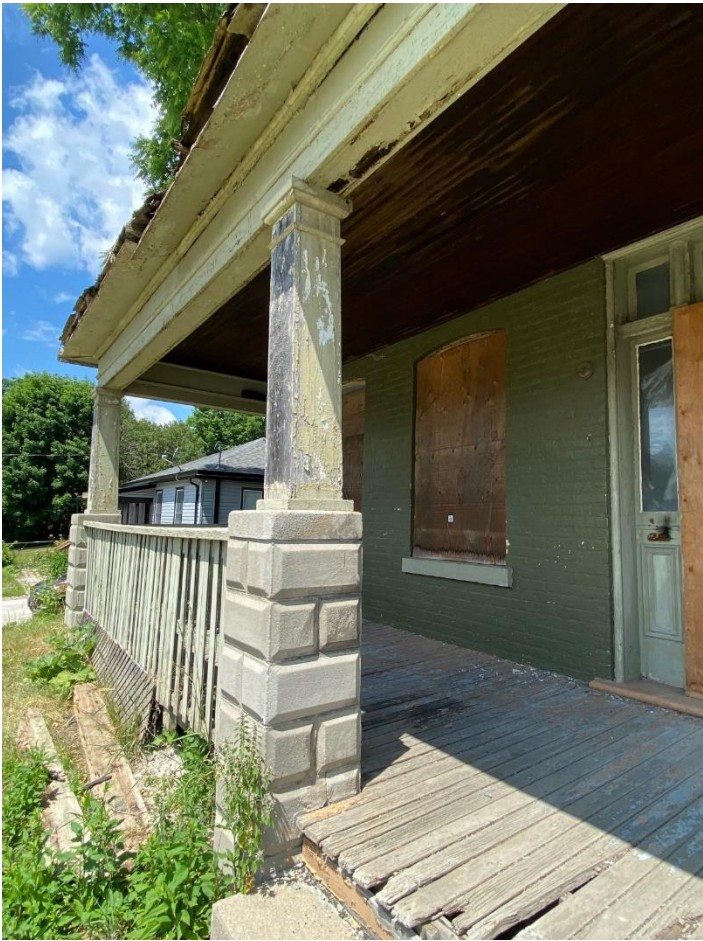
Image 10. Porch supported by concrete blocks and wooden posts

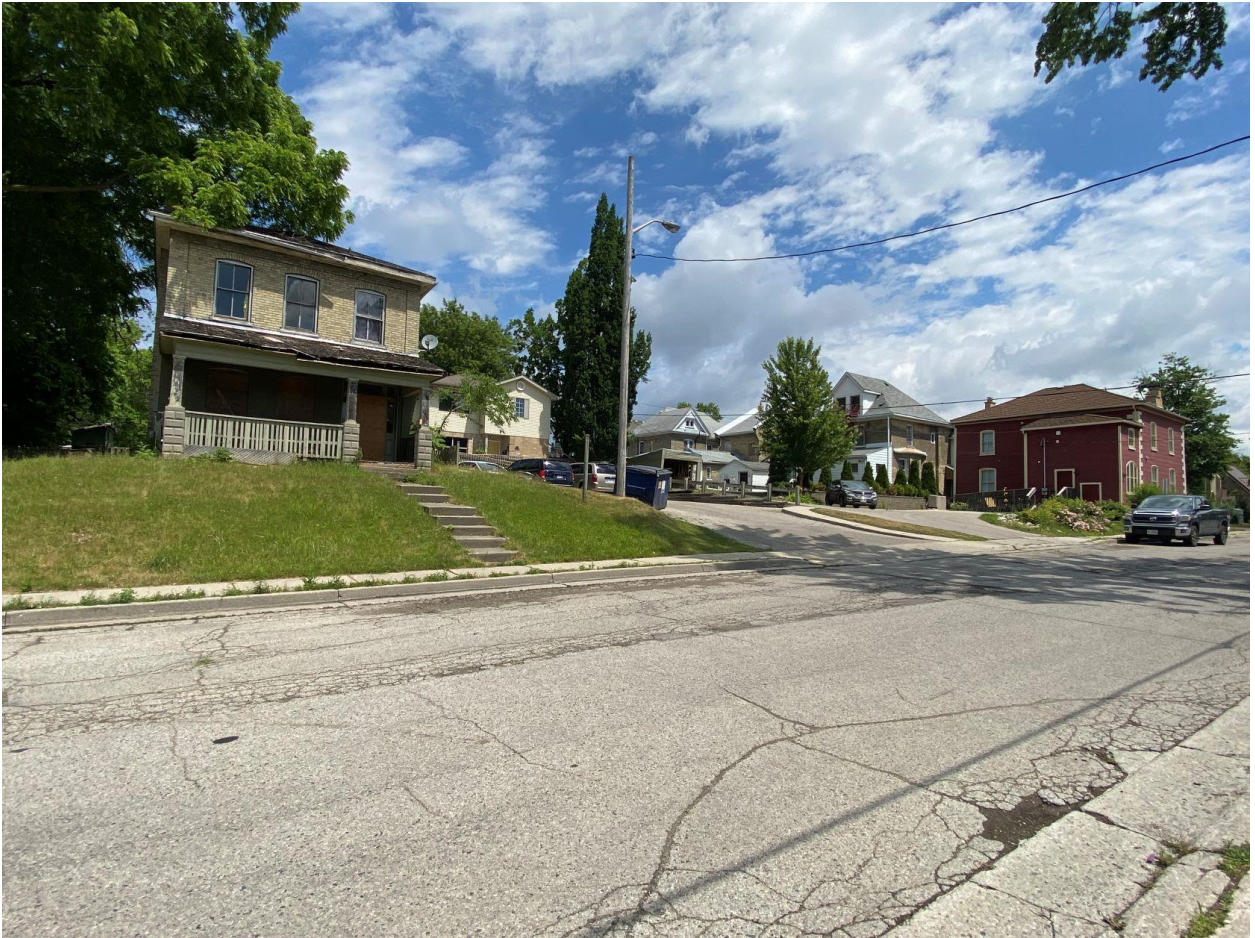
Image 11. Front elevation at 254 Hill Street showing positioning on embankment

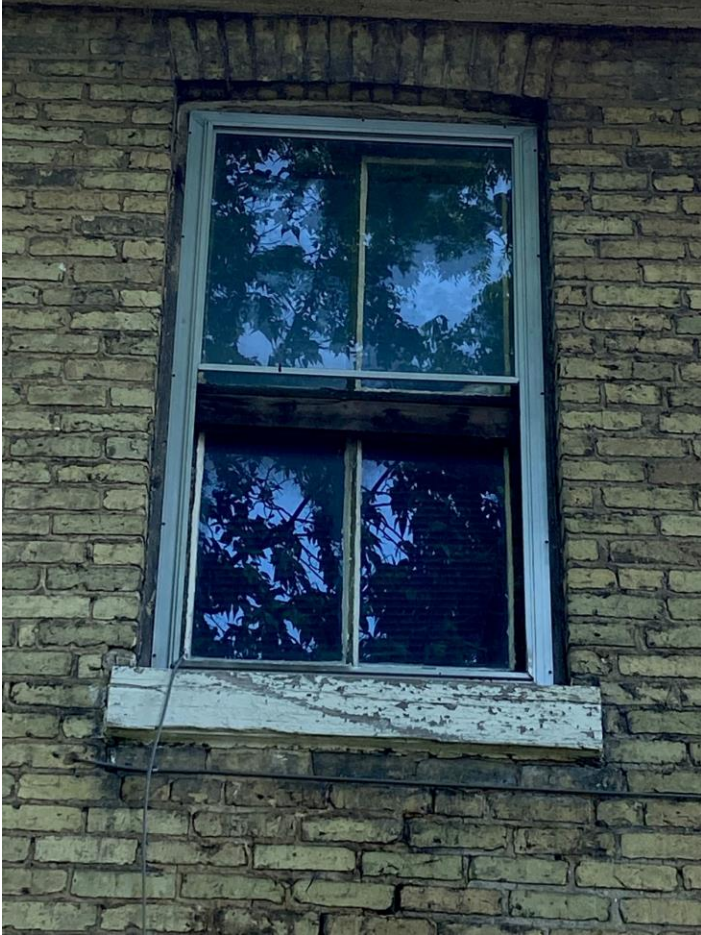
Image 13. Detail of window opening – 2<sup>nd</sup> floor, west elevation – showing shallow arch with voussoirs and two-over-two (2/2) wooden window frame and wood sill

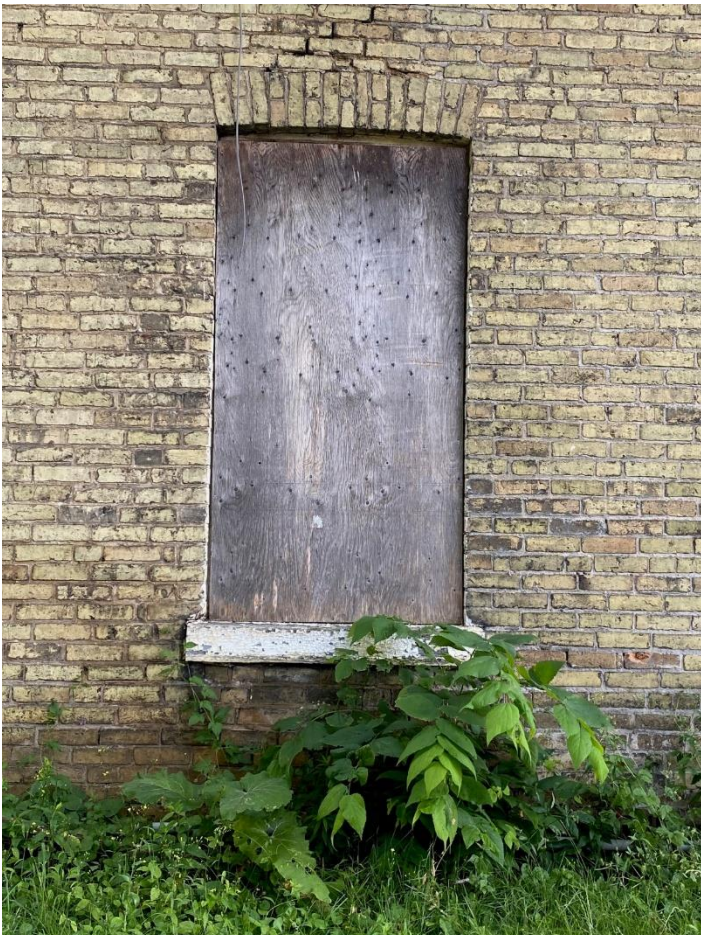
Image 14: Detail of boarded-up window opening – 1<sup>st</sup> floor, west elevation – showing shallow arch with voussoirs and two-over-two (2/2) wooden window frame and wood sill
