Report to Planning and Environment Committee

Subject: Heritage Alteration Permit application by A. Franze at 45
Bruce Street, Wortley Village-Old South Heritage
Conservation District

Date: Monday July 25, 2022

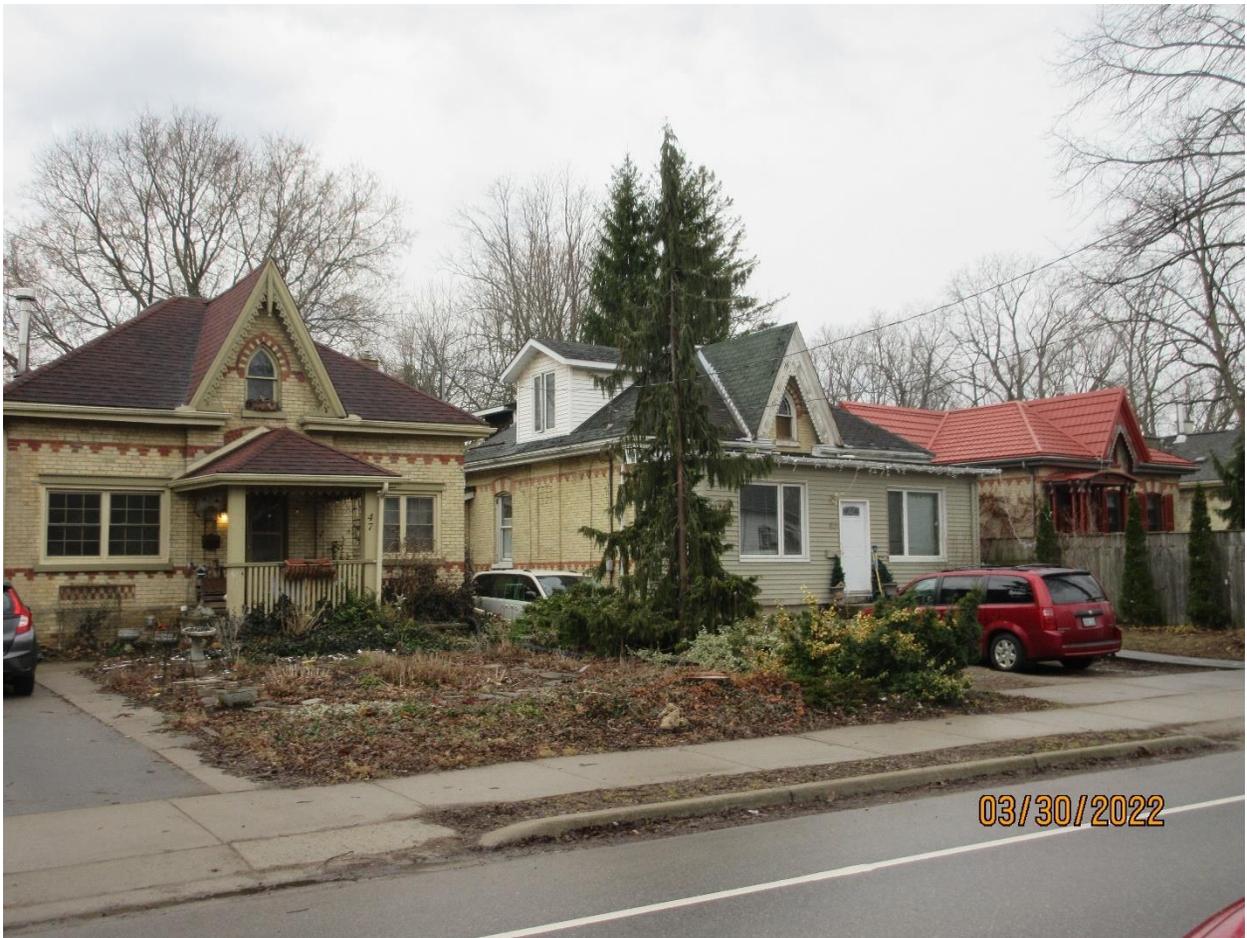
Image 1: Photograph showing the subject dwelling at 45 Bruce Street (centre) within its context on Bruce Street. Note, the adjacent properties at 47 Bruce Street (left) and 43 Bruce Street (right) share similar design and details (2022).

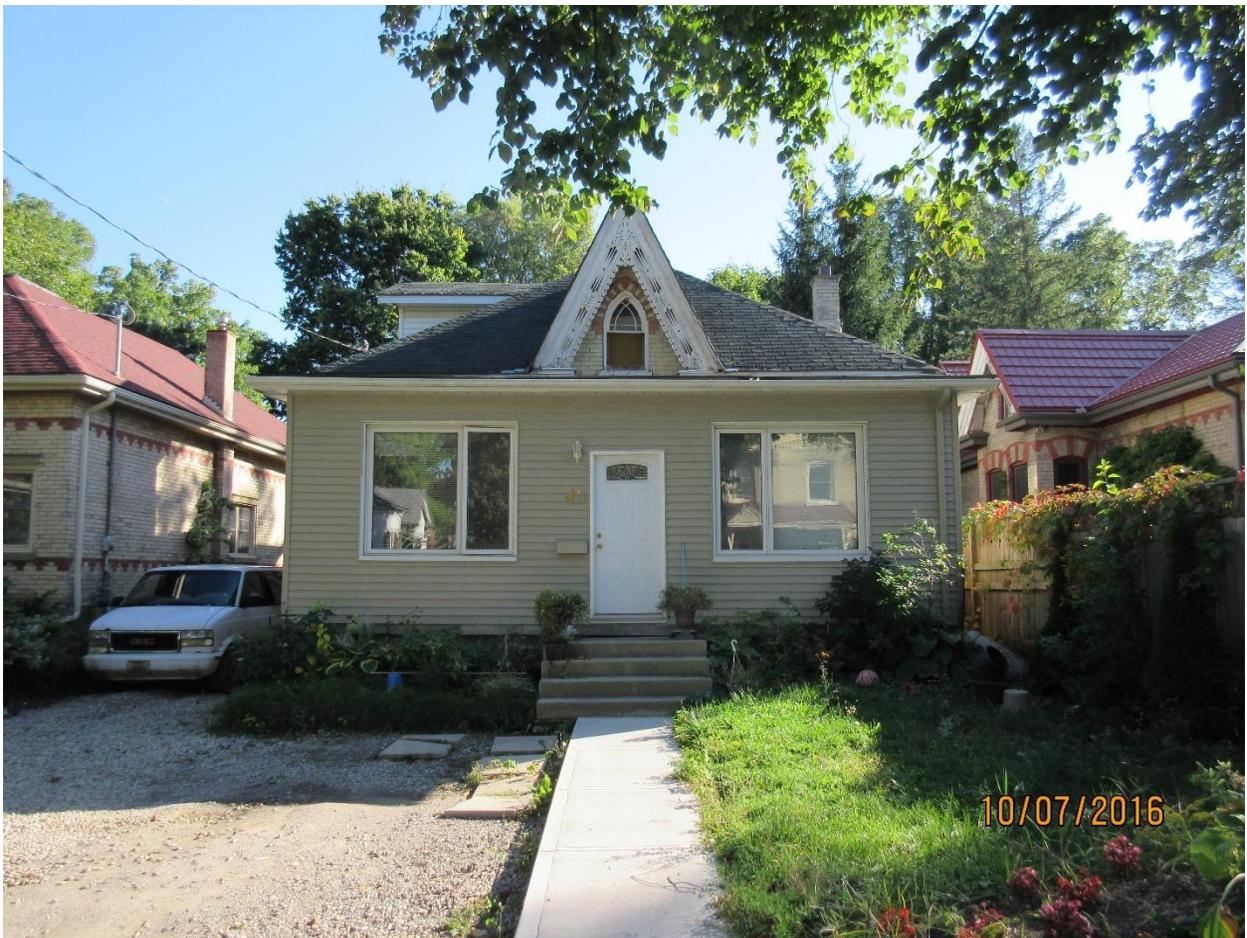
Image 6: Photograph of the subject dwelling at 45 Bruce Street. Note, the front elevation has been obscured by a later addition that has been clad in vinyl, however, the dwelling still retains its cultural heritage value and various heritage attributes, including the scale and mass, and design details including the roof shape, gable peak, brick details visible on side elevations, and brick chimney (2016).

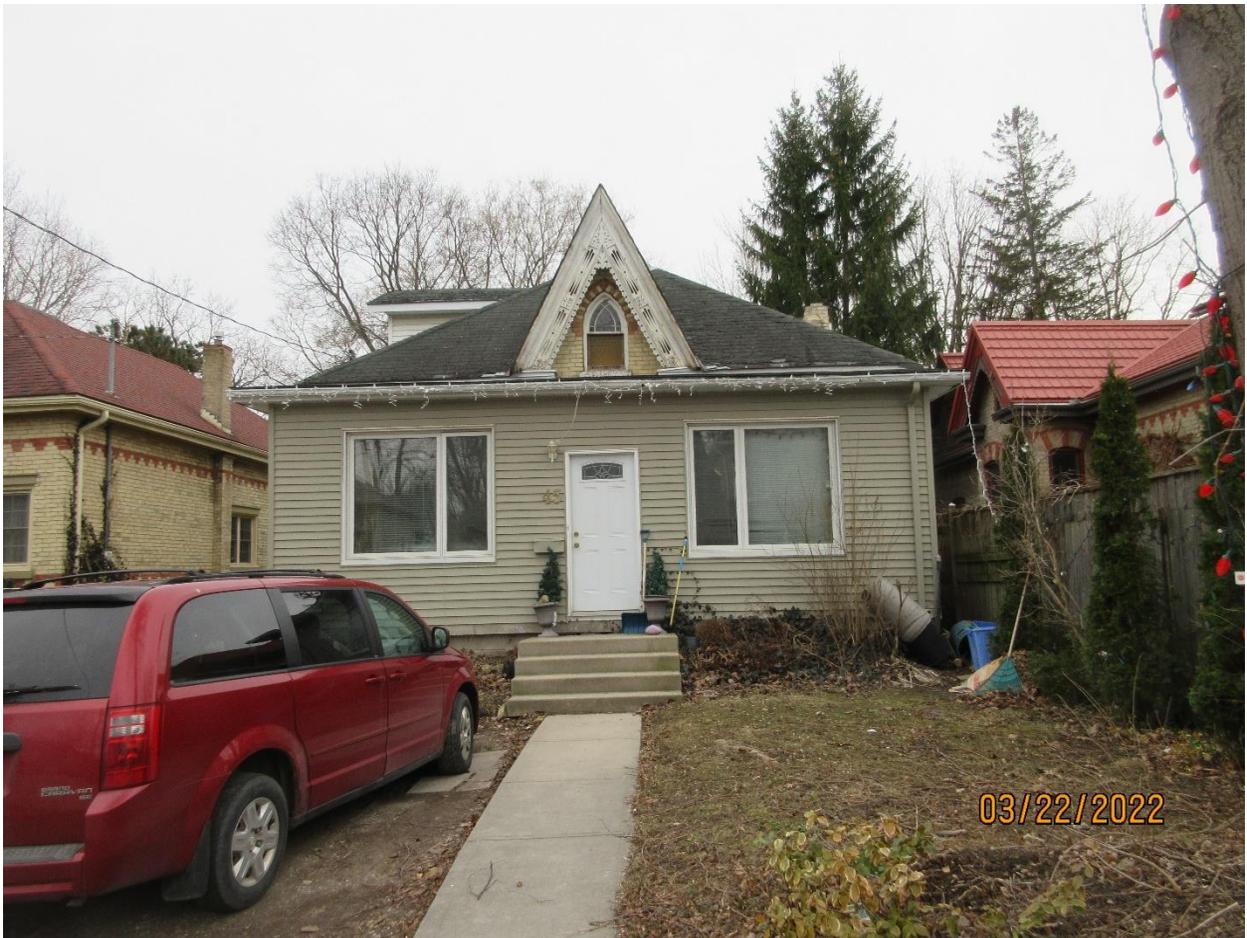
A complaint from the community in mid-March 2022 brought to the City’s attention that the chimney on the dwelling located at 45 Bruce Street had partially collapsed as a result of its deteriorating condition. Approximately one week later, the City was alerted that another portion of the chimney was removed bringing the chimney down closer to the roof line.

Due to deteriorating property standards, the existing chimney on the dwelling at 45 Bruce Street partially collapsed and was further dismantled, lowering the overall height of the chimney.

Image 7: Photograph of the subject dwelling at 45 Bruce Street, shortly after the partial collapse of the chimney (2022).

The proposed chimney removal would result in adverse impacts to the heritage attributes of the property and the Wortley Village-Old South Heritage Conservation District. Further, removing the chimney would not address the Property Standards Order to repair and maintain the chimney. The applicant is encouraged to retain, repair, and/or cap the chimney in order to conserve the heritage attribute of the property.

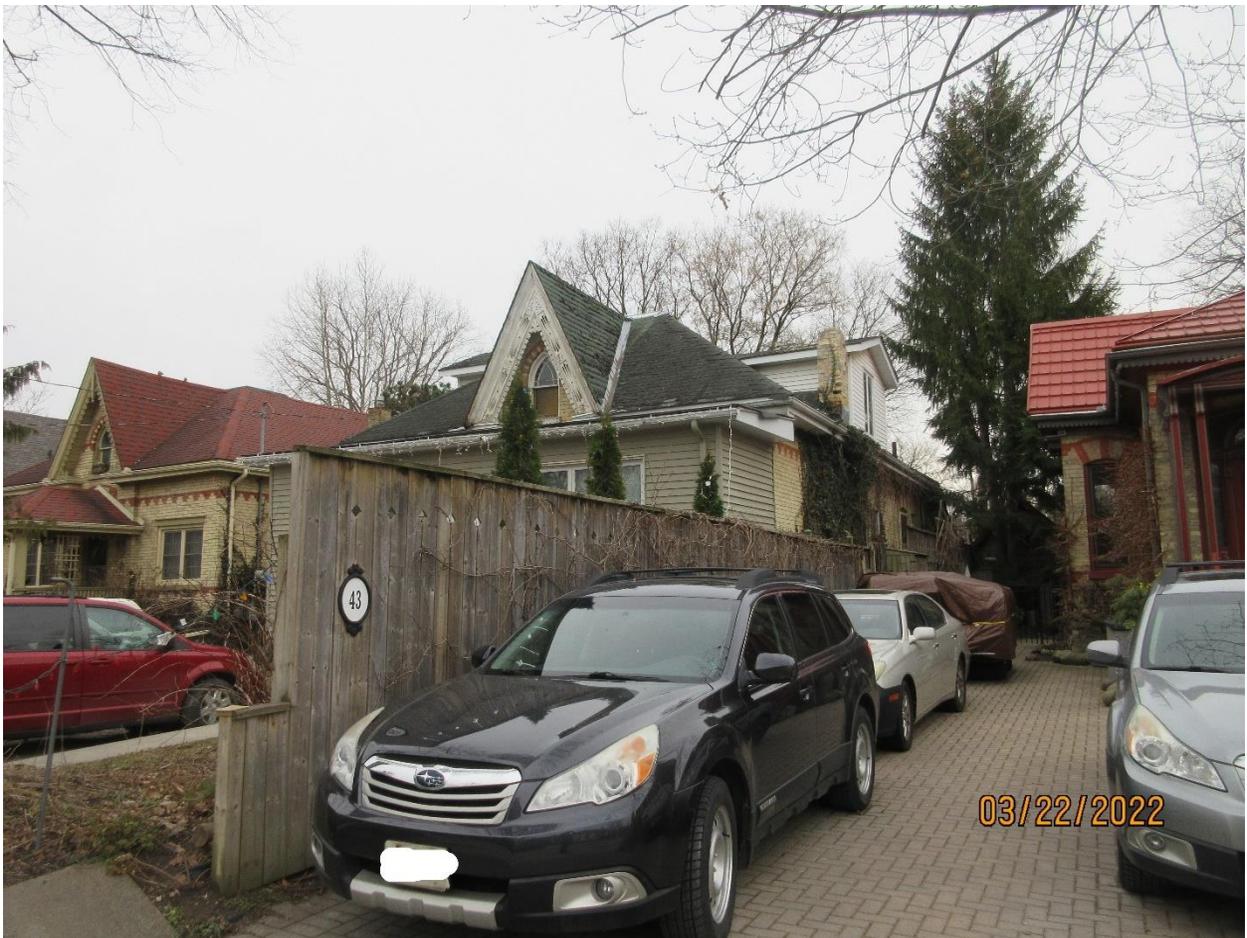
Image 8: Photograph of the subject dwelling at 45 Bruce Street, shortly after the partial collapse of the chimney. Note, the decorative dichromatic brick on the side elevations of the dwelling can be observed in this photograph as well as on the adjacent properties (2022).

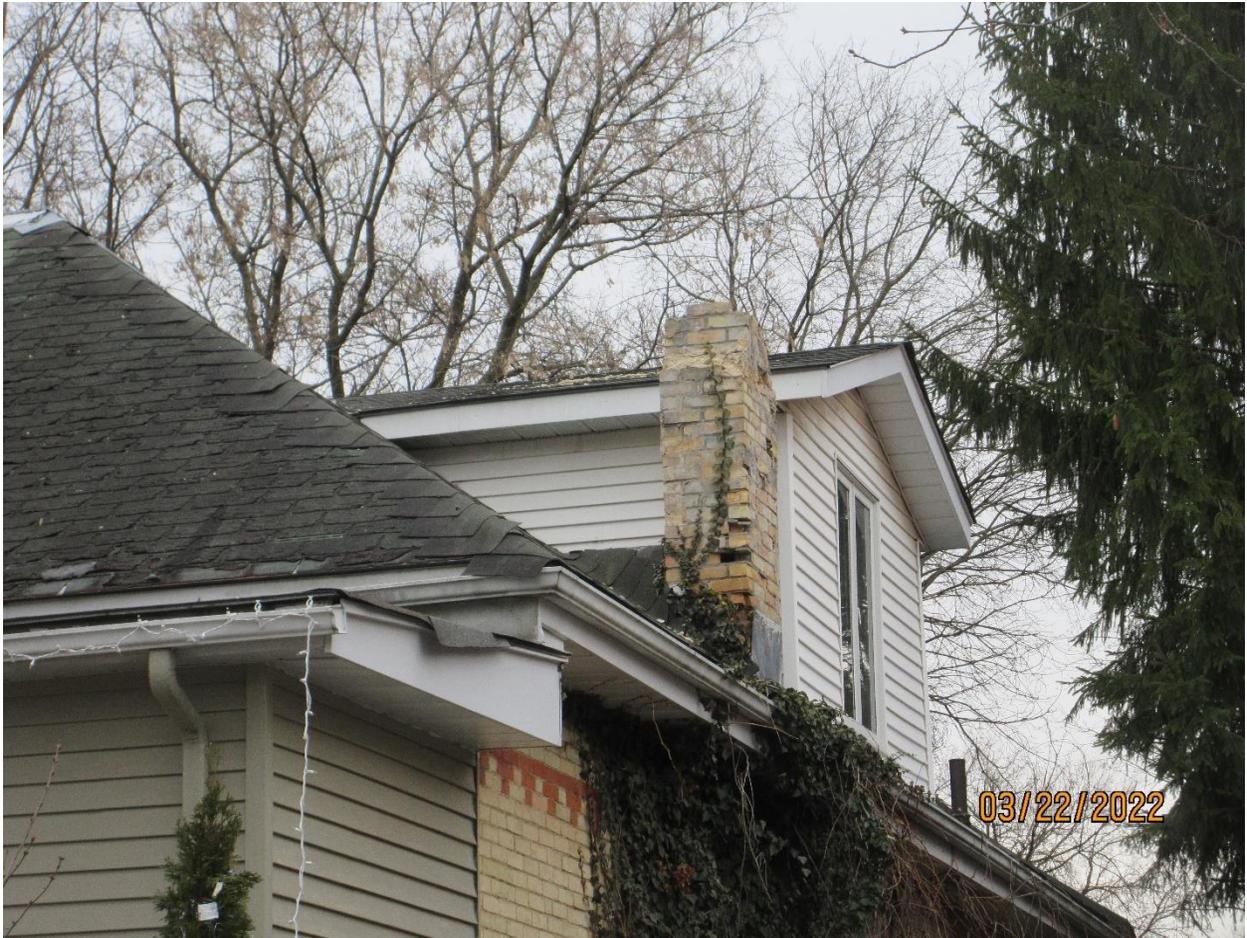
Image 9: Photograph showing the partially collapsed chimney on the subject dwelling at 45 Bruce Street (2022).

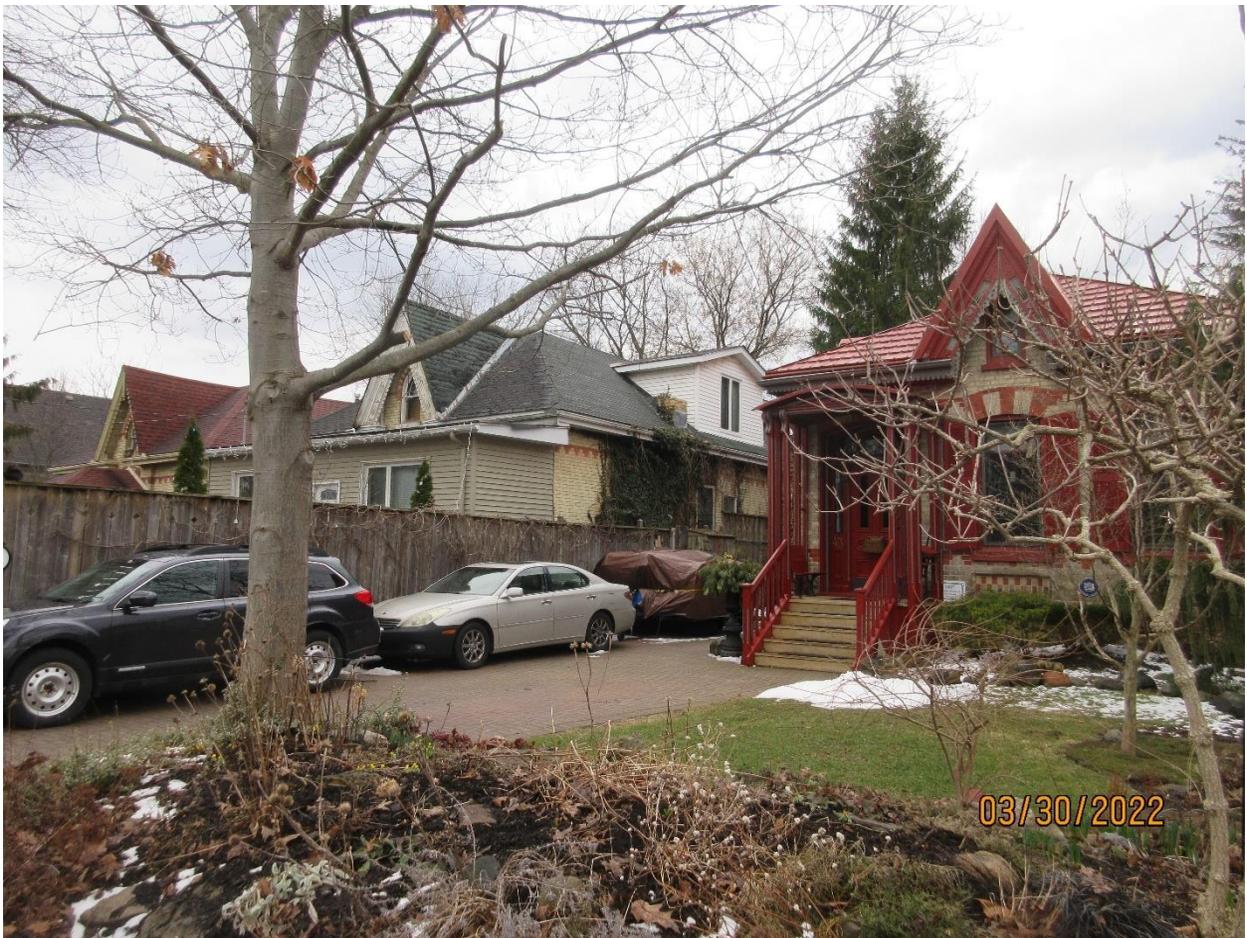
Image 10: Photograph showing the chimney further removed on the subject dwelling at 45 Bruce Street. Note, the chimney was further lowered shortly after the initial partial collapse (2022).

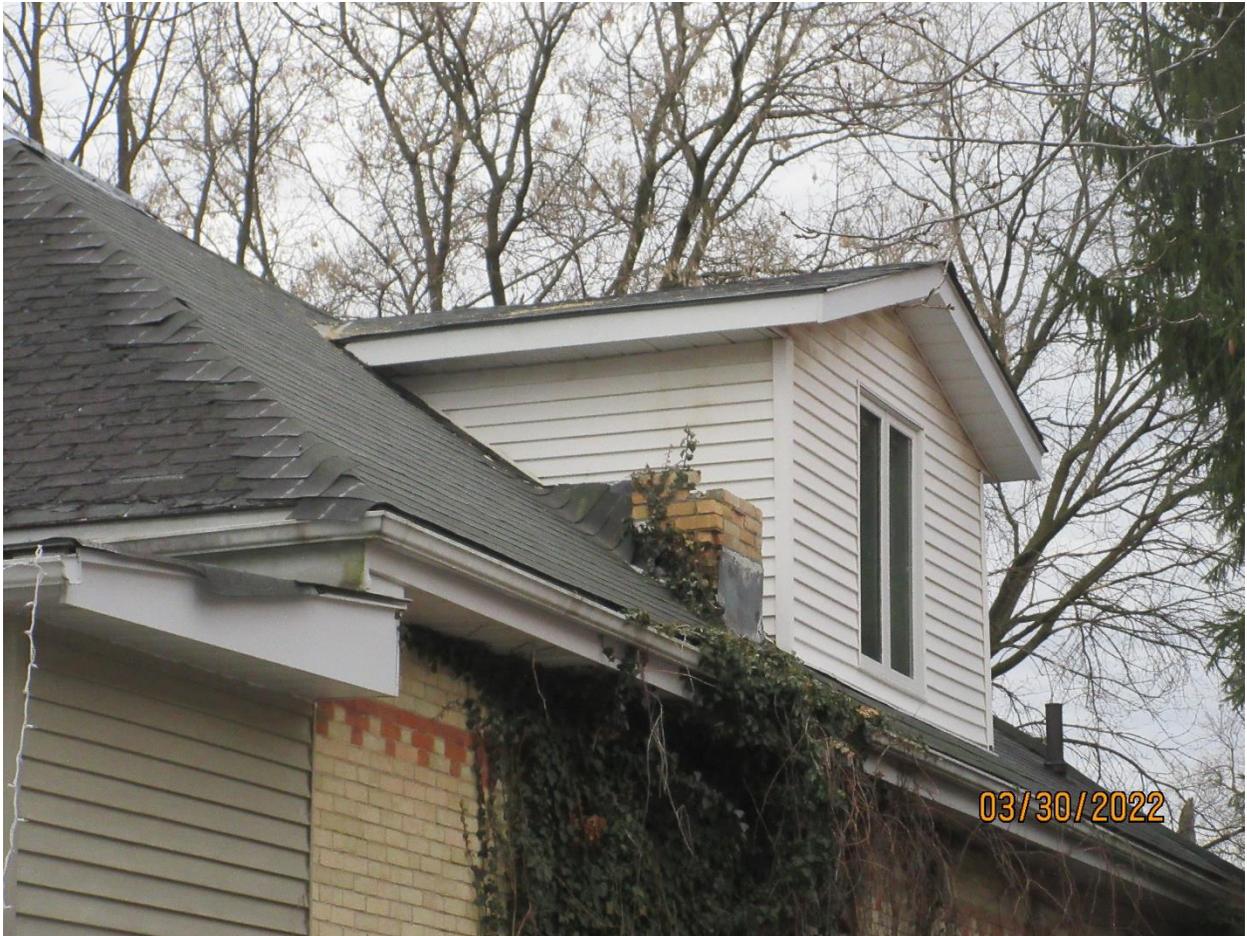
Image 11: Photograph of the chimney following its further removal in March 2022.

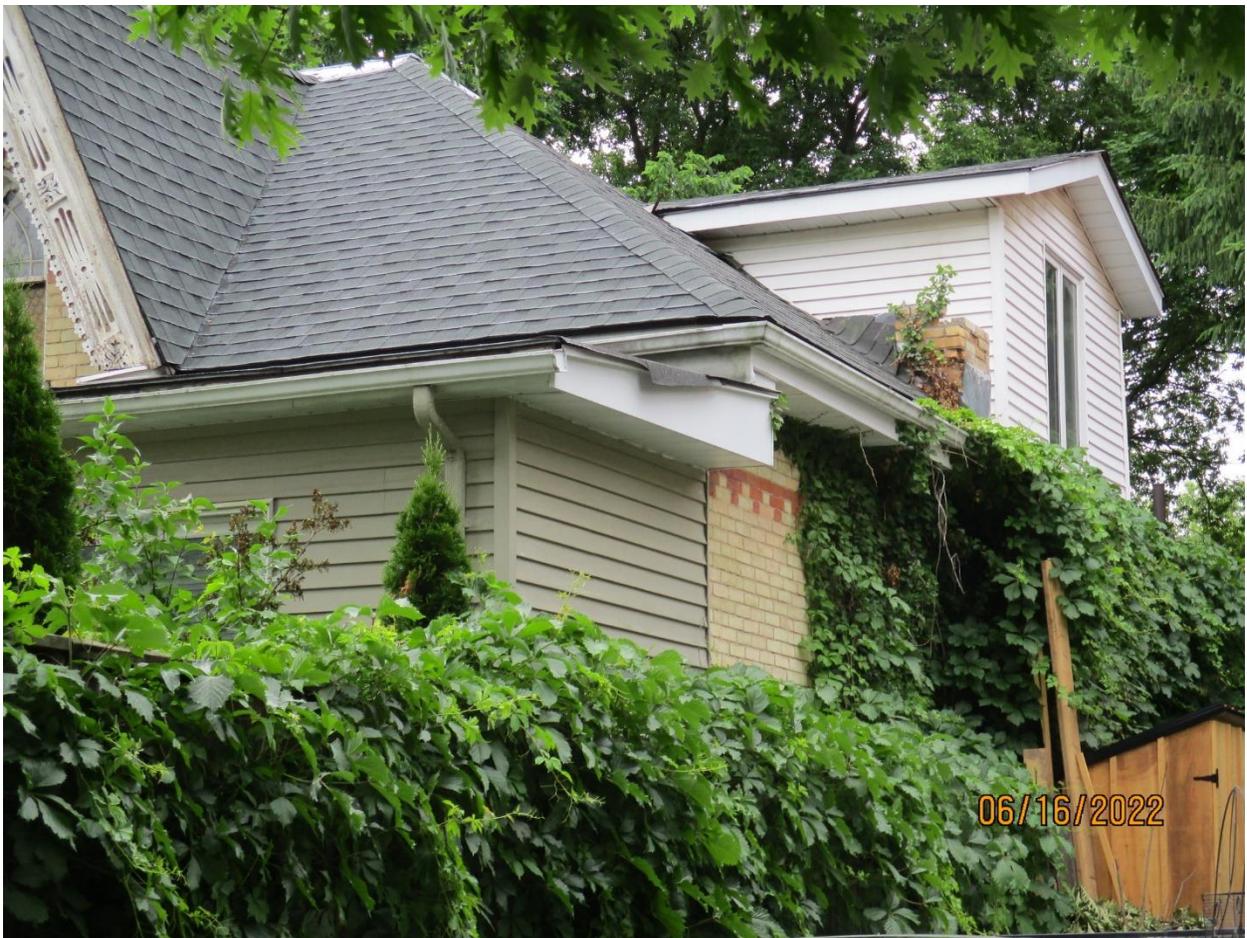
Image 12: Photograph of the subject dwelling and lowered chimney in June 2022, following submission of the Heritage Alteration Permit application.
