Report to Community Advisory Committee on Planning

Subject: Demolition Request for Heritage Designated Property at 520
Ontario Street, Old East Heritage Conservation District

Date: Wednesday August 10, 2022

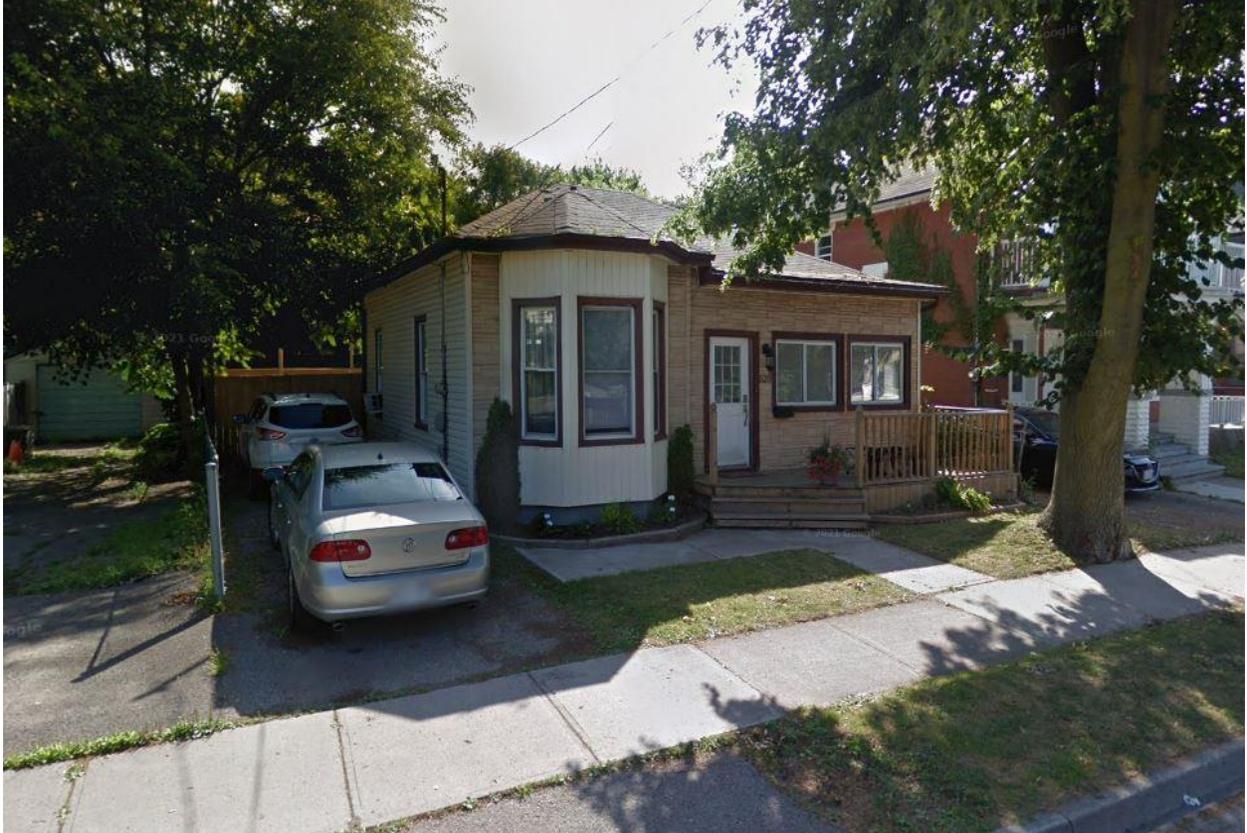
The dwelling on the property at 520 Ontario Street consists of a single storey cottage with a low-pitch hipped roof. The dwelling's front façade is clad with angel-stone, a faux stone cladding and includes a projecting bay, front door, and pair of windows. A small front porch extends across a portion of the front façade. The side elevations of the dwelling include a few windows but are primarily characterized by the horizontal vinyl siding cladding that wraps the remainder of the elevations.

Image 1: Google Street Image of the dwelling on the subject property at 520 Ontario Street, shown in August 2019, prior to experiencing damage.

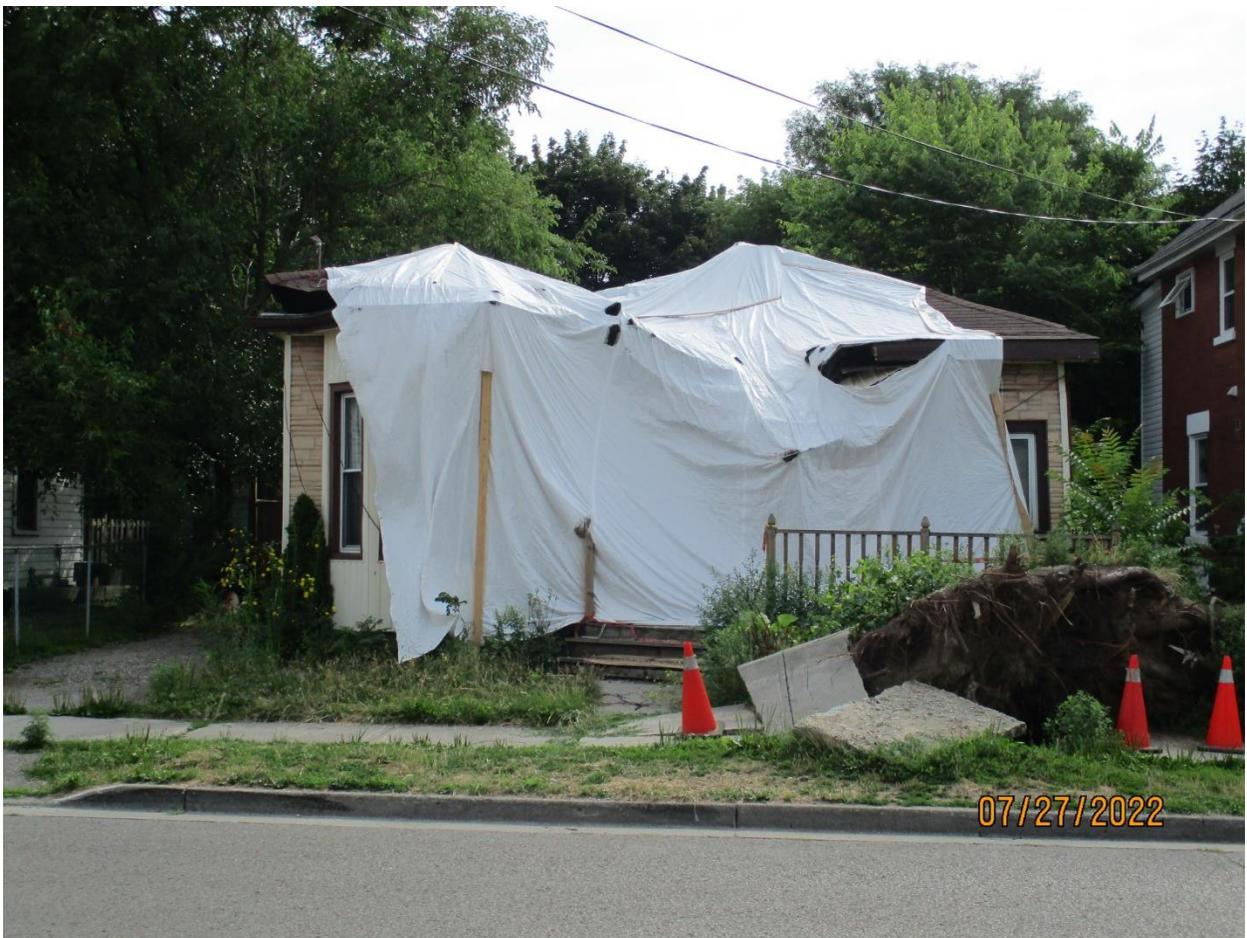
During a severe windstorm on May 21, 2022 a large mature tree fell onto the dwelling located at on the property at 520 Ontario Street, causing extensive damage to the dwelling. The tree caused damage to the entirety of the roof, as well as extensive damage to the structural components of the dwelling.

A Structural Assessment prepared for the dwelling (Pow Peterman Consulting Engineers, dated May 27, 2022) noted that the tree which was blown over during the storm was approximately 24" to 36" in diameter. It crushed the roof of the house, as well as the sitting room and front entryway. In addition, a large beam supporting the roof structure, as well as interior load bearing walls were cracked. The assessment

Image 2: Photograph of the subject property at 520 Ontario Street in its current condition following the tree damage caused in May 2022.

recommends that the entire roof and wall structure be demolished.

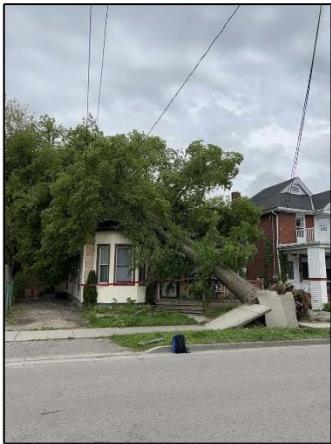
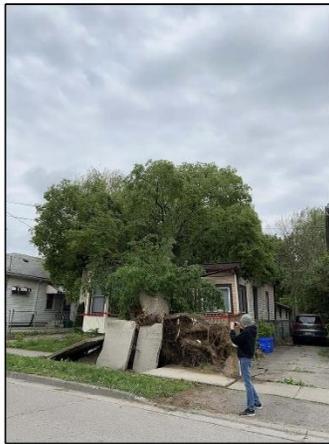
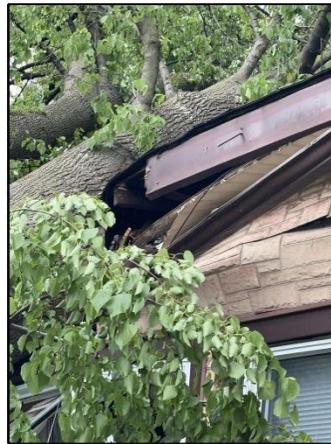
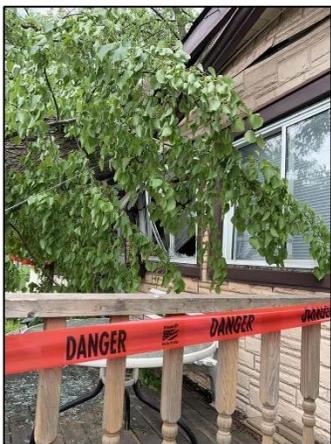
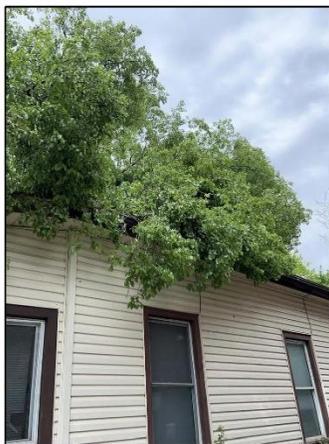
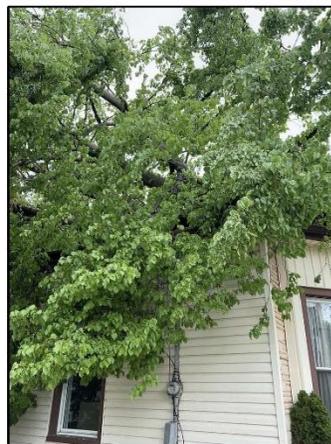
Image 3: Photographs included within an inspection report demonstrating extent of the damage to the dwelling at 520 Ontario Street.

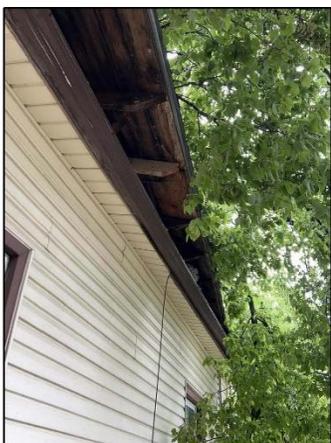
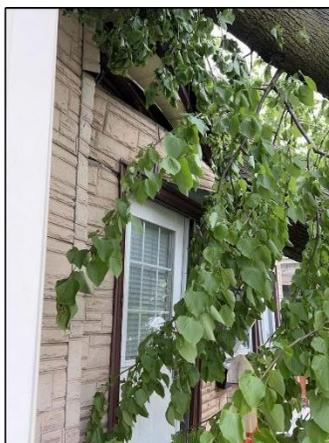
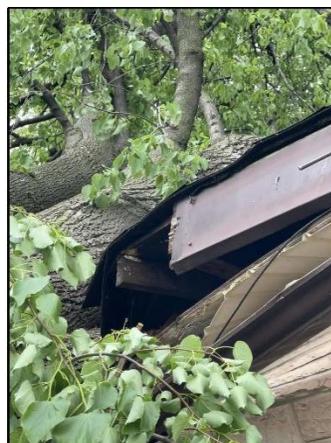
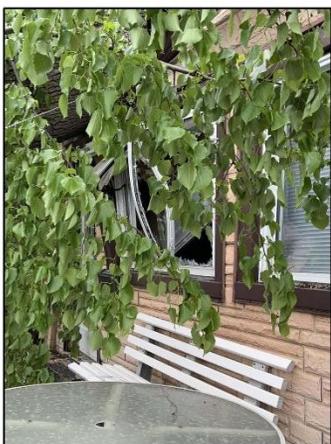
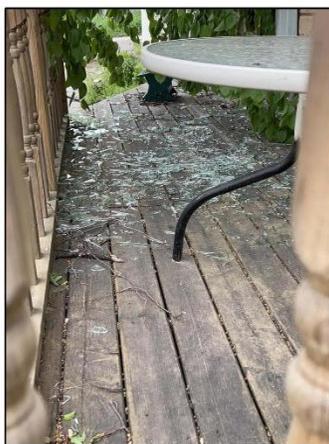
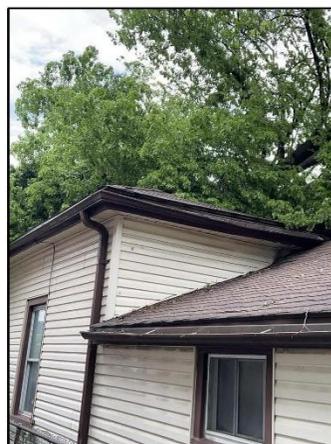
Image 4: Photographs included within an inspection report demonstrating extent of the damage to the dwelling at 520 Ontario Street.

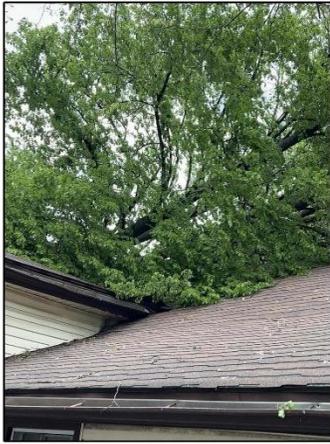
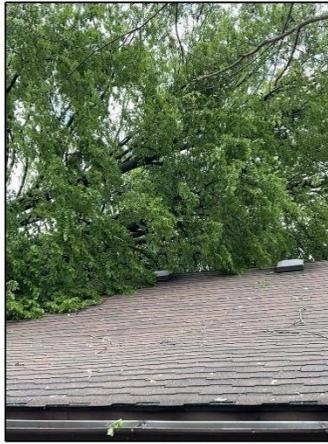
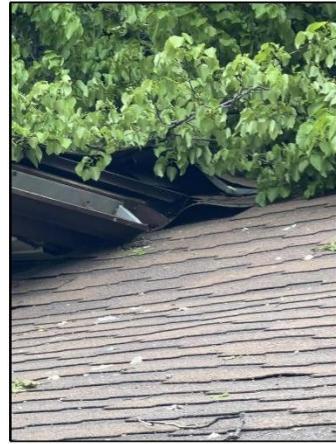
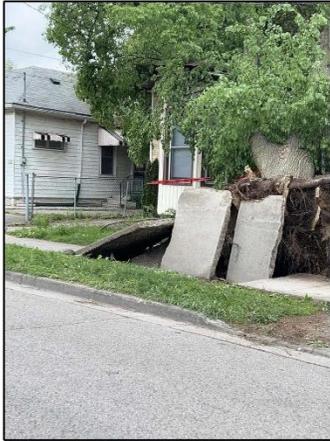
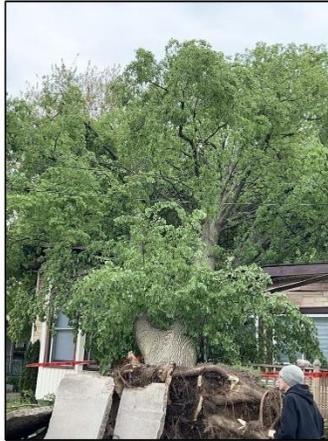
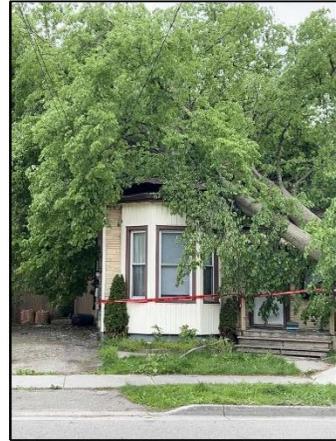
Image 5: Photographs included within an inspection report demonstrating extent of the damage to the dwelling at 520 Ontario Street.

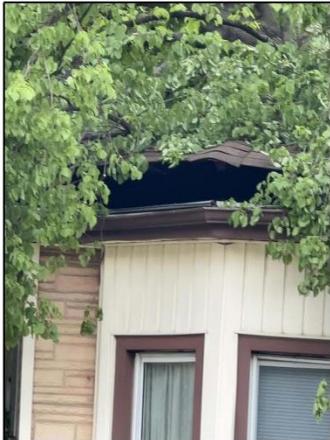
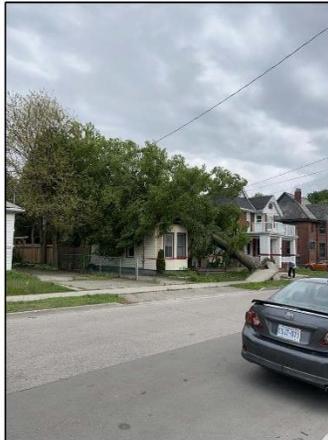
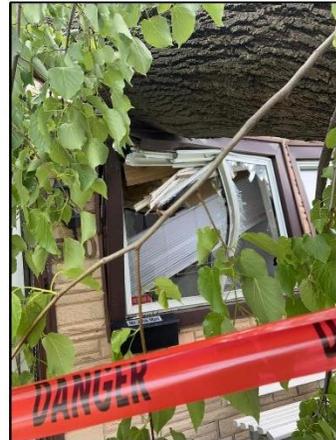
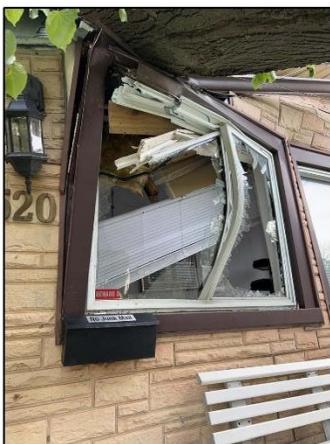
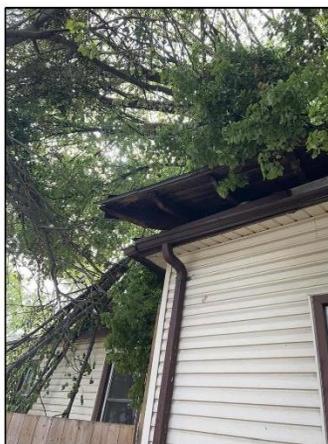
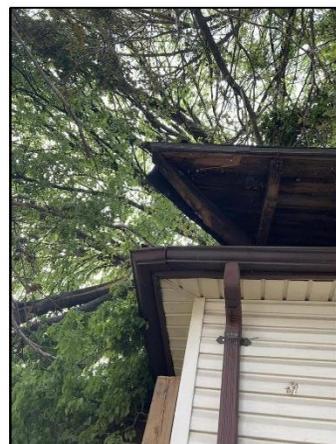
Image 6: Photographs included within an inspection report demonstrating extent of the damage to the dwelling at 520 Ontario Street.

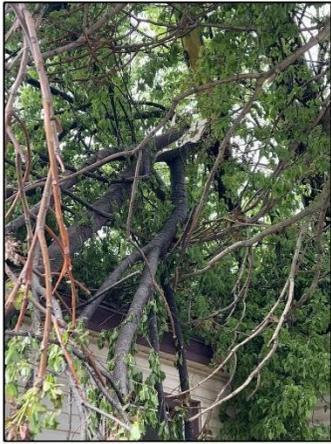
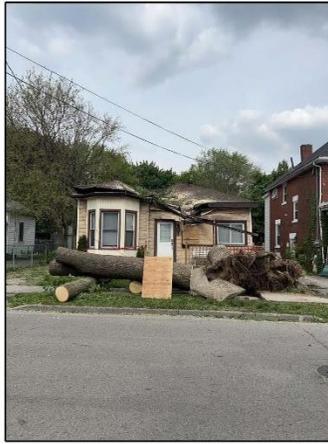
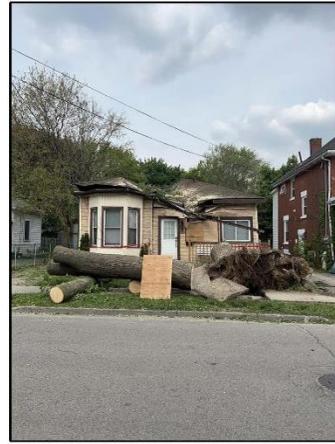
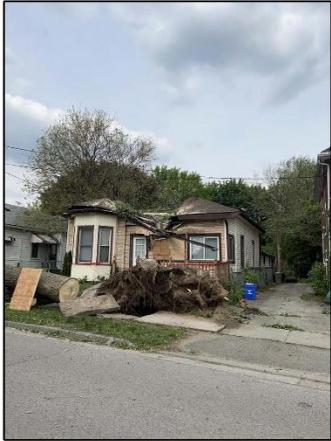
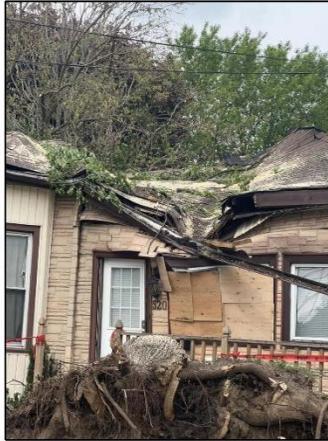
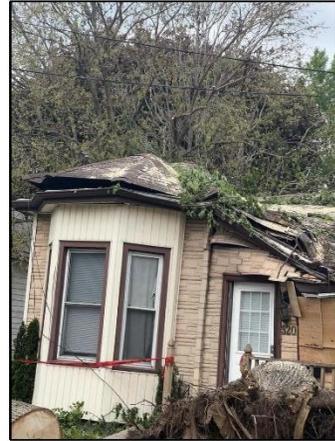
Image 7: Photographs included within an inspection report demonstrating extent of the damage to the dwelling at 520 Ontario Street.

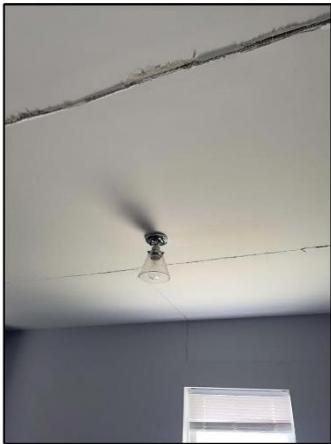
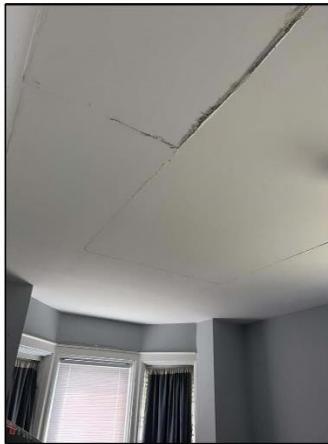
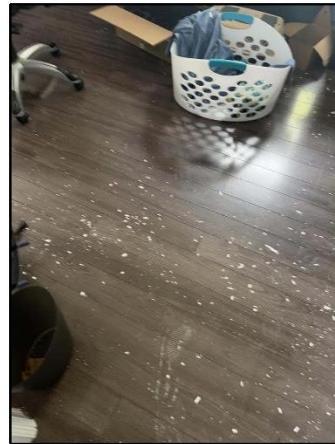
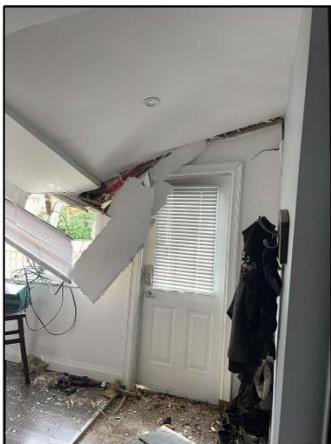
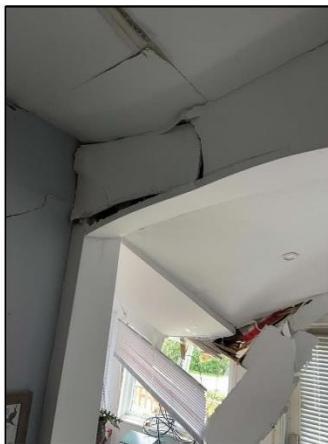
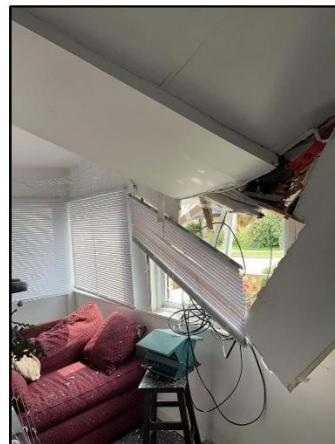
Image 8: Photographs included within an inspection report demonstrating extent of the damage to the dwelling at 520 Ontario Street.
