Report to Planning and Environment Committee

Subject: Demolition Request for Heritage Designated Property at 520 Ontario Street, Old East Heritage Conservation District
Public Participation Meeting

Date: Monday August 22, 2022

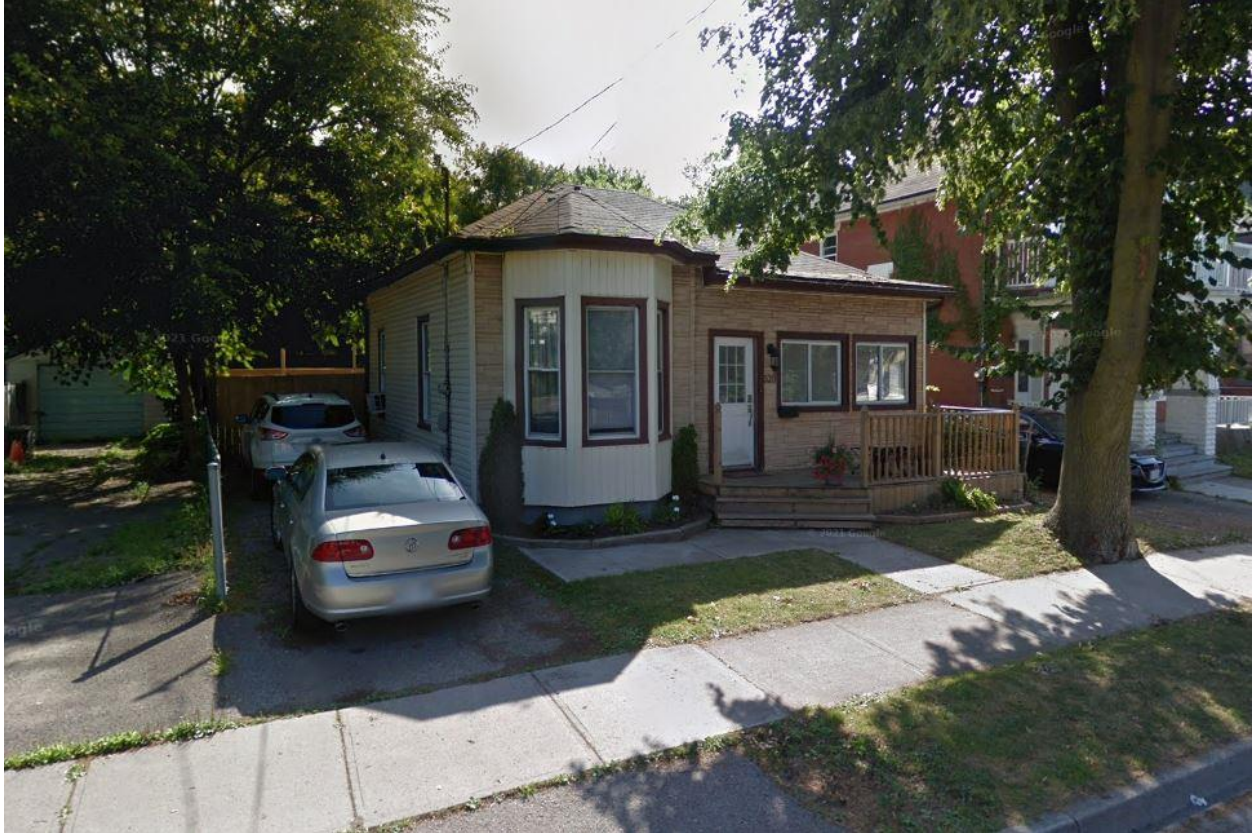
The dwelling on the property at 520 Ontario Street consists of a single storey cottage with a low-pitch hipped roof. The dwelling's front façade is clad with angel-stone, a faux stone cladding and includes a projecting bay, front door, and pair of windows. A small front porch extends across a portion of the front façade. The side elevations of the dwelling include a few windows but are primarily characterized by the horizontal vinyl siding cladding that wraps the remainder of the elevations.

Image 1: Google Street Image of the dwelling on the subject property at 520 Ontario Street, shown in August 2019, prior to experiencing damage.

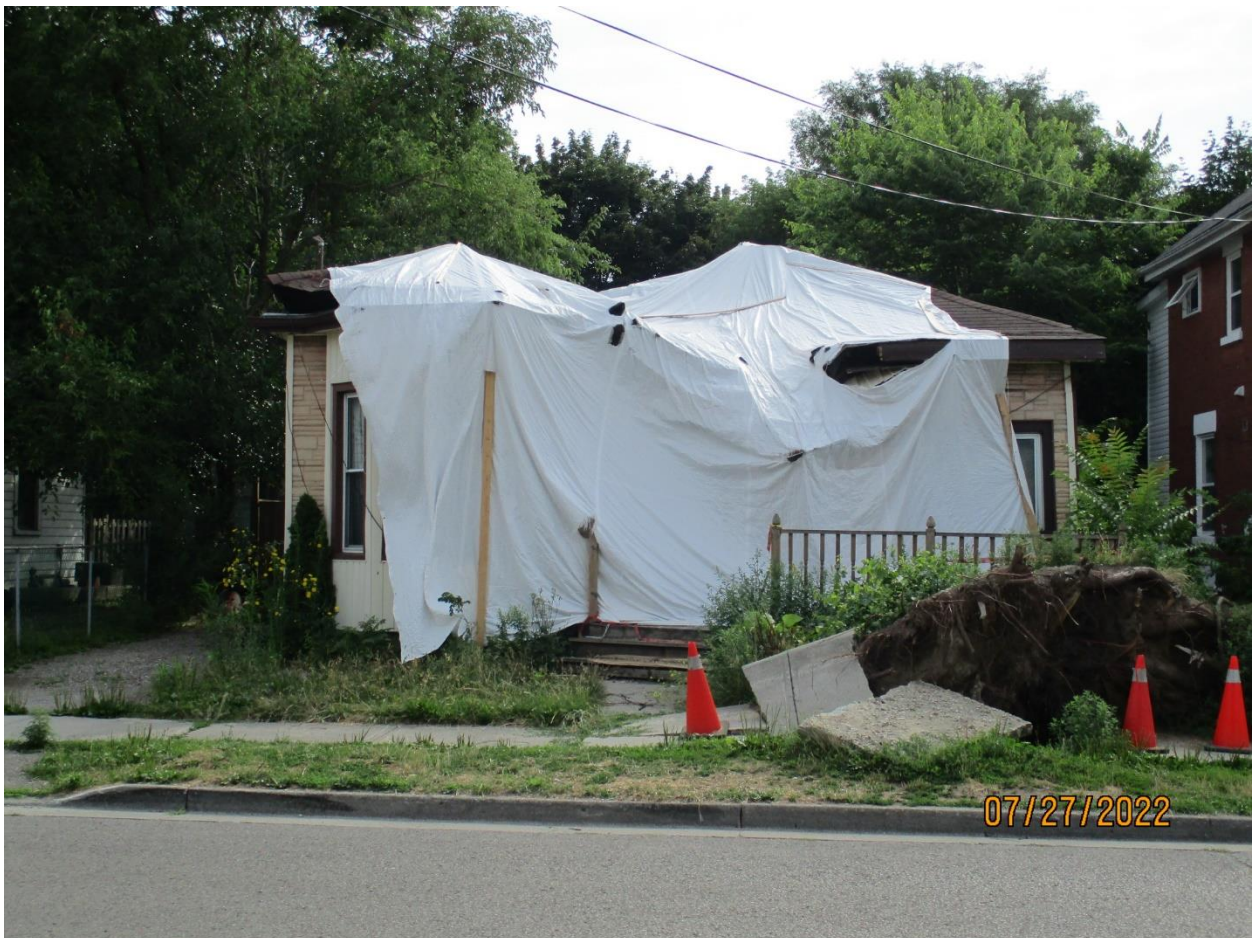
During a severe windstorm on May 21, 2022 a large mature tree fell onto the dwelling located at on the property at 520 Ontario Street, causing extensive damage to the dwelling. The tree caused damage to the entirety of the roof, as well as extensive damage to the structural components of the dwelling.

A Structural Assessment prepared for the dwelling (Pow Peterman Consulting Engineers, dated May 27, 2022) noted that the tree which was blown over during the storm was approximately 24” to 36” in diameter. It crushed the roof of the house, as well as the sitting room and front entryway. In addition, a large beam supporting the roof structure, as well as interior load bearing walls were cracked. The assessment recommends that the entire roof and wall structure be demolished.

Image 2: Photograph of the subject property at 520 Ontario Street in its current condition following the tree damage caused in May 2022.

That, on the recommendation of the Director, Planning and Development, with the advice of the Heritage Planner, the request to demolish the building on the heritage designated property at 520 Ontario Street, within the Old East Heritage Conservation District, **BE PERMITTED** pursuant to Section 42(1) of the *Ontario Heritage Act* subject to the following terms and conditions:

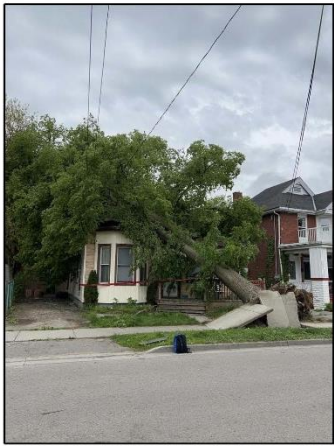
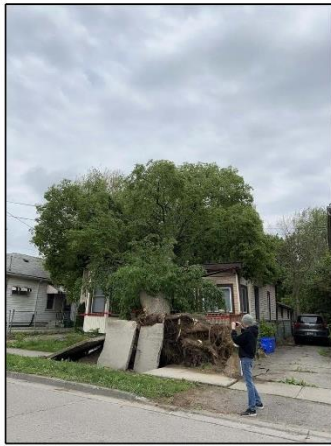
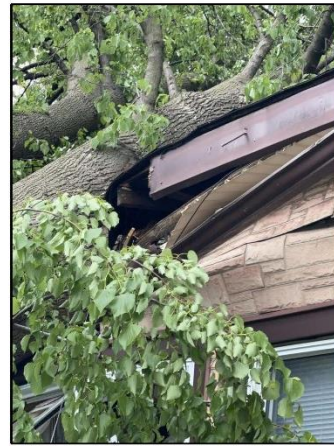
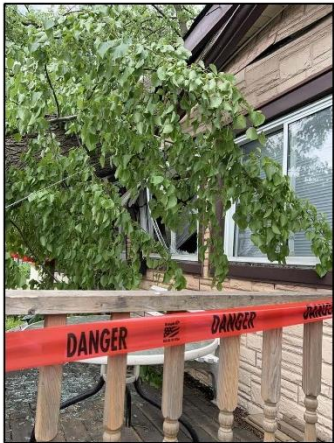
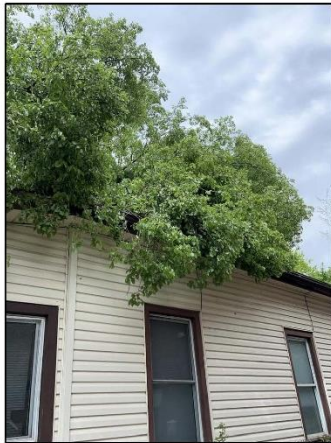
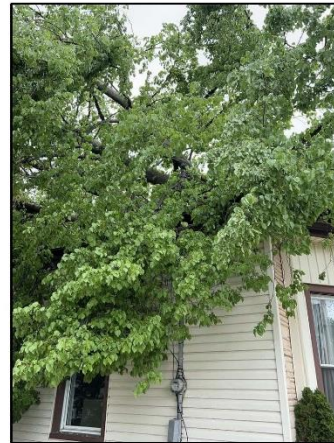
Image 3: Photographs included within an inspection report demonstrating extent of the damage to the dwelling at 520 Ontario Street.

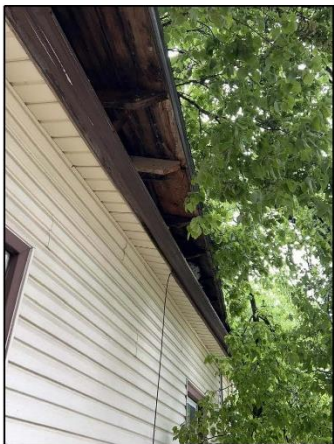
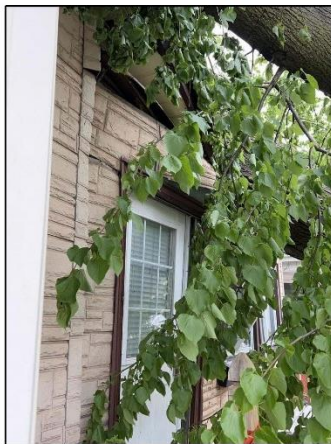
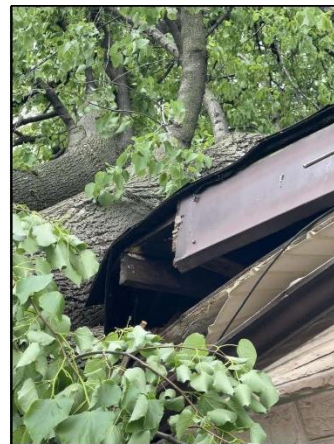
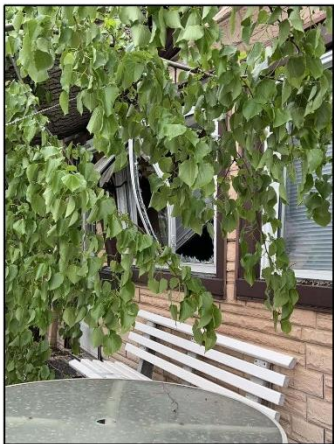
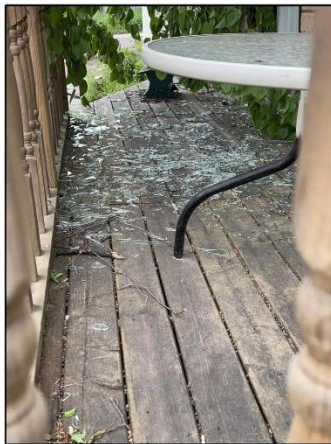
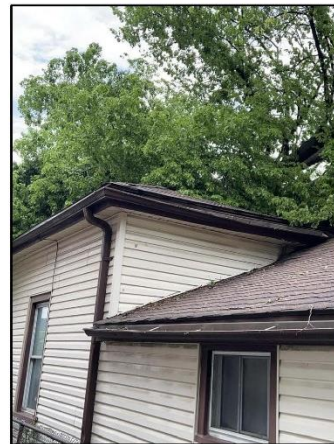
Image 4: Photographs included within an inspection report demonstrating extent of the damage to the dwelling at 520 Ontario Street.

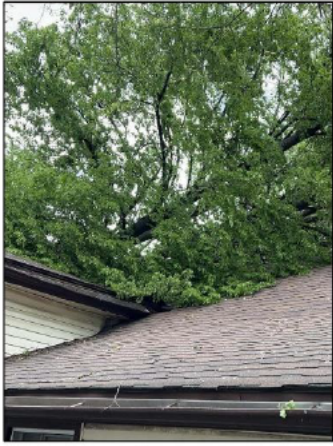
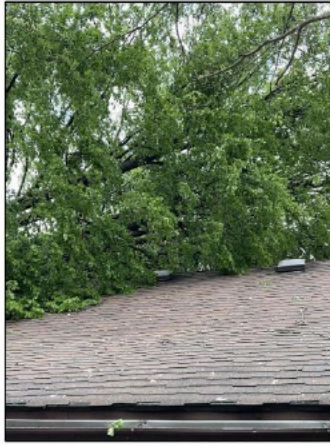
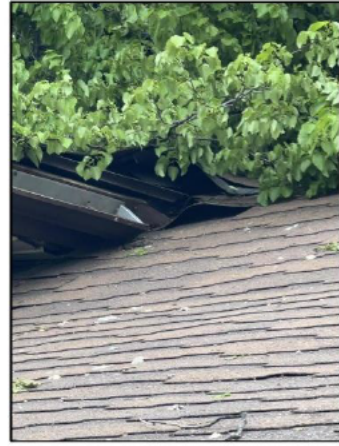
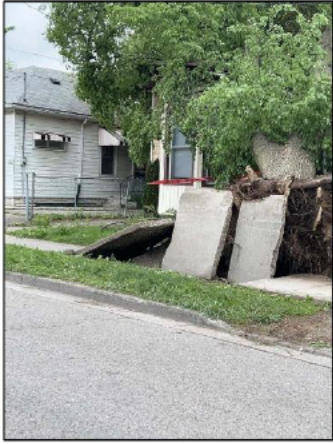
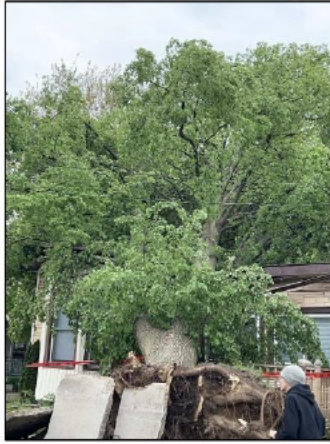
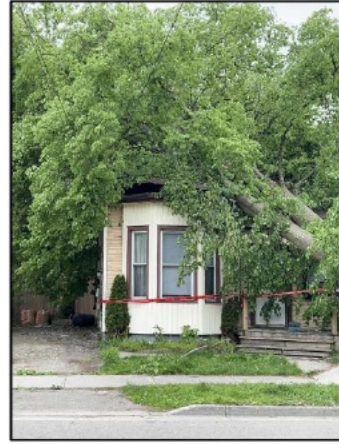
Image 5: Photographs included within an inspection report demonstrating extent of the damage to the dwelling at 520 Ontario Street.

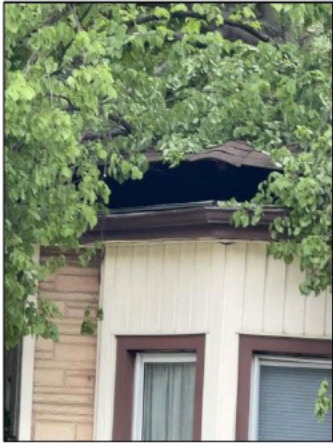
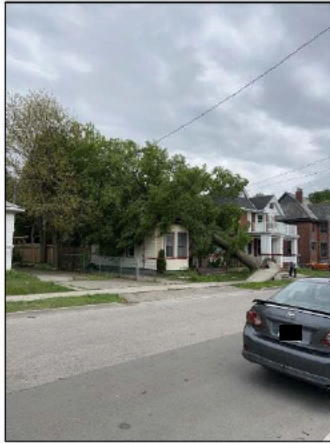
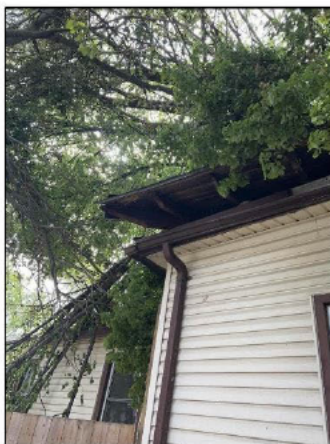
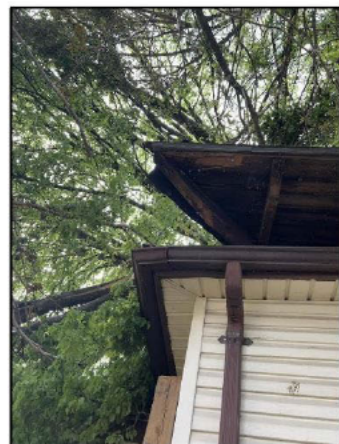
Image 6: Photographs included within an inspection report demonstrating extent of the damage to the dwelling at 520 Ontario Street.

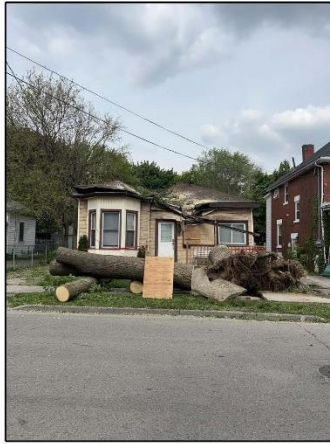
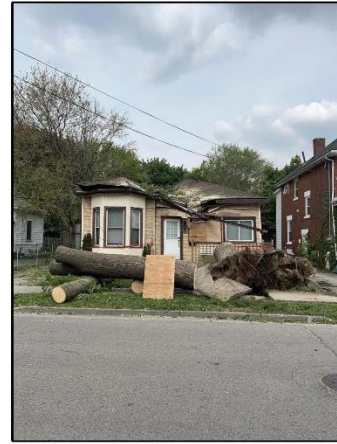
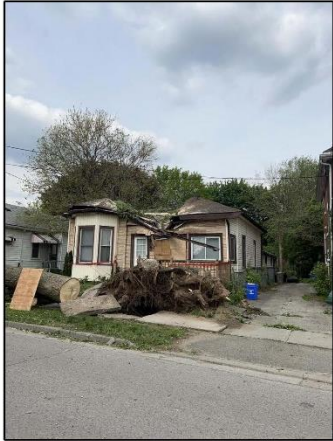
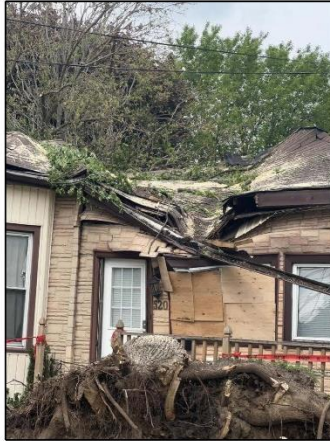
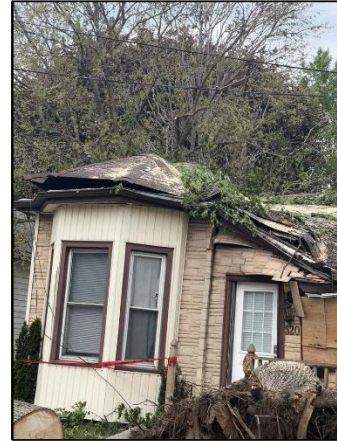
Image 7: Photographs included within an inspection report demonstrating extent of the damage to the dwelling at 520 Ontario Street.

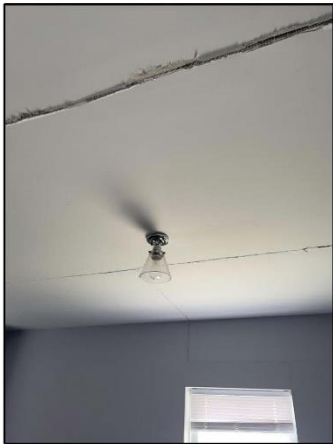
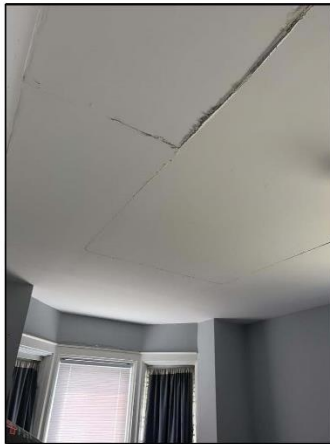
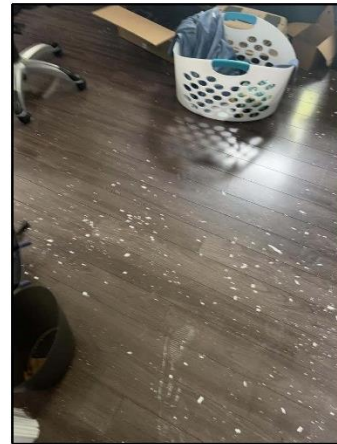
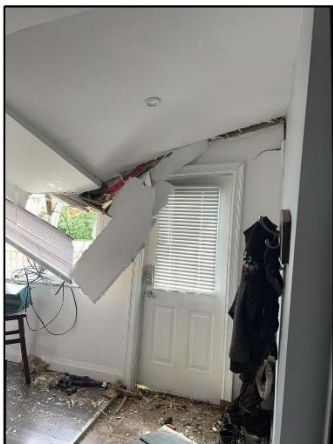
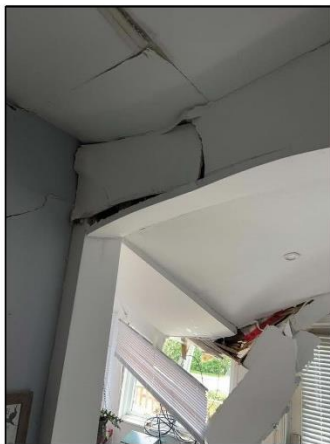
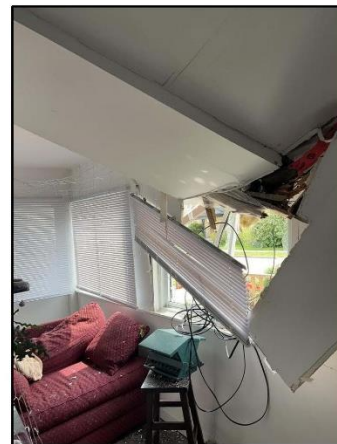
Image 8: Photographs included within an inspection report demonstrating extent of the damage to the dwelling at 520 Ontario Street.
