CONSERVATION PLAN

Routledge Farmhouse

1656 Hyde Park Road

Final Report

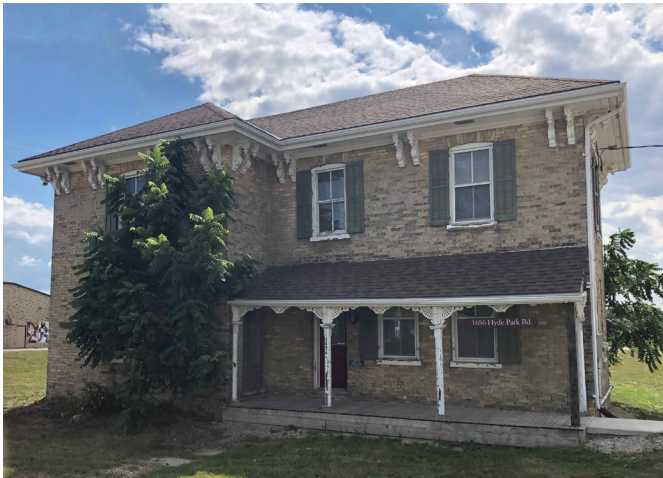
1656 Hyde Park Road- East Elevation (Street Front)

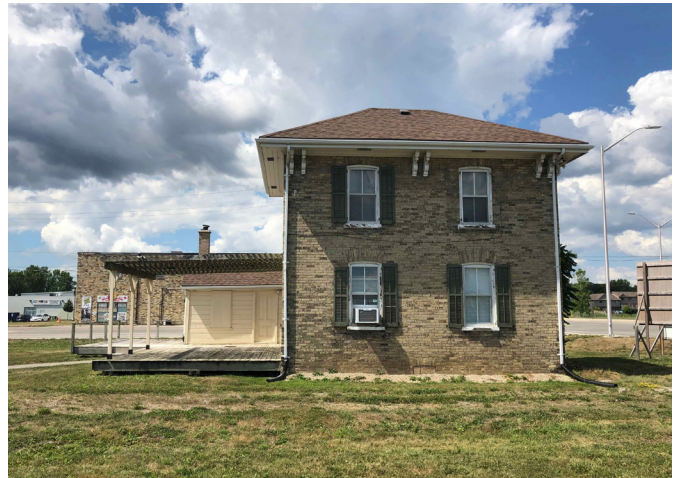
1656 Hyde Park Road- South Elevation

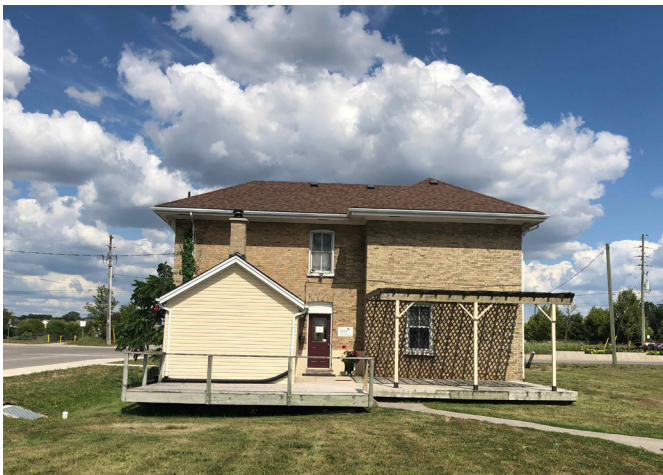
1656 Hyde Park Road- West Elevation

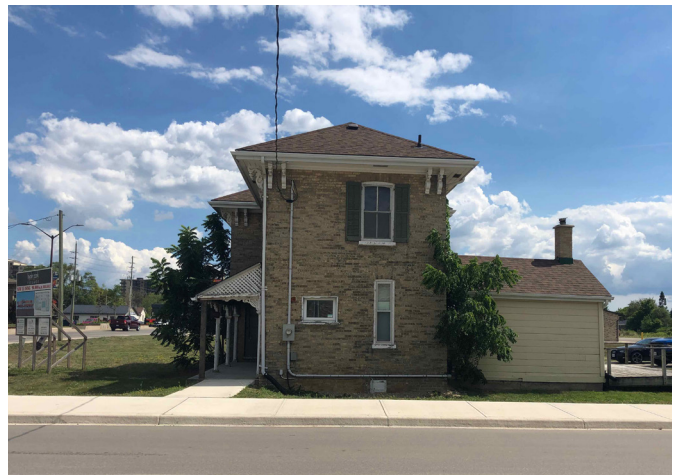
1656 Hyde Park Road- North Elevation

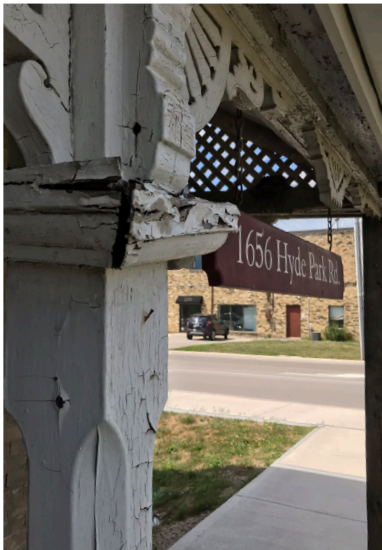
Existing front porch, east elevation. Photo by: a+LiNK Architecture Inc., 2020

- Review of swales and grading to avoid water draining towards building as part of Stormwater Management plan and grading plan.
- Weeping system installed around foundation system.
- Restore and repair front porch elements such as columns and spandrels, replace as necessary for structural requirements.
- Remove contemporary deck

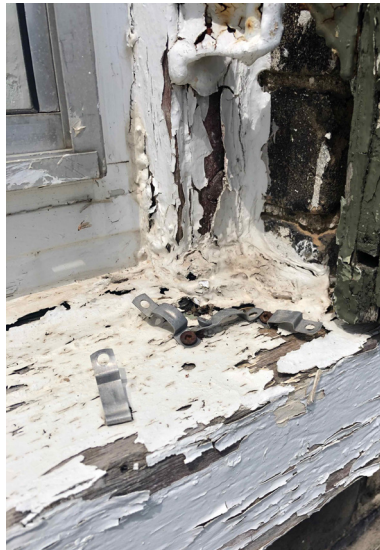
Windows and Doors: The windows and doors were observed from grade. The windows are primarily single-glazed, two-over-two wood framed with aluminum storms and segmental arched voids above. Some windows are missing storms. The windows are in 'poor' condition, with signs of decay, paint peeling and cracking. Pieces of the windows are breaking off and the sills are decaying. Shutters with original hardware flank the windows, with evidence of some shutters decaying, missing paint and a few have been removed. A contemporary window was added to the north elevation. The main west entry door at the porch appears to have been replaced. This door is not considered of heritage value as per the Heritage Designation. The alternate, entrance at the south end of the porch on the west elevation is original and is sealed shut. It is noted as a heritage attribute along with the original wood screened door. The paint is chipping at the base of the door near the step. The 6-pane, divided light screen door was sealed so the door could not be fully viewed, as a film has been applied to the divided light glass of the wooden screen door.

Decay at heritage wood windows, frames, sills and shutters. Photo by: a+LiNK Architecture Inc., 2020

- Observed and monitor stepped cracking on exterior.
- Windows and Doors: comprehensive window and door restoration program as part of the Conservation Plan, including wood shutters and the original wooden door and screen at the south end of the west elevation. May require use of a boom lift to assess condition of upper windows.

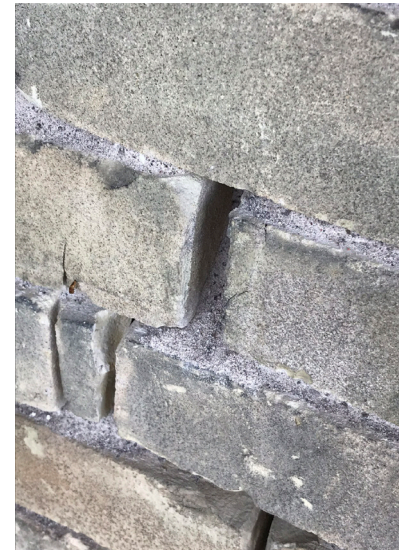
Signs of mortar failure. Photo by: a+LiNK Architecture Inc., 2020

- Brick and Mortar: repointing assessment and program as part of the Conservation Plan. May require use of a boom lift to assess condition of upper brick coursings.

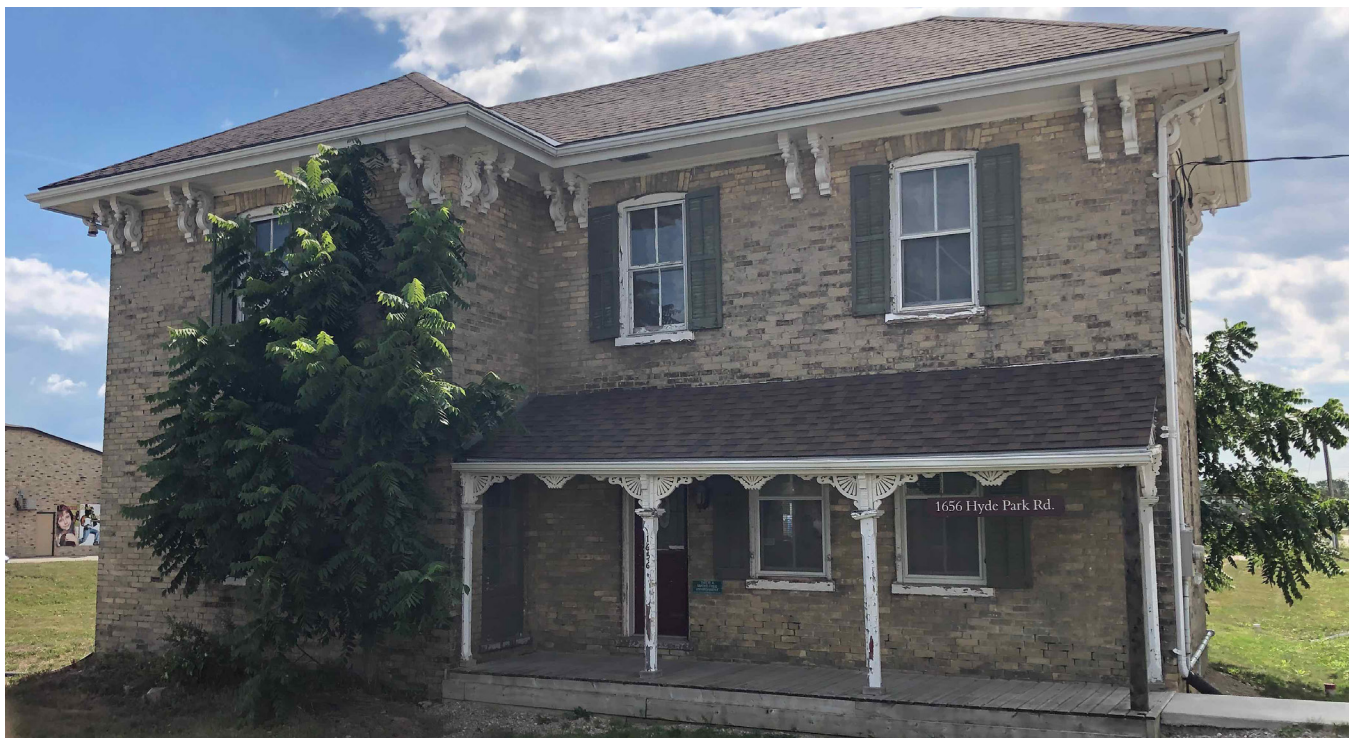
1656 Hyde Park Road. Main/East elevation. Photo by: a+LiNK Architecture Inc., 2020

The two-storey yellow-brick Routledge Farmhouse heritage building is exhibiting several aspects of wear, degradation and lack of conservation. The property would benefit from several conservation programs to ensure its longevity, given the conditions observed with particular attention to the exterior, including heritage elements and the structure. These programs might include restoration, preservation and/or rehabilitation, and will be further profiled in the following section, Conservation Principles, under Goals of Conservation as the second step to conservation. A summary of the issues observed and recommendations of prioritized deficiencies outlined in the report are summarized below.

Overall, the observations and recommendations made for 1656 Hyde Park Road indicate that the property, and in particular, many of the exterior heritage elements and the envelope, would benefit from a conservation program. Specifically, exterior wood heritage attributes such as the porch, windows, doors and shutters, and detailing such as paired brackets, spandrels and finials. The brick cladding also requires repointing and would benefit from conservation work, along with reinforcement of the brick tied to the exterior wall system and structure. The foundation requires alteration in order to ensure the longevity of the buildings structure, due to settling. Further conservation measures to implement this work are outlined in the Conservation Measures, Section 7 of this report.

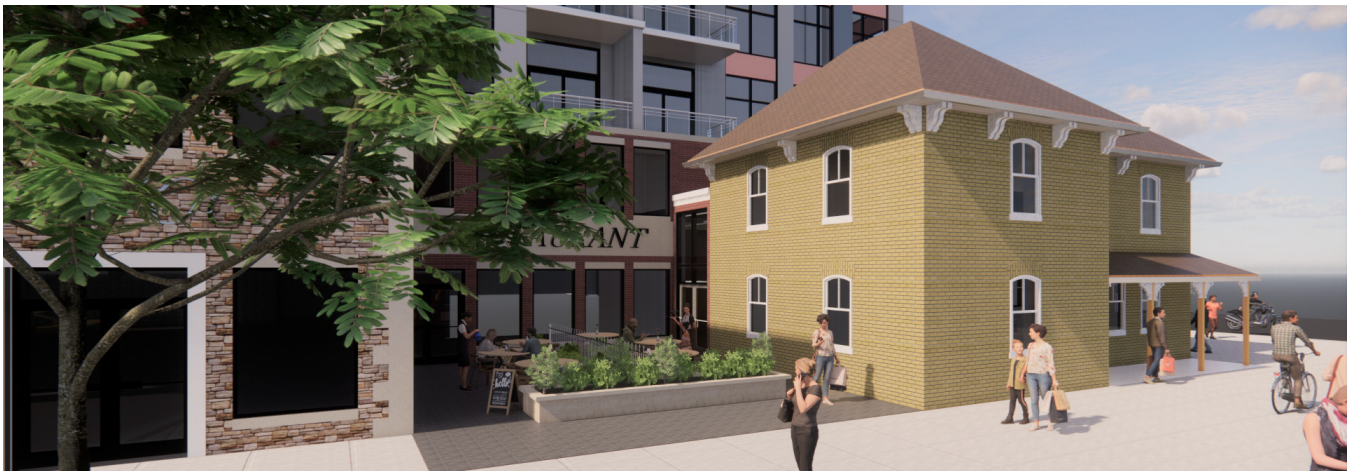
Proposed rendering of Routledge Farmhouse (southeast), integrated into the proposed development for *Hyde Park Village*. Drawing by 17 | 21 Architects Inc., 2020

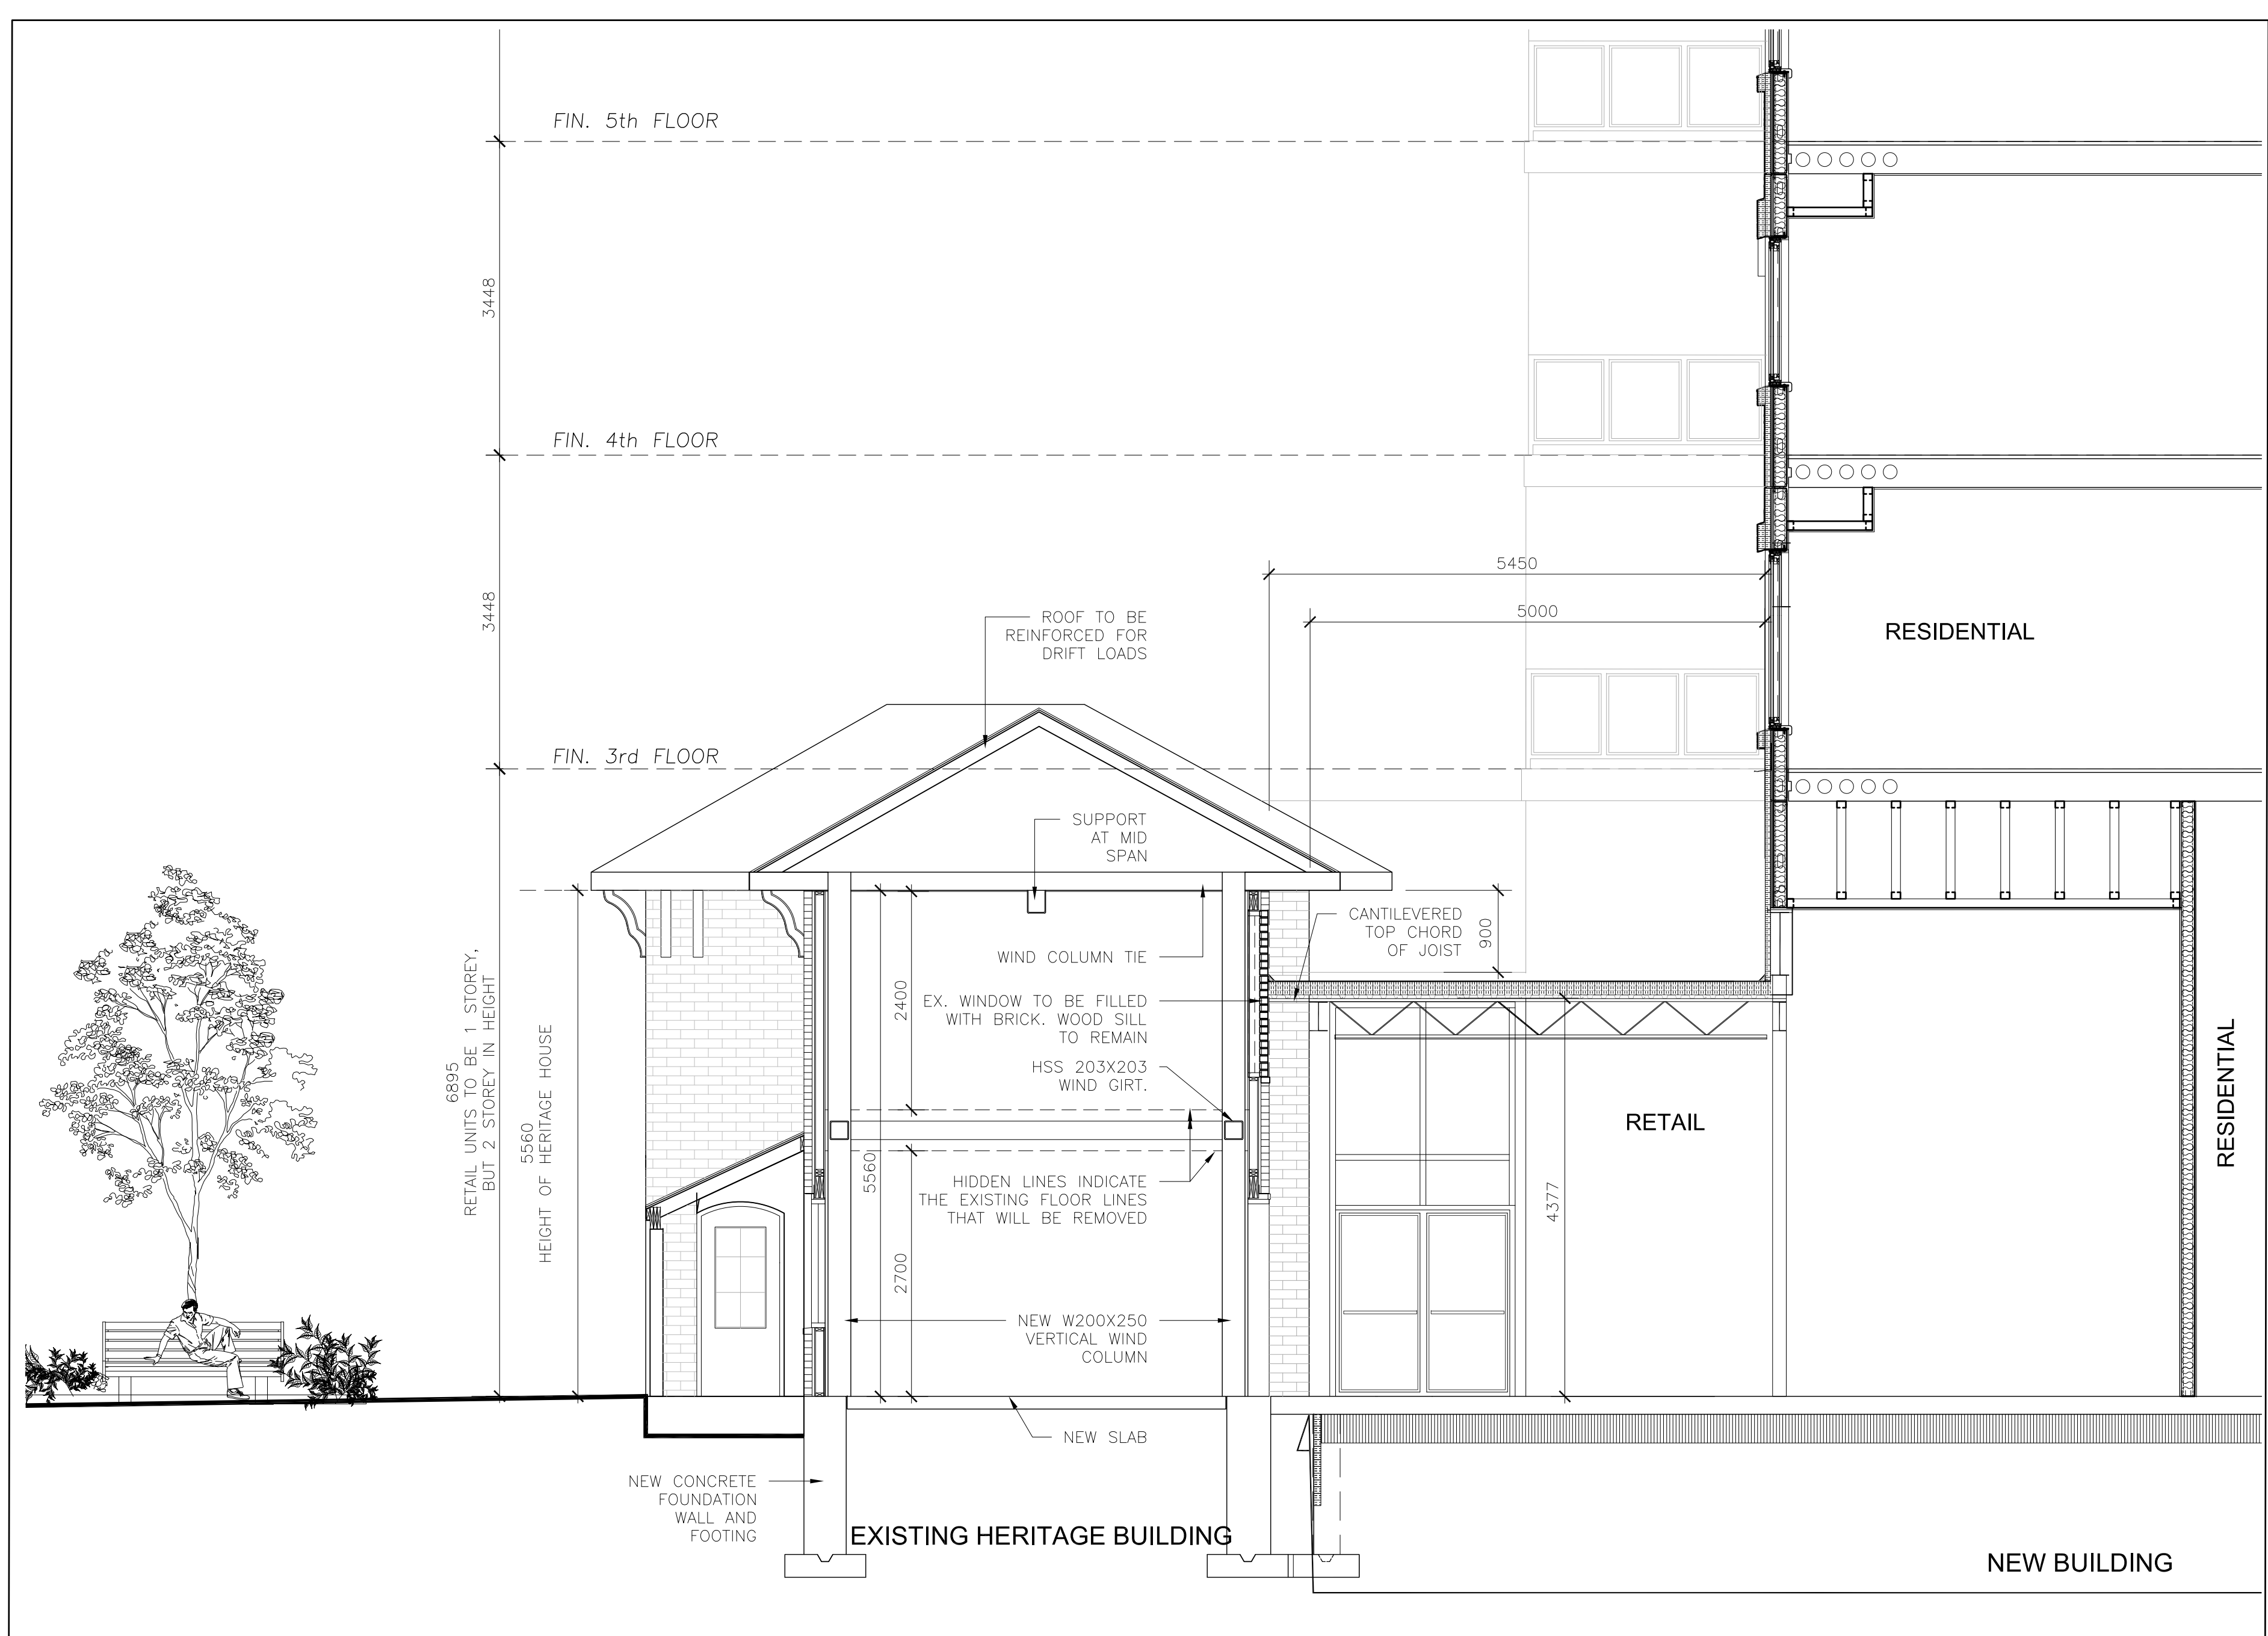
2 ENLARGED SECTION - 1
 SCALE = 1:50

STRUCTURE OF THE NEW ADDITION TO BE SELF-SUFFICIENT (NOT BEAR ON THE EXIST. HERITAGE HOUSE) AND IS PROVIDED TO SEAL THE SPACE AS AN INTERIOR, THERMALLY CONTROLLED SPACE.

REFER TO CONSERVATION PLAN:
 "THE LOCATION OF THE NEW STEEL STRUCTURAL BEAMS OF THE ROOF OF THE ADDITION, WHERE IT MEETS THE BRICK OF THE WEST ELEVATION, WILL TOUCH THE EXISTING HERITAGE HOUSE BUT WILL NOT BE TIED INTO THE STRUCTURE OF THE HOUSE. THE STRUCTURE WILL BE COMPLETELY SEPARATE AND SELF-SUFFICIENT, CREATING A FRAME THAT CAN BE SUPPORTED OUTSIDE OF THE CONNECTION TO THE HOUSE. WHERE THE ADDITION MEETS THE WEST ELEVATION OF THE HOUSE, THE CONNECTIONS WILL BE MINIMAL AND ONLY TO PROVIDE FOR THERMAL BRIDGING AND SEALANT TO ENCLOSE THE INTERIOR OF THE SPACE AS AN INTERNALLY AND ENVIRONMENTALLY CONTROLLED PUBLIC ENTRANCE AND COURTYARD."

REINFORCED EXISTING WOOD STUD WALL FOR ADDED LOADS FROM SNOW DRIFT.
