# Kensington Bridge Municipal Class Environmental Assessment

**Community Advisory Committee on Planning**

February 8, 2022, from 5-6 p.m.

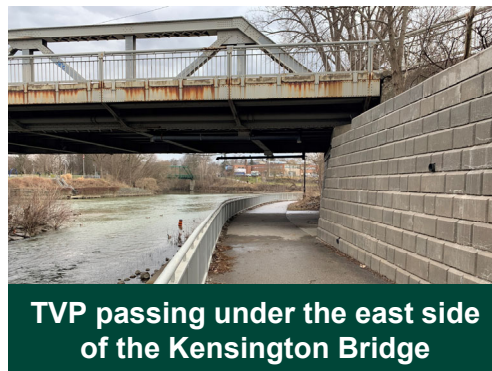
TVP passing under the east side of the Kensington Bridge

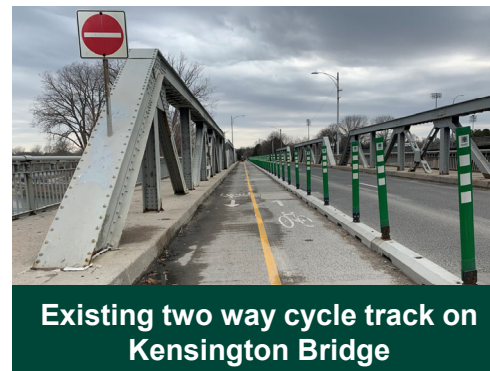
Existing two way cycle track on Kensington Bridge

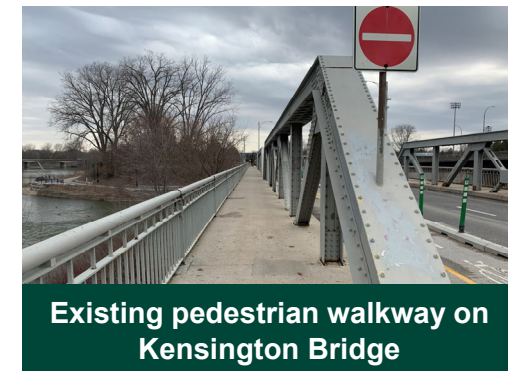
Existing pedestrian walkway on Kensington Bridge

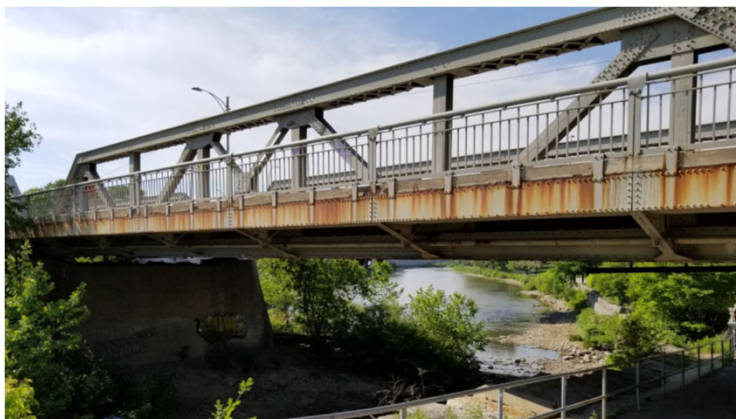
Kensington Bridge – South Elevation

- Previous major rehabilitation includes deck replacement (1960), construction of an exposed concrete overlay (1985), and structural steel recoating (1996). Kensington Bridge is 92 years old and has ongoing maintenance issues. Maintenance of the bridge since 2004 has included abutment refacing, sidewalk and deck repairs, bearing seat repairs, and replacement of the expansion joints.
- Exposed concrete deck is in fair to poor condition with narrow to wide cracking, concrete delaminations and previous patching. Concrete repairs and lane closures are required annually to address issues.
- Structural steel is in fair condition with localized poor conditions below the deck at the abutments and piers.
- Bridge bearings are in fair to poor condition with light to severe corrosion, flaking and pack rust.

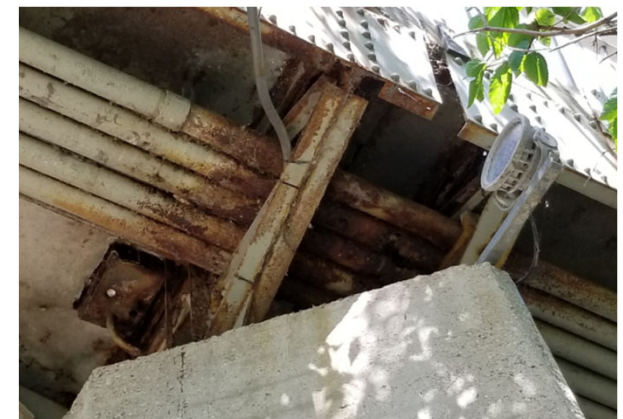
Kensington Bridge Soffit

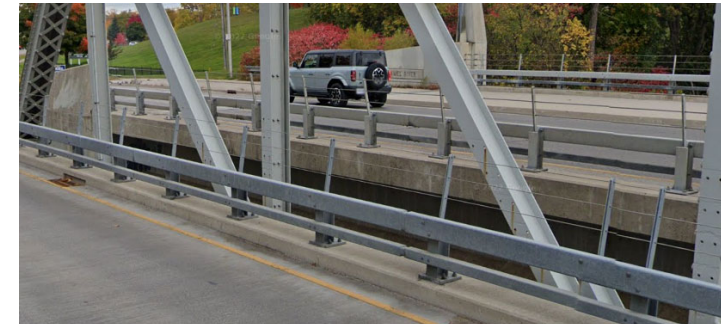
West Brough's Bridge – Example of two tube system

- Less aesthetic impact, preserves views from the bridge.
- Protects cyclists from impacts with the bridge trusses.
- Provides some vehicle collision protection for the bridge trusses.

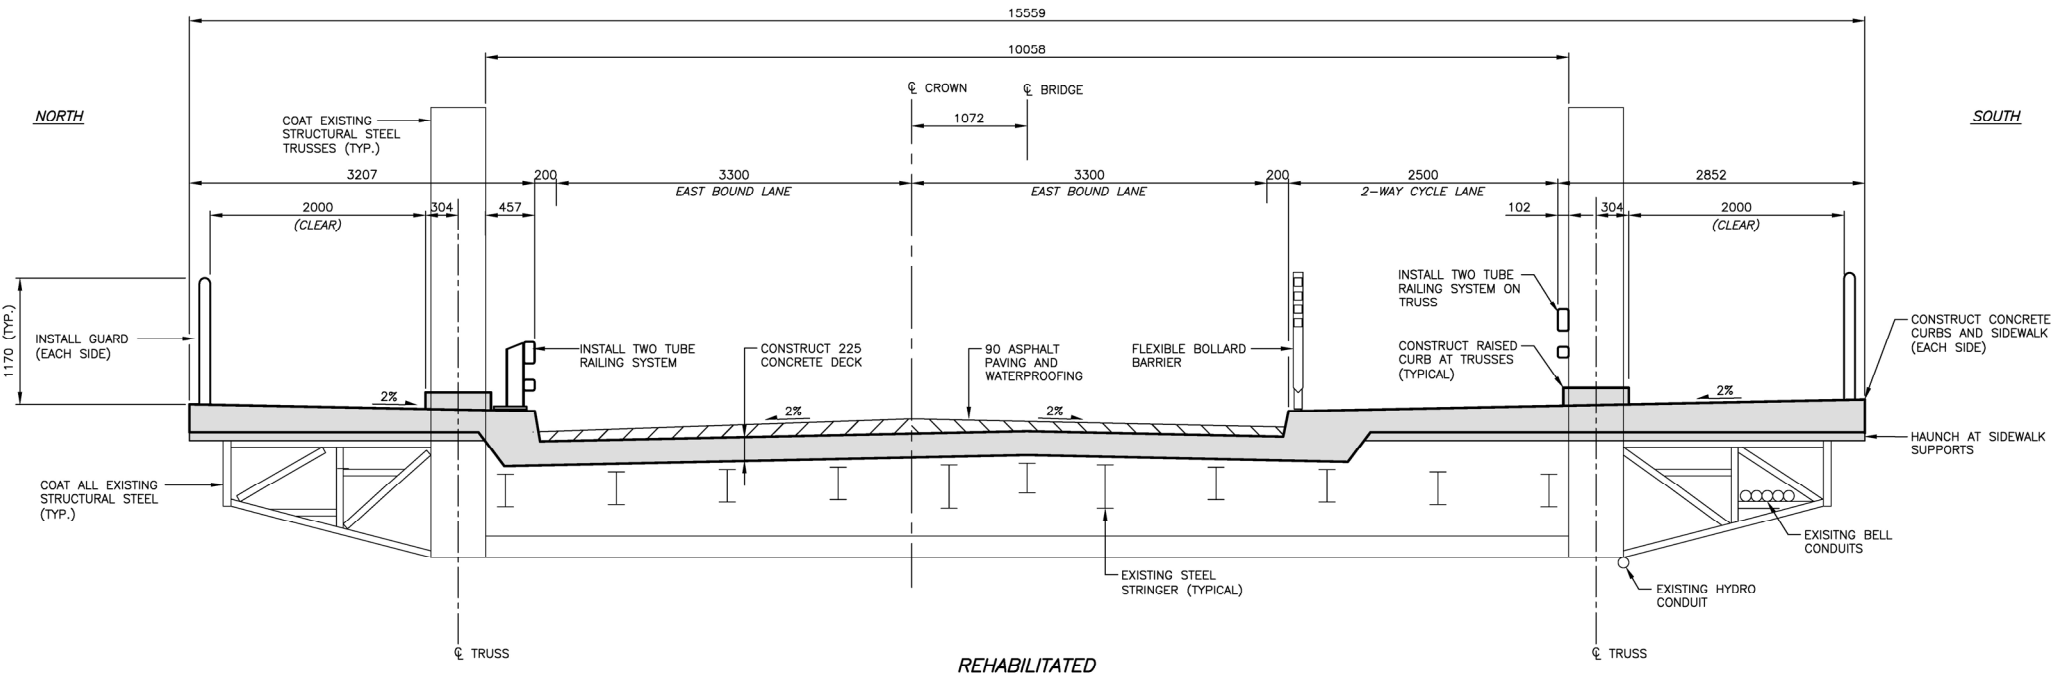
- Barrier will be adjacent to the curb on the north side of the bridge.
- Barrier will be adjacent to the trusses on the south side of the bridge.

Preliminary Design Only – Lane widths and tube railing system to be confirmed during detailed design

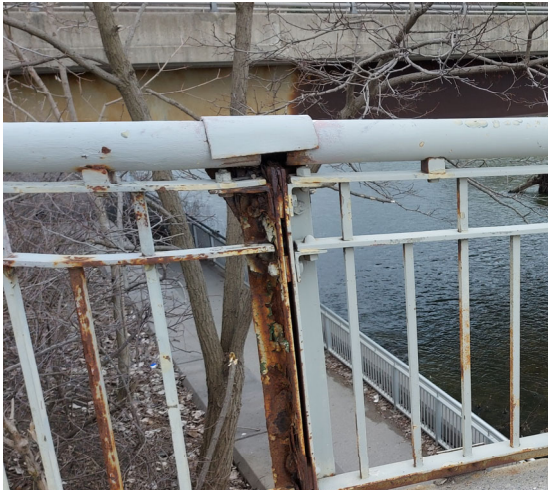
- Existing railing have sections with perforations and section loss (holes).
- Hidden deterioration likely and additional damage during rehabilitation (abrasive blast cleaning).
- Existing railing top rail has a large diameter (exceeds some code requirements).
- Top rail caps pose an injury risk to pedestrians such as hand abrasions.
- Replacement of the railing will provide a longer service life.
- The cost of replacement vs. rehabilitation is comparable.

15 Kensington Bridge Existing Railing

- Replicated railing will maintain general arrangement and aesthetics of the existing railing.
- A reduced top rail diameter may be incorporated (subject to further review during detailed design).
- Maintain existing post spacing with an additional post between.
- Top cap plates at the posts would not be integrated with the new design.
- Heritage Alteration permit required.

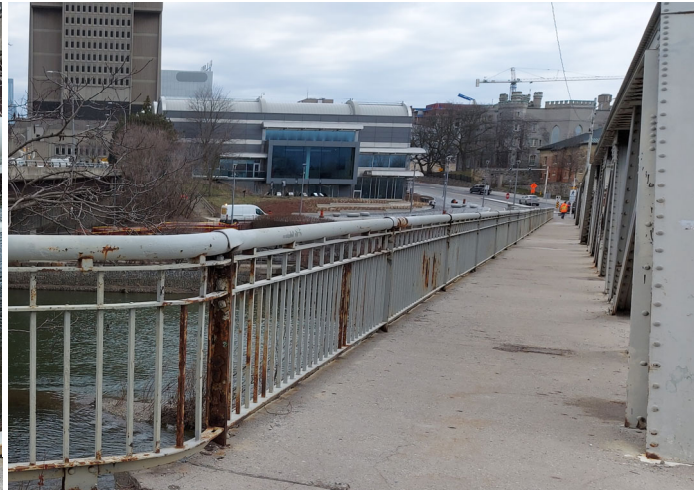
Kensington Bridge Existing Railing

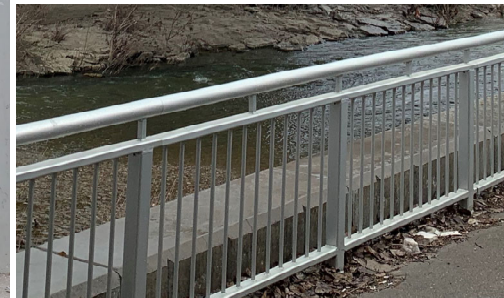
TVP - Existing Railing

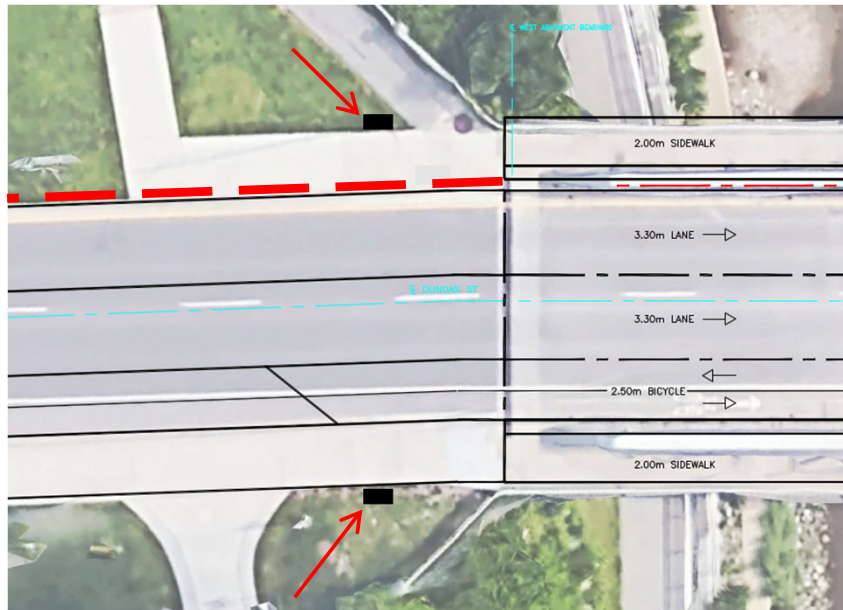
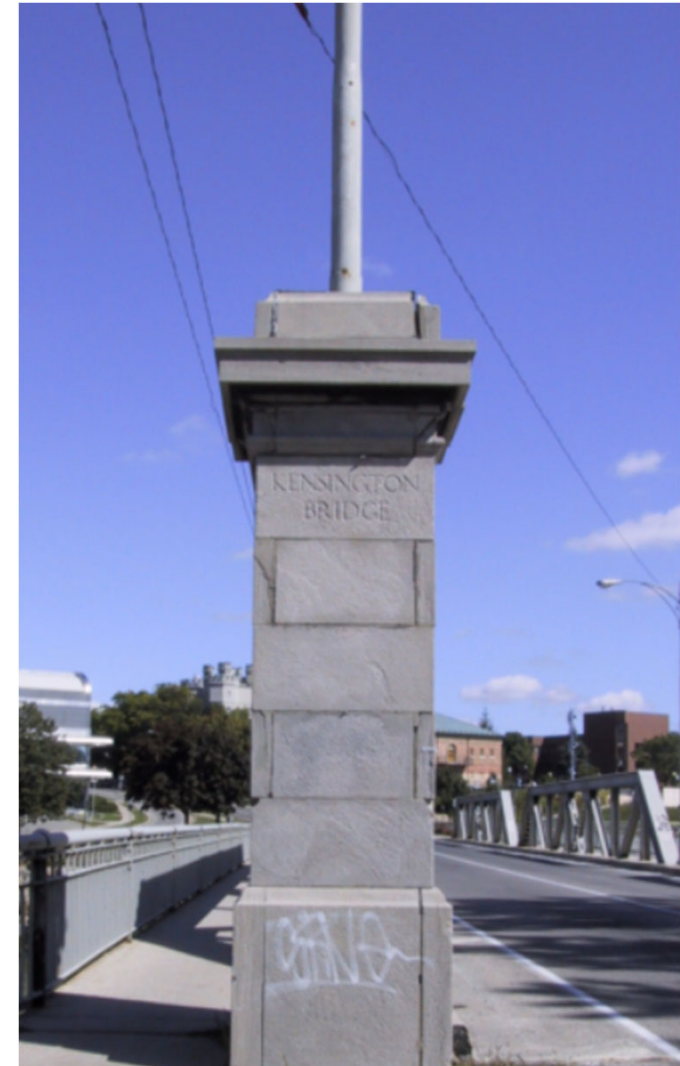
- Original Pillars are not officially recognized as a Heritage Attribute.
- Removed circa 2006.
- Opportunity to use similar sympathetic light fixtures.

Kensington Bridge Pillar (Removed in 2006)

- Placing Pillars outside of the walking area is safer for active transportation and road users.
- Does not obstruct site lines.
- Prevents damage from vehicles and ploughs and reduces potential for deterioration from winter salt.
- Placing the Pillars on the west side will create a gateway feature entering the Downtown Core.

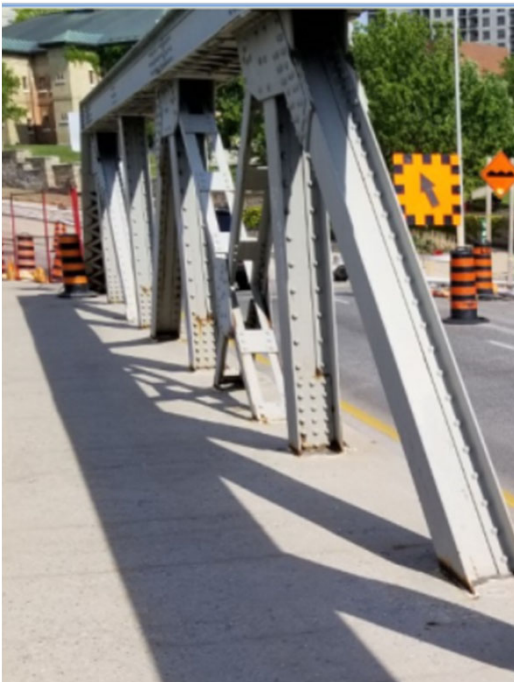
- Coating to be similar grey colour as existing.

Kensington Bridge Truss

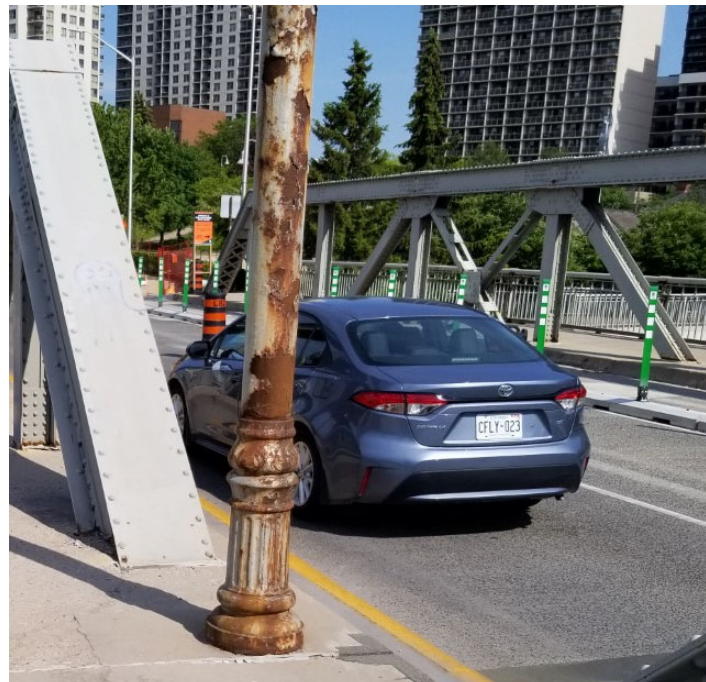
- Two of four original poles are still in place, but original decorative lighting arms were replaced.
- Existing light poles are in poor condition and require replacement.
- Existing light poles have decorative sleeve that will be mimicked.
- Lighting levels to be upgraded to current standards.

Kensington Bridge Existing Light Standard  
Base

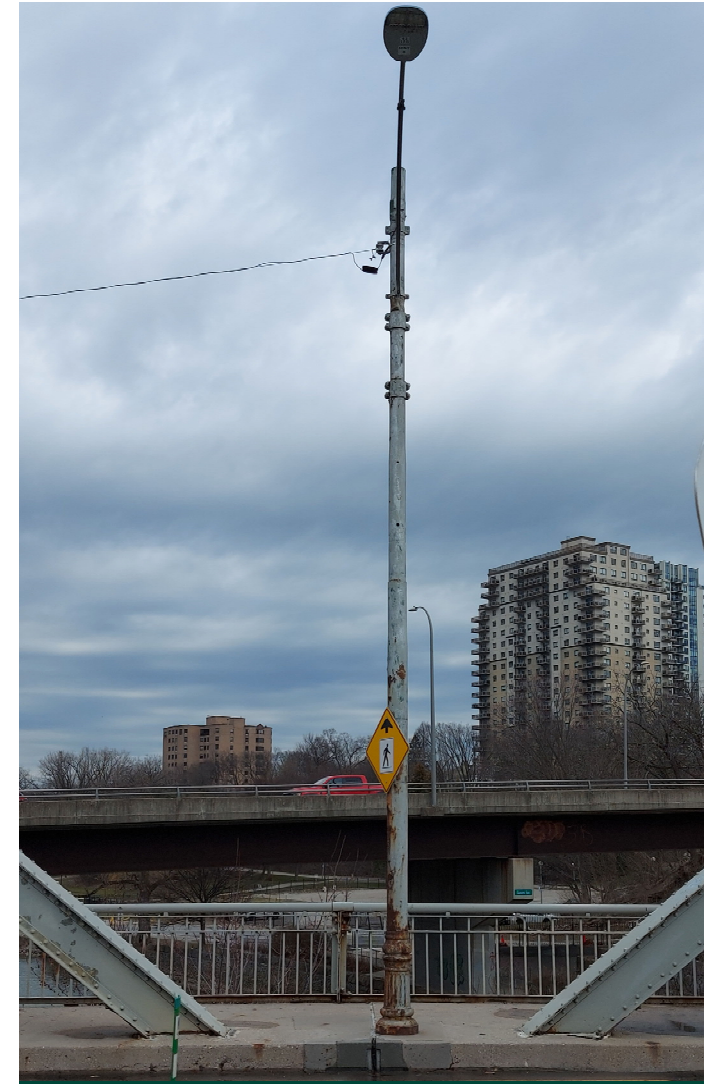
Kensington Bridge Existing Light Standard
