Kensington Bridge Municipal Class Environmental Assessment

Integrated Transportation and Community Advisory Committee

February 15, 2022, from 3:00-4:30p.m.

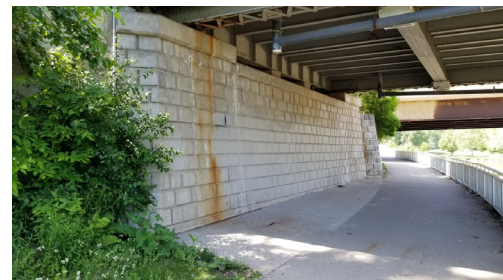
TVP passing under the west side of the Kensington Bridge

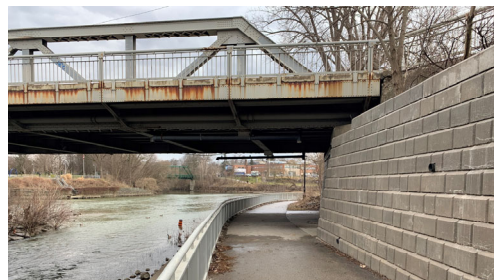
TVP passing under the east side of the Kensington Bridge

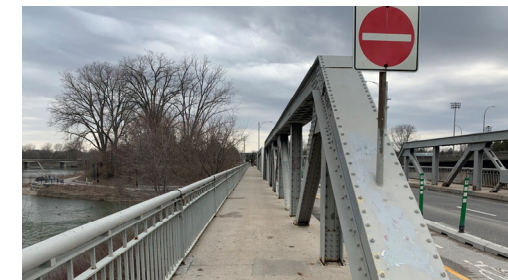
Existing pedestrian walkway on Kensington Bridge

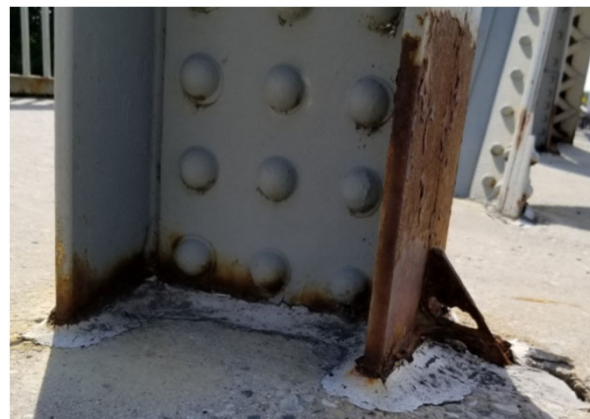
Localized corrosion on bridge truss

- Previous major rehabilitation includes deck replacement (1960), construction of an exposed concrete overlay (1985), and structural steel recoating (1996). Kensington Bridge is 92 years old and has ongoing maintenance issues. Maintenance of the bridge since 2004 has included abutment refacing, sidewalk and deck repairs, bearing seat repairs, and replacement of the expansion joints.
- Exposed concrete deck is in fair to poor condition with narrow to wide cracking, concrete delaminations and previous patching. Concrete repairs and lane closures are required annually to address issues.
- Structural steel is in fair condition with localized poor conditions below the deck at the abutments and piers.
- Bridge bearings are in fair to poor condition with light to severe corrosion, flaking and pack rust.

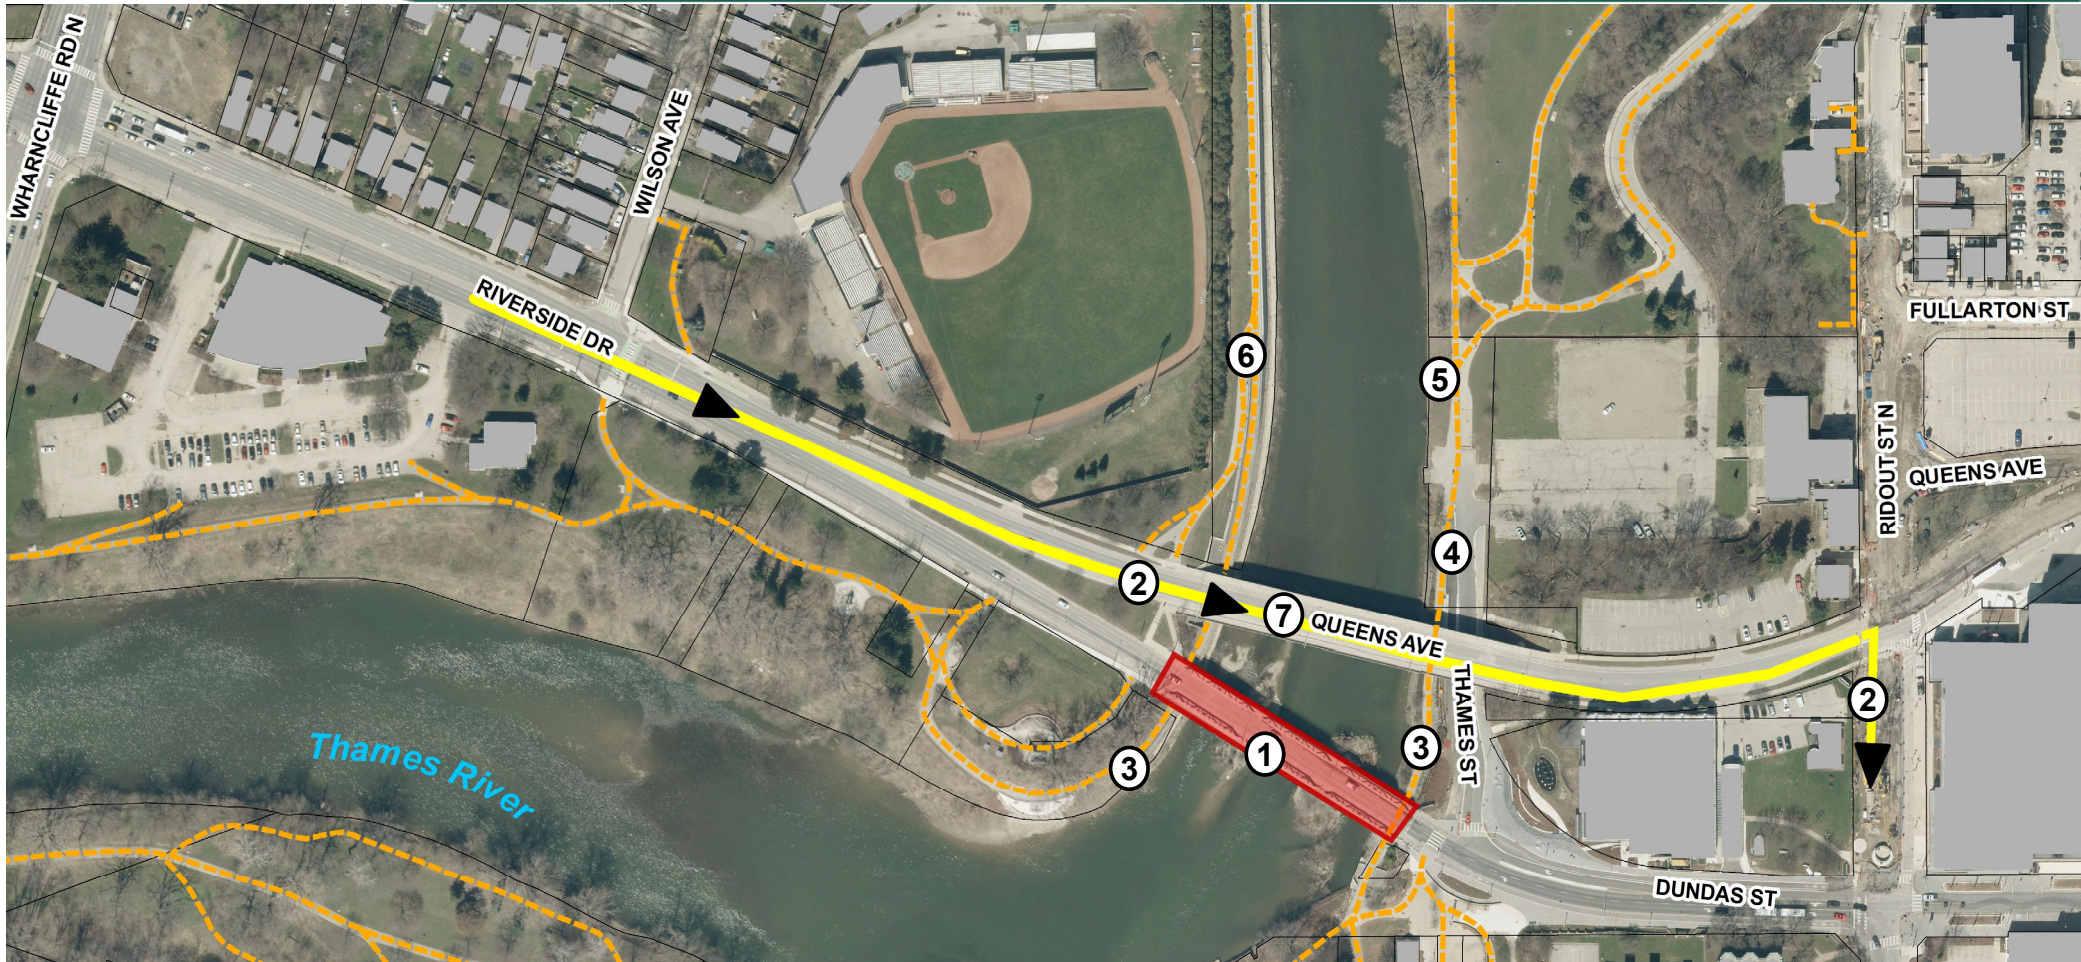
PIC #1 Recommendation: Rehabilitate the Existing Structure

- ① Rehabilitate existing bridge with **necessary repairs to increase** service life.
- ② Traffic Detour using The Queens Bridge during construction. (Coordination with Rapid Transit required) Right turn required at Ridout St.
- ③ TVP closed during construction. TVP detours necessary.
- ④ Coordination with planned replacement of retaining wall.
- ⑤ Coordination with Harris Park erosion control project.
- ⑥ Coordination with West London Dyke feasibility study.
- ⑦ Coordination with Queens Bridge rehabilitation project.
