Hydrogeological Assessment

Western Prestige Village

Proposed Apartment Complex
735 Southdale Road West
London, Ontario

KCH-00257251-A0

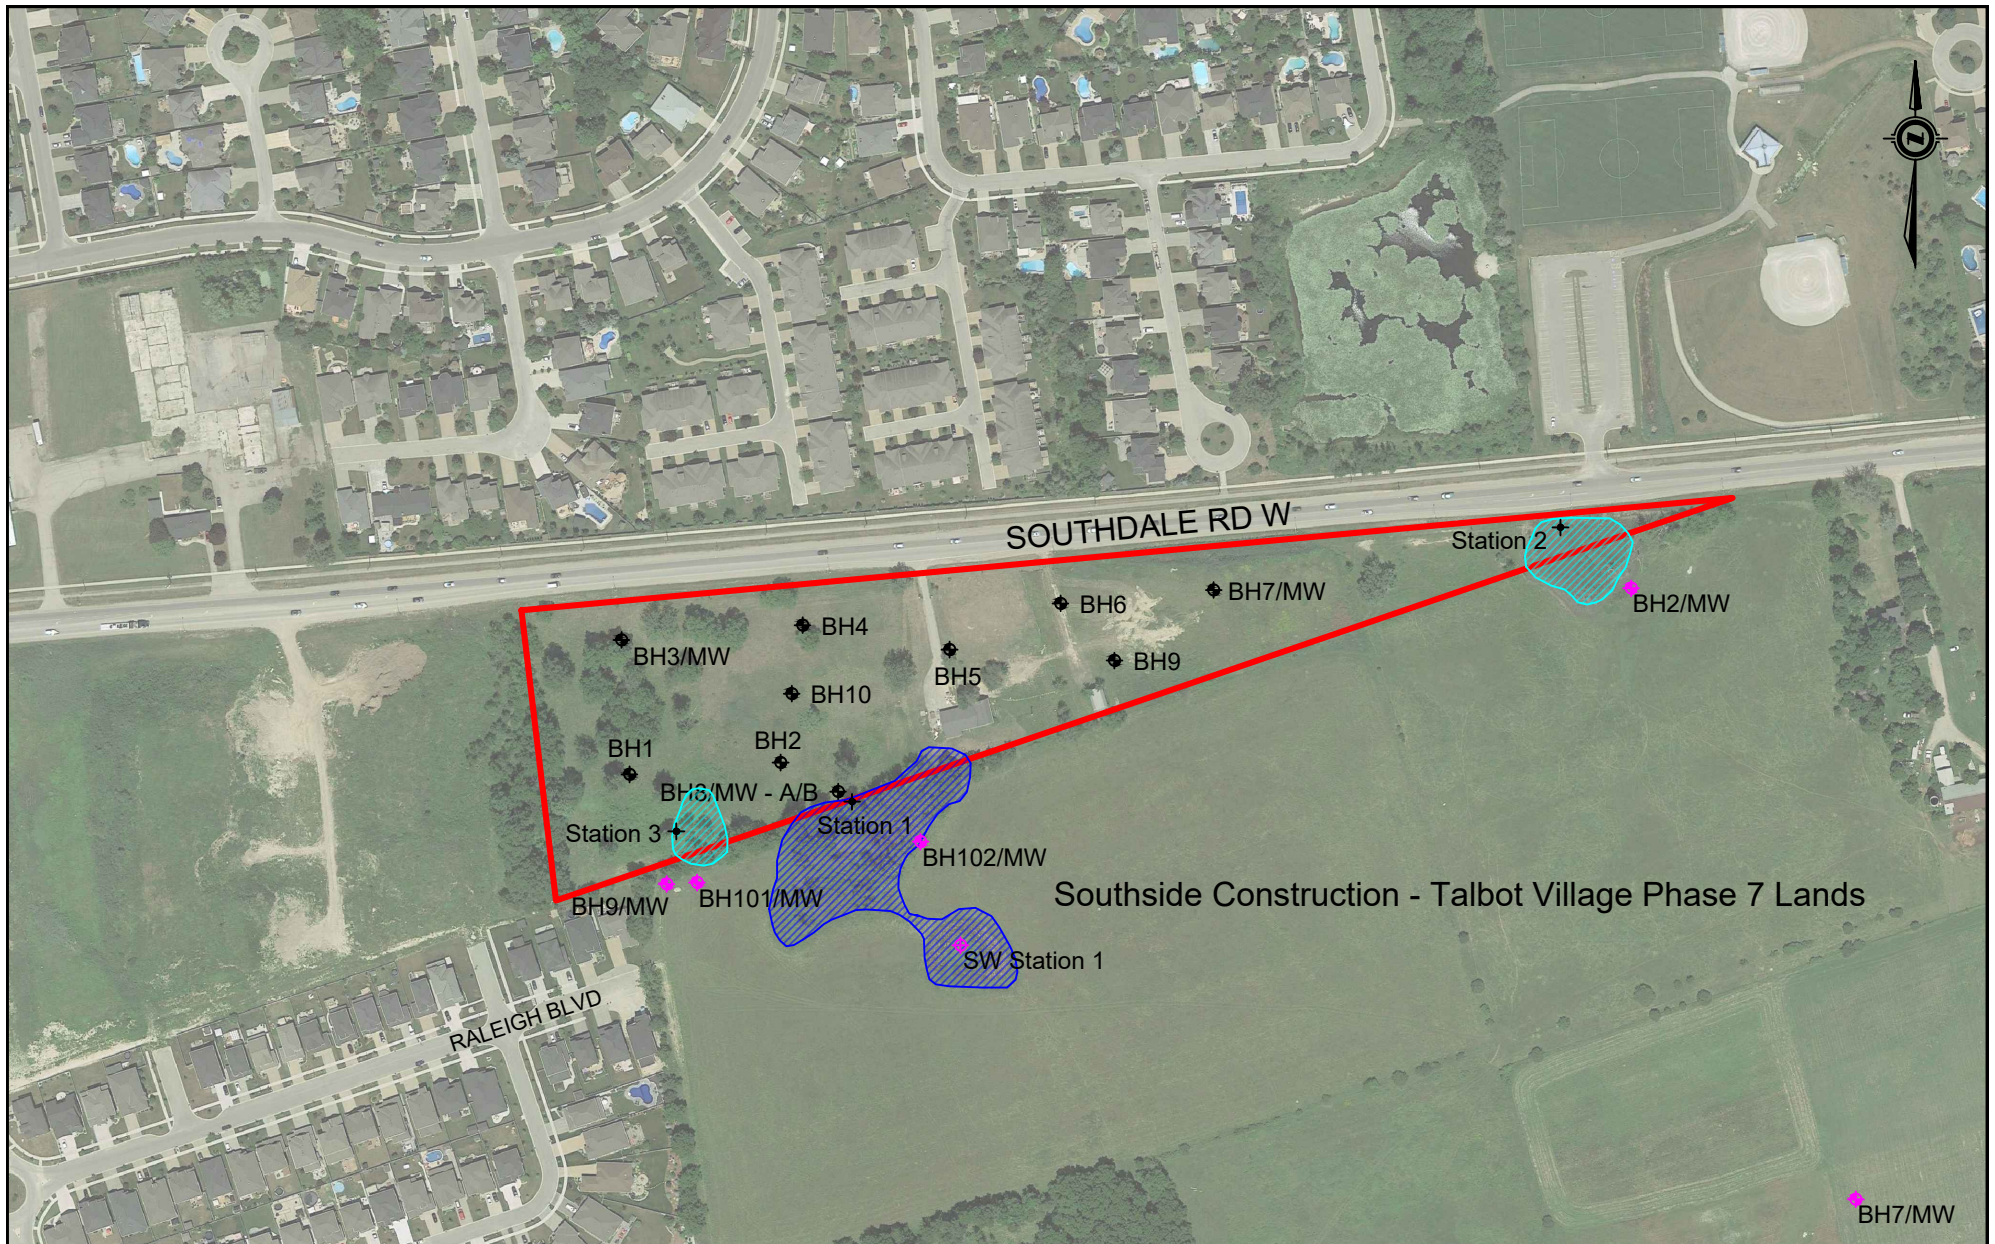
EXP Services Inc. 15701 Robin's Hill Road, London, ON, N5V 0A5	
DATE	APPROXIMATE SCALE	PROJECT NO.	DWG.
NOVEMBER 2020	1:3,500	KCH-00257251-A0	2

- LEGEND-**
- ◆ BH1 Approximate Borehole Location
 - ✦ Station 1 Approximate Surface Water Station Location
 - Approximate Site Boundary
 - ◆ BH9/MW Approximate Monitoring Well Location (Project 16262)
 - ◆ SW Station 1 Approximate Surface Water Location (Project 16262)
 - ▨ Unevaluated Wetland
 - ▨ Provincially Significant Wetland

The purpose of the assessment was to examine the subsoil and groundwater conditions at the Site by advancing a series of boreholes at the locations chosen by EXP and illustrated on the attached Borehole Location Plan (**Drawing 2**). Subsoil and groundwater information from the Geotechnical Investigation prepared by EXP in December 2019 was used to assist in the preparation of this report.

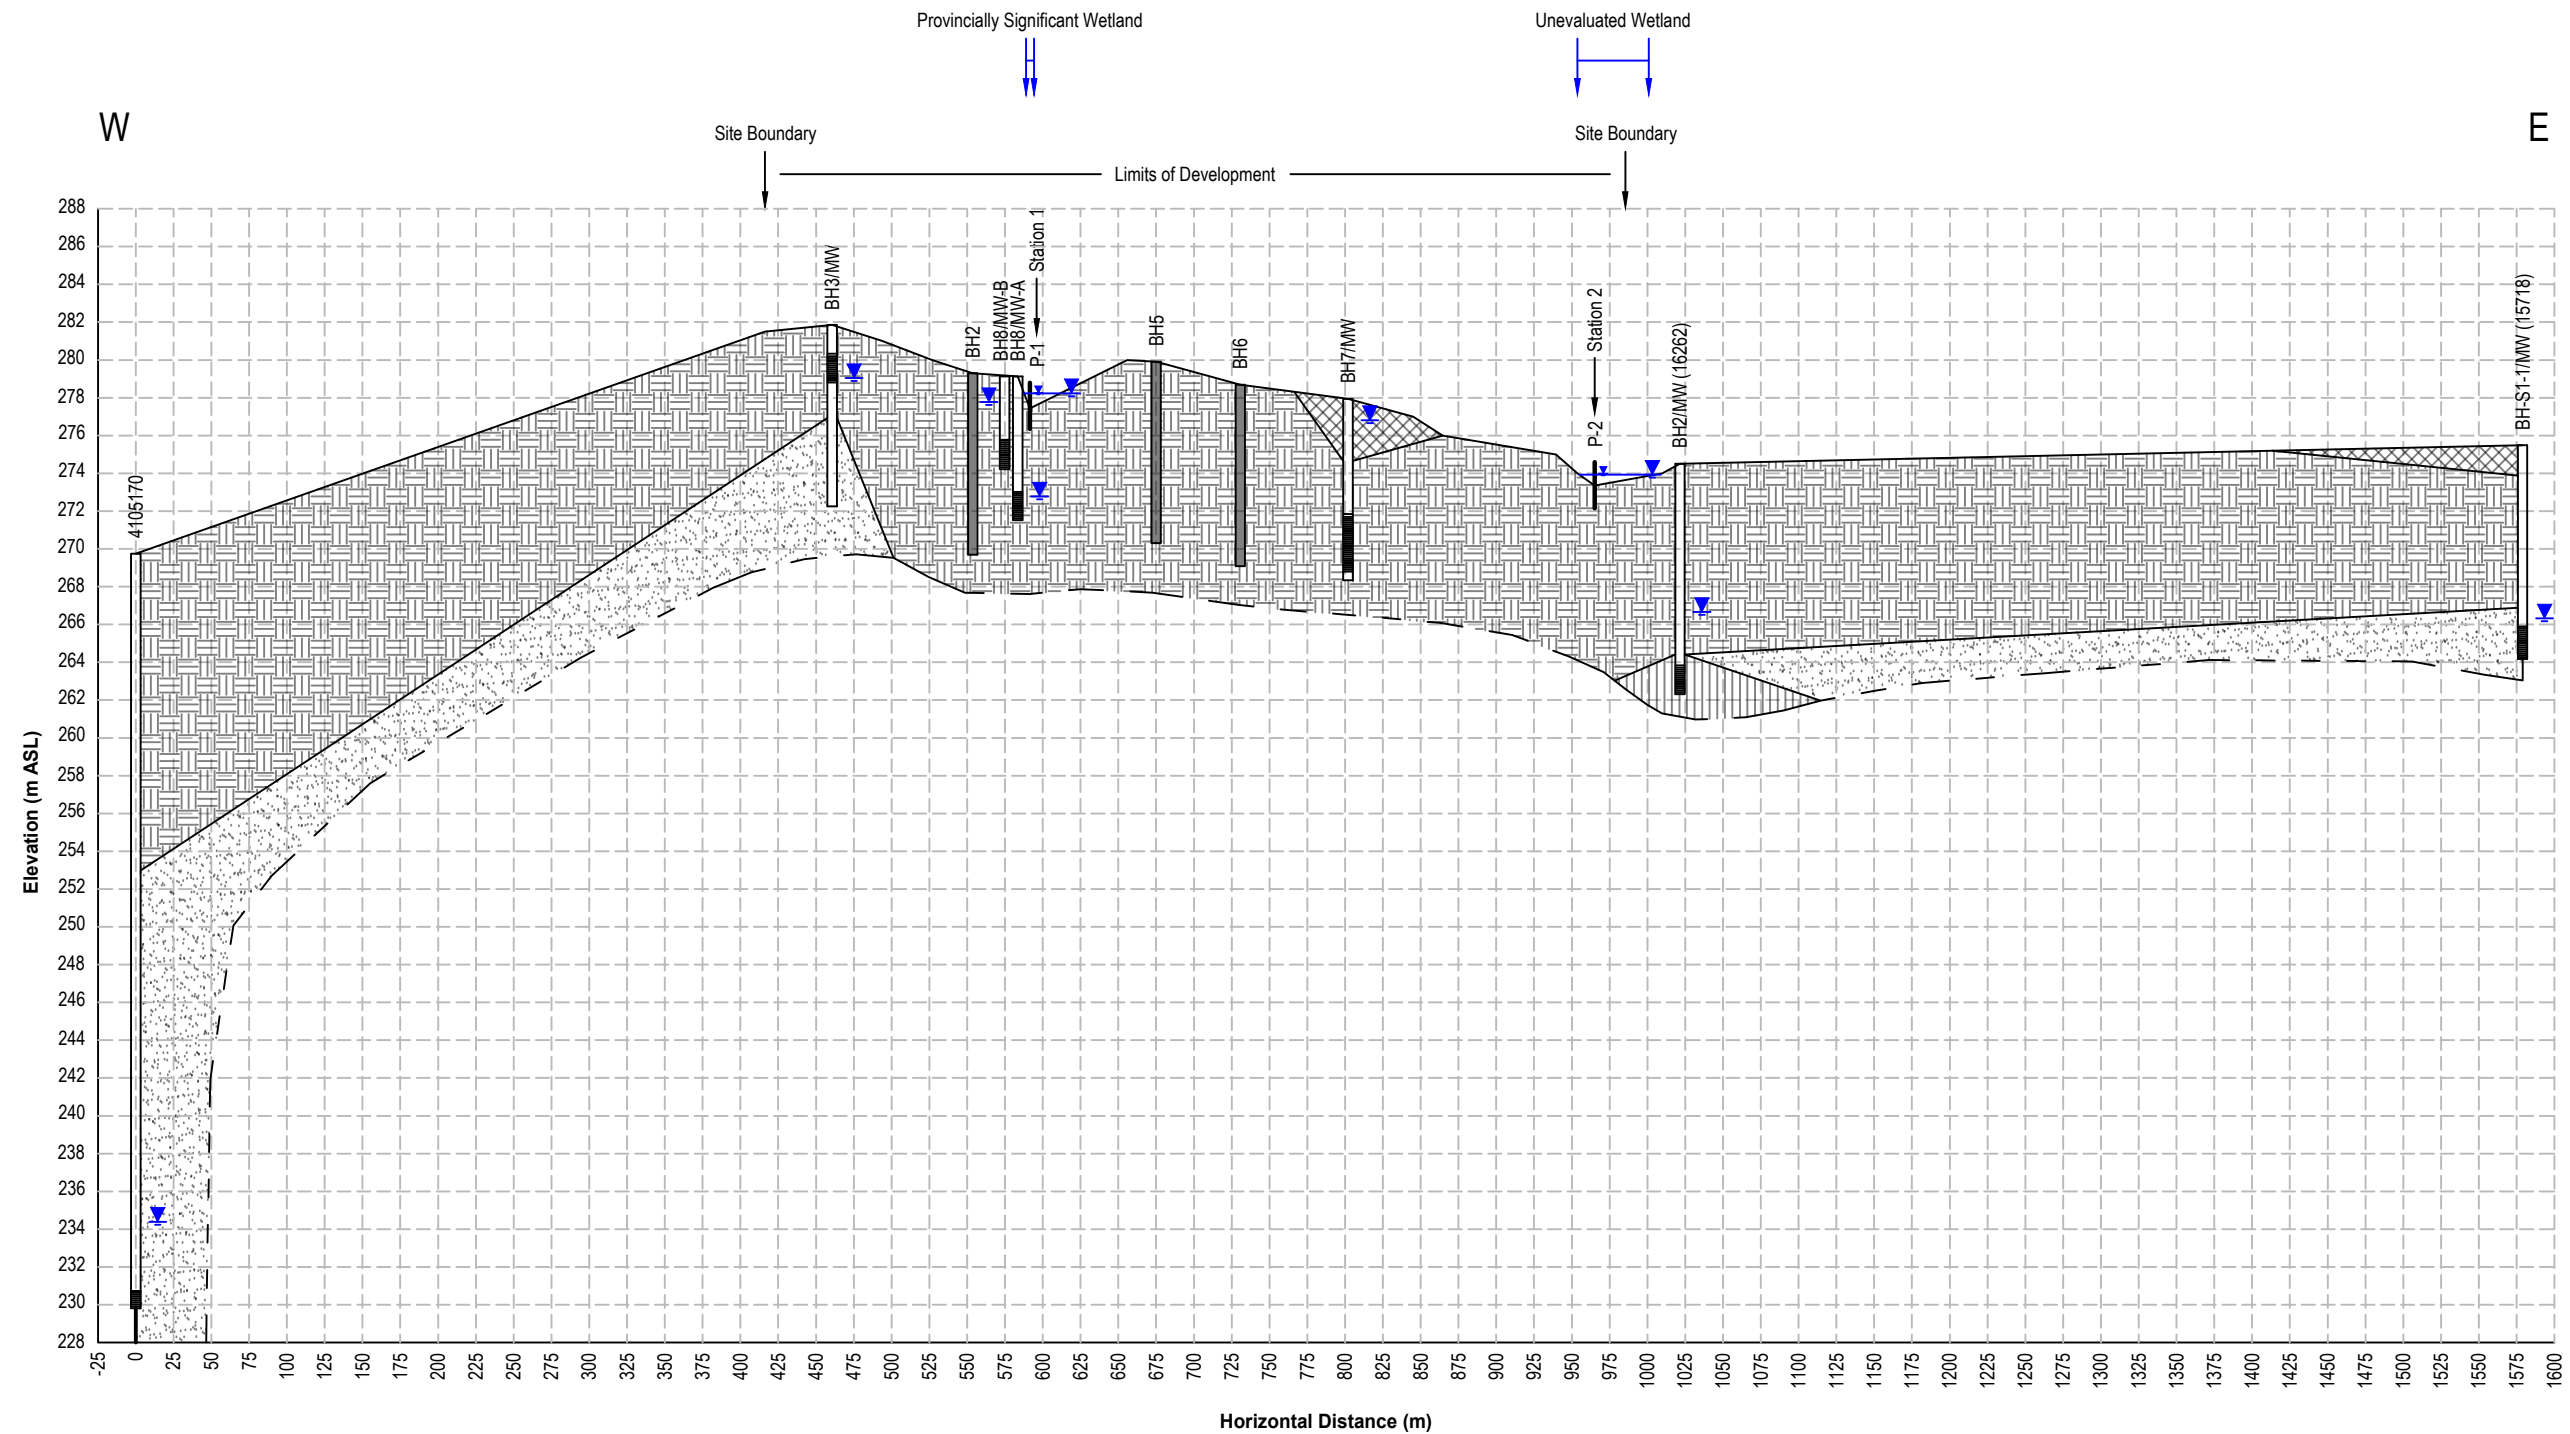
Generalized Cross Section A - A'

Groundwater Measurement
	Fill
	Clayey Silt/Silty Clay/Glacial Till
	Sand and Silt
	Sand

Generalized stratigraphic cross sections through the Site, as shown in **Drawing 10**, are provided as **Drawings 11** and **12**. The cross sections include wells from EXP's Hydrogeological Assessment of the neighbouring property to the south (EXP, 2020) and Ministry of Environment, Conservation and Parks (MECP) Water Well Records (WWR), and generally shows a low permeability clayey silt/silty clay till layer overlying the Site, with fill noted at surface of some boreholes. Permeable sand and silt layering is noted within the till layer and an extensive sand unit is noted beneath the till at the west end of the Site. The detailed stratigraphy encountered in the boreholes is summarized below.

Generally, the Site is overlain by a layer of topsoil. Fill material was encountered beneath the topsoil at Boreholes BH7/MW and BH10, extended to depths of 2.0 to 3.3 m bgs and consisted of loose clayey silt with some sand and some topsoil inclusions. All other boreholes encountered clayey silt till or clayey silt beneath the topsoil. Sandy silt till was encountered under the clayey silt till in Borehole BH3/MW. Beneath the till, sand was encountered in Boreholes BH1 and BH3/MW. A sand and gravel lens within the till was noted in Borehole BH4. Review of MECP Well Records for the area suggests that an extensive sand to sand and gravel stratum is located below the clayey silt till at elevations ranging between 253 m and 272 m. The layer was noted as dry in the upper levels, with static water levels at approximate depths of 234 m to 236 m.

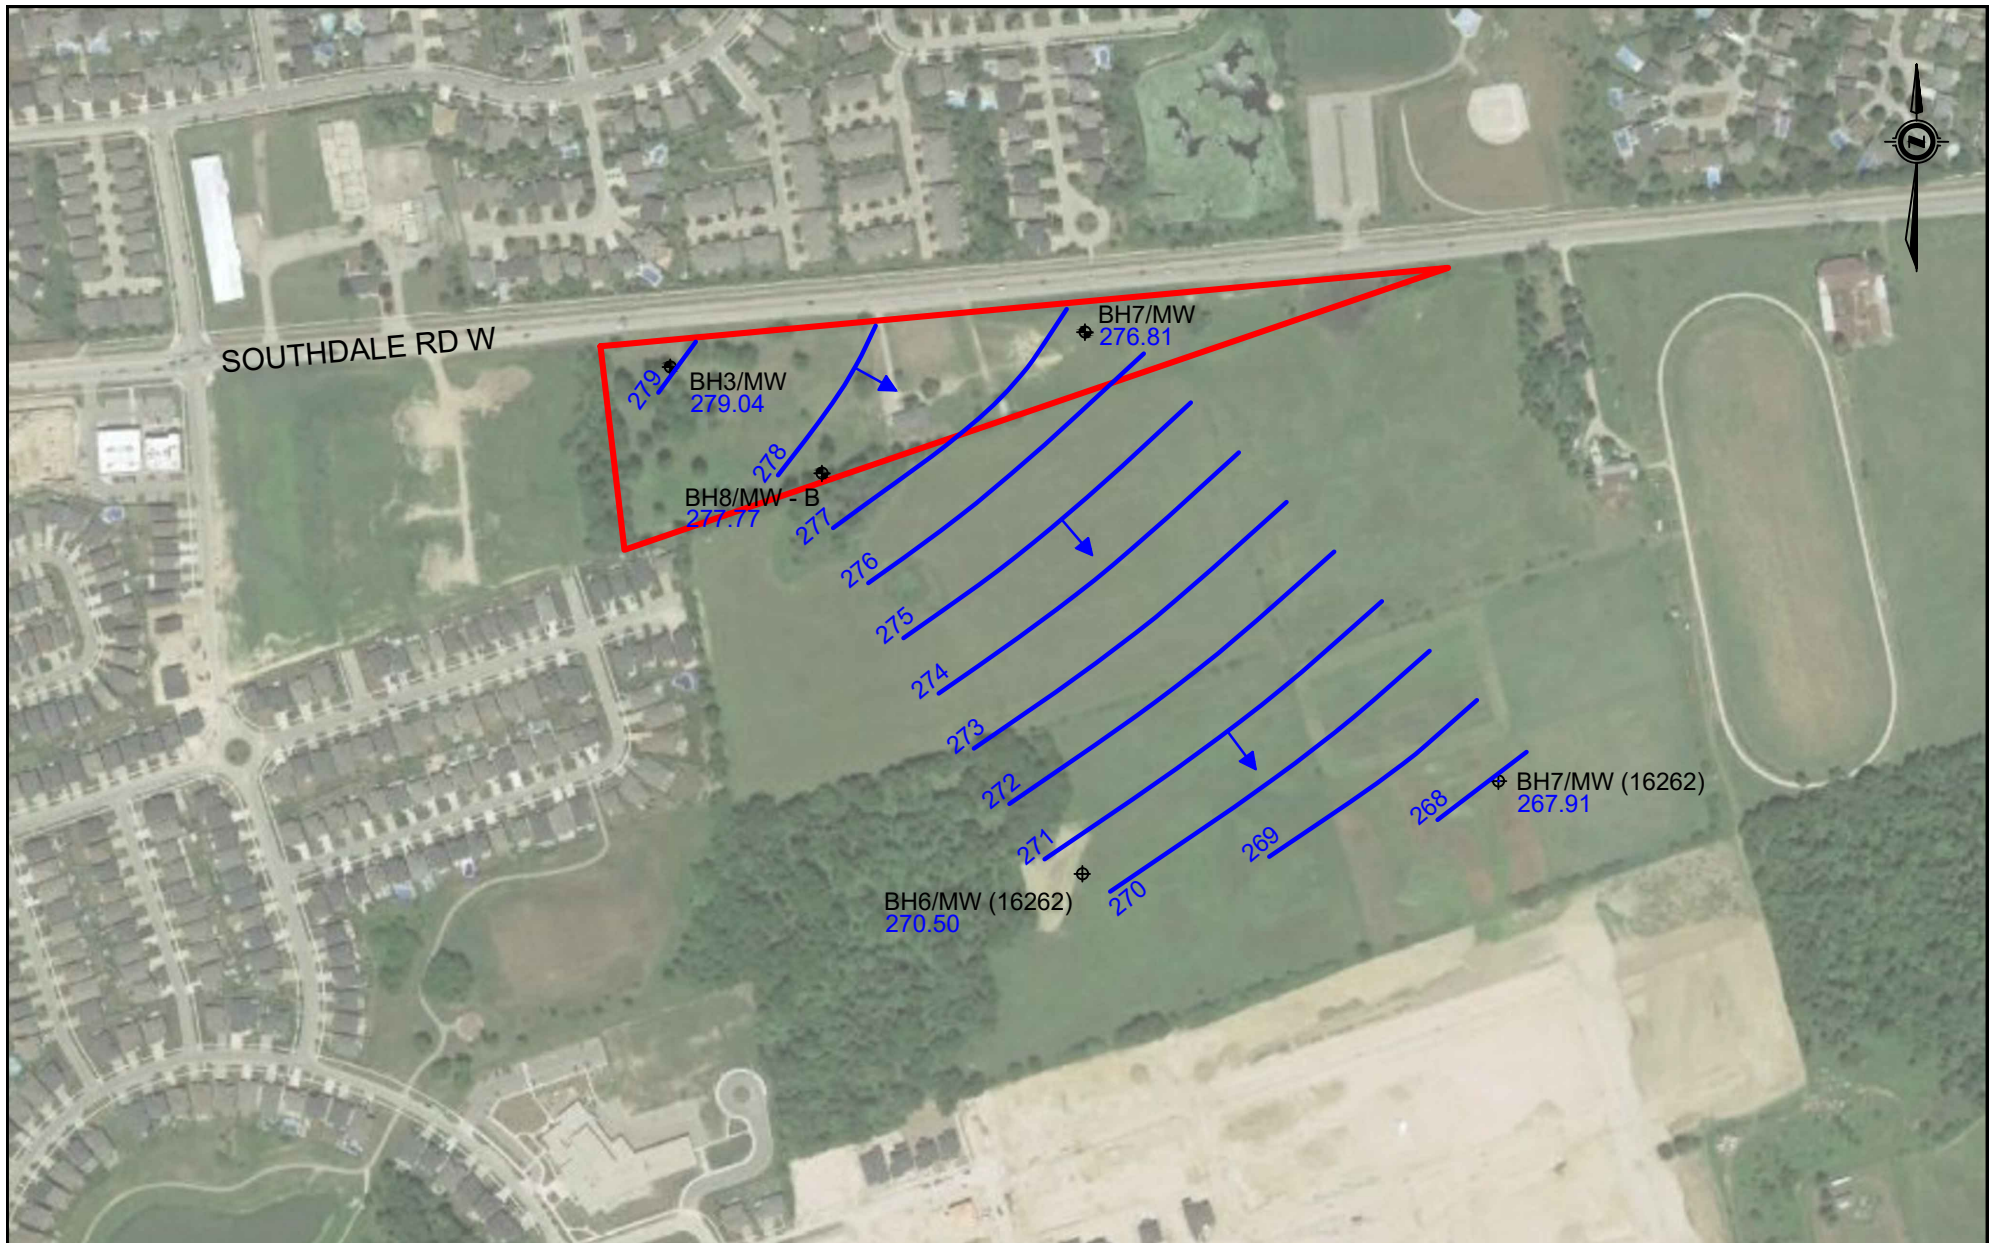
CLIENT Western Prestige Village			
TITLE Groundwater Flow Direction			
Prepared By: E.B.		Reviewed By: H.J.	
		EXP Services Inc.	
		15701 Robin's Hill Road, London, ON, N5V 0A5	
DATE JUNE 2020	APPROXIMATE SCALE 1:5,000	PROJECT NO. KCH-00257251-A0	DWG. 14

- Approximate Site Boundary
- ⊕ BH3/MW Approximate Borehole Location
- ⊕ BH6/MW Approximate Borehole Location (16262)
- 279.04 Groundwater Measurement (May 23, 2020)
- Groundwater Equipotential Line
- Groundwater Flow Direction

Groundwater recharge is largely controlled by soil conditions, and typically occurs in upland areas. The groundwater flow direction has been previously identified as flowing in a southeastern direction.

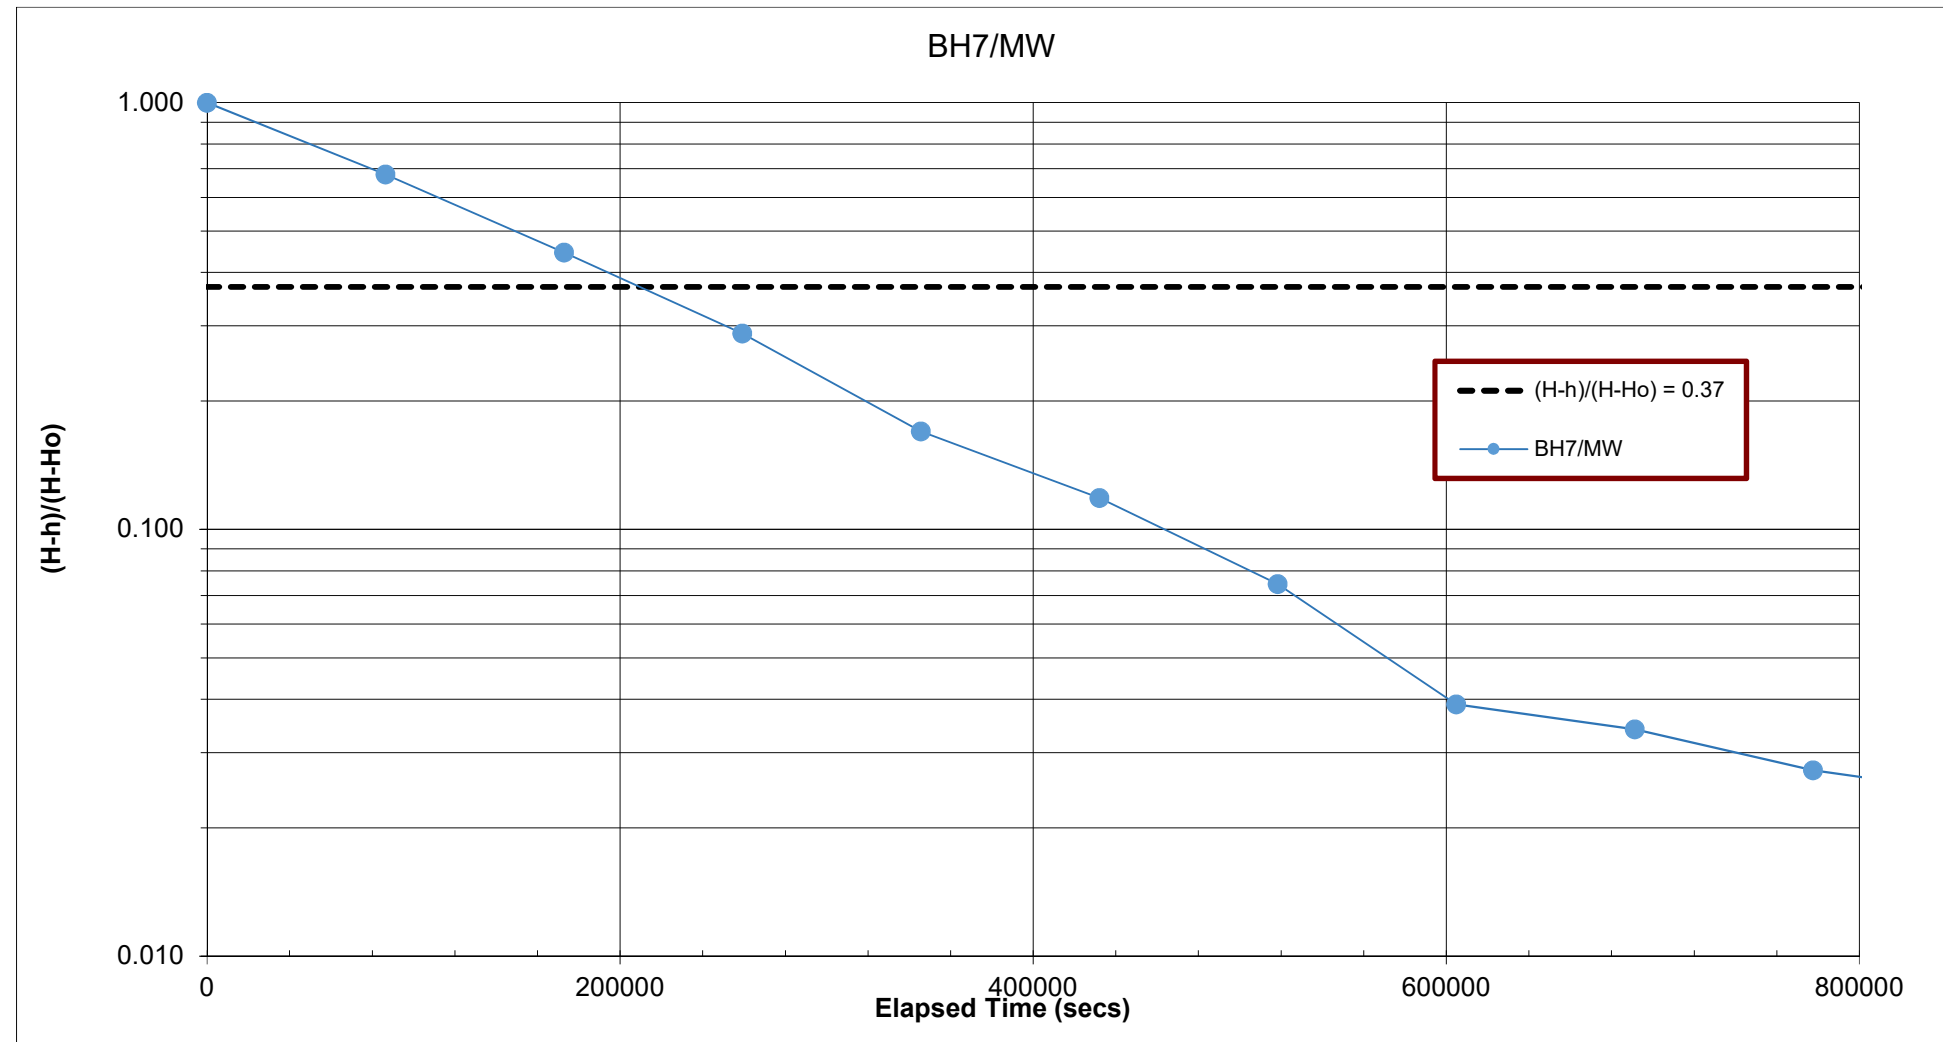
Recovery Testing - Hvorslev Method (1951)

Initial Water Level 3.07 m bgs
 Maximum Drawdown 6.66 m

r (m) = 0.0254
 L (m) = 3.05
 R (m) = 0.1048
 T_o (sec) = 205,000

K (m/s) = 1.7E-09

Note:
 1 - T_o is determined from plots where $(H-h)/(H-Ho) = 0.37$
