## Report to Community and Protective Services Committee

**Subject:** Infrastructure Update – Thames Outdoor Pool

**Date:** March 21, 2023

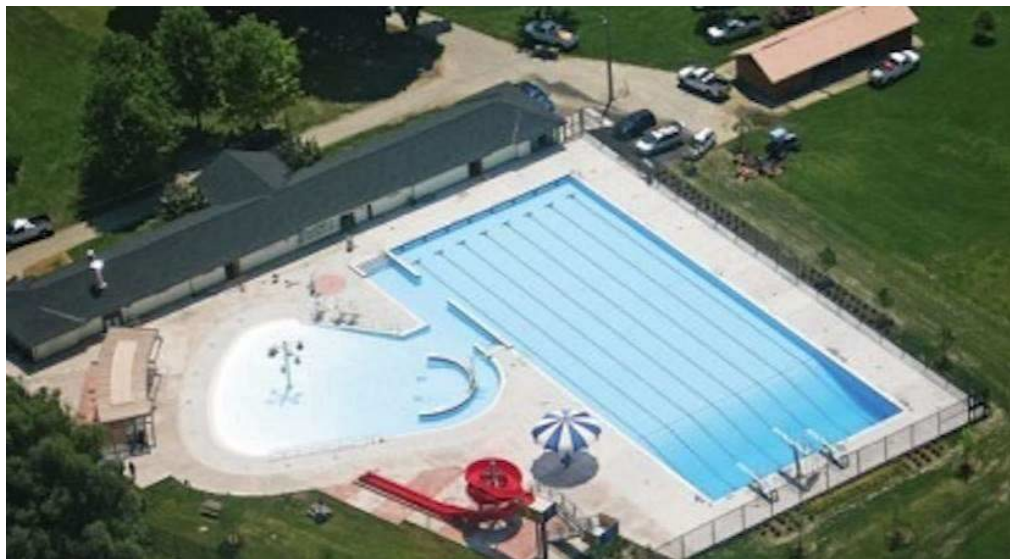
Photo 1 – Stock Aerial Photo of Thames Pool

Thames Pool is an outdoor pool complex located at 15 Ridout Street South, within Thames Park. Approximately 70 metres (230 ft.) north of the pool is the south branch of the Thames River. The pool is constructed in the river's floodplain making it vulnerable to hydrogeologic forces, specifically flooding and groundwater. (Appendix A, Photo 1)

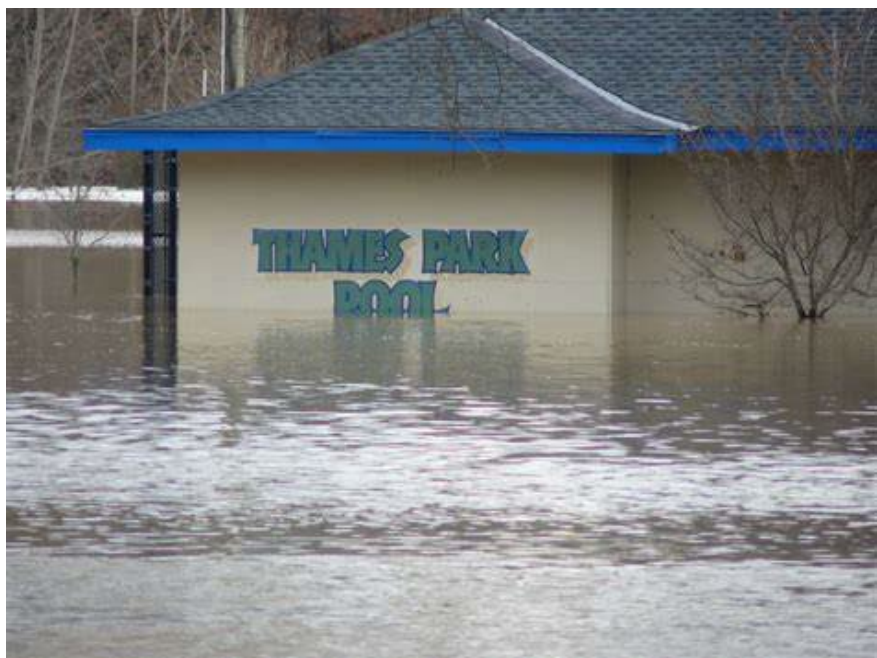
Photo 2 – Thames Pool Flooding 2018

- 2016 - Pool deck repairs (\$5,000)
- 2017 - Leaks in circulation lines repaired (\$11,000)
- 2018 - Major flood, height of the Thames River was 1.2m (4 ft.) above pool deck (\$145,000) (Appendix A, Photo 2)
- 2019 - Leaks in return lines repaired (\$15,000)
- 2020 - Flooding reached filtration room, equipment damaged/replaced (\$7,500)
- 2021 - Return lines repaired (\$20,000)
- 2022 - Pool caulking redone and repainted tank floor for waterproofing (\$35,000)

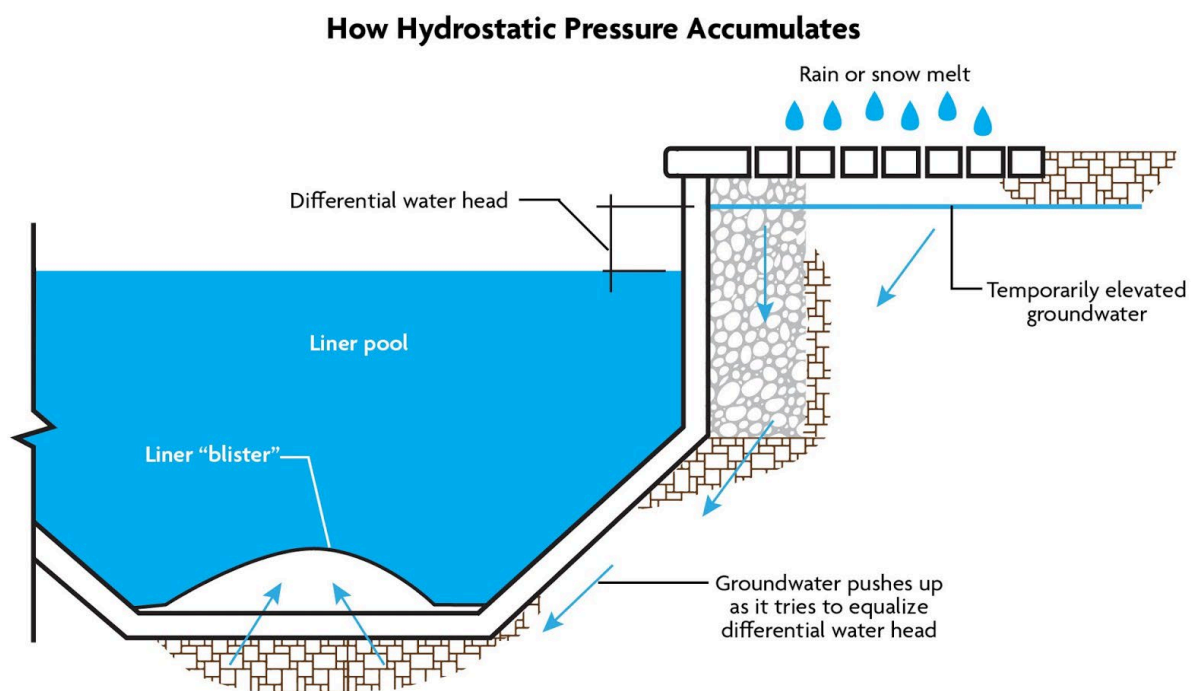
Figure 1 – Hydrostatic Pressure Diagram

Hydrostatic uplift pressure occurs when the groundwater levels rise above the base of the structure, putting upwards pressure on the structure. If the uplift pressure exceeds the downwards pressure of the structure, then upwards movement occurs. (Appendix A, Figure 1)

The downwards pressure in a slab-on-grade pool is created in two ways. At the sides, the pool tank walls and surrounding soil exert downwards pressure on the slab. In the middle, it is the weight of the concrete slab and any water in the tank that exert downward pressure. The downwards pressure at the sides is greater than in the middle of the pool so the hydrostatic uplift pressure of high groundwater would result in differential slab movement.

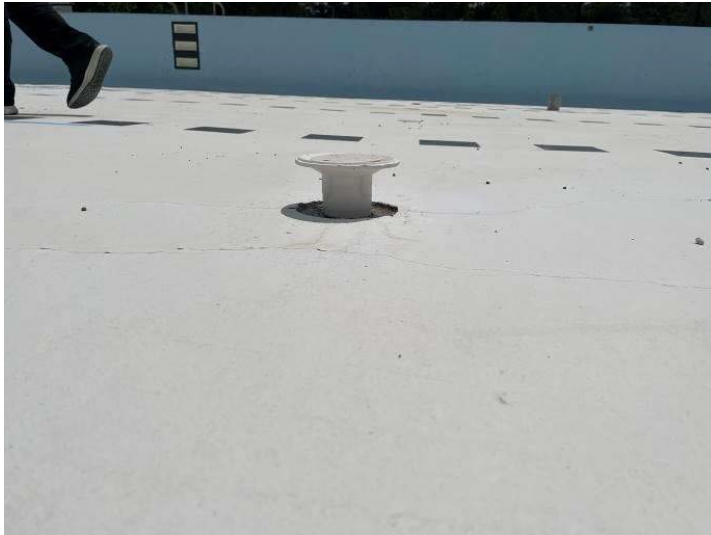
**Photo 3 – Protruding Floor Drain**

Any movement of the pool slab will result in probable damage to the pool piping system. The protruding floor drain is evidence of significant hydrostatic uplift pressure. (Appendix A, Photo 3). Cracking in the pool slab (Appendix A, Photo 4) and damage at the pool walls (Appendix A, Photos 5 & 6) are the result of differential movement of the pool tank. The extent of the cracking is shown in (Appendix A, Figure 2)

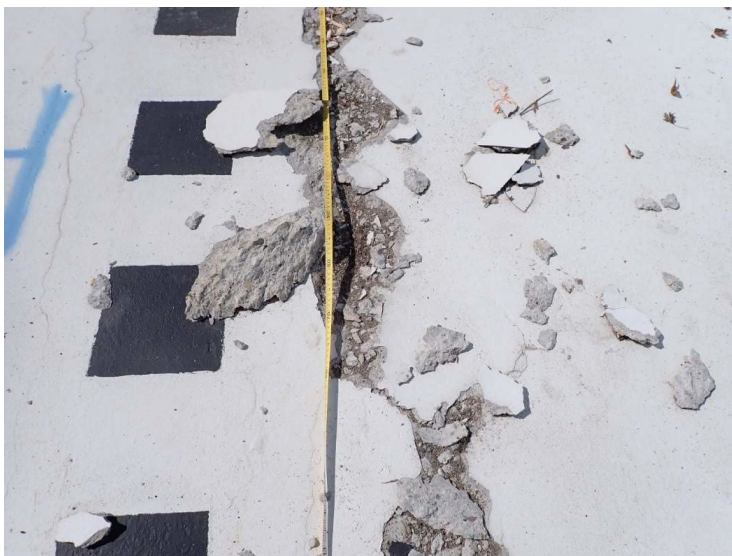
**Photo 4 – Spalling of concrete along the crack line evident in the pool slab**

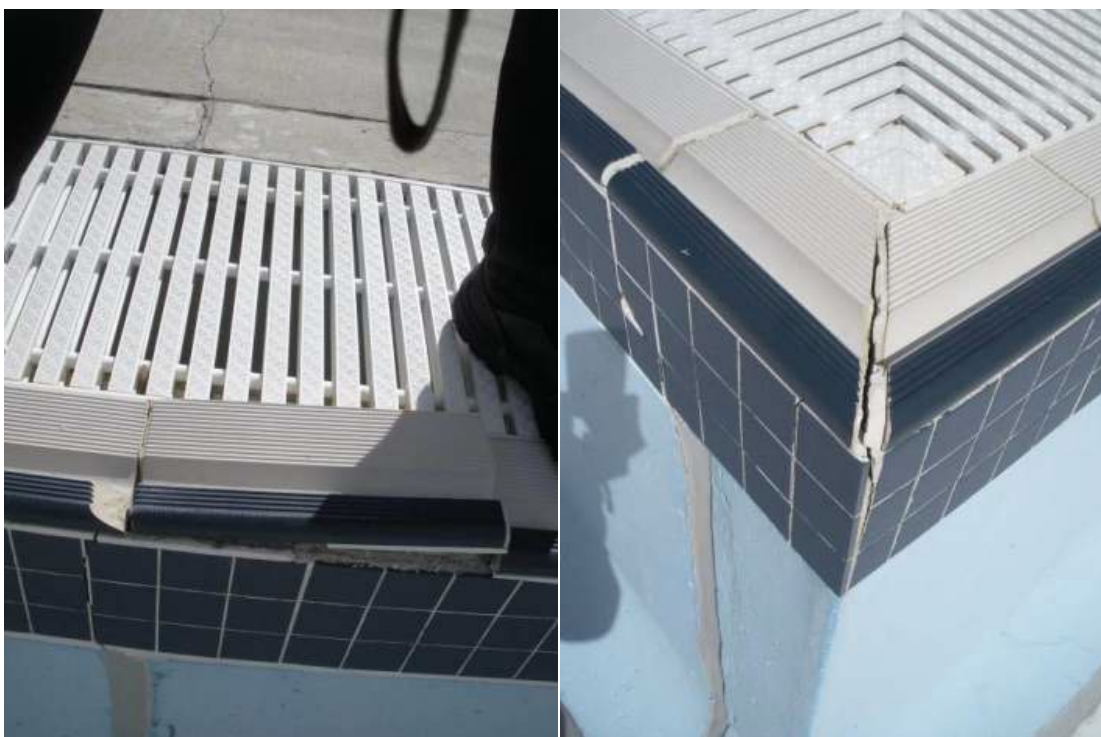
**Photo 5/6 - Indication of Pool Movement**

**Damage to coping and gutter – indication of pool movement, recently repaired**

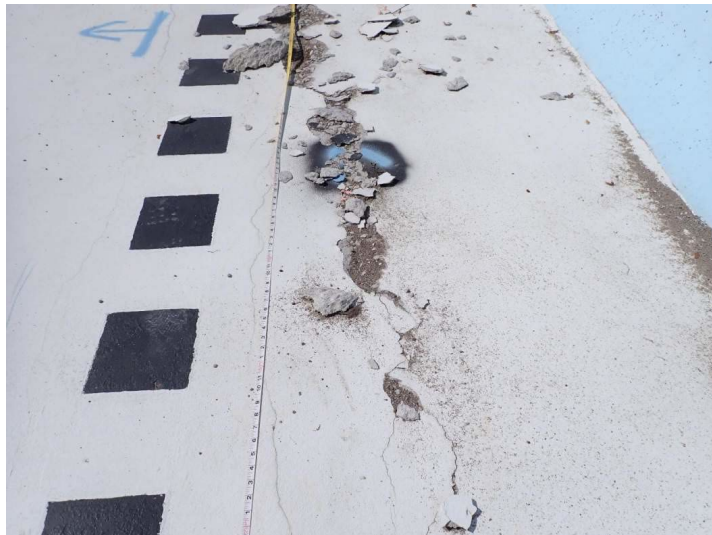
**Photo 7 – Subgrade Deterioration**

A geotechnical investigation, including boreholes, completed by Terrapex Environmental in September 2022, found that voids appeared to be present in the granular base material below the pool floor. Leaking from broken piping could create localized voids, but the widespread existence of the voids suggests hydrostatic uplifting has disturbed the granular material. This may have created high and low points in the base material that the slab rests on and additional stress on the slab.

Sand in the floor returns and extruded through cracks in the concrete is evidence of the degradation of the base layer. (Appendix A, Photo 7)

Hydrostatic pressure evidence: subgrade material forced out along crack line
