# Kensington Bridge Municipal Class Environmental Assessment

Ecological Community Advisory Committee Meeting

February 16, 2022

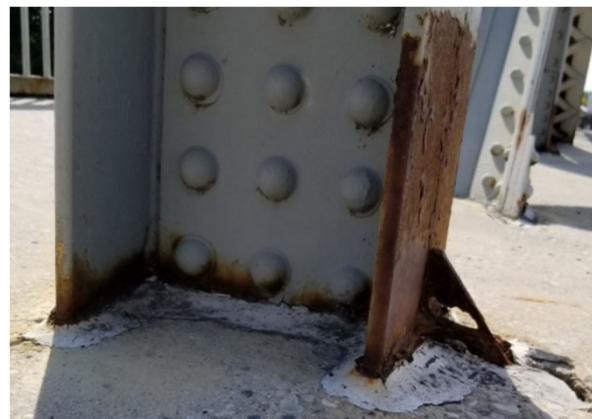
Localized corrosion on bridge truss

- Previous major rehabilitation includes deck replacement (1960), construction of an exposed concrete overlay (1985), and structural steel recoating (1996). Kensington Bridge is 92 years old and has ongoing maintenance issues. Maintenance of the bridge since 2004 has included abutment refacing, sidewalk and deck repairs, bearing seat repairs, and replacement of the expansion joints.
- Exposed concrete deck is in fair to poor condition with narrow to wide cracking, concrete delaminations and previous patching. Concrete repairs and lane closures are required annually to address issues.
- Structural steel is in fair condition with localized poor conditions below the deck at the abutments and piers.
- Bridge bearings are in fair to poor condition with light to severe corrosion, flaking and pack rust.

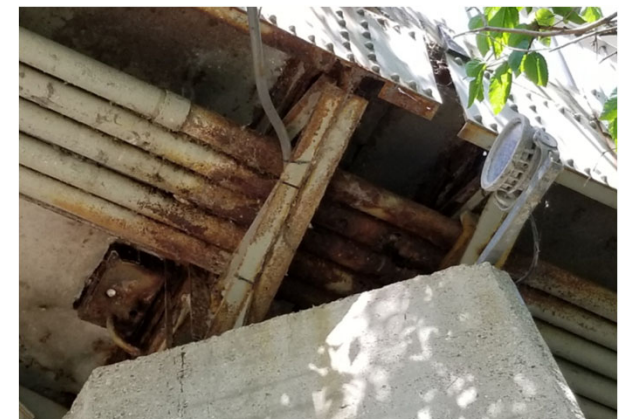
Kensington Bridge Soffit

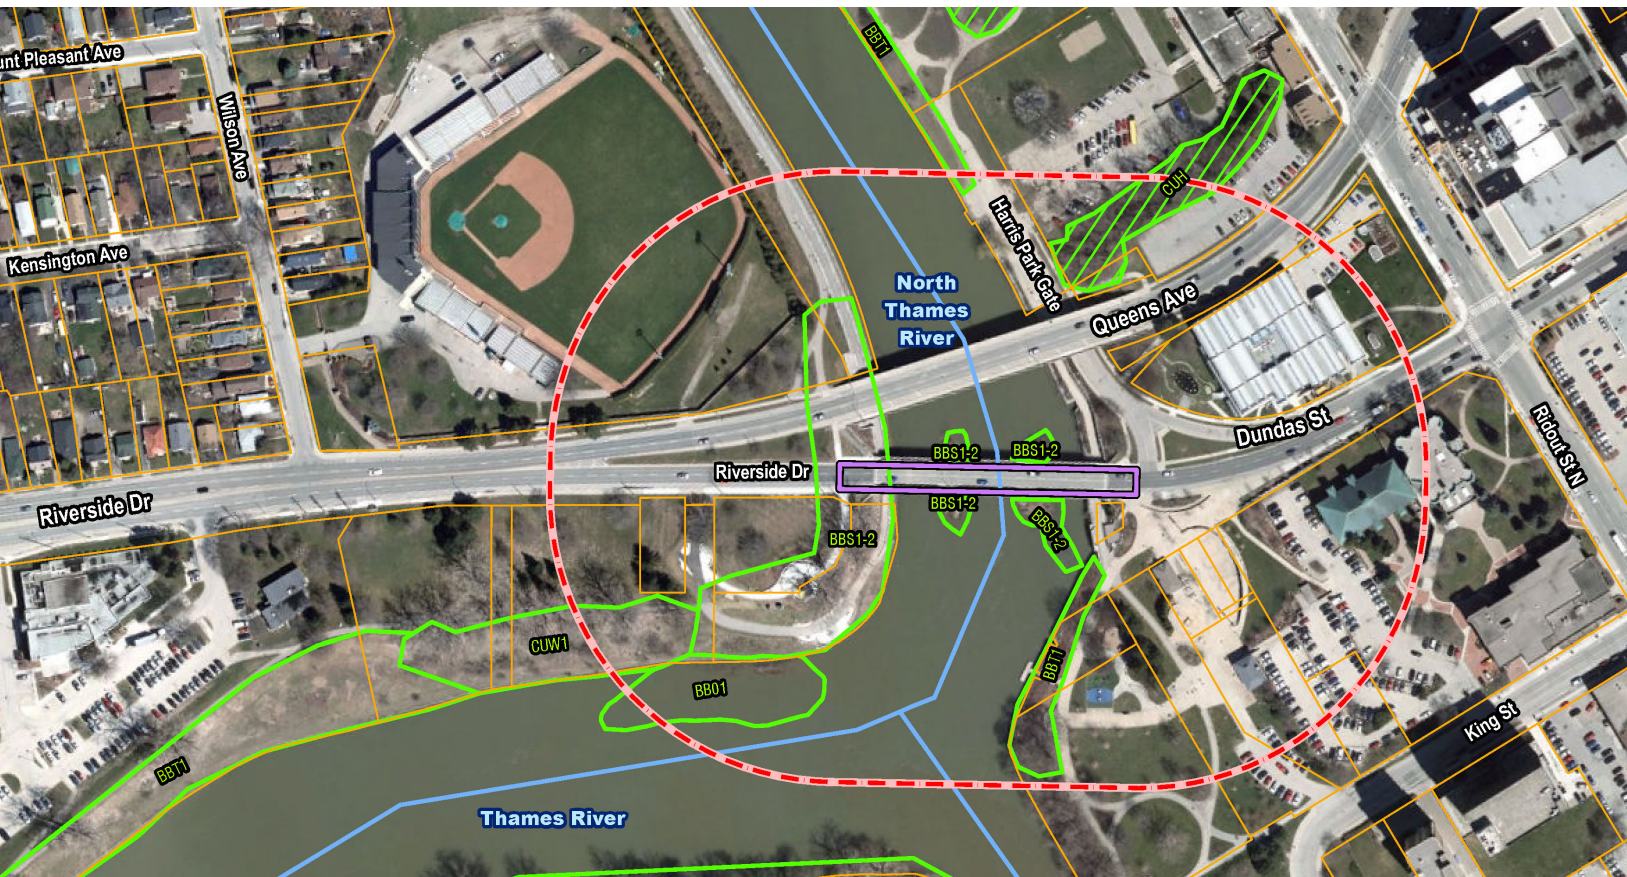
## Study Area and Ecological Land Classification (ELC)

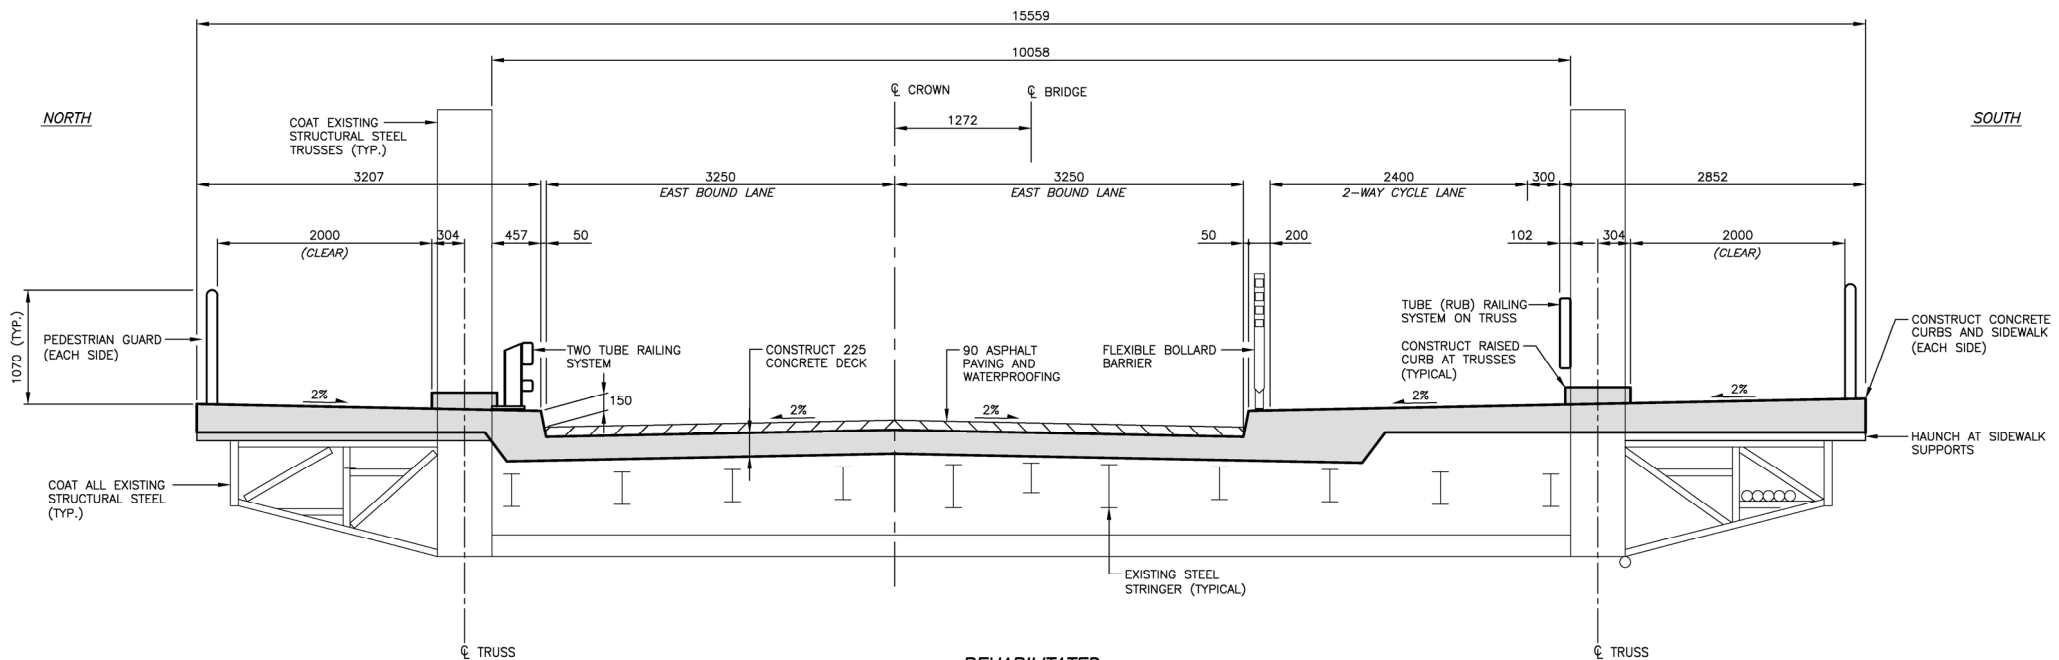
REHABILITATED  
 Preliminary Design Only – Lane widths and tube railing system to be confirmed during detailed design  
 Type of Barrier System being used will not impact Natural Heritage

## Design Summary for Tubes System Barrier

- Barrier will be adjacent to the curb on the north side of the bridge.
- Barrier will be adjacent to the trusses on the south side of the bridge.

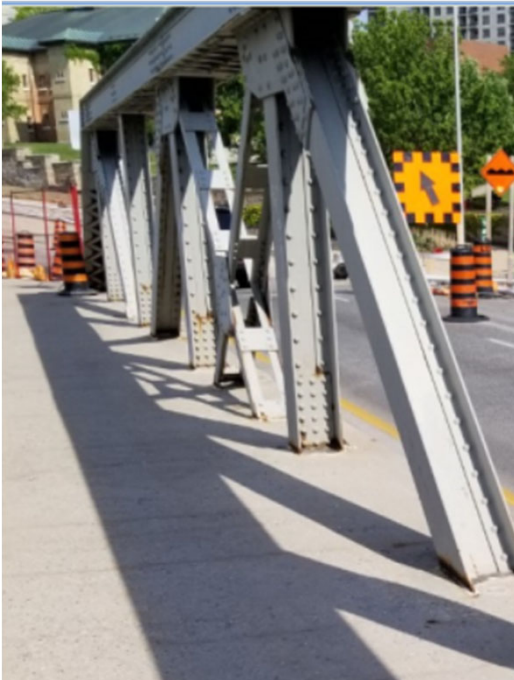
Kensington Bridge Truss

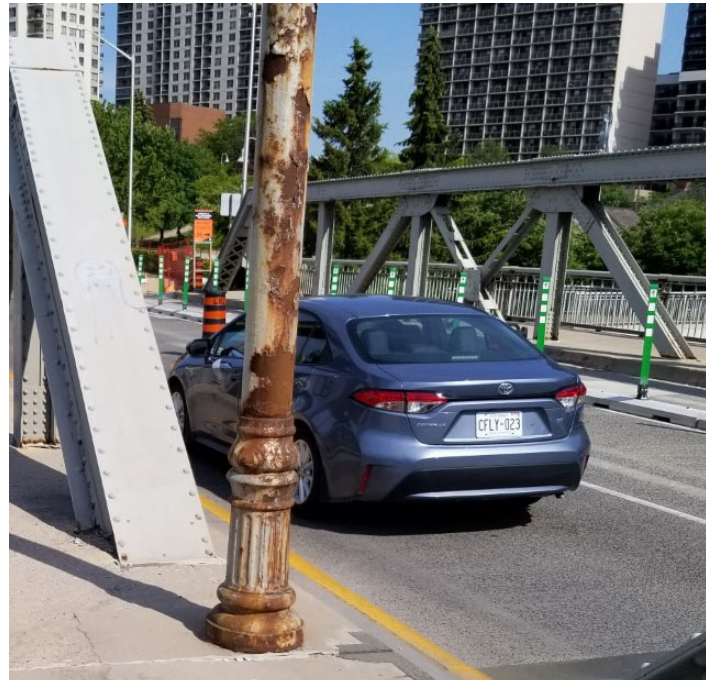
Kensington Bridge Existing Light Standard  
Base

- Two of four original poles are still in place, but original decorative lighting arms were replaced.
- Existing light poles are in poor condition and require replacement.
- Existing light poles have decorative sleeve that will be mimicked.
- Lighting levels to be upgraded to current standards.

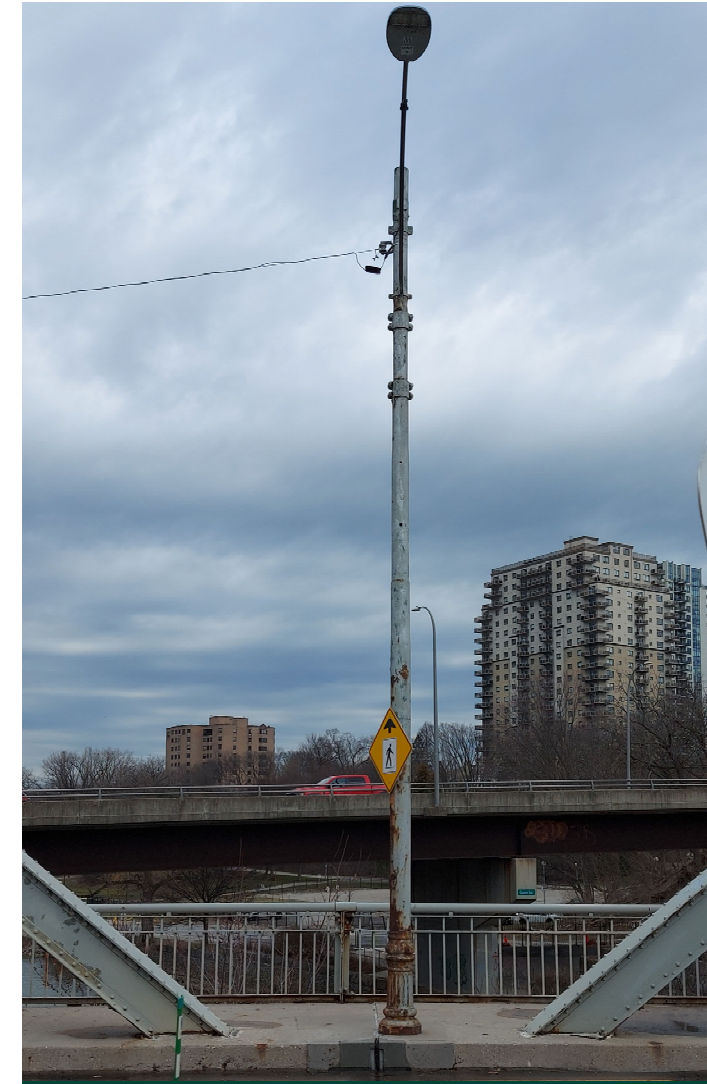
Kensington Bridge Existing Light Standard
