# Heritage Impact Assessment: Kensington Bridge

City of London

**Date:** April 2023

**Project #:** 60672088

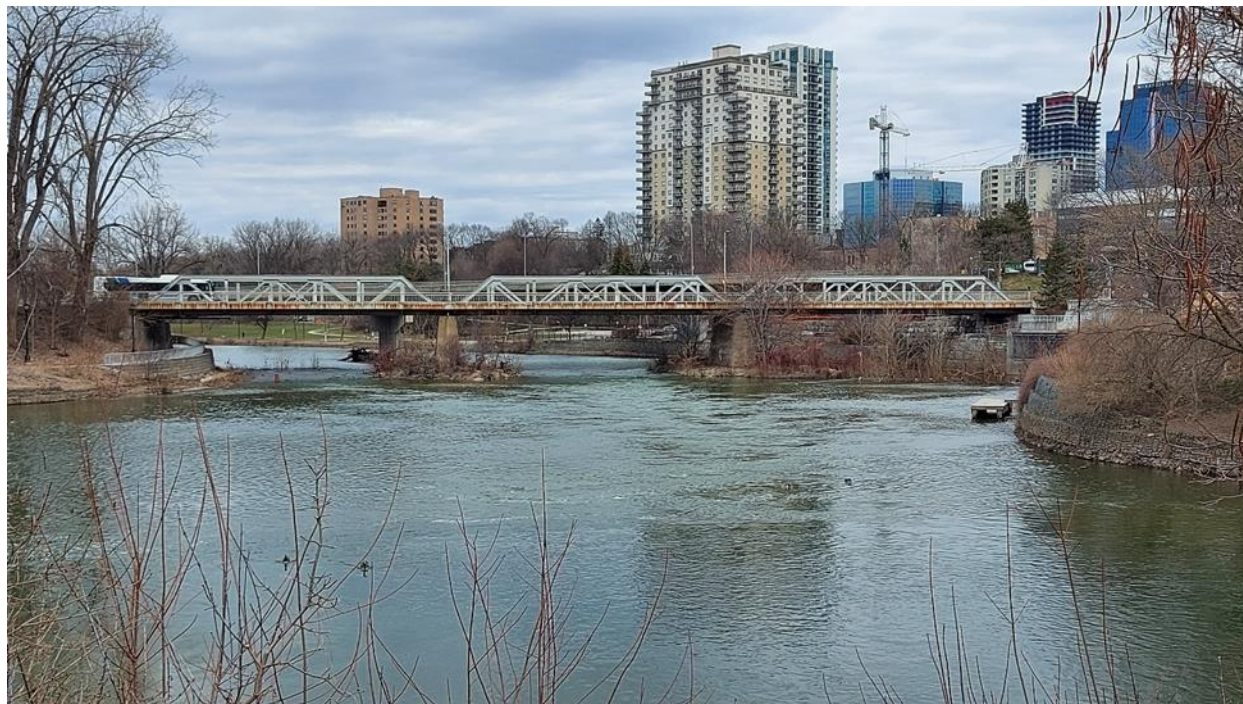
**South Elevation of Kensington Bridge (AECOM, April 2022)**

Kensington Bridge is a three-span metal seven-panel rivet-connected modified Warren pony-truss structure built in 1930 by the Hamilton Bridge Company, a prolific Ontario bridge builder (**Photograph 1**, below). The bridge was designed by the Hamilton Bridge Company and by John Rostron who was the assistant engineer on structural works for the City of London (see **Appendix A**, the original design drawings). This three-span steel bridge was built to the same plan and around the same time as the skewed two-span Victoria Street Bridge (now removed and a new crossing underway). Kensington Bridge (and the former Victoria Street Bridge) is a rare variation of the Warren pony truss where the center panel "breaks" the Warren pattern and introduces a panel with two diagonals forming an "X" at this point, rather than continuing the Warren pattern. The superstructure rests upon two concrete abutments that are built into the earth embankments on either side of the Thames River. Two concrete piers are located within the river and support the bridge spans. It has a crossing length of 95.4 m and a deck travel width of 14.87 m. There is currently no posted load limit however historically, the bridge had a posted limit of 12 tones (AECOM, 2018a).

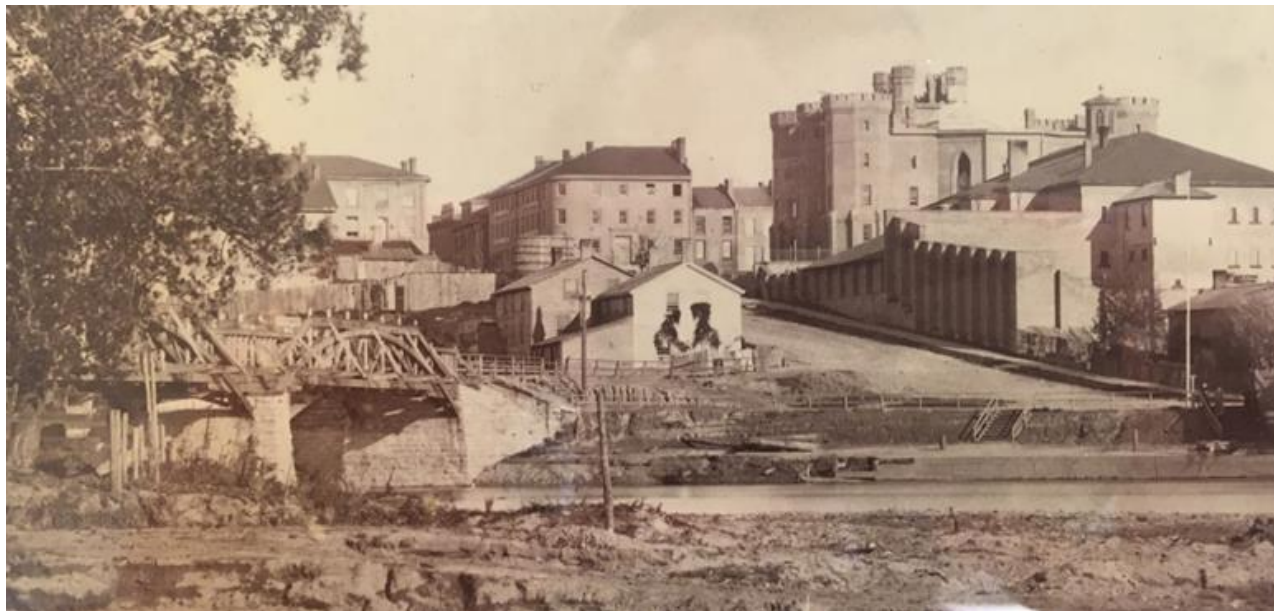
**Image 1: Historical view from the west side of the Thames River showing the 1871 Kensington Bridge as well as Dundas Street rising up to Ridout Street at right (Western Archives. Western University. Regional Photograph Collection. RC80296)**

In 1871, the first crossing at this location was built as a two-span timber truss bridge (**Image 1**). This resulted in a new community extending west along the new east-west route. Popularly known as Kensington, the new community merged with Petersville in 1875 to form an incorporated village, called Petersville until 1881, when it changed its name to London West. Therefore, the 1871 bridge connected London to the Kensington/Petersville area and was appropriately named after the name of the area that it was built to service.

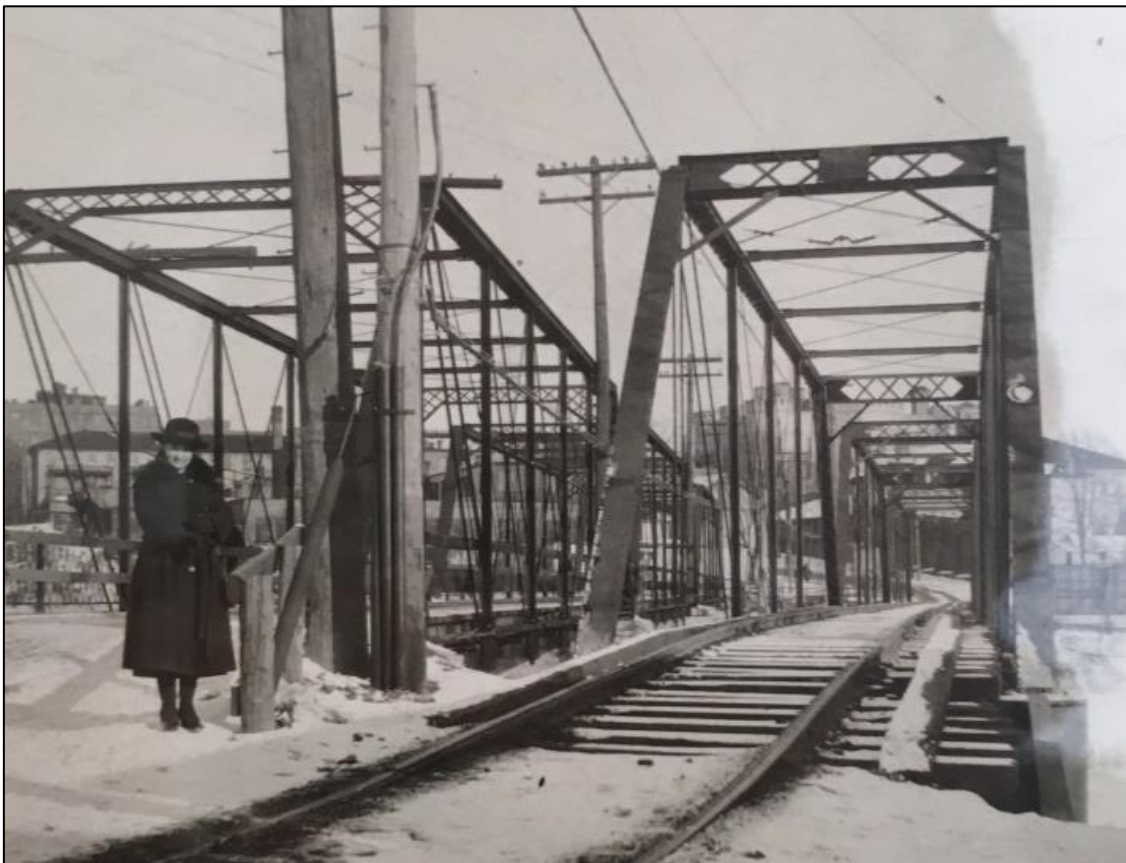
**Image 4: View looking eastward toward Downtown London of the 1895 LSR bridge (on right) and the 1884 three-span Pratt truss bridge (on left), ca. 1923 (Western Archives. Western University. Regional Photograph Collection. RC60082)<sup>3</sup>**

<sup>2</sup> The CHER had referred to this bridge as a Warren pony truss, but the span seen clearly in Image 4 below shows a Pratt truss type. The CHER referred to the 1884 iron bridge as a two-span, but it was three as indicated in Image 4 below and the Image 4 in the CHER on page 10.

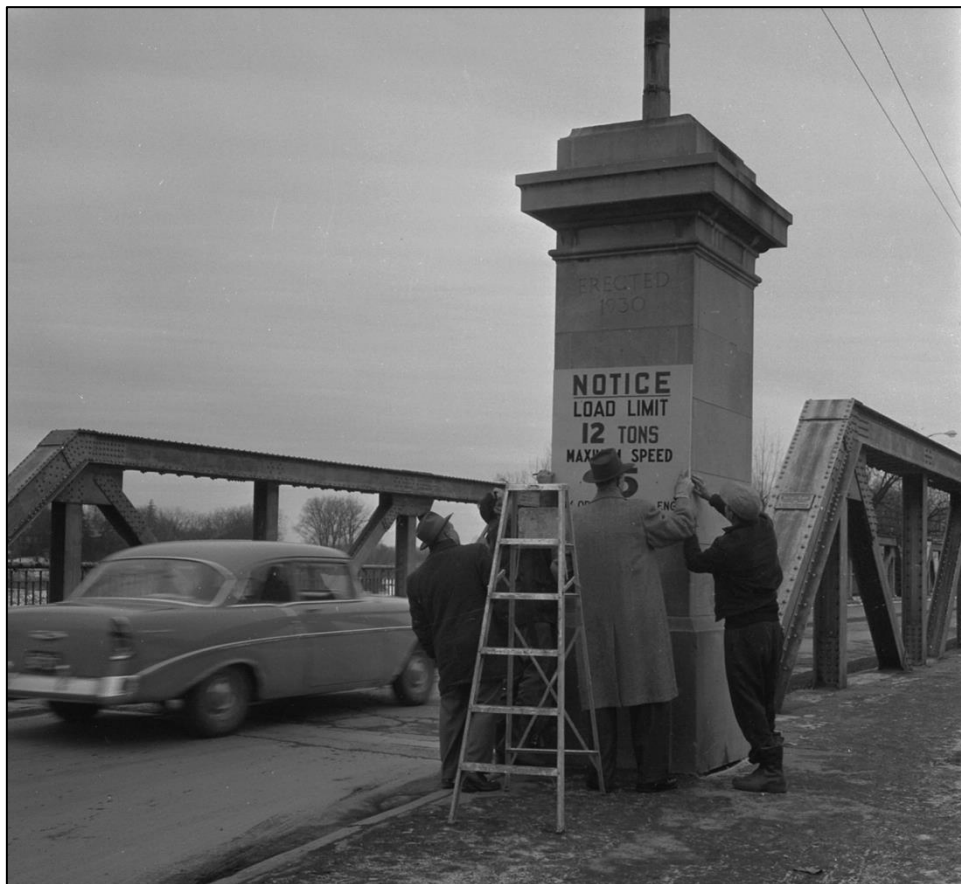
**Image 5: Pillar with load limit and a date stone “Erected 1930” (Western University, London Free Press, January 9, 1960)**

be applied first. There were two large decorative pillars with ornate lamps erected at both ends of the bridge within the sidewalk area (**Image 5**). The pillars rose above the trusses. They were removed in 2006 and the date stone was salvaged and incorporated into the sidewalk (also no longer extant). The remnants of the posts have been entirely removed from the bridge in the early 21<sup>st</sup> century.

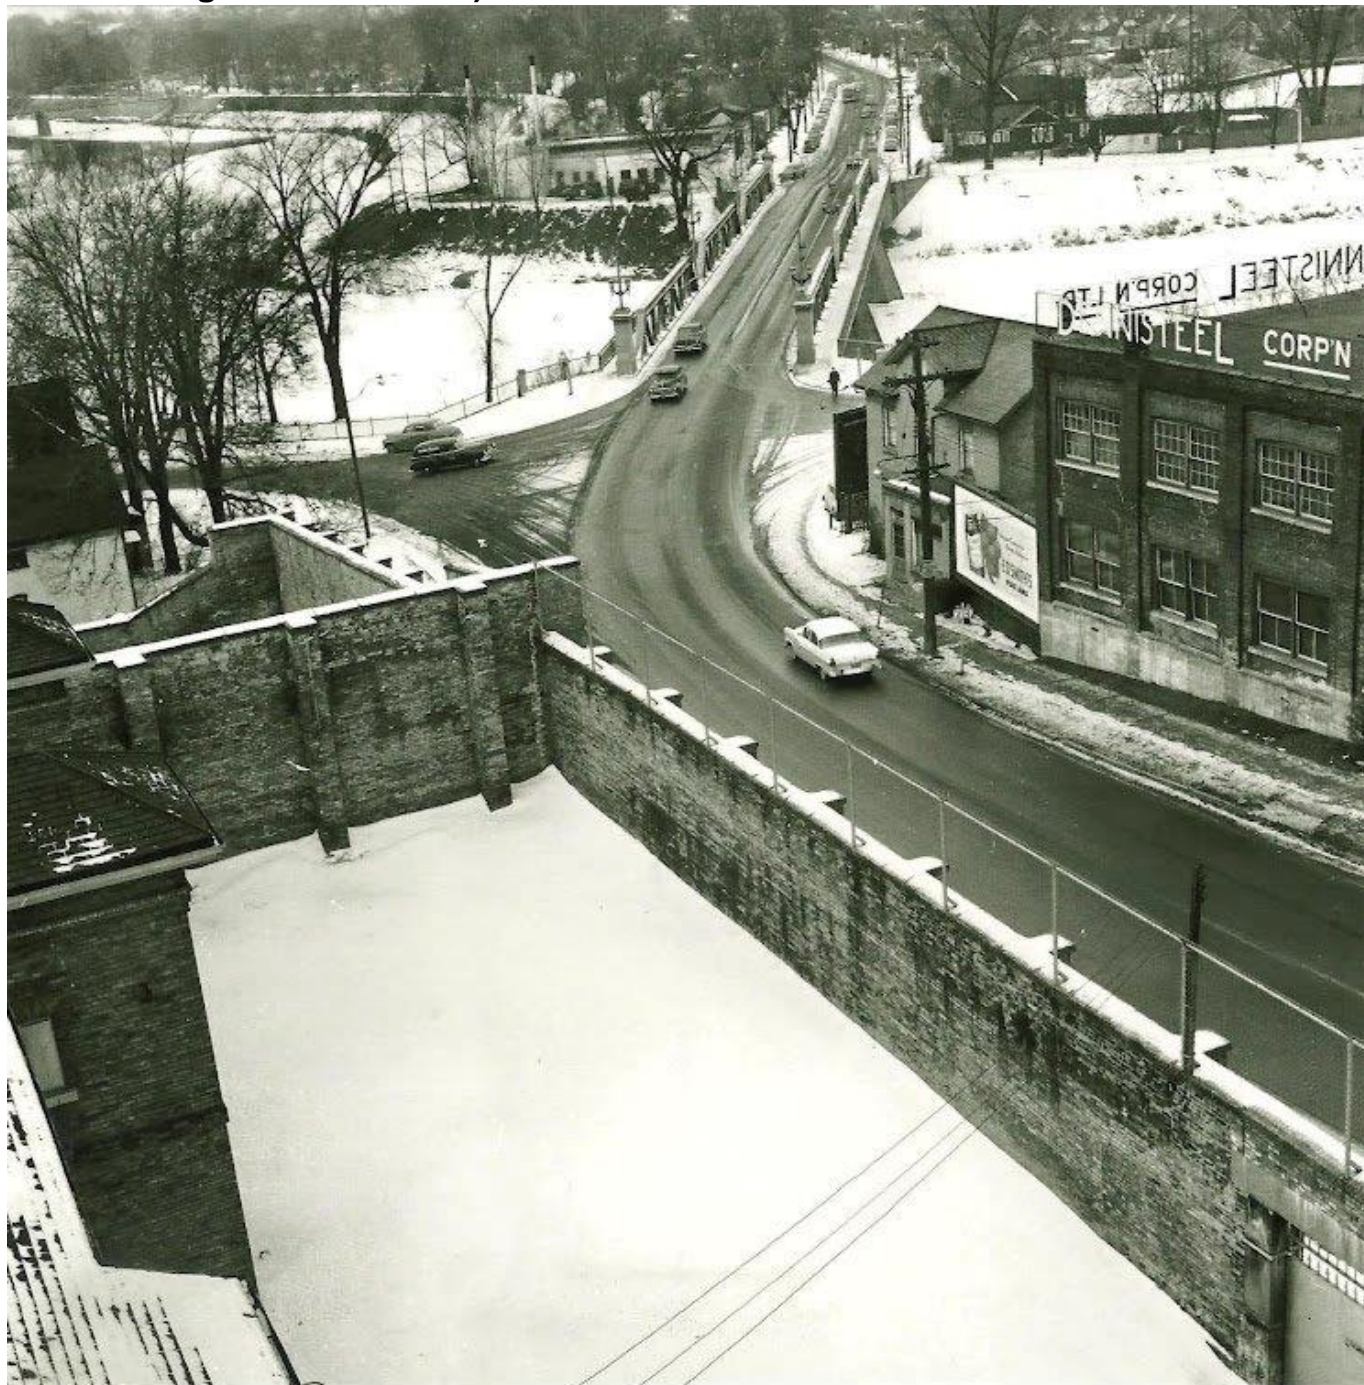
**Image 7: Historical view in 1956 showing the existing Kensington Bridge with the concrete end posts and lighting systems that are no longer in place (London Free Press, January 26, 1956; Western University Archives, Negative Collection)<sup>4</sup>**

There are cantilevered sidewalks and steel pedestrian handrailings located outside the main trusses (**Photograph 14**). Each sidewalk measures approximately 1.8 m in width. In addition, two decorative lampposts are located in the centre of the bridge between trusses and appear to have been a part of the original construction of the bridge with the exception of the light fixtures which have been replaced as well as the decorative arms. Attached to the handrailing system over the wingwalls, are two original concrete posts at the west end of the bridge and one on the east side of the bridge (although seen in **Image 7** the southeast concrete end post has been removed).

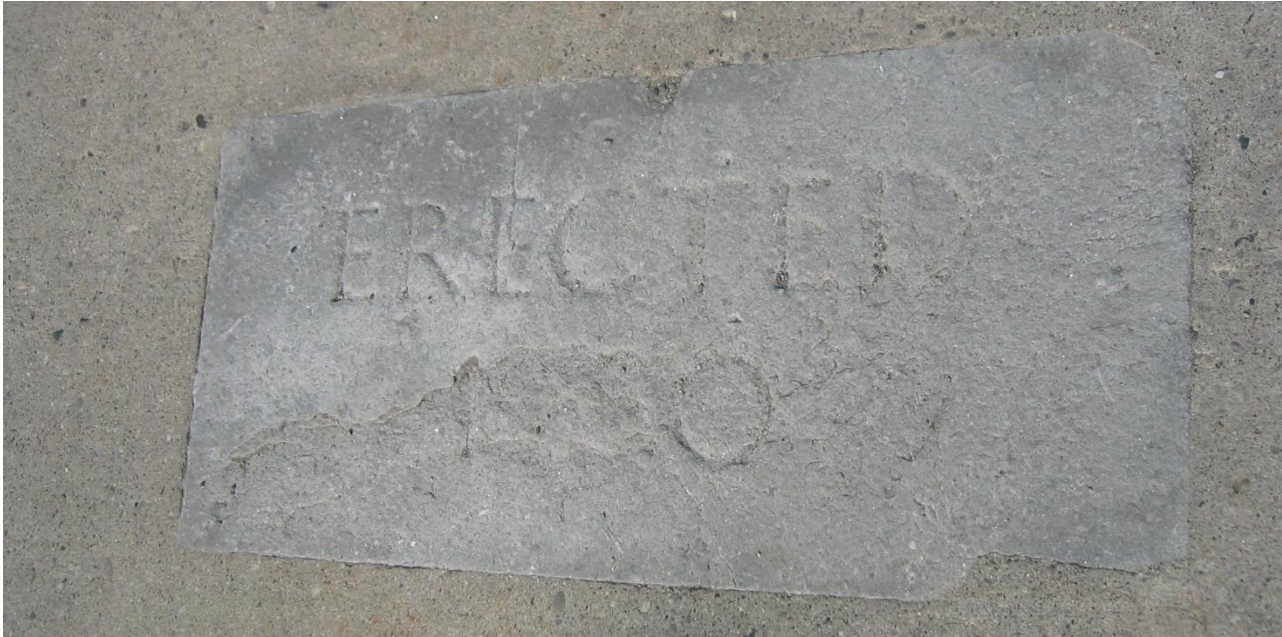
**Image 8: Date stone in sidewalk, photographed by Nathan Holth on July 12, 2005  
([historicbridges.org](http://historicbridges.org))**

Date unknown (post-2005)- date stone in the sidewalk with “Erected 1930” (**Image 8**, below), salvaged from the pillar as seen in **Image 5** above, has been removed or covered over.

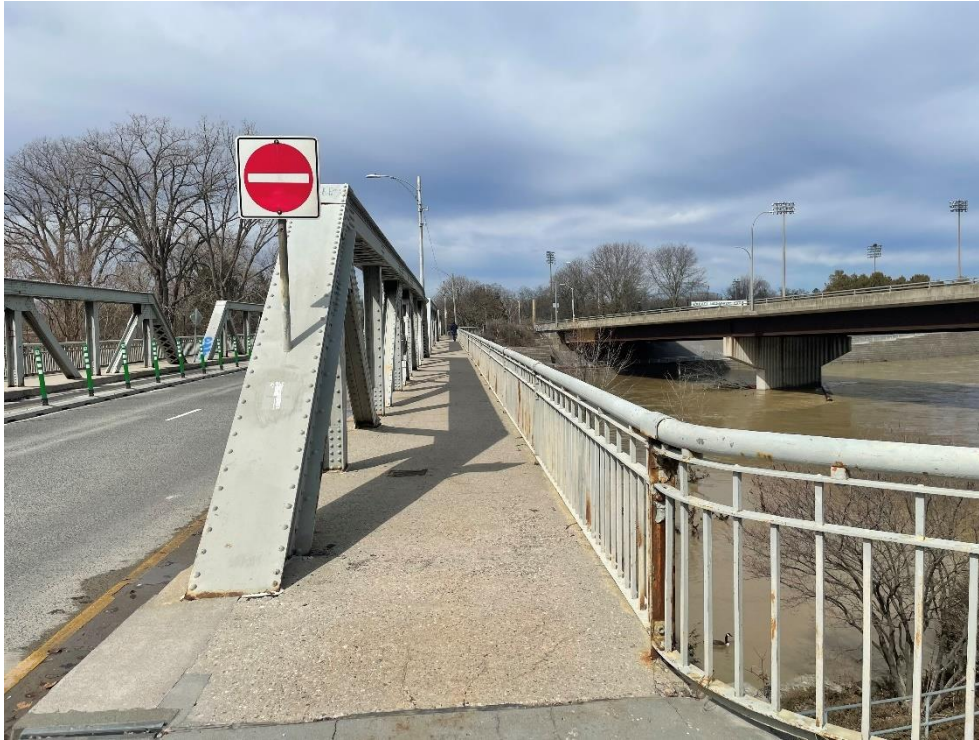
**Photograph 9:  
Southwest  
concrete post and  
handrailing  
(AECOM, April  
2023)**

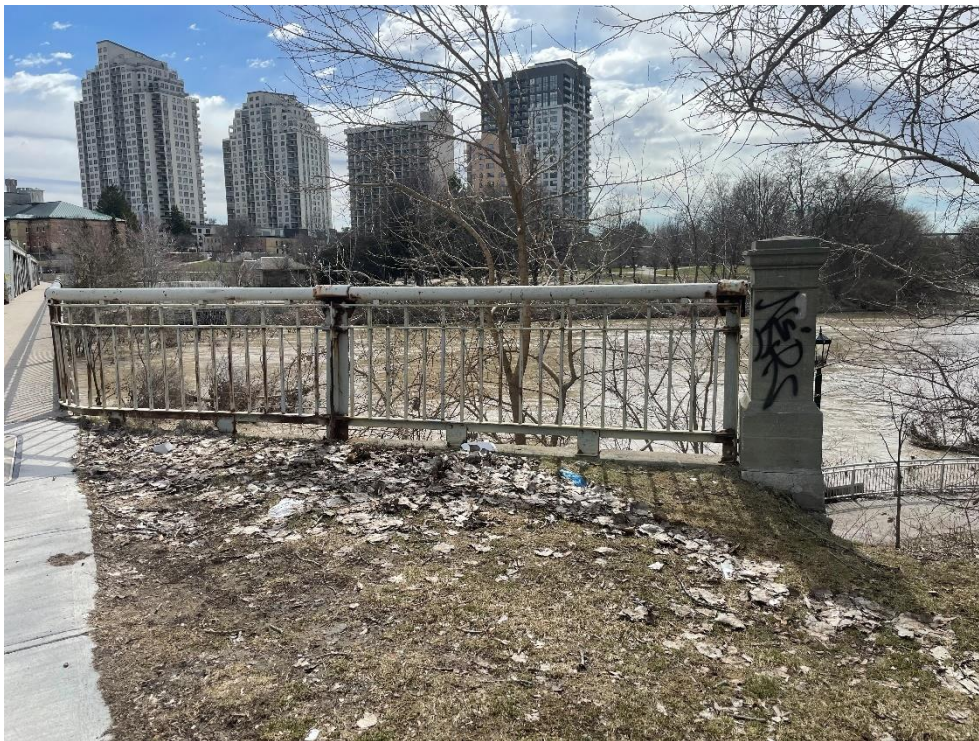
**Photograph 10:  
Northwest concrete  
post and  
handrailing  
(AECOM April  
2023)**

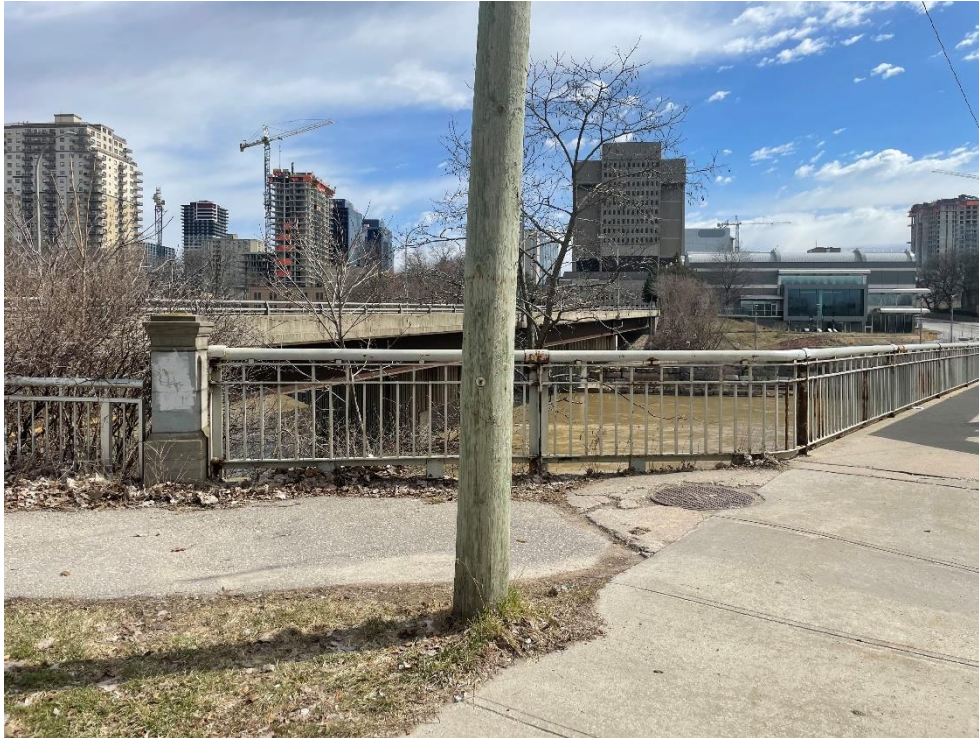
**Photograph 11:  
West expansion  
joint over the  
abutment (AECOM,  
April 2023)**

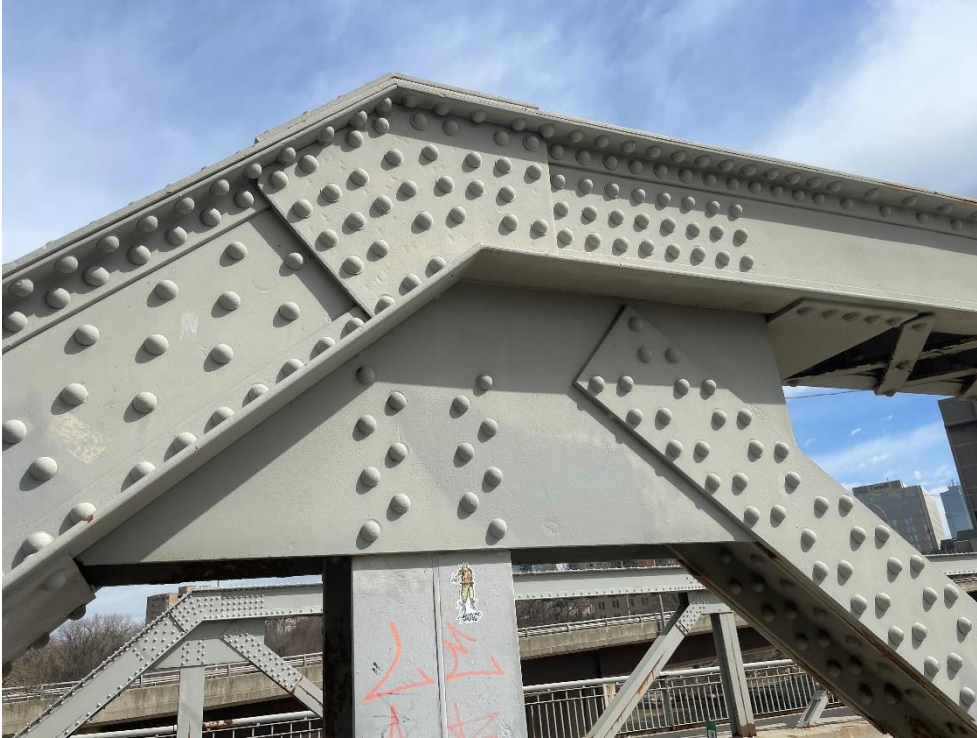
**Photograph 13:**  
Riveted lattice on  
the top chord  
(AECOM, April  
2023)

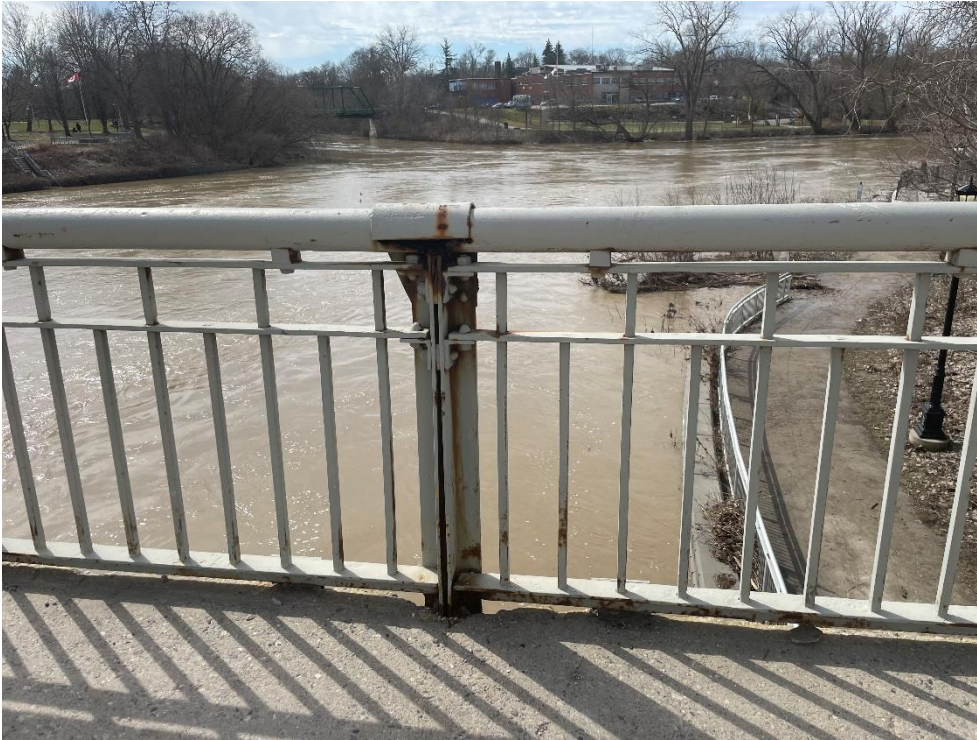
**Photograph 15:  
Intermediate  
connection viewed  
from the south  
sidewalk (AECOM,  
April 2023)**

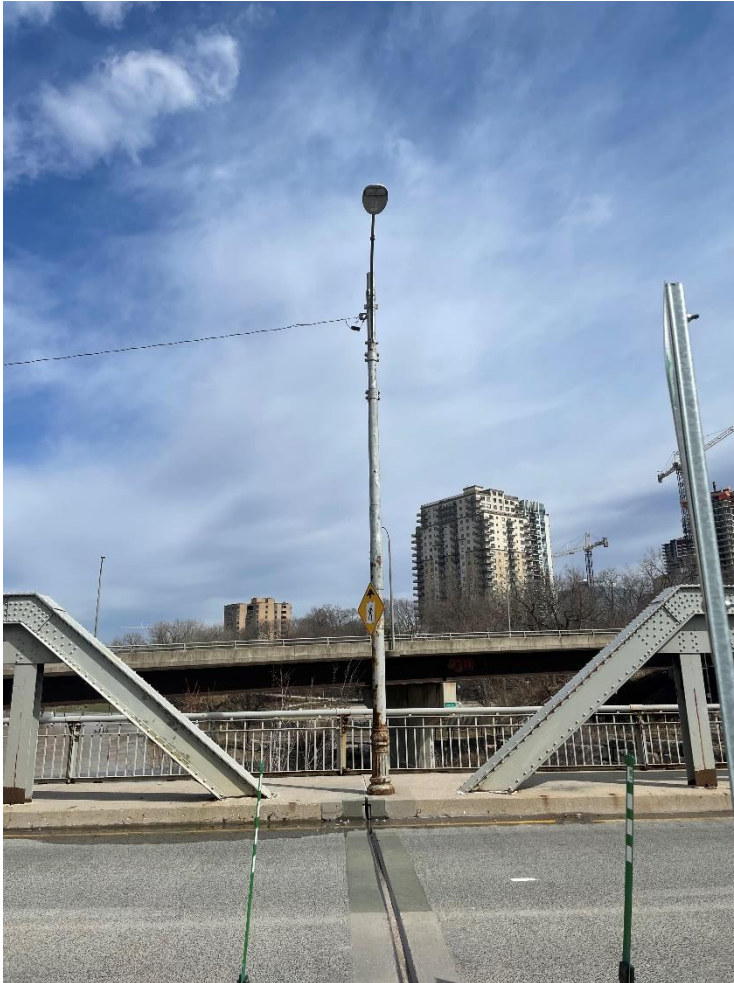
**Photograph 18:**  
Northeast original  
concrete end post  
connected to the  
handrailing and  
Bridge sign:  
“Thames River,  
Kensington Bridge,  
Since 1872”  
(AECOM, April  
2023)

The bridge is currently used as a vehicular bridge that accommodates two lanes of traffic, as well as a cycle lane and sidewalks. The Thames River signage is present at the bridge which indicates a crossing since 1872. The CHER noted, there are no remnants of the decorative concrete and limestone end posts at the west end of the bridge.

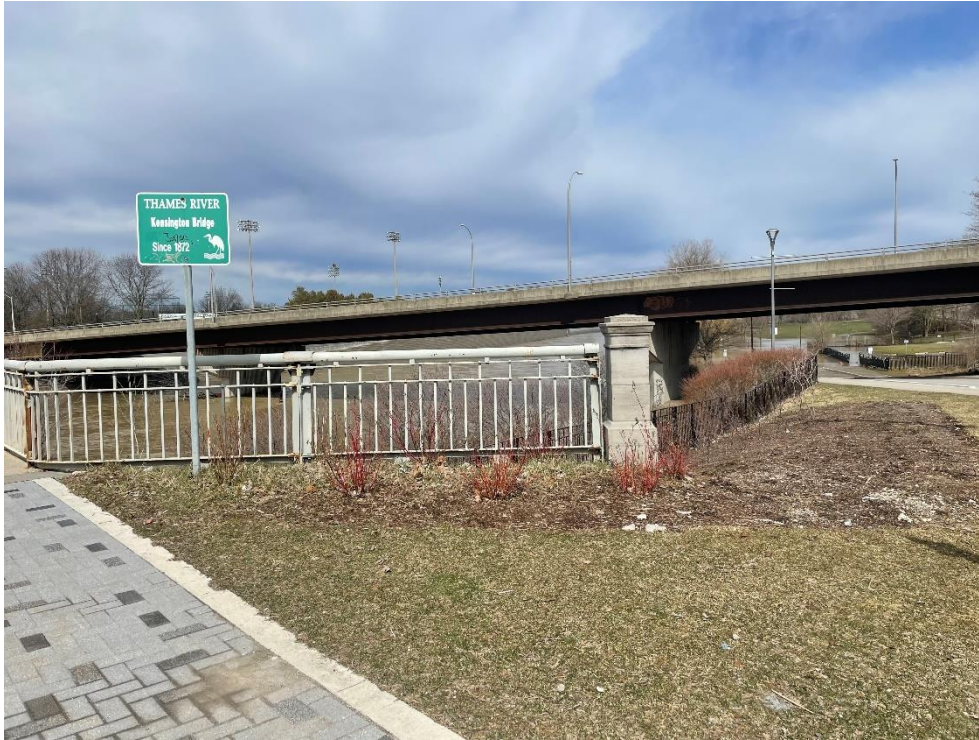
**Photograph 19:**  
Oblique view of the  
south elevation  
from the southeast  
quadrant and piers  
(AECOM, April  
2023)

The TVP is located on the east and west banks of the Thames River (**Photograph 20**). It provides the local community with a walking trail to connect the residential and commercial areas. At the site of the existing Kensington Bridge, the Thames River flows through a wide channel with shallow sloped banks on the east side of the river. The west side of the Thames River is defined by the West London Dyke, which has recently undergone significant repairs and reconstruction. Two concrete piers, located within the river support the Kensington Bridge (**Photograph 19**).

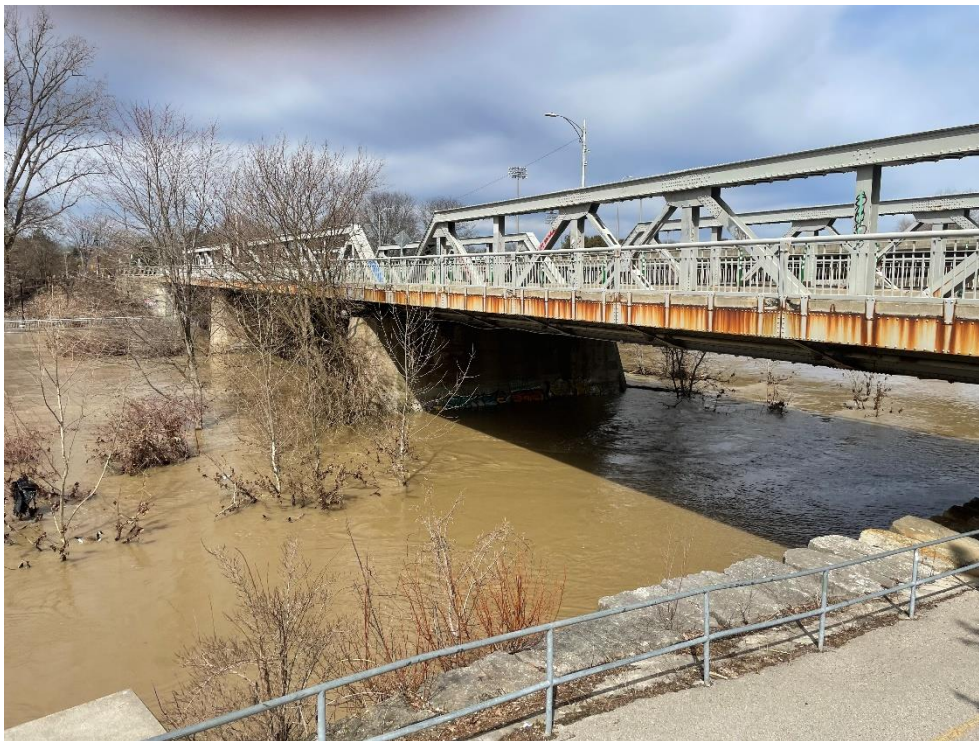
**Photograph 20:**  
**View of the east**  
**end abutment and**  
**TVP below bridge**  
**(AECOM, April**  
**2023)**

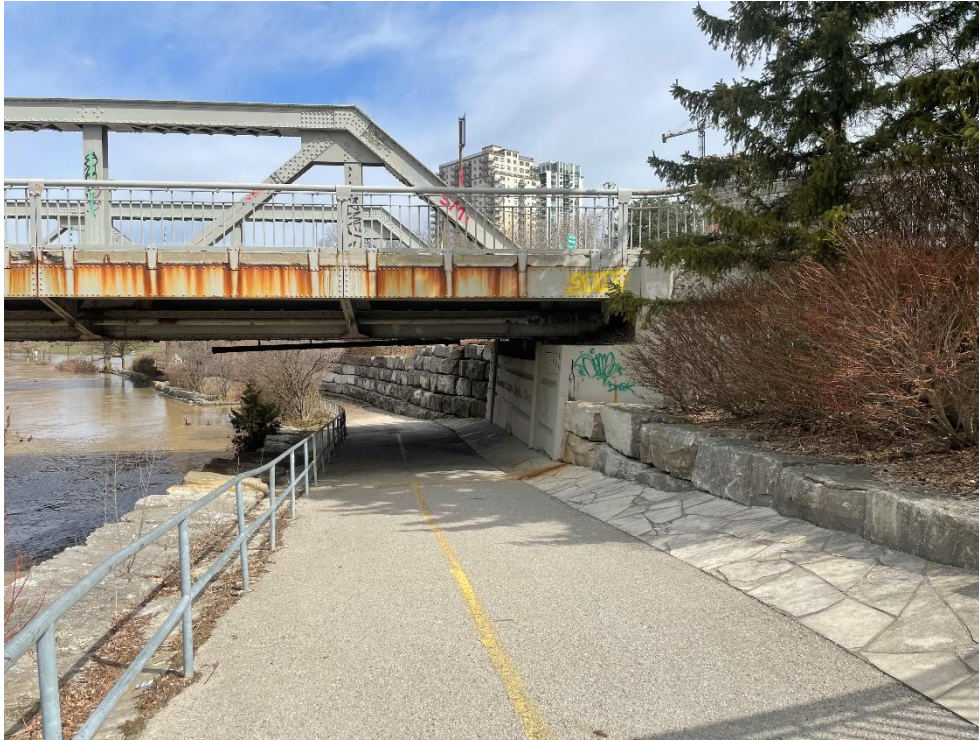
**Photograph 21:**  
**Close-up of the**  
**east abutment**  
**(AECOM, 2021)**

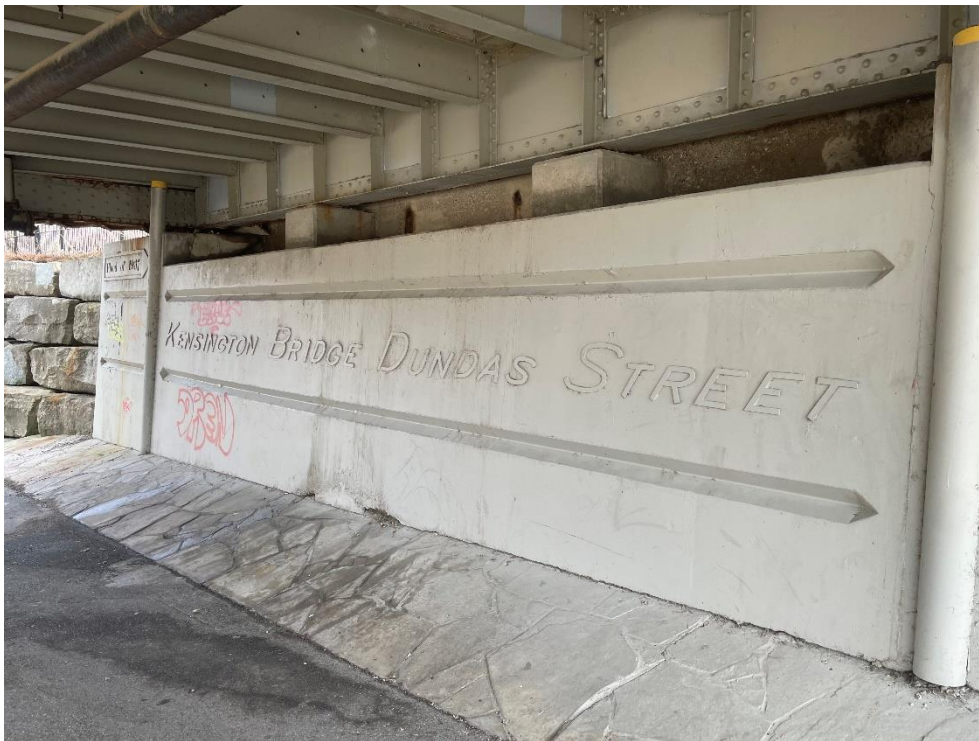
**Photograph 22:**  
View of underside of  
bridge at the east  
abutment with  
conduits (AECOM,  
April 2023)

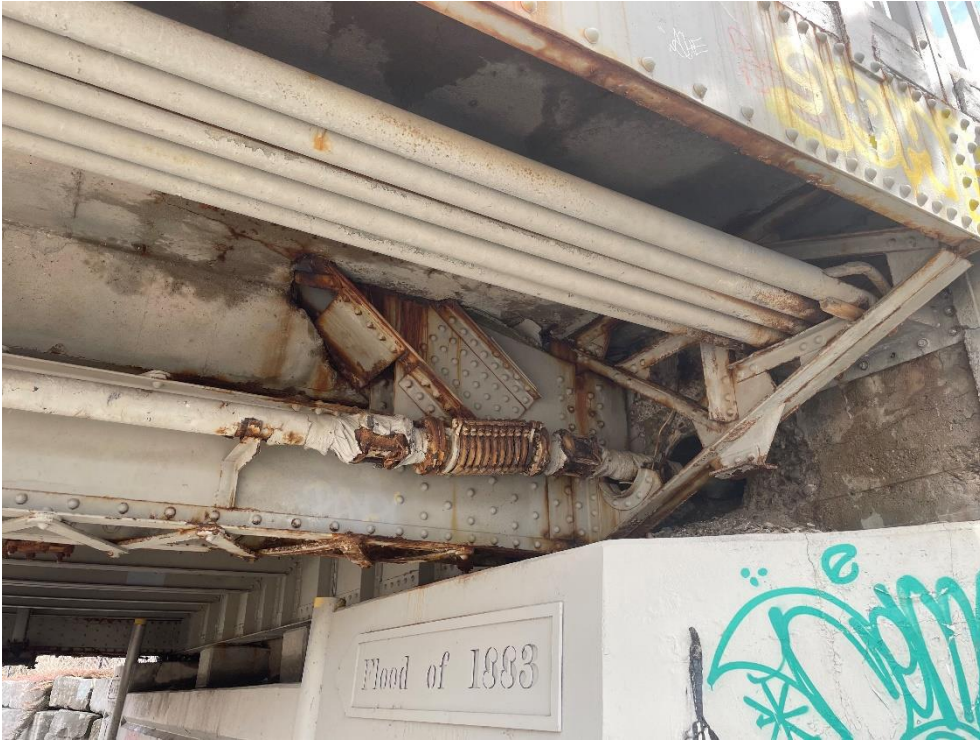
**Photograph 23:**  
View of the east  
pier from the  
underside of the  
east end of the  
bridge (AECOM,  
April 2023)

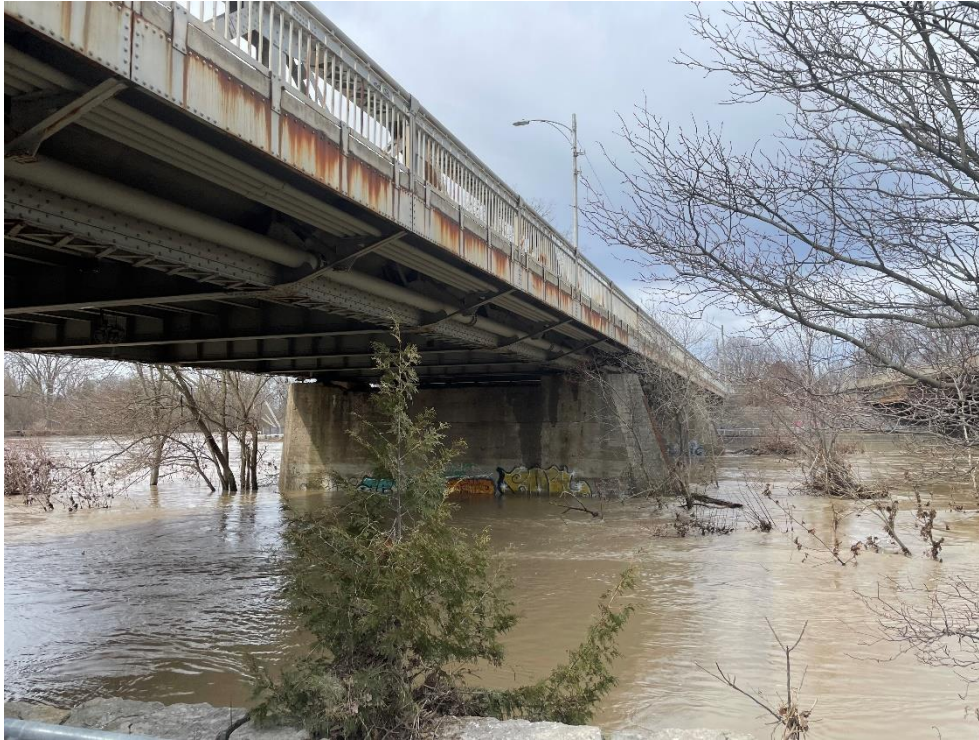
**Photograph 25:**  
**View of the**  
**concrete deck**  
**soffit, the steel**  
**stringers and steel**  
**floor beams**  
**(AECOM, April**  
**2023)**

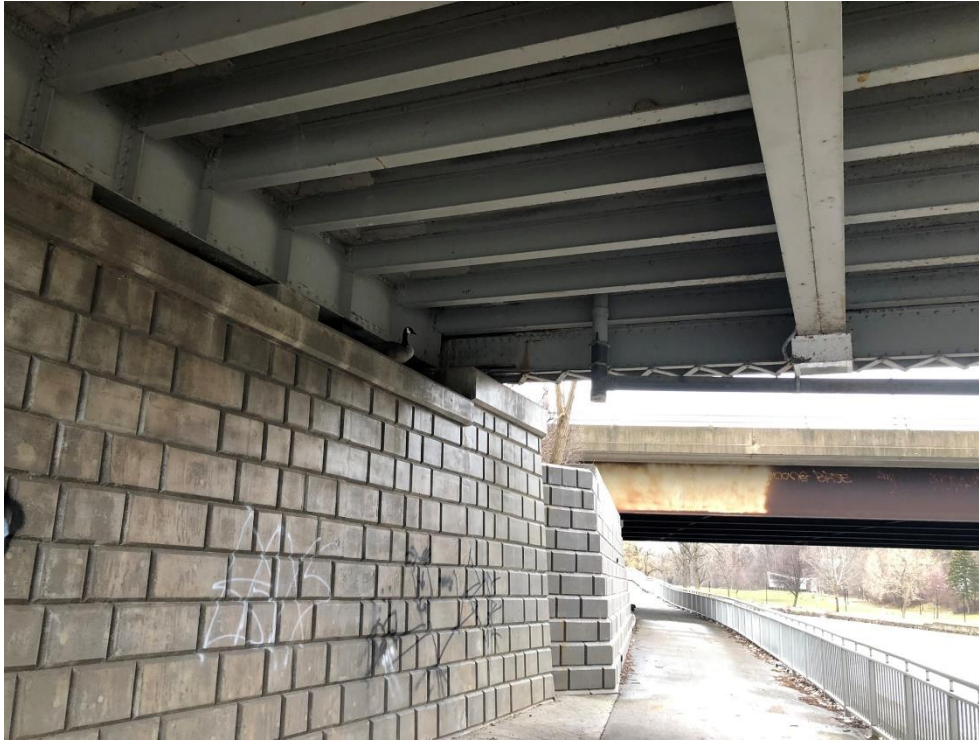
**Photograph 29:  
Southwest  
wingwall (AECOM,  
2022)**
