TO:	CHAIR AND MEMBERS PLANNING & ENVIRONMENT COMMITTEE MEETING ON DECEMBER 12, 2011
FROM:	GEOFFREY P. BELCH CORPORATION COUNSEL
SUBJECT	LONDON HEALTH SCIENCES CENTRE SOUTH STREET CAMPUS DECOMMISSIONING

**Re: Building Condition Assessment and
Adaptive Reuse Study for
Colborne Building at
London Hospital, South Street Campus**

This report assesses the condition of the Colborne Building (Building #67) located at the corner of Colborne and South Streets, forming part of the London Health Sciences Centre in the City of London. This assessment focuses on building enclosure and building structure.

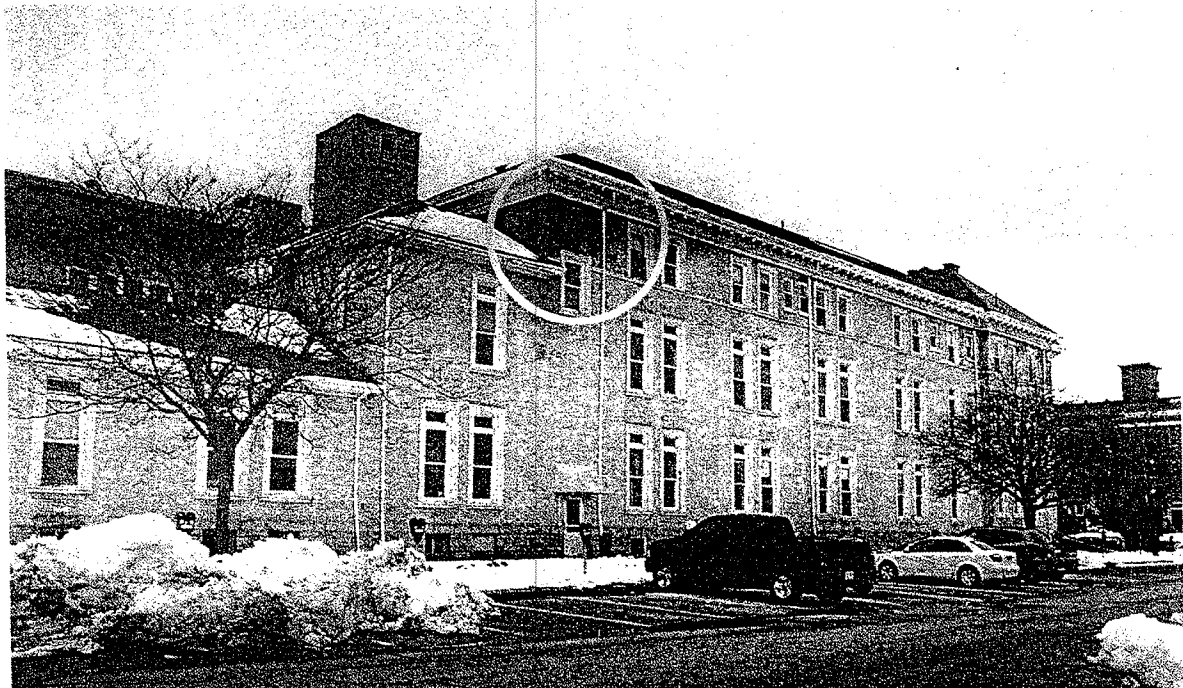
East Façade from Northeast Corner

Staining at corners (yellow circles) is primarily related to leaks at eave gutters, roof flashings and downpipes.

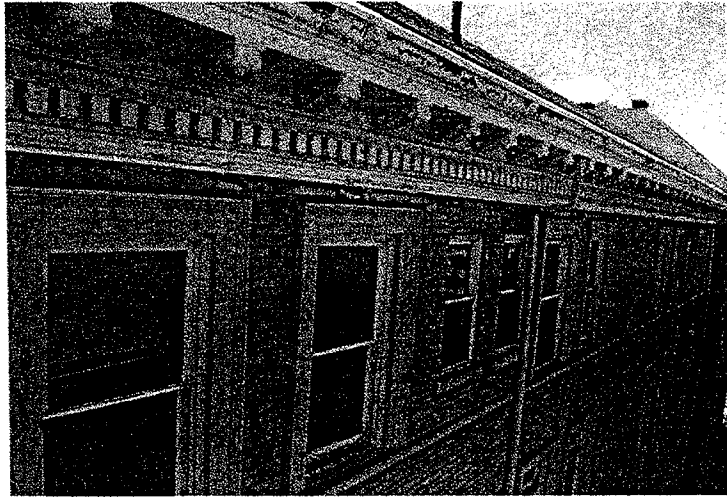
East Façade, Original 1899 Building

Decorative metal cornice is continuous around upper roof at original building and later additions.

Mortar was robust and required mechanical cutting equipment and hammer/chisel to remove brick. Brick units appear to be sound and in good condition as did inner wall core backup brick.

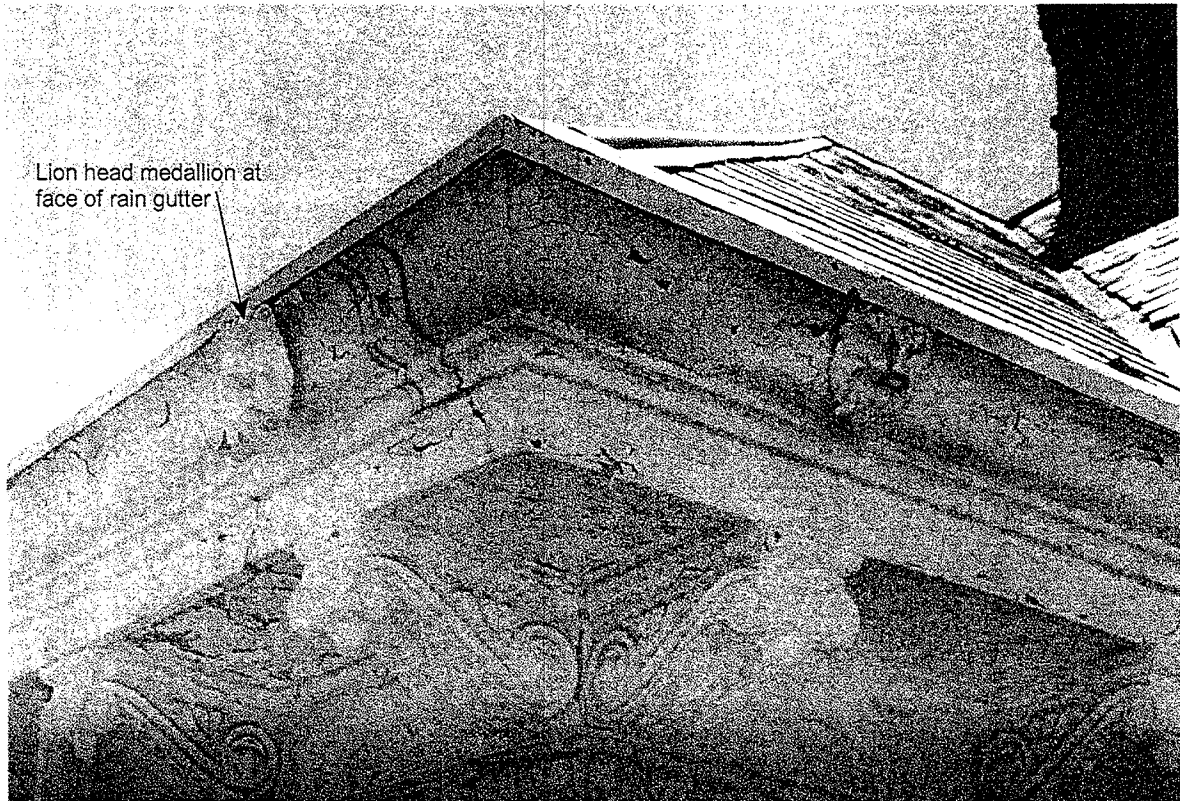
Decorative Metal Cornice, Soffit and Built-in Rain Gutter

Lion head medallion at
face of rain gutter

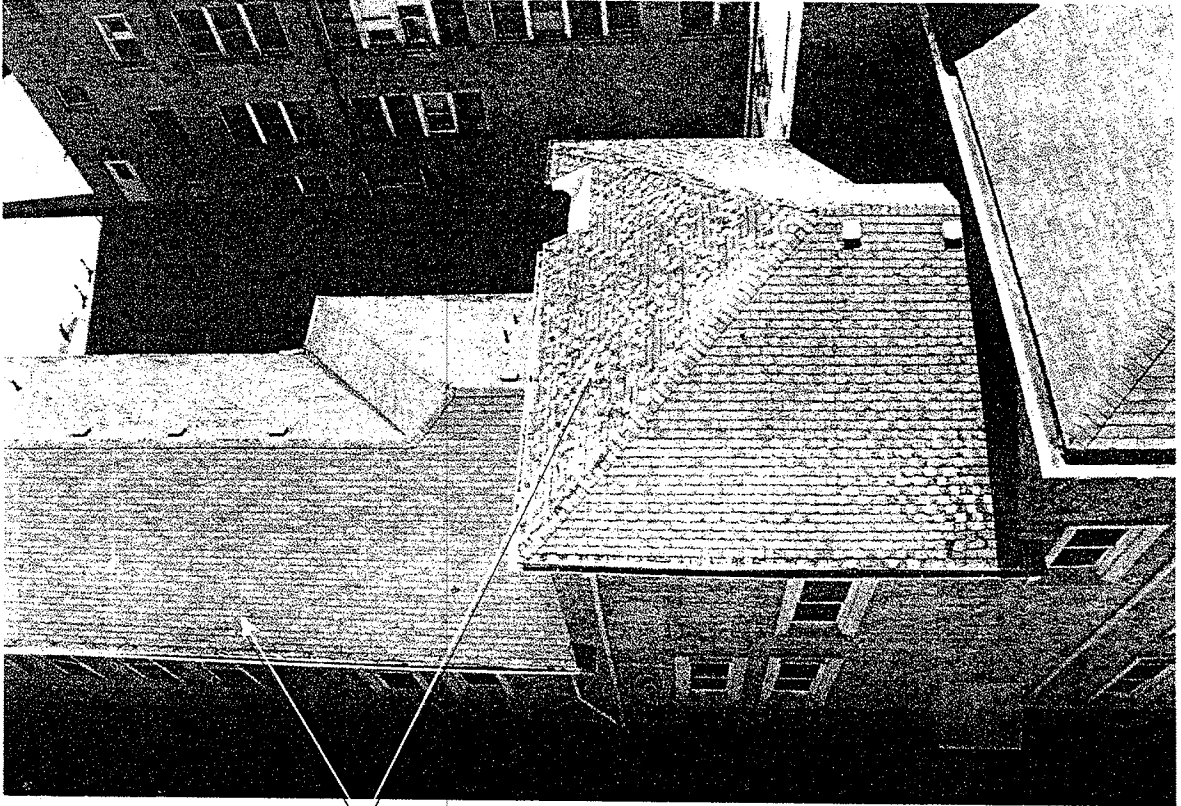
Asphalt shingle roofing at low and intermediate roofs are in poor condition and require replacement as soon as possible.

Existing asphalt shingle roofing is essentially falling apart and sliding off of the roof.
