# **Lambeth Community Health and Wellness**

## **MB McEachren Demolition Analysis Report**

May 2016

**S3AEC + StudioS3AEC**

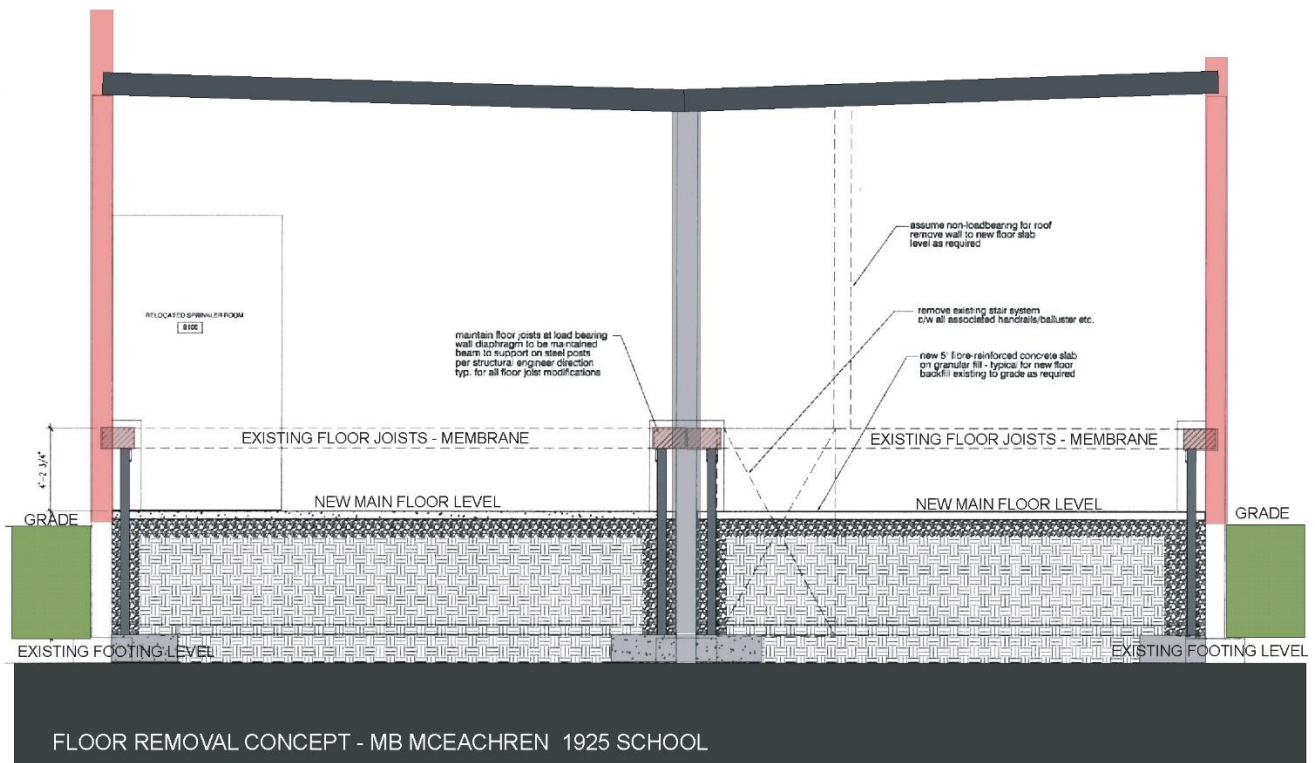
Figure 2.0 Graphic Cross Section of 1925 School

There is significant deterioration primarily to the south and north parapets. The stone copings have failed and over several freeze-thaw cycles, water has penetrated the airspace, frozen and expanded to bow the brick rain screen. The masonry to approximately 3.5 m above grade, on both walls north and south for the entire length, would require a rebuild and tie-back of the masonry to the structure to make them safe and structurally sound. Since the 1925 building is wood framed, further investigation would be required once the exterior materials are removed to determine the extent of structural damage to the exterior skin of the building. We suspect there would be significant damage to the structural integrity of the wall framing due to moisture content, freeze and thaw cycles that over time would cause warping and lead to failure eventually. This is all dependent on the type and quality of sheathing used. Given its age, we can safely assume it is a wood product, and not a fibrous glass product which deflects water.

the building once the masonry is removed we believe the back-up walls will ostensibly need to be dismantled, investigated for integrity and salvaged what can be salvaged, mould remediated, and rebuilt from virtually the main floor level upward.

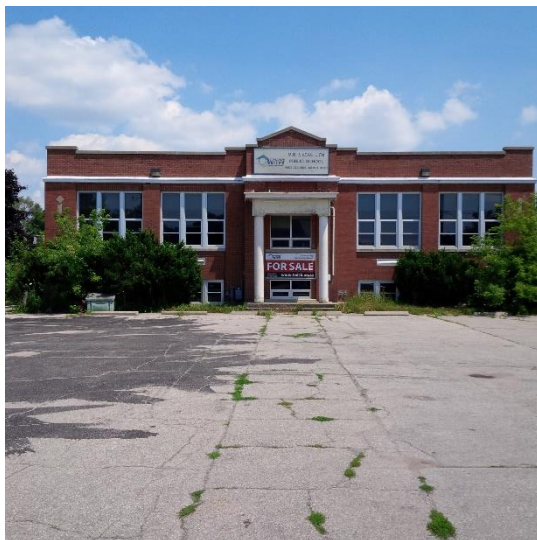
MB McEachren School 1925 c.

corners, the building is not a good example or echo of Beaux Arts style. Beaux Arts has been a style attributed to civic buildings of significance, using limestone as a primary material, not brick. Additionally, Corinthian or Ionic columns tend to adorn the facades of Beaux Arts style buildings, The MB McEachren school falls short on any of these typically iconic features.
