172 Central Ave
Subject Property
Built 1883
“Italianate”
Level 1

Re: Structural Review
Private Residence at 172 Central Avenue
Our file No. 18-15-0142

Unsafe Building – Order to Make Safe

RE: 172 Central Ave Site Inspection

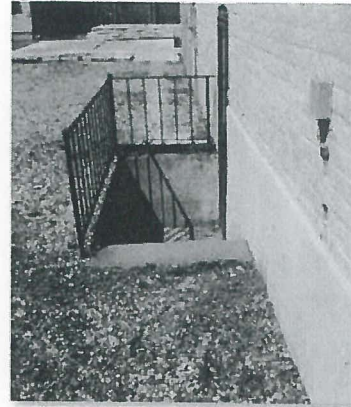
Stair accessing basement; The concrete retaining walls framing around the exterior basement stairs appeared to be in relatively good condition. The top of the retaining wall was noted to be at grade level. Due to the noted grade, water will flow over the retaining wall and down the stairs into the basement. Overtime, improper drainage and grading will result damage to the wall, stair and building foundation.

Image 2: Basement Stair at Grade
(West Side of House)

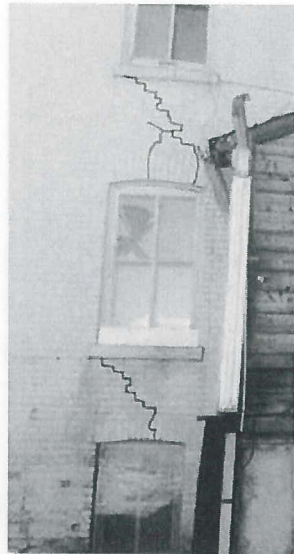
Cracks in the exterior brick were observed at many location including most window and door opening. The cracking was predominantly within the mortar joints however, where windows were stacked between the main floor and second floor, cracks were seen to pass through several bricks. At the rear of the house, cracks in the brick extended from the foundation up to the eave.

Image 6: Rear Brick Wall

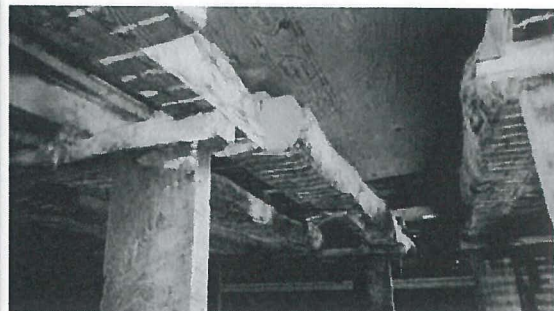
Stud Framing; Stud and headers within interior bearing walls at the front of the house were installed on their flats. At some location, headers and top plate were missing. The stud framing was offset of supporting beams and load bearing wall below. Reworking of the stud framing is required with installation of proper headers to support the floor framing above.

Image 17: Cut joist and stud top plate.

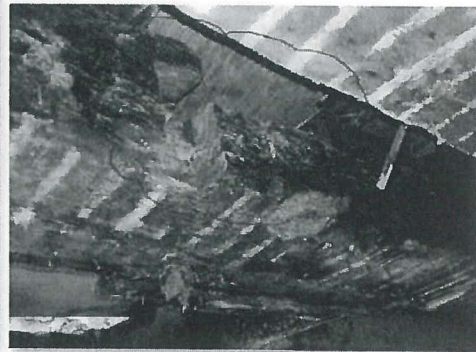
Throughout the second floor framing, several floor joists had longitudinal cracks, in some cases exceeding 1" in width. Joists throughout were seen to be cut, damaged, rotted, charred and in some location with minimal joist depth at bearing points. Spaces between friction joints have developed as the building settles. The current state of the framing requires repair or replacement. Rotting of wood joists were confirmed by drill testing and are not suitable to support the floor loading.

Image 21: Charred and cut joist at rear of house.
