TREE ASSESSMENT REPORT

348 SUNNINGDALE ROAD, LONDON ONTARIO

DECEMBER 2018

**RON KOUDYS
LANDSCAPE
ARCHITECTS INC**

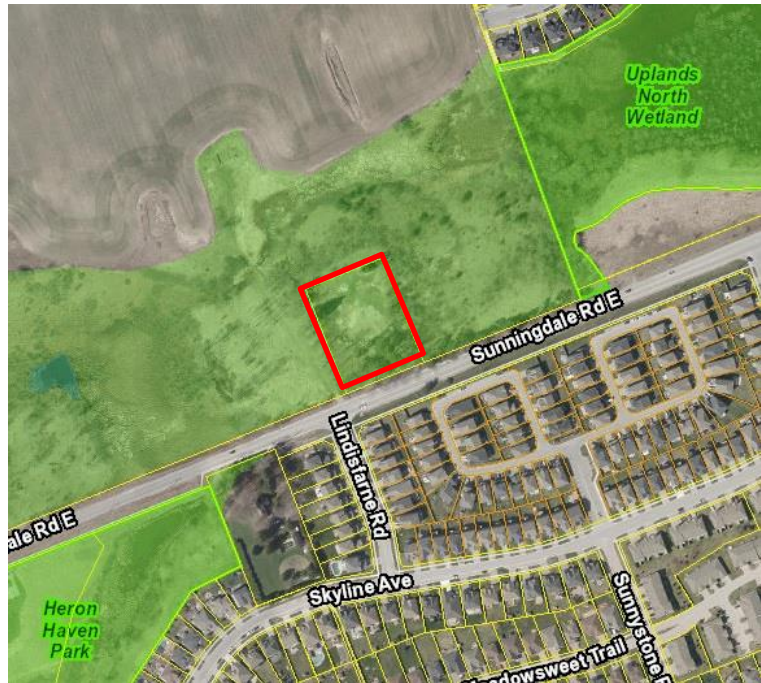
Figure 1: Subject site - from City of London website NTS
Green indicates tree protection area
Red outlines the subject site

Note that the subject site and the land immediately around it is within a tree protection area as defined by the City of London.

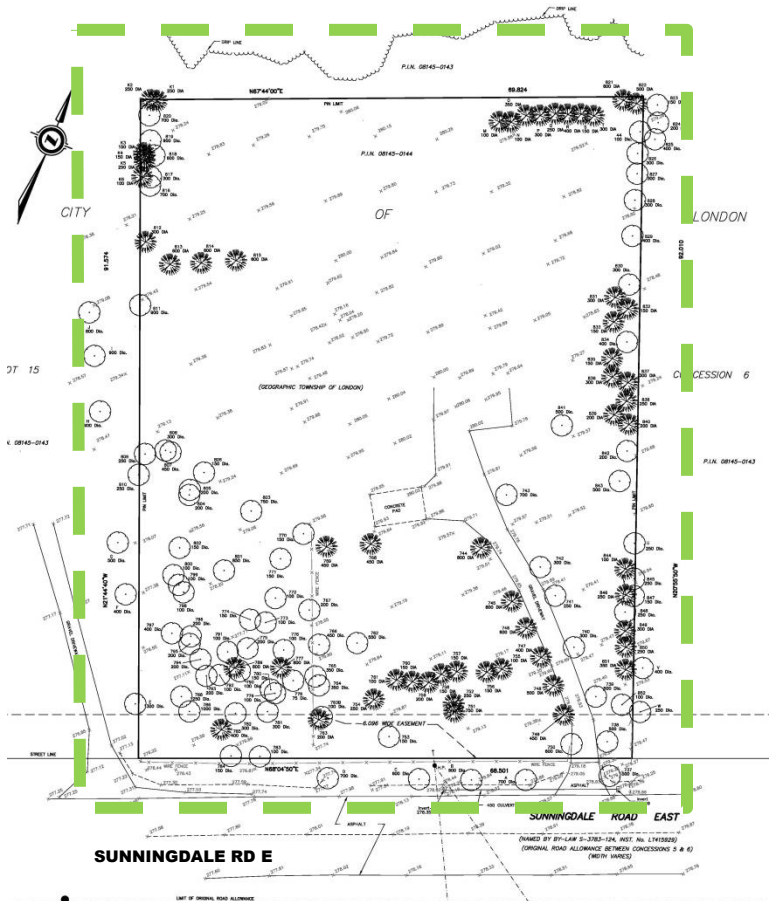
Site survey -The green dashed outline represents the tree inventory scope included in this report. NTS
