161 Windermere Road, EIS

EIS Dated January 24, 2014

Reviewers: N. Bergman, D. Ellis, S. Levin, Dr. C. Smart
March, 2014

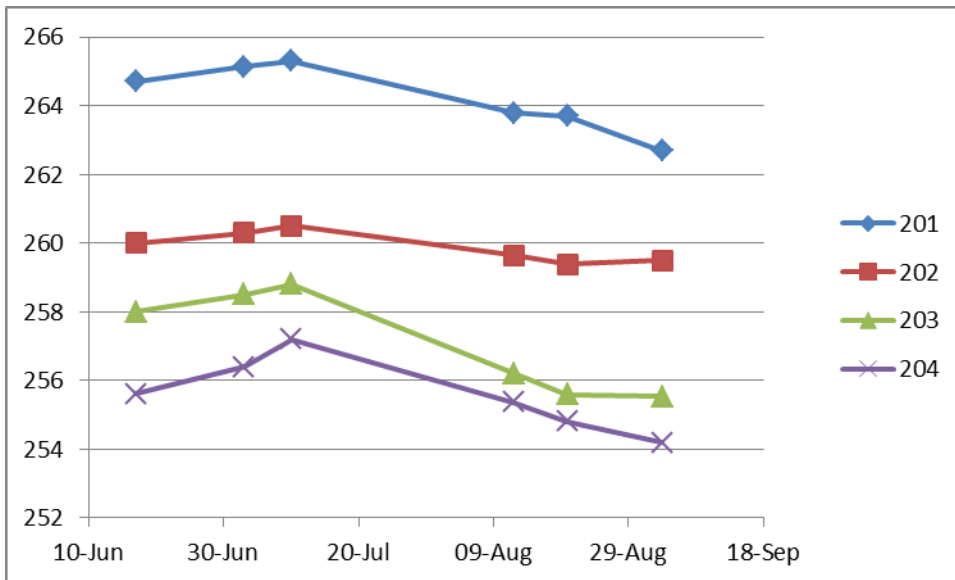
Water levels are reported on the observation wells (Table 2 p.6), but not analysed. Well elevations were only estimated from topographic maps, leaving some uncertainty in the data. Well coordinates were not provided.

The above plot was not provided, although a monthly rainfall plot was provided for some reason. No interpretation or explanation is provided for the trends observed. But the responsiveness confirms that groundwater flow is active at the site. Unfortunately, the finite depths to water are not consistent with the presence of seeps on the site (in which case dtw should $\rightarrow 0$ m). This is problem also requiring explanation.
