TO:	CHAIR AND MEMBERS PLANNING & ENVIRONMENT COMMITTEE PUBLIC PARTICIPATION MEETING ON MONDAY, FEB. 6, 2012
FROM:	JOHN M. FLEMING DIRECTOR, LAND USE PLANNING AND CITY PLANNER
SUBJECT:	REQUEST FOR DEMOLITION 86 CARTWRIGHT STREET KAPLAND CONSTRUCTION

The building at 86 Cartwright Street is a single storey frame cottage style structure located on the east side of Cartwright Street between Princess Avenue and Central Avenue. (Appendix 1) Built circa 1894, it is designated under Section 41 of the Ontario Heritage Act by virtue of its location in the West Woodfield Heritage Conservation District established in 2009. In the background study prepared for the District this building is identified as a category “C” building. Category “C” buildings are described as buildings whose form and massing belong to a “historical category of buildings and who might be considered a good example of a modest design representing the area or repeated in many locations.” Prior to the creation of the West Woodfield District, this building had not been identified as a listed building on the City’s *Inventory of Heritage Resources*.

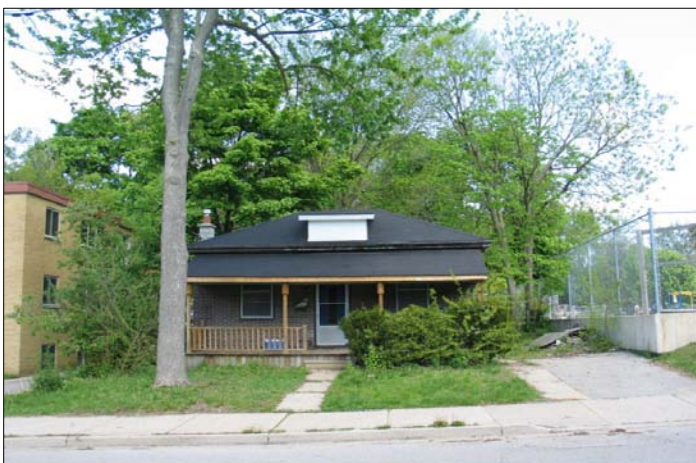
Recent

Appendix 2 Photos: 86 Cartwright

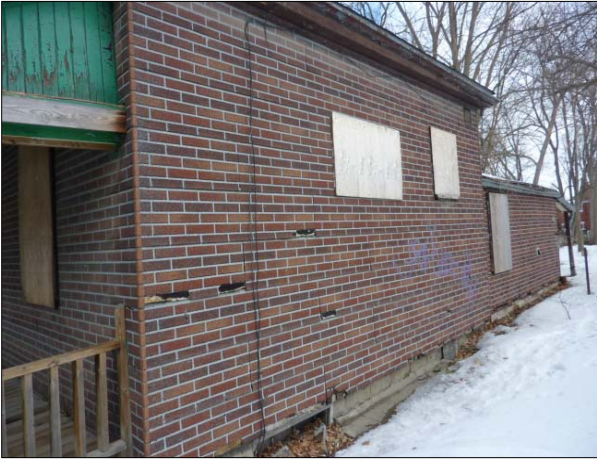
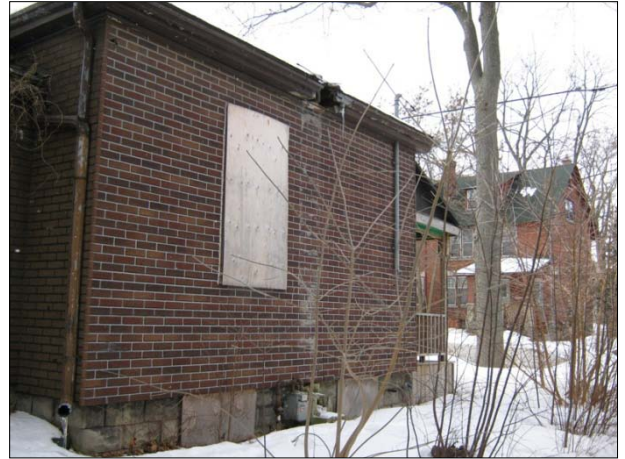
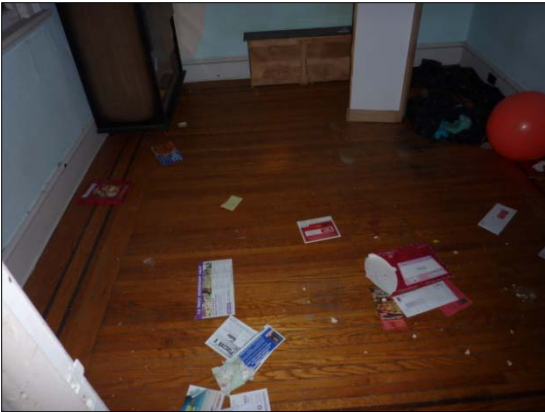
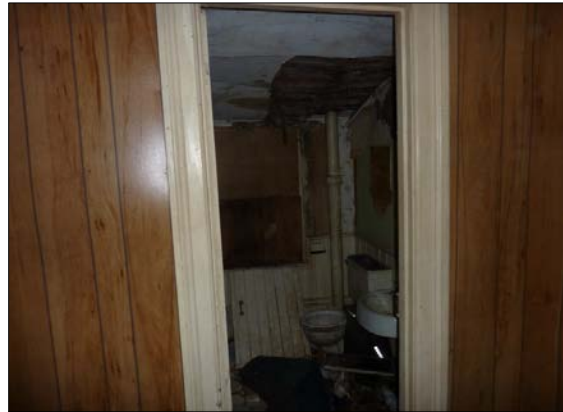
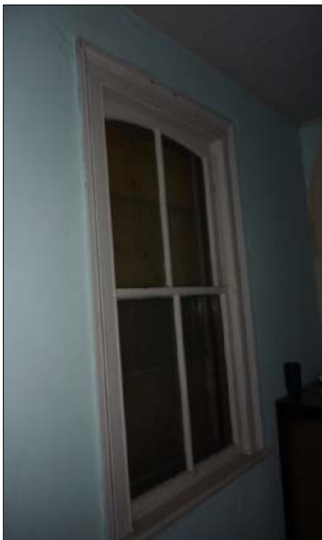
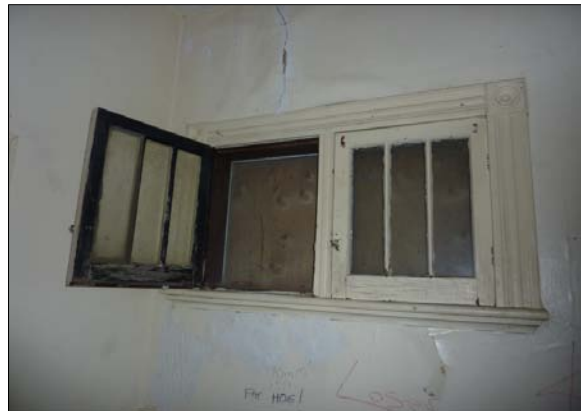
Appendix 2 Continued –Photos -86 Cartwright Street -2010

The single-storey house appeared to be approximately 100 years old with a cottage roof at the front (west side) of the house (Photograph 1) a gable roof in the middle (Photograph 2) and a 'lean-to' addition at the rear. (Photograph 3) The building was clad in an asphalt shingle type material with a brick appearance. Although the front porch deck and railing appeared to be relatively new, the porch canopy was original and framed with 2x4s at approximately 24" on centre. This canopy framing does not meet current OBC requirements. The foundations consisted of hollow concrete block with two window wells on the south side. Although some minor mortar repointing was required in the foundation wall, it appeared to be generally in sound condition. (Photograph 4). No evidence of significant water ingress was observed. The window wells did require some repair and the basement walls required interior insulation to below the frost line (OBC requirement).

The main floor framing appeared to be in good condition; however the central floor beam consisted of a 2x8 member on the flat, which did not meet current OBC requirements. A walk out from the basement was boarded-up; however this could be corrected by installation of an insulated door. The roof framing was not observed, however the main cottage roof appeared to be in good condition with no dips or deflections observed. The asphalt shingle on the cottage and gable roofs were in good condition. The gable roof framing also appeared to be in good condition, other than a dip in the roof at the south east corner above an overhang. Upon closer examination, we noted that dip in the roof was a deliberate framing technique. The 'lean-to' roof framing at the rear of the building, however, was in poor condition as demonstrated by the large sag in the roof. The paint of the 'lean-to' was also in very poor condition. Interior partitions were in fair to good condition, with peeling paint and cracks in the plaster in several locations. A portion of the lath and plaster ceiling in the bathroom was broken and sagging (Photograph 5). The interior of the building in general was strewn with debris and 'junk' and required cleaning, patching and painting.

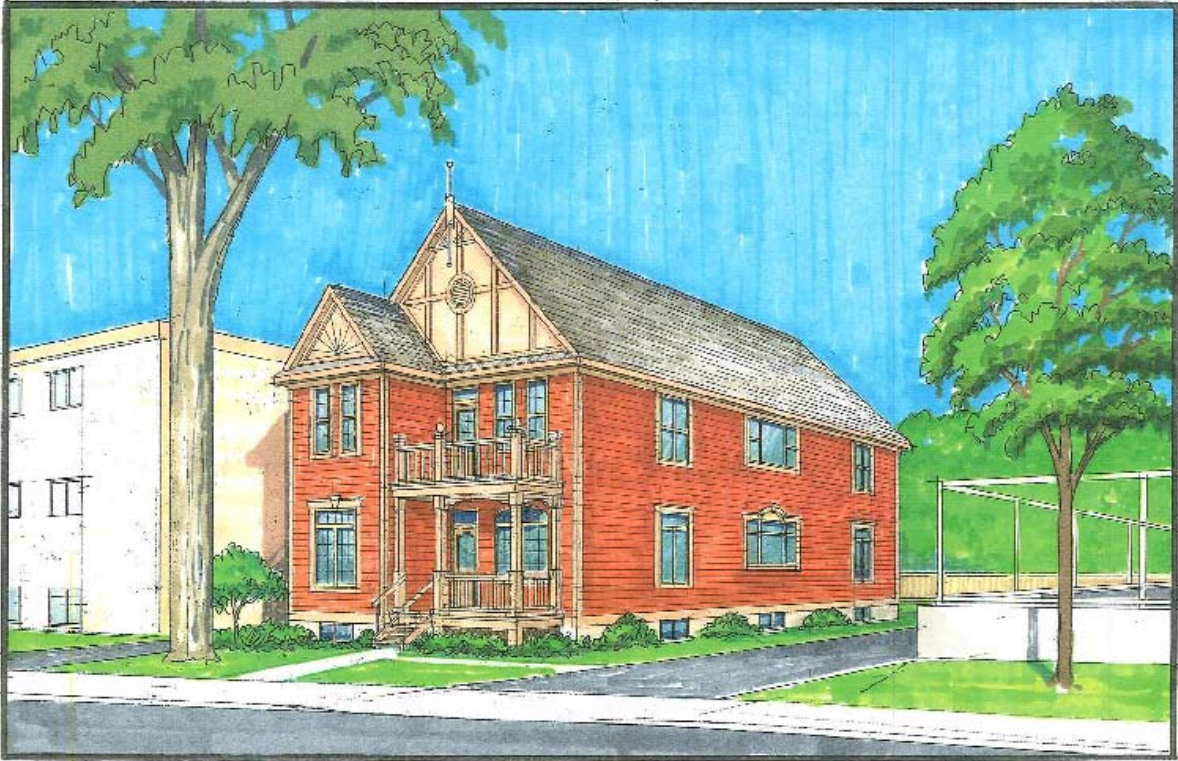
Appendix 4: Concept Drawing of Proposed New Build

PROPOSED BUILDING 86 CARTWRIGHT ST. LONDON

Nov 2011

The dilemma posed by this request for demolition was evident for members of the Advisory Committee on Heritage as it considered this matter at its meeting on January 11, 2012. After a wide ranging discussion, the LACH recommended to Council that it not oppose the demolition provided the new building to be constructed on the site conformed to the concept drawing shown at the meeting by the applicant.
