то:	CHAIR AND MEMBERS LONDON ADVISORY COMMITTEE ON HERITAGE WEDNESDAY DECEMBER 9, 2015
FROM:	JOHN M. FLEMING MANAGING DIRECTOR, PLANNING AND CITY PLANNER
SUBJECT:	HERITAGE ALTERATION PERMIT APPLICATION: M. PEPPER, 281 GROSVENOR STREET

The purpose of the recommended action is to permit the alteration of a property located within the Bishop Hellmuth Heritage Conservation District (HCD), in accordance with Section 42 (2.1) of the *Ontario Heritage Act*.

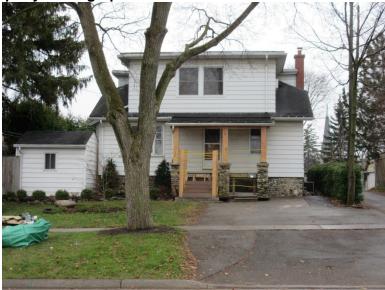
Image 1: 281 Grosvenor Street (December 1, 2015).

The building located at 281 Grosvenor Street is a detached, one-and-a-half storey house (Appendix B). 281 Grosvenor Street demonstrates influences from the Craftsman Style, particularly in its horizontal emphasis, hipped gable roof, and shed dormers. Part of the foundation of 281 Grosvenor Street is clad in applied field stone, as are the three column plinths of the porch. Previously, the porch had plain wooden posts, painted white, with vertical balustrade/skirting set below a top handrail, wooden steps with a metal hand railing, and what appears to have been wooden tongue-and-groove porch flooring.

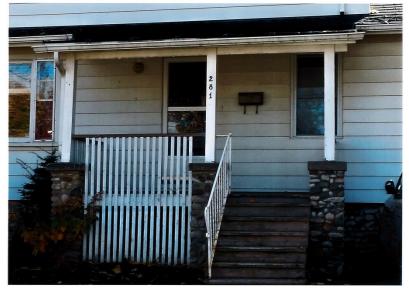
Image 2: Detail of porch at 281 Grosvenor Street, prior to alteration (submitted by applicant).

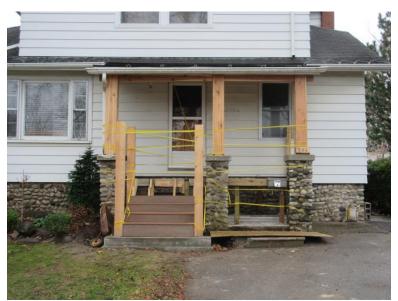
Image 3: Detail of porch at 281 Grosvenor Street (December 1, 2015).

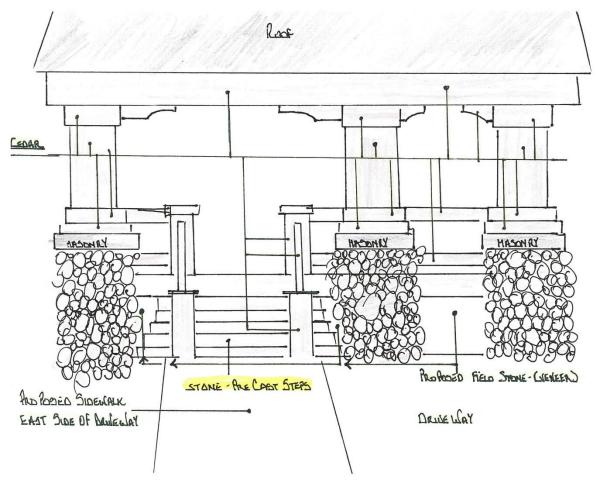
Image 1: North elevation of new porch (submitted by applicant). Note: not to scale.

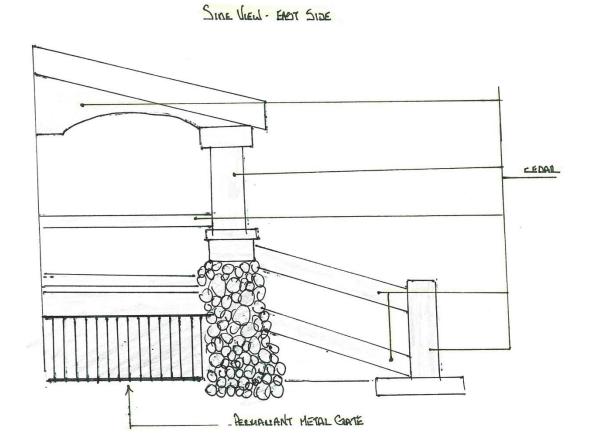
Image 2: East elevation of new porch (submitted by applicant). Note: not to scale.

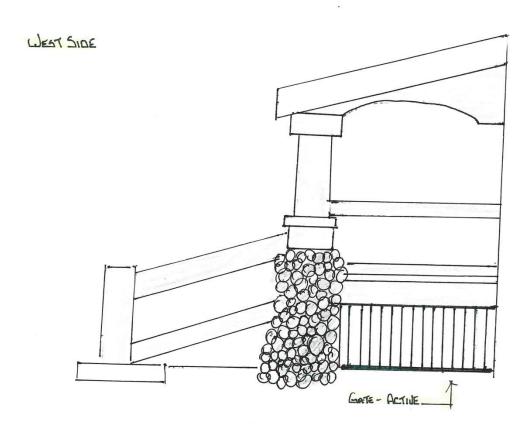
Image 3: West elevation of new porch (submitted by applicant). Note: not to scale.

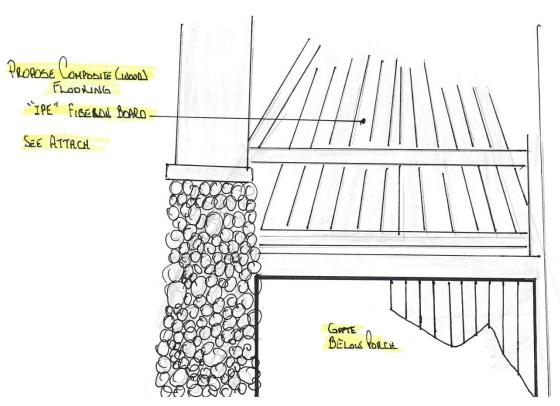
FLOOR BOARDS - WEST SIDE

Image 4: Detail of porch flooring (submitted by applicant). Note: not to scale.

Porch Maintenance			
Element	Bishop Hellmuth HCD Guidelines	Assessment	
Floor Boards	These are prone to extreme weathering and wear, particularly the outer ends above the header board. Replace only those boards, or parts thereof, and fit in to match the original.	The proposed "Fiberon Horizon" composite deck material is not compatible. The <i>Bishop Hellmuth HCD Guidelines</i> discourage materials that mimic authentic, historic materials.	
	If the entire floor needs replacement, consider Douglas fir, which is the hardest softwood, with a dense close grain.	Tongue-and-groove wood, such as Douglas fir, 7/8" deep and 6" wide, should be used for the porch floor.	
Skirting	Being close to the ground, porch skirtings are susceptible to deterioration. Ensure a minimum clearance to the ground of 3". Keep foundation planting back by 3' for breathing and drying of the understructure.	The proposed metal grate and applied field stone veneer is compatible, particularly noting the existing field stone piers. The field stone veneer should be recessed from the field stone piers to provide dimension to the porch skirt.

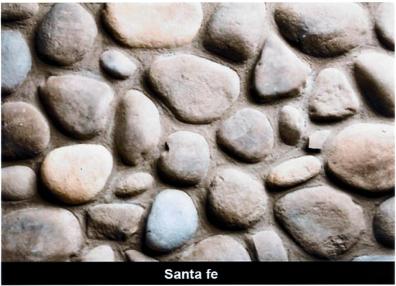
Image 6: Proposed field stone veneer material for porch skirting (submitted by applicant).

- a. All exposed wood be painted or stained following the appropriate weathering period;
- b. Tongue-and-groove wood be used for the porch floor;
- c. The field stone veneer should be recessed from the field stone piers to provide dimension to the porch skirt;
- d. Wooden spindles be used, approximately 1-3/4" square set apart 3-1/2" on centre, between a wooden top and bottom rail:
- e. Photographic documentation of the alteration and addition be submitted to the Heritage Planner upon completion of the work;
- f. Display of a Heritage Alteration Permit in a location visible from the street until the work is completed.

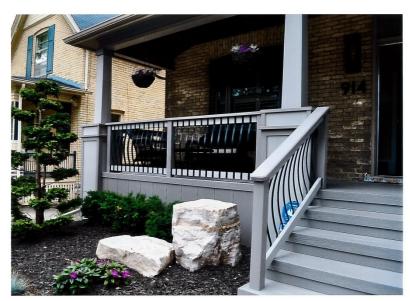
Image 7: Proposed metal spindles for porch (submitted by applicant).

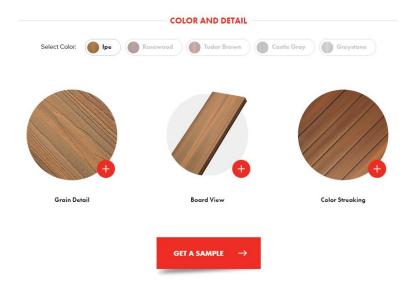
Image 8: Fiberon Horizon capped composite decking – Ipe colour (retrieved from <a href="https://www.fiberondecking.com">www.fiberondecking.com</a>).

- The proposed "Fiberon Horizon" composite decking be replaced by wood, tongue-and-groove board flooring that is painted or stained. Wood tongue-and-groove board is historically appropriate and compatible with the *Bishop Hellmuth HCD Plan & Guidelines*;
- The field stone veneer be recessed from the field stone piers to provide dimension to the porch skirt. A few inches (~3") would be sufficient to articulate this rhythm;
- The proposed metal spindles be replaced by wooden spindles, approximately 1-3/4" square set apart 3-1/2" on centre, between a wooden top and bottom rail. Wood must be used because the physical goals of the *Bishop Hellmuth HCD Plan* support the replication of historic elements, rather than replacement with new materials with limited historic precedence in the Bishop Hellmuth HCD.
