TO:	CHAIR AND MEMBERS LONDON ADVISORY COMMITTEE ON HERITAGE MEETING ON WEDNESDAY DECEMBER 14, 2016
FROM:	JOHN M. FLEMING MANAGING DIRECTOR, PLANNING AND CITY PLANNER
SUBJECT:	HERITAGE ALTERATION PERMIT APPLICATION AT 309-311 WOLFE STREET, WEST WOODFIELD HCD BY: NELMS GROUP LTD.

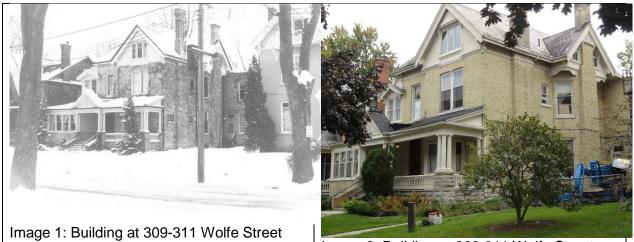
Image 1: Building at 309-311 Wolfe Street (c.1977)

Image 2: Building at 309-311 Wolfe Street (October 11, 2016).

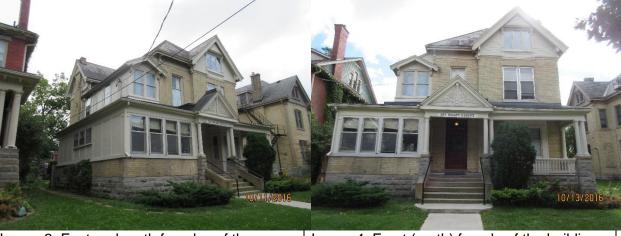
Image 3: East and north facades of the building at 309-311 Wolfe Street.

Image 4: Front (north) façade of the building at 309-311 Wolfe Street.

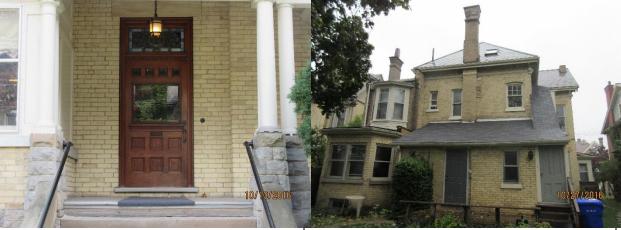
Image 5: Front door and transom.

Image 6: South (rear) façade of the building at 309-311 Wolfe Street.

No alterations to the existing front door and transom with stained glass are proposed or permitted.

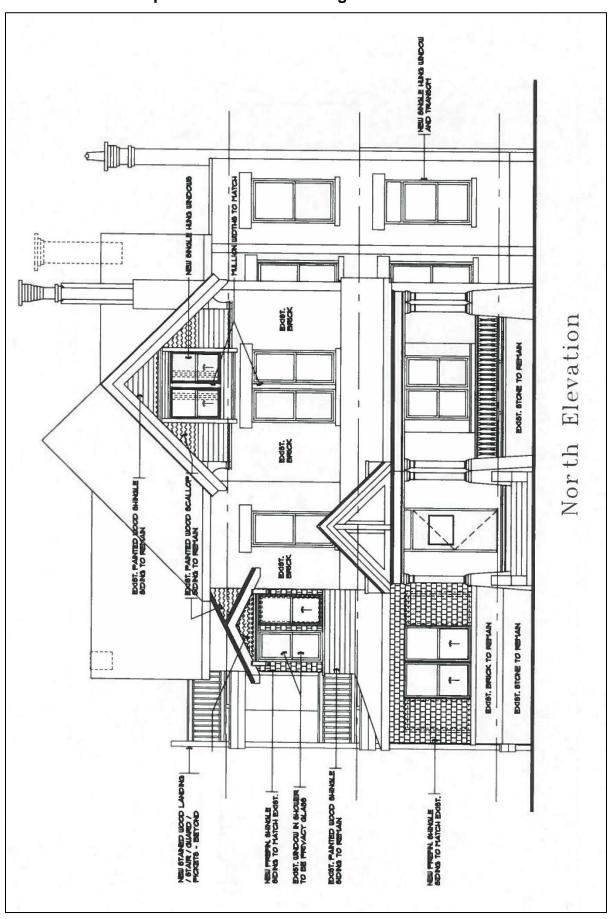
Figure 1: North elevation of 309-311 Wolfe Street (provided by the applicant as part of the Heritage Alteration Permit application).

The applicant has proposed to replace the existing three casement windows of the north gable with a pair of sash windows, more in keeping with the historic character of the building. The existing casement windows are not historic, and the proposed replacement would be closer aligned to the historic window style. The historic photograph of the property indicate a triplet of windows was located in the gable, which appear to be sash windows (see Image 1, Appendix B). The replacement of the existing casement windows with a pair of sash windows with a wooden mullion detailing is more compatible; a triplet of sash windows with wooden mullion detailing is more historically appropriate and should be considered.

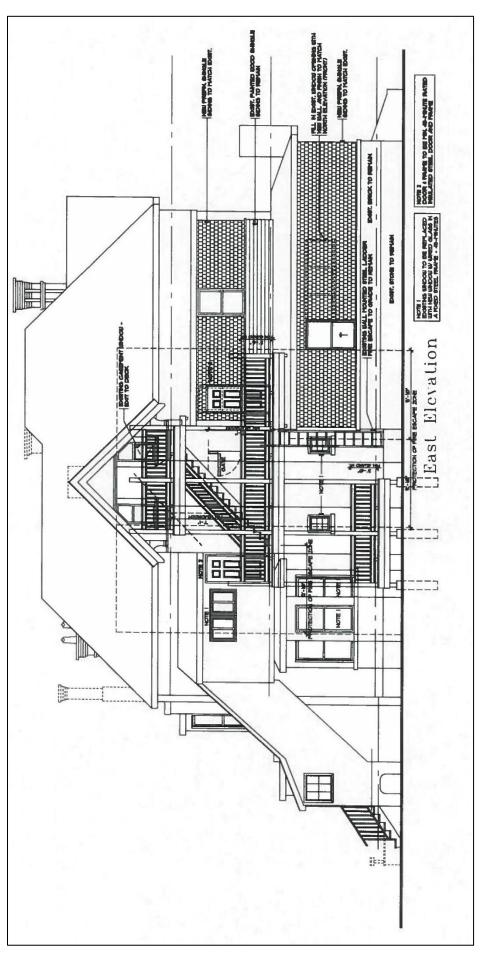
Figure 2: East elevation (provided by the applicant as part of the Heritage Alteration Permit application).

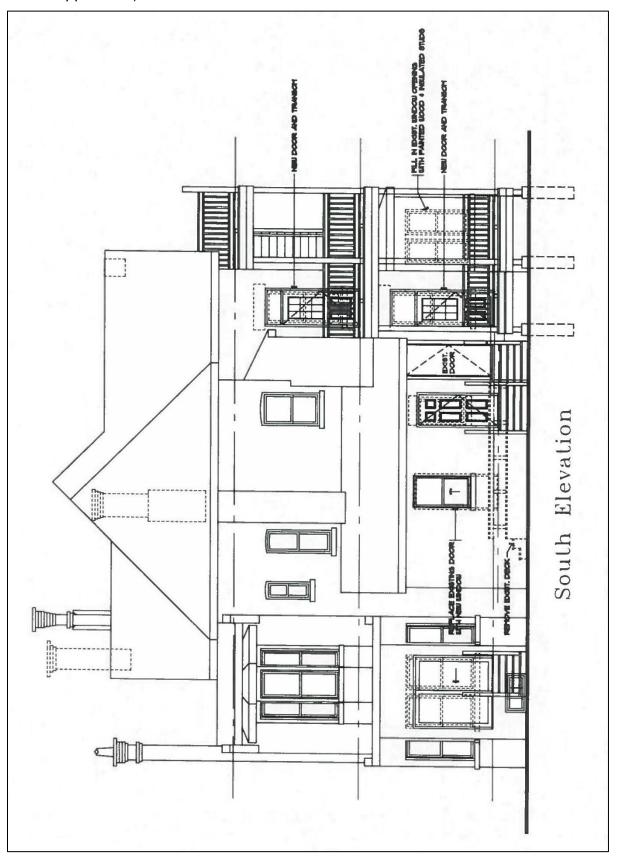
Figure 3: South elevation (provided by the applicant as part of the Heritage Alteration Permit application).

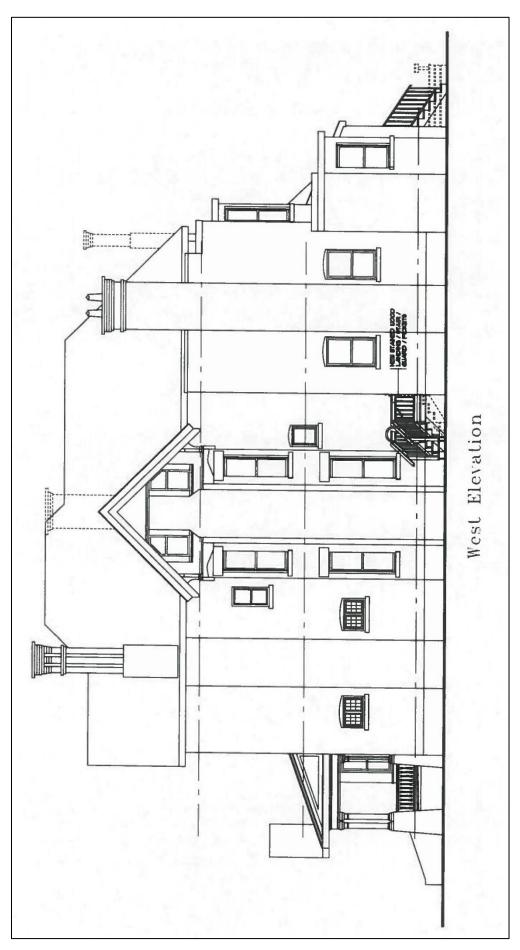
Figure 4: West elevation (provided by the applicant as part of the Heritage Alteration Permit application).

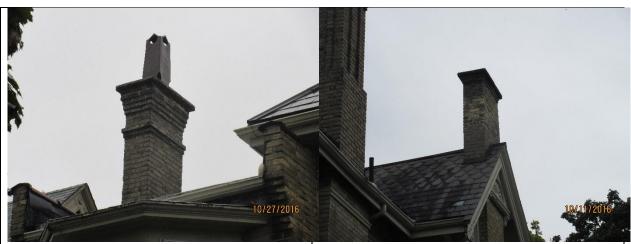
Image 1: Chimney 1: southwest corner of the building at 309-311 Wolfe Street.

Image 2: Chimney 2 (centre): west façade of the building at 309-311 Wolfe Street.

- Chimney 1: Furthest west chimney on building with decorative brick collar detailing and elongated chimney cap (see Image 1, Appendix D);
- Chimney 2: Unadorned "service" chimney located at the peak of the cross gable on the west façade (see Image 2, Appendix D);
- Chimney 3: Visually prominent chimney on the west façade, most clearly seen from Wolfe Street. Corbelling detailing on the chimney identifies Chimney 3 as the most decorative of the five chimneys (see Image 3, Appendix D);
- Chimney 4: Previously lowered chimney, remains of which can be seen at the peak of the cross gable on the east façade (see Image 4, Appendix D);
- Chimney 5: Located on the south façade of the building, this chimney is not visible from the street. Its detailing is modest with collar brickwork (see Image 5, Appendix D).

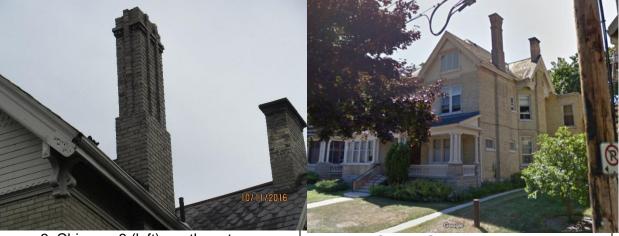
Image 3: Chimney 3 (left): northwest corner of the building at 309-311 Wolfe Street. Note the removed cap.

Image 4: GoogleStreetview showing Chimney 3 at 309-311 Wolfe Street prior to alteration (July 2016).

- a. Restoration work be completed within one year to Chimney 3 (as identified in the Appendix D) to its full historic height and detailing using compatible buff brick material and lime-based mortar;
- b. The applicant be encouraged to consider a triplet of sash windows with wooden mullion details for the north gable window replacement;
- c. The addition of the fire escapes be constructed as reversible interventions;
- d. All exposed wood be painted or stained; and,
- e. The Heritage Alteration Permit be displayed in a location visible from the street until the work is completed.

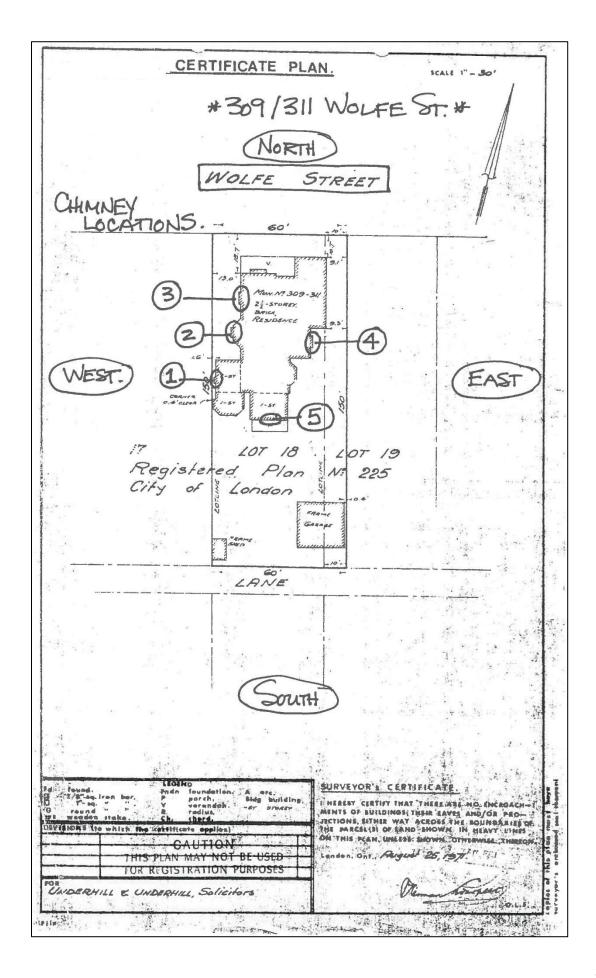
Figure 1: Chimney Schedule (provided by the applicant as part of the Heritage Alteration Permit application).

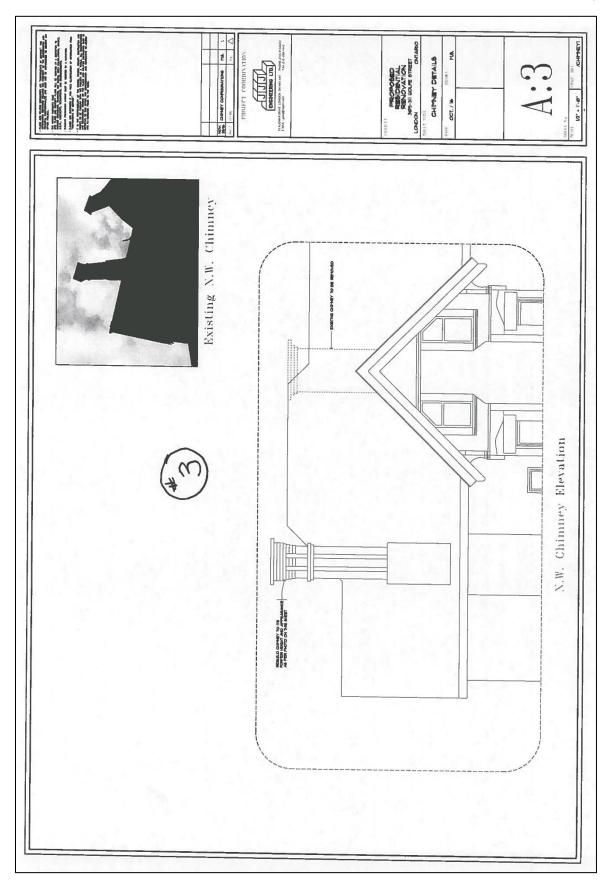
Figure 2: Note for Chimney 3 (left): "Rebuild chimney to tis former height an appearance as per photo on this sheet." Note for Chimney 2 (right): "Existing chimney to be removed."
