Report to London Advisory Committee on Heritage

Subject: Heritage Alteration Permit application by P. Scott at 40 & 42
 Askin Street, By-law No. L.S.P.-2740-36 and Wortley Village-
 Old South Heritage Conservation District

Meeting on: Wednesday February 12, 2020

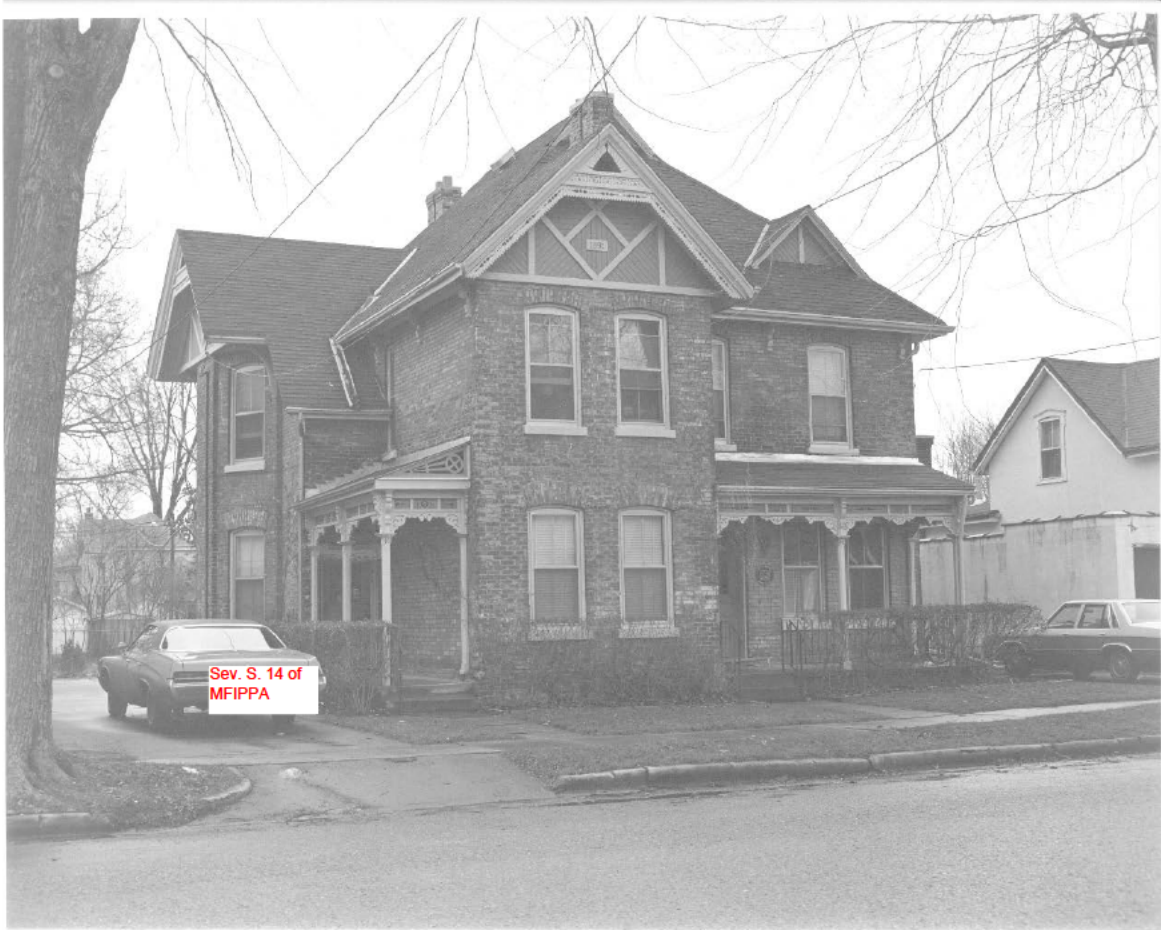
Image 1: Photograph of the properties at 40 & 42 Askin Street (1985).

The windows of the semi-detached dwelling are wood, two-over-two true divided light sash windows, with a segmented arch upper sash. Rectangular aluminum storm windows have been applied over the original windows; the aluminum storm windows can be seen on the 1985 photograph of the property (see Appendix B, Image 1).

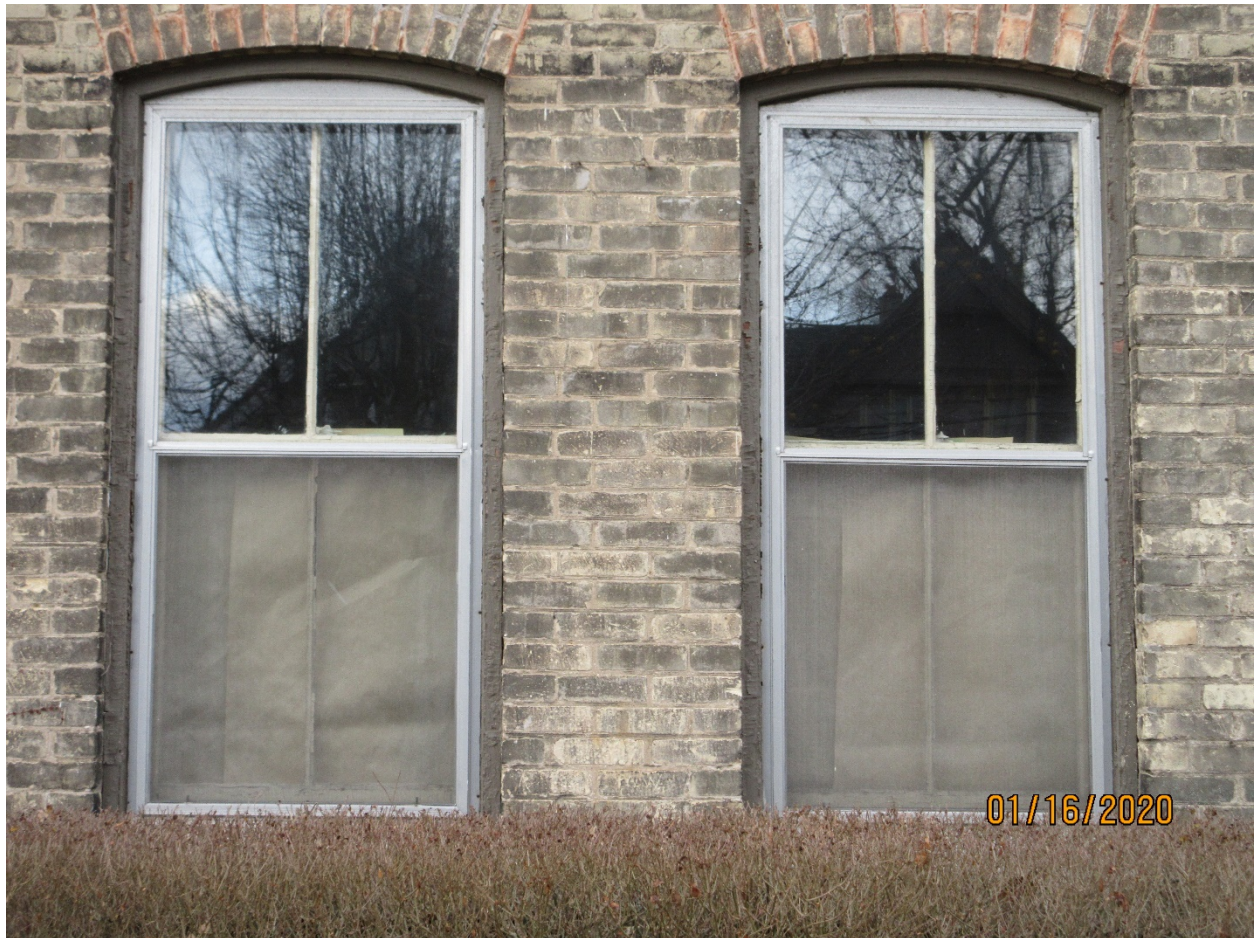
Image 5: Detail photograph of the exterior of the front windows (facing Askin Street) on the property at 40 Askin Street.

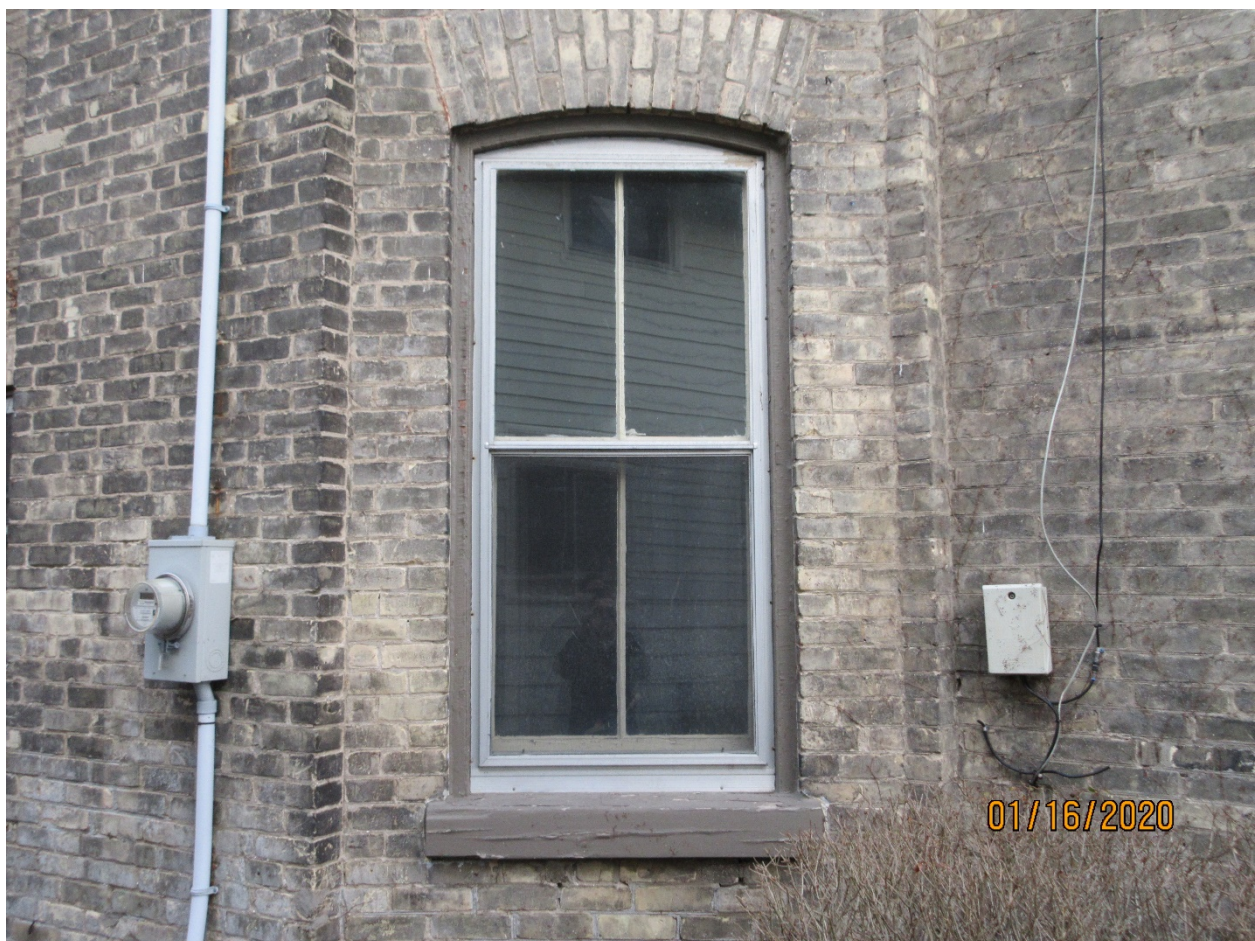
Image 6: Detail photograph of the exterior of the window on the easterly bay on the property at 40 Askin Street.

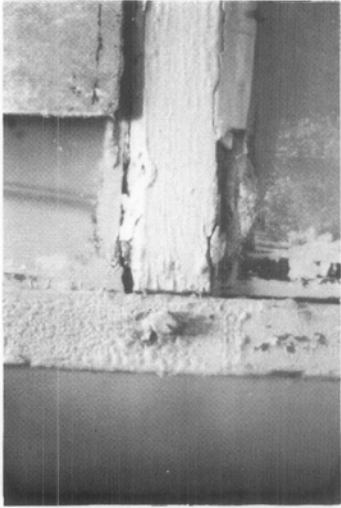
Figure 4a. The following series of photographs of the repair of a historic double-hung window use a unit which is structurally sound but has many layers of paint, some cracked and missing putty, slight separation at the joints, broken sash cords, and one cracked pane. Photo: John H. Myers

The routine maintenance required to upgrade a window to "like new" condition normally includes the following steps: 1) some degree of interior and exterior paint removal, 2) removal and repair of sash (including reglazing where necessary), 3) repairs to the frame, 4) weatherstripping and reinstallation of the sash, and 5) repainting. These operations are illustrated for a typical double-hung wooden window (see figures 4a-f), but they may be adapted to other window types and styles as applicable.

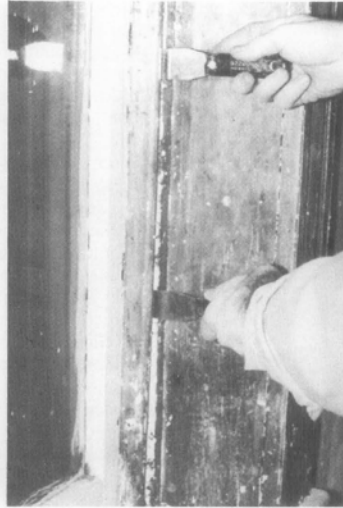
Figure 4b. After removing paint from the seam between the interior stop and the jamb, the stop can be pried out and gradually worked loose using a pair of putty knives as shown. To avoid visible scarring of the wood, the sash can be raised and the stop pried loose initially from the outer side. Photo: John H. Myers

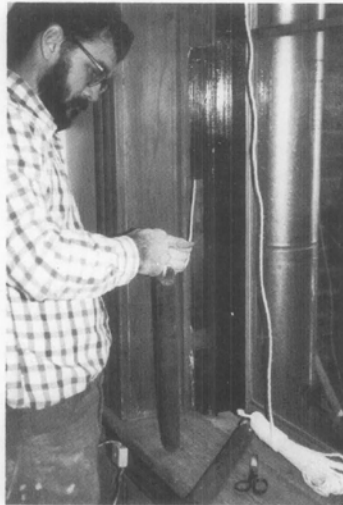
Figure 4e. A common repair is the replacement of broken sash cords with new cords (shown) or with chains. The weight pocket is often accessible through a removable plate in the jamb, or by removing the interior trim. Photo: John H. Myers

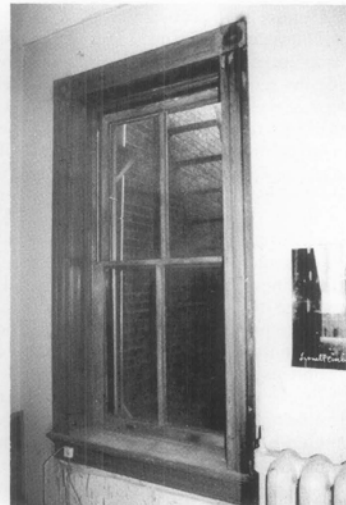
Figure 4f. Following the relatively simple repairs, the window is weathertight, like new in appearance, and serviceable for many years to come. Both the historic material and the detailing and craftsmanship of this original window have been preserved. Photo: John H. Myers

The operations just discussed summarize the efforts necessary to restore a window with minor deterioration to "like new" condition (see figure 4f). The techniques can be applied by an unskilled person with minimal training and experience. To demonstrate the practicality of this approach, and photograph it, a Technical Preservation Services staff member repaired a wooden double-hung, two over two window which had been in service over ninety years. The wood was structurally sound but the window had one broken pane, many layers of paint, broken sash cords and inadequate, worn-out weatherstripping. The staff member found that the frame could be stripped of paint and the sash removed quite easily. Paint, putty and glass removal required about one hour for each sash, and the reglazing of both sash was accomplished in about one hour. Weatherstripping of the sash and frame, replacement of the sash cords and reinstallation of the sash, parting bead, and stop required an hour and a half. These times refer only to individual operations; the entire proc-

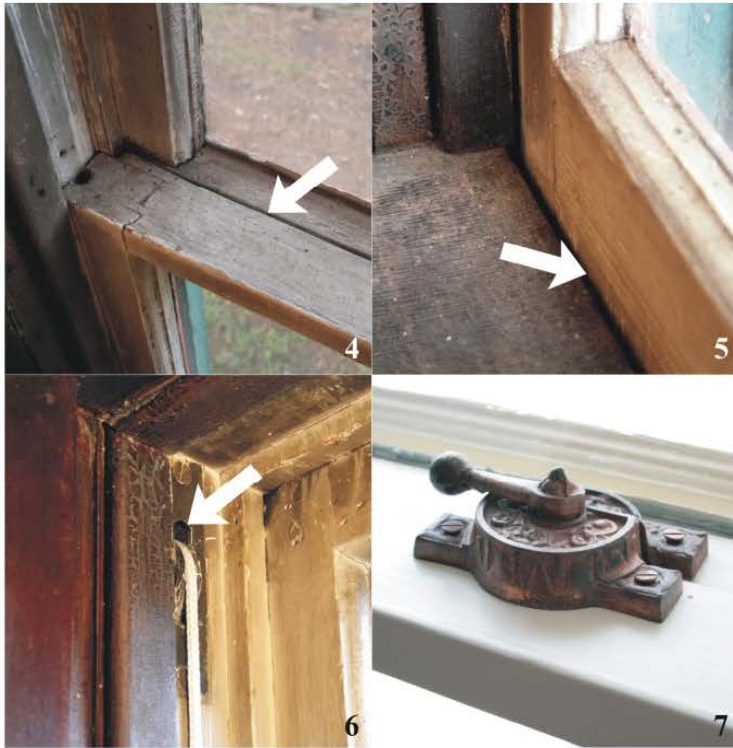
Another area for air infiltration is at the meeting rails (**see Image 4**) and where the lower sash rests behind the stool (**see Image 5**) and at the weight pulley (**see Image 6**).

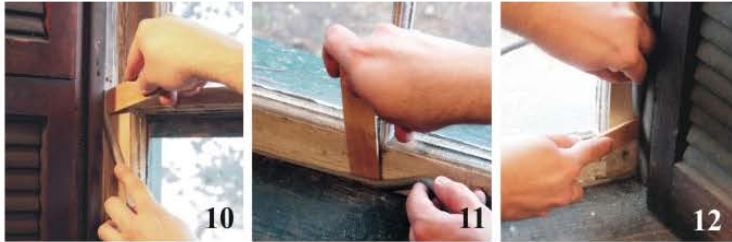
I am using a 3/8" diameter backer rod, starting on the left side of the stop at the meeting rail and running the rod down and across the stool and up to the right side meeting rail (**see Images 10, 11 & 12**). The results are amazing. This will completely stop the air infiltration, and if the space is bigger, the backer rods are available in many sizes starting at a 1/4" diameter.

The areas located at Images 3 and 5 are the most notorious air infiltration points. I take care of these areas using a modern product. However, it will not damage the window in any way and can be installed in minutes! Foam backer rods (available at your local hardware store) can easily be pushed into the gap at the interior stop and at the stool, effectively stopping draft in its tracks. The backer rod is pushed into place using a wooden shim I have fashioned with soft rounded edges that does not damage the surrounding wooden surfaces or tear the backer rod (**see Image 9**).

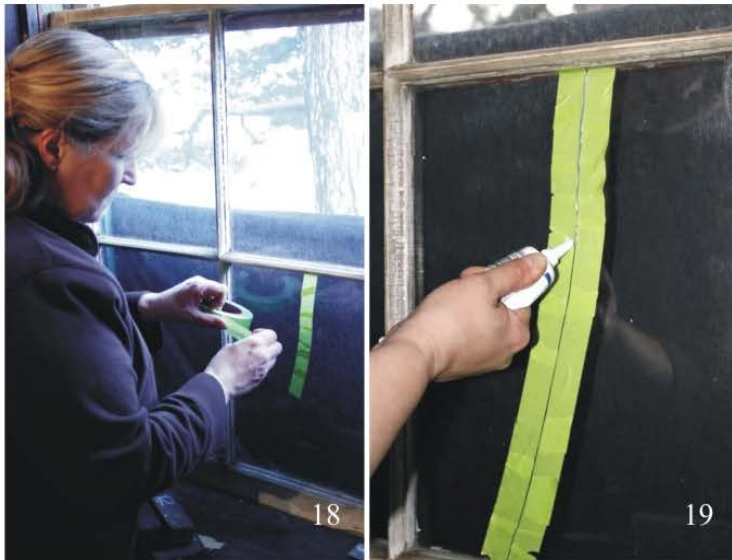
My apprentice, Janet, demonstrates placing masking tape on both sides of the window crack on the interior side of the window before using the silicone (**see image 18**). Approximately a sixteenth of an inch on either side of the crack is needed. For wavy or arched cracks, use a 2-inch-wide roll of masking tape and use a razor to trim away an eighth of an inch swath where the crack is; this will allow a smoother appearance. This step with the masking tape can be skipped if appearance is not a concern. Janet then simply runs a bead of silicone over the crack between the masking tape (**see image 19**).

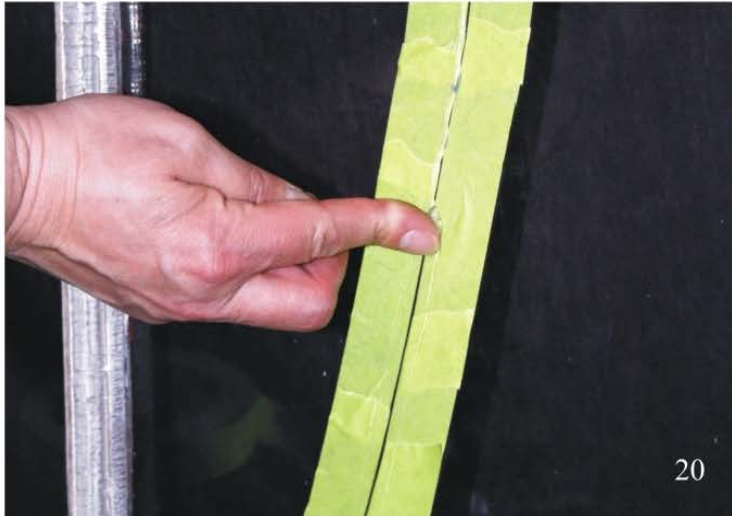
Then, with a moistened finger, Janet smooths out the silicone (**see image 20**). After the silicone is smoothed out, the masking tape is removed carefully so as not to ruin the uncured silicone (see image 21). Allow the interior repair to cure overnight and follow the same process as above on the exterior side of the glass.
