| TO: | CHAIR AND MEMBERS CIVIC WORKS COMMITTEE MEETING ON APRIL 8, 2013 |
| FROM: | EDWARD SOLDO, P. ENG. DIRECTOR, ROADS & TRANSPORTATION |
| SUBJECT | PEDESTRIANS CROSSING RICHMOND STREET AT PICCADILLY STREET |

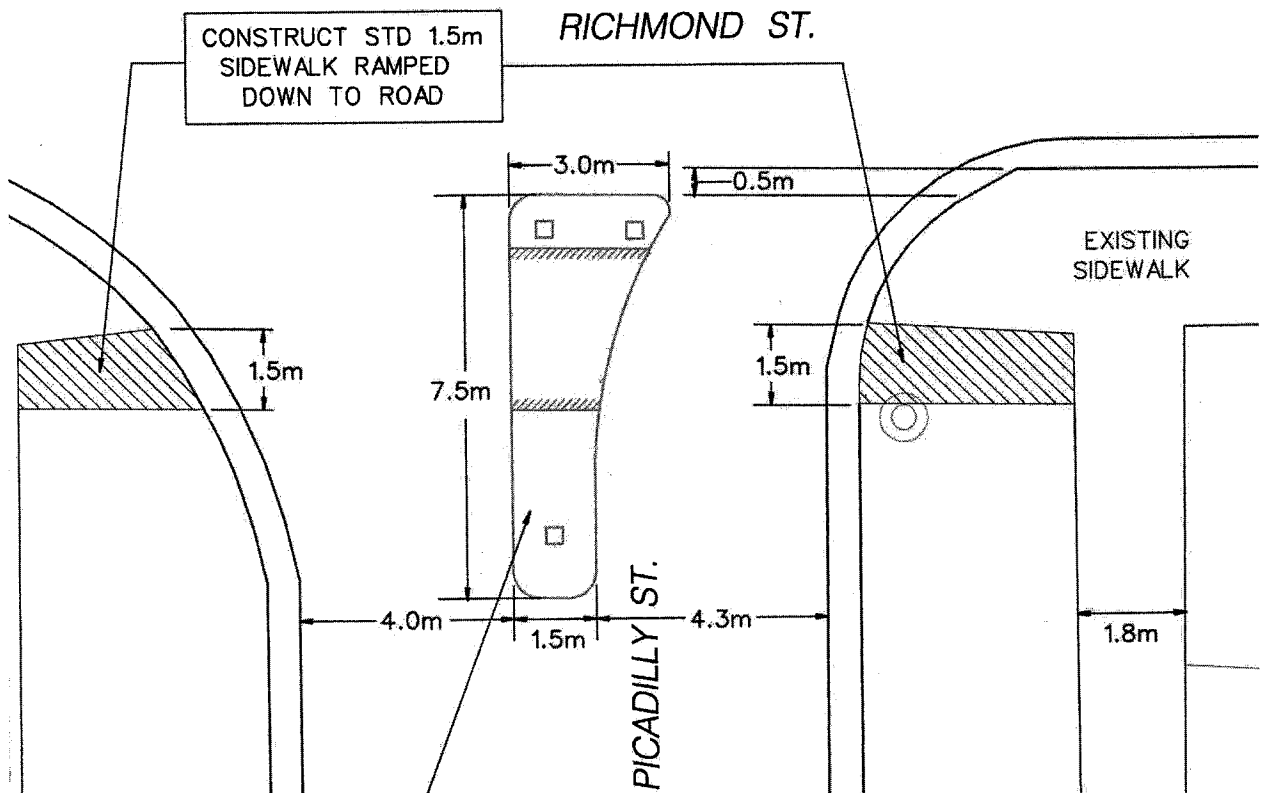
The intersection is currently signed prohibiting left-turns from Piccadilly Street and through movements; however, drivers continue to disobey the restrictions. In order to mitigate the number of collisions and ensure compliance with the restrictions, an island (shown below) is schedule to be constructed this year on the east side of Richmond Street at Piccadilly Street that would physically prohibit westbound vehicles from turning-left or crossing Richmond Street. This accounts for 10 of the collisions (43%) which should improve safety for both vehicles and pedestrians.

Taking into consideration the pedestrian volumes and impact that a pedestrian signal would have on the flow of traffic on Richmond Street, the installation of an IPS is not recommended. The installation of the right-turn island at the Piccadilly Street/Richmond Street intersection will reduce the severity of collisions at the intersection and should improve safety for pedestrians.
