SECTION 1 - INTRODUCTION

1.1 Purpose of Heritage Impact Assessment

The lands located at 850 Highbury Avenue North have a Heritage Conservation Easement registered on the property as well as a part IV designation under the Ontario Heritage Act.

CONSERVATION PLAN FINAL

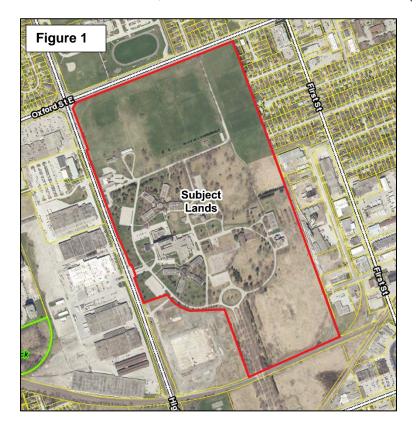
The subject lands are a generally rectangular parcel with frontage on Highbury Avenue, and Oxford Street East. The subject lands have an area of 58.13 hectares (143.64 acres) with a frontage of 730.4 m (2,395.0 ft) along Highbury Avenue North, and frontage of 584.9 m (1,919.0 ft) along Oxford Street East. The subject lands also have potential vehicular access to Howland Avenue, and Rushland Avenue to the east (Figure 1).

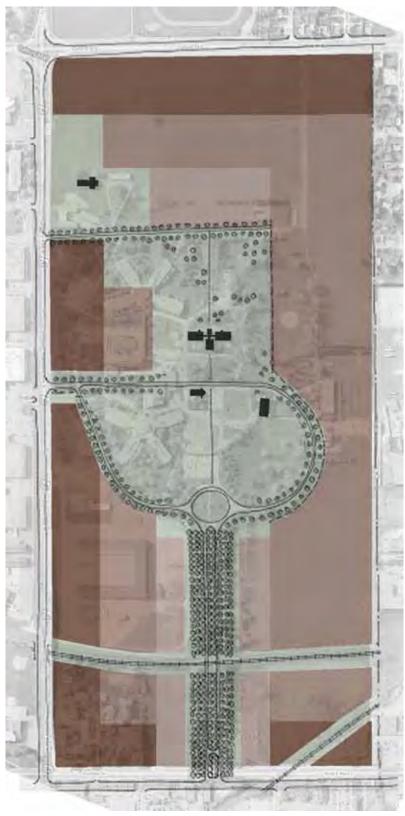
Proposed redevelopment of London site, including preservation of existing heritage resources. Shading is used to indicate progressively higher height limits.

The attached plan shows the recommendations for the site overlaid on the existing site conditions. The shading indicates the proposed gradation in recommended building heights. The development areas are designed not only to protect the existing buildings, but also their landscape settings and the visual connections between them.

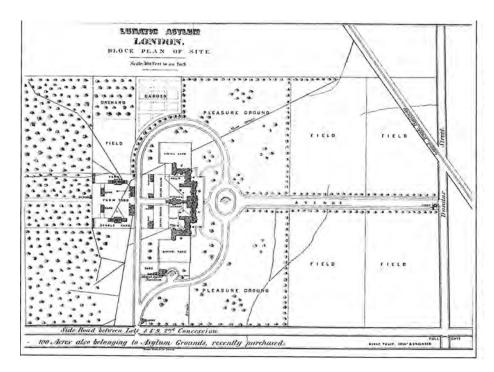
Site plan, 1869, from the Report of the Commissioner of Public Works

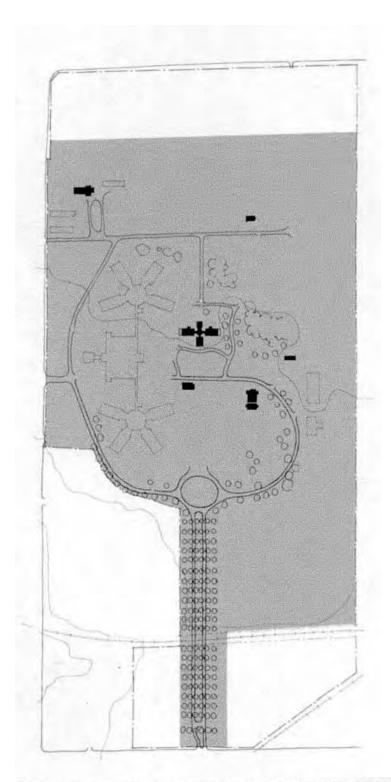
Dark grey zone indicates cultural landscape of provincial significance.

Significant buildings within the designated cultural landscape (listed clockwise starting at the far left)Horse Barn B12035Recreation Hall B12029Infirmary Building B12018Potting Shed B17057Chapel B12019

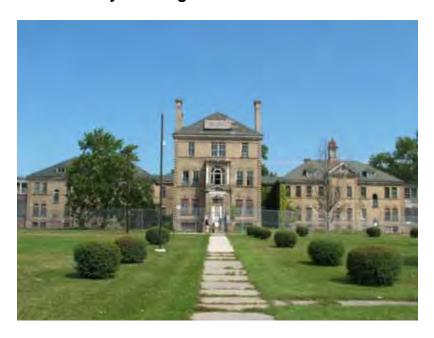
South Elevation, 2008

The building has a central administration block with two symmetrical wards on either side, used to house patients by gender. The central block is three stories high, on a raised basement. Its silhouette is marked by tall chimneys on its east and west walls. It has a hipped roof with a central skylight to light the operating theatre, and decorative projecting bays on the front and side elevations.

The 2-storey wings housing the wards are connected to the central block by a narrow corridor and small central pavilion. The wings are completely symmetrical and echo the stylistic cues of the main block, with paired windows, pedimented bays and arched windows at feature locations. There is a bellcast cupola centrally located at the apex of each roof. The original sunporches at the end of each wing were trapezoidal in shape; the existing porches are rectangular and date from 1945.

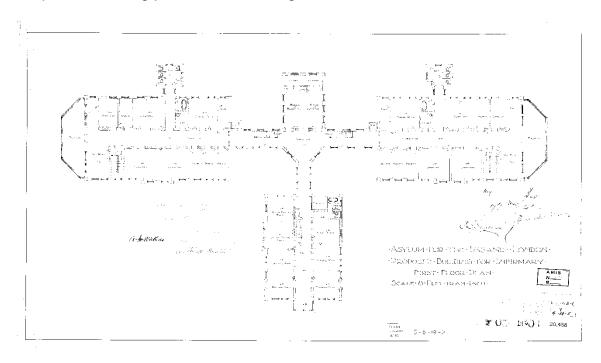
Original floor plan, Infirmary Building, showing administration block below, male and female wards above. Note octagonal sunrooms at east and west facades.

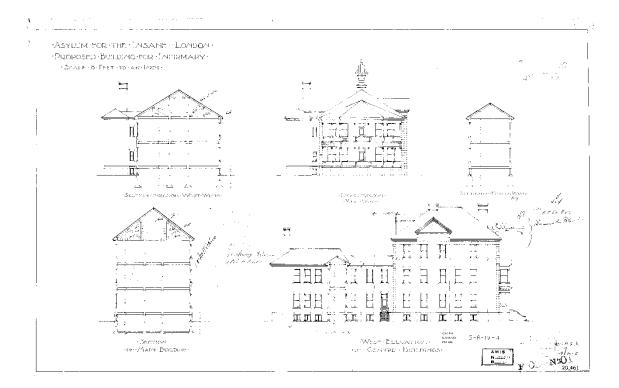
Infirmary Building, original drawings, elevations and sections

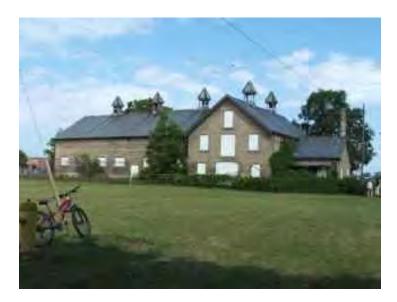
Exterior:

The stable, built in 1894 under the direction of Superintendent Bucke, is an impressive 2 storey buff brick building with a slate roof. There are two intersecting gable roof sections, plus a 1-storey ell with small shed-roofed porch. Five cupolas along the ridgeline provide ventilation and give the building a distinctive silhouette. There is a brick chimney on the east side of the 1-storey ell. The segmental arch windows have decorative brick voussoirs, and most have stone sills. The eaves have tongue and groove soffits and ogee moldings on the vergeboards. A large second storey board and batten door provides access to the hay loft. The scale and quality of materials shows the importance of agriculture to the Asylum and reflects the simplified classical details common in industrial buildings in the late 19th century. The building's significance is as a support building to the main hospital.

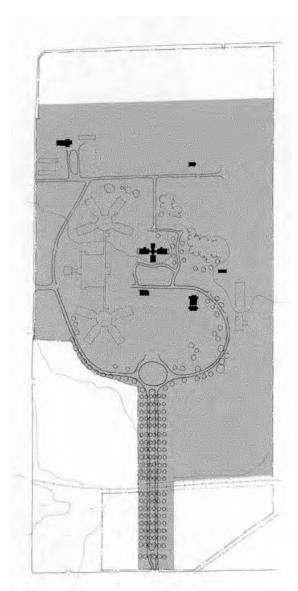
Dark grey zone indicates cultural landscape of provincial significance.

Significant buildings within the designated cultural landscape (listed clockwise starting at the far left)
Horse Bam B12035 Recreation Hall B12029 Infirmary Building B12018
Potting Shed B17057 Chapel B12019

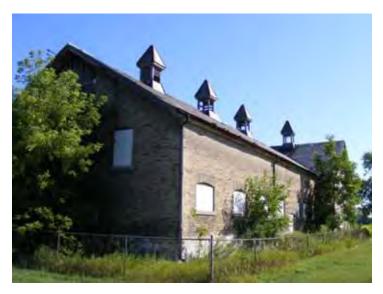
Inside, the building can be adapted for almost any viable use. The particular cross section with its limited second floor height suggests either removing the second floor, already in bad condition in areas of water infiltration, or developing residential uses where each bay is a separate vertical two-storey space. The heavy timber beams define the logical bay sizes. Because of the unusual truss design, a single open space would provide a dramatic setting for certain commercial or community uses. The trusses appear to be structurally sound, but at risk because of ongoing water problems.

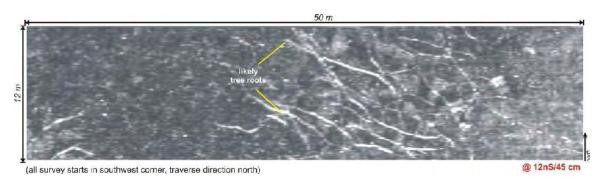
b) 27nS/145 cm

Image 24: Grid 6 Results

Grid 6 (Image 24)

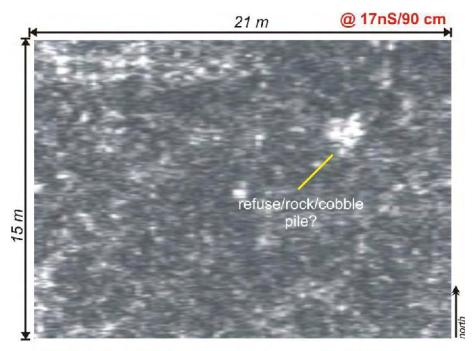
Image 27: Grid 9 Results

(all survey starts in southwest corner, traverse direction north)

Grid 9 (Image 27)

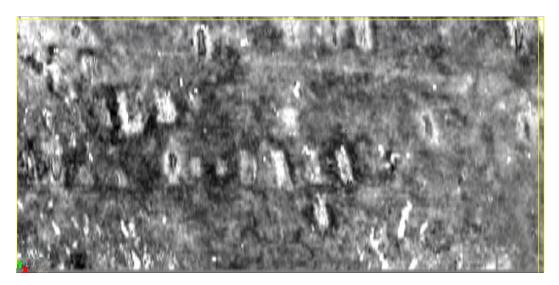
- a) poorly-marked cemetery area with less regular gravel placement (identity withheld for privacy) (TMHC collected data)
 - multiple rows are shown, one at top of image and one at bottom; grave shafts appear as distinct rectangular to ovoid features in white and light grey

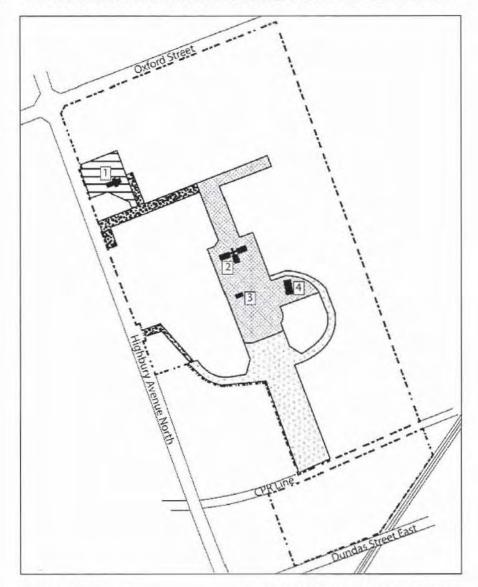
SITE SKETCH SHOWING

- THE APPROXIMATE LOCATION AND CONFIGURATION OF THE PROTECTED LANDS AND THE ACCESS LANDS ON THE FORMER HOSPITAL LANDS
- THE APPROXIMATE LOCATION AND CONFIGURATION OF THE ALLEE AND RING B. ROAD ZONE ON THE PROTECTED LANDS
- THE APPROXIMATE LOCATION OF BUILDINGS ON THE PROTECTED LANDS

SKETCH NOT TO SCALE
